# Shrewton House, Shrewton

A Historic Buildings Statement and history

Report No. B736

July 2017

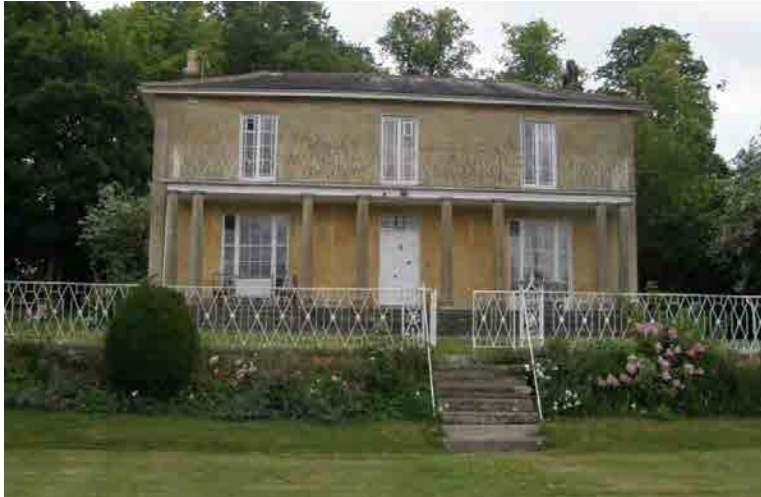
***Fig. 1 Main south elevation and ornamental railings to terrace***

Limestone ashlar front with full-length portico reached by limestone steps repaired in 1979.<sup>6</sup> Two-storey with 3-light margin-pane sashes to principal rooms either side of 6-panel door with rectangular overhead. Unusual arrangement of lantern incorporated into overhead.

Ground floor sheltered by portico of paired Tuscan columns supporting balcony with fine geometric railing matching those in front of house. Three upper floor French casement doors from principal bedrooms leading to balcony.

Shallow hipped slate roof with ashlar stacks on return walls.

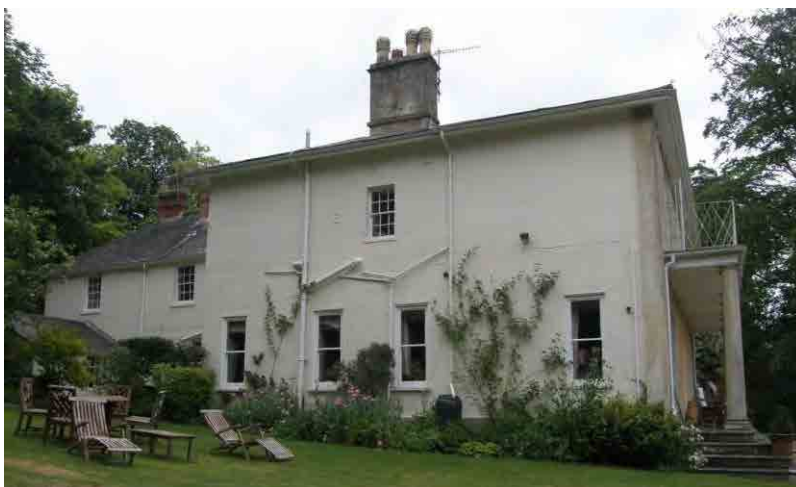
***Fig. 2 West elevation***

The **main south block** of c1830 is rendered, possibly over brickwork. The 1 x 1 ground floor sash windows with projecting sills are all the same, and were therefore inserted in c1956, soon after purchase by Sir Robert and Lady Evelyn Hinde.<sup>7</sup> All have bell-moulding above the lintels. The upper window lighting the bedroom 1 bathroom may be a remodelling of an earlier opening, given its similarity to those in the c1900 rear range.

Ashlar lateral stack with two string courses. Later chimney pots. Flues serving north and south rooms converge above first floor window. Deep eaves to hipped slate roof.

**Rear service range** c1900 of painted stretcher-bond cavity brickwork with reserved 6 x 6 sash windows with projecting sills. Hipped slate roof with two red brick chimneys. Projecting former single storey wash house incorporated into later wing with gabled slate roof. The cellar steps land at a flagstone yard in front of the house, flanked by low rendered walls. To the rear is a partly rendered brick and stone former wash house with gabled slate and clay tiled roofs.

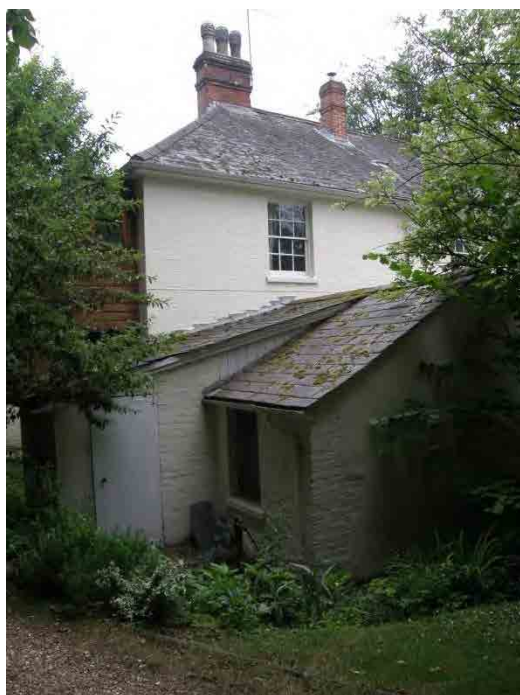
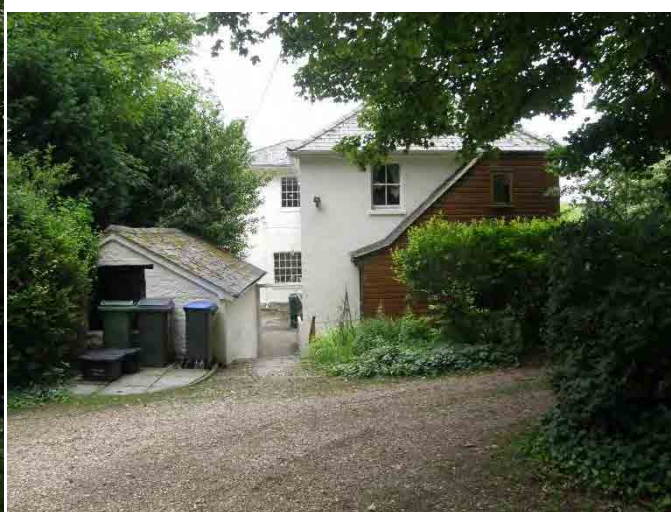
**Fig. 3 Wash house at west of rear**      **Fig. 4 Rear (north) elevation**

Attached to the rear of the main service range is an external weatherboarded stair (**fig. 4**) serving the flat built in the early 1990s<sup>8</sup>. To the east is a brick oil store with slate roof, added in c1900 when the rear service range was built.

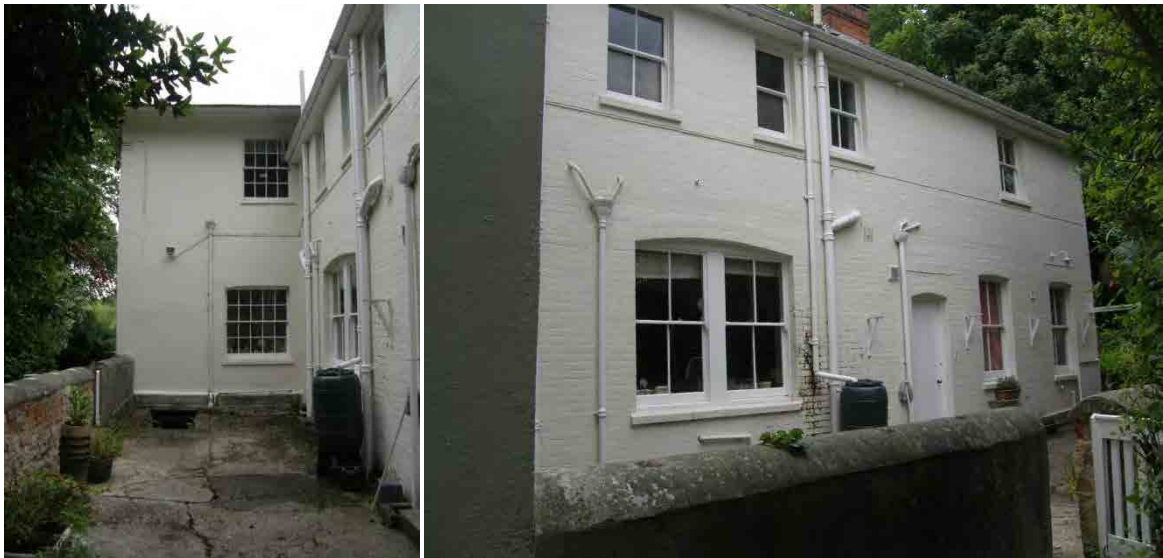
***Fig. 5 Rear of main range, east side    Fig. 6 East elevation of service wing***

The rear of the main block is of render, with east entrance to cellar. The service wing is of cavity wall stretcher bond construction. Ground floor windows with 2 x 2 sash windows and cambered heads, upper openings under the eaves. All enclosed within a rendered brick wall to narrow yard.

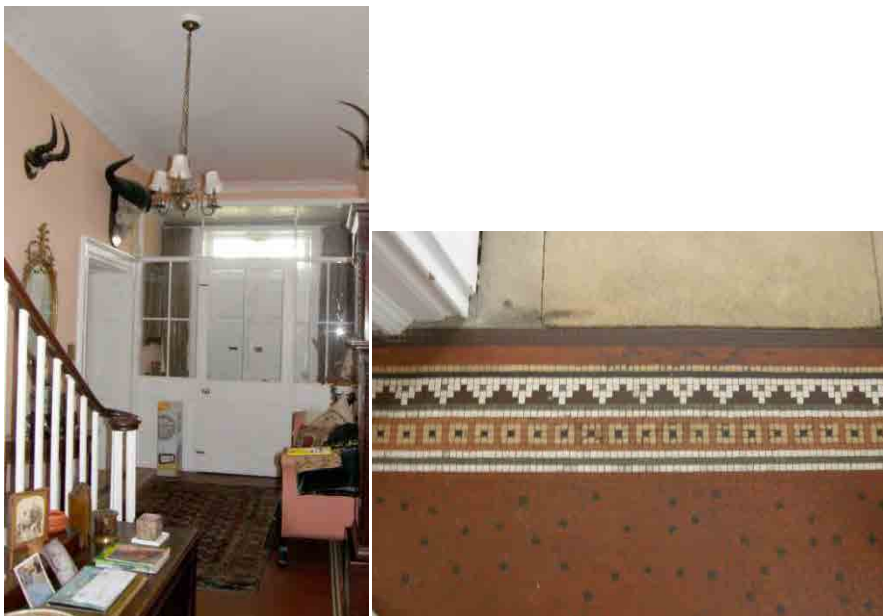
***Fig. 7 Entrance hall***

***Fig. 8 c1900 mosaic hall tiling***

| <b>Floor:</b> | Red and black mosaic with polychrome border of c1900. Let into former stone sett floor, one edge of which is still visible in front of the dining room door. |
| <b>Staircase:</b> | Original stone open-well stair with cut string and simple rounded nosing. Stick balustrade with plain mahogany handrail wreathed to cast iron newel on curtail step. |

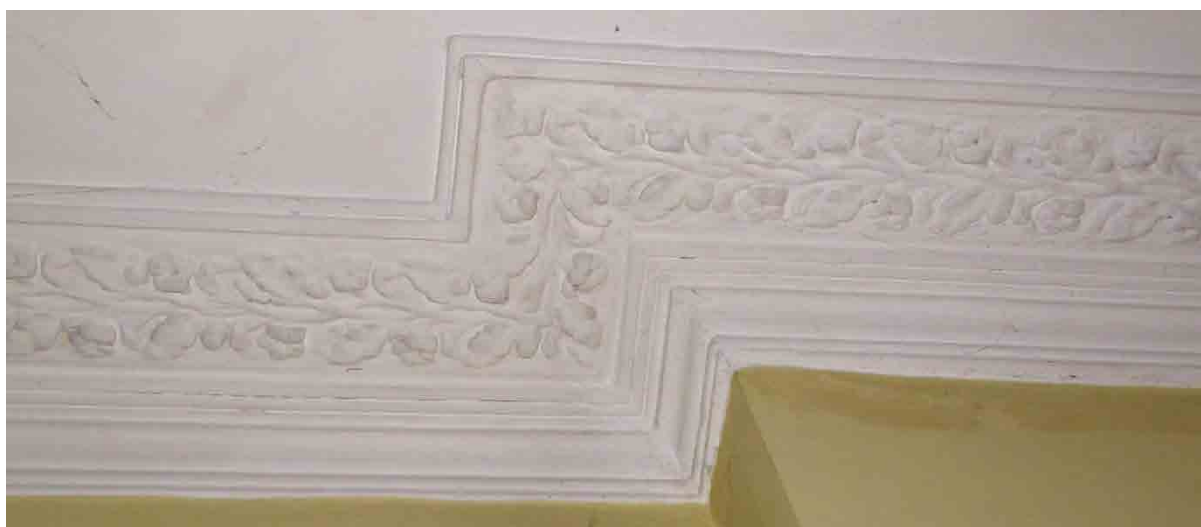
**Fig. 9 Oak leaf and acorn ceiling band within reeded moulding**

| <b>Ceiling:</b> | Lath and plastered with small ogee-moulded cornice and decorative ceiling band with oak leaf and acorn trail. |

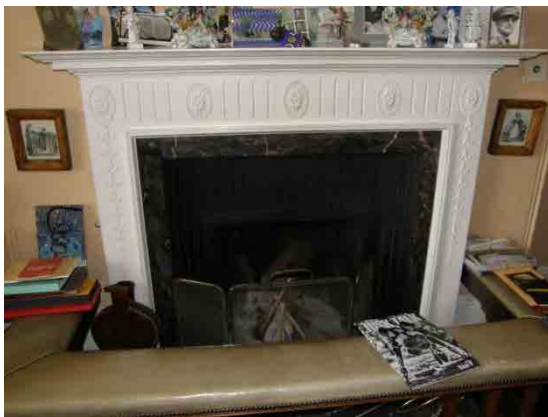
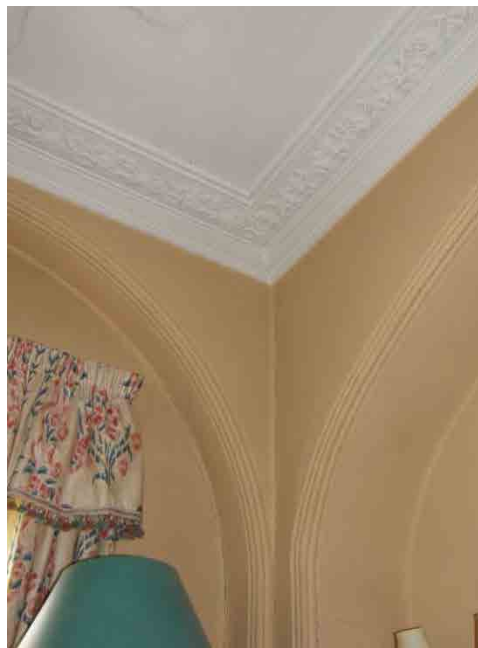
**Fig. 10 Mid-1950s chimneypiece**    **Fig. 11 Arched moulded recesses and ceiling band**

- Ceiling:** Lath and plastered with pulvinated cornice and vine trail ceiling band.
- Walls:** As above. The back wall has a wide segmental-headed recess with later-inserted (probably mid-20<sup>th</sup> century) tri-partite inner recesses, the central being round-headed and taller. The inserts combine shelving with single-panel cupboards below.

**W4-5** (side windows) As W2. Both have been inserted into round-headed feature recesses either side of the fireplace. The arrises of the recesses are reed-moulded.

**Fireplace:** Mid-20<sup>th</sup> century chimney-piece, as in dining room.

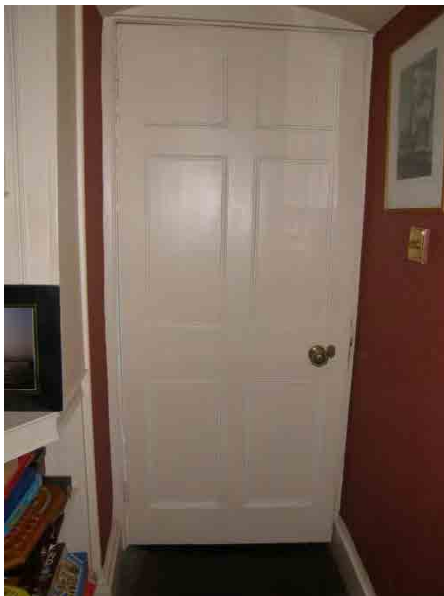
**Fig. 11** 6-panel door to hall (D5)

**Doors:** **D5** (from hall) 6-panel on smaller scale. Hung on plain butt hinges. Flattened ogee-moulded architrave externally. Internally the door has been encased by a full-height wall unit incorporating moulded shelves in round-headed recesses, and panelled door cupboards beneath.

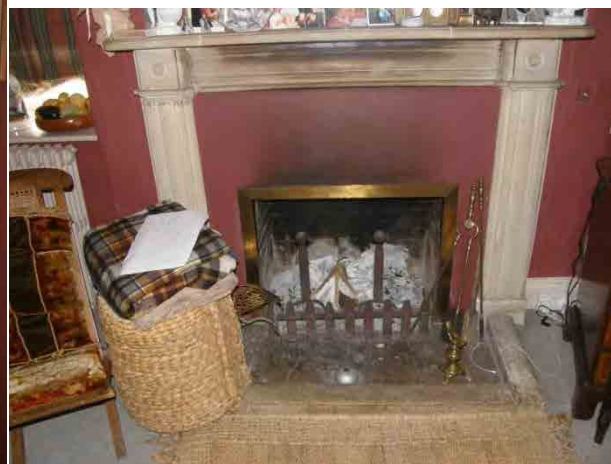
**Fig. 12** Possibly original chimneypiece

- D6** (from kitchen) 6-panel as D5. 6-pane rectangular overlight with moulded glazing bars. Simple architrave surround.
- Windows:** **W6-7** As W4-5, mid-20<sup>th</sup> century.
- W8** 10x10 sash, no horns. Mid-20<sup>th</sup> century replacement of later 19<sup>th</sup> century window. Sunk panelled shutters. Plain shelf.
- Fireplace:** Possibly original (**fig.12**). Limestone with reeded and pulvinated jambs. Corner blocks with roundels and plain mantelshelf. Stone kerb added later.

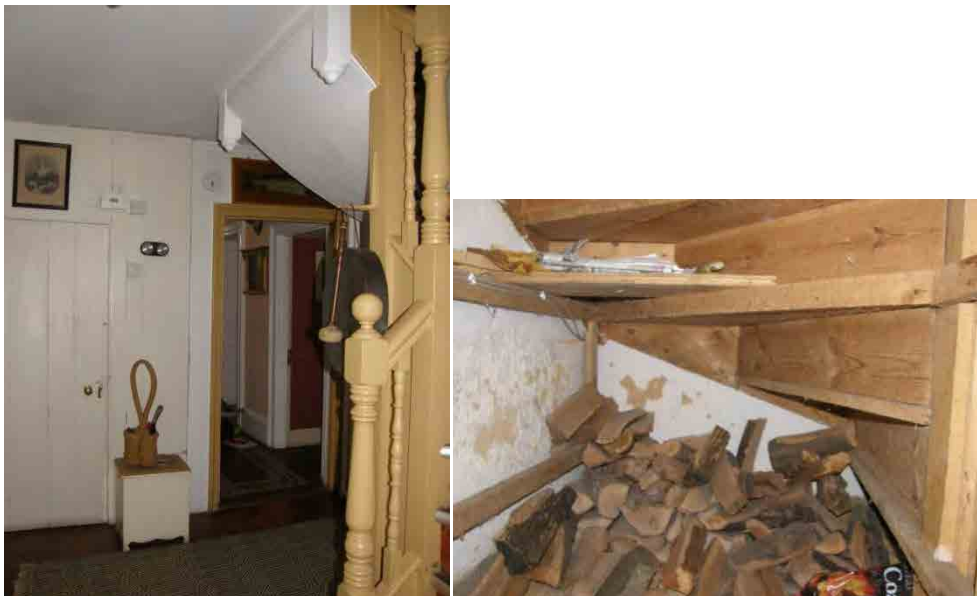
**Fig. 13** Rear of hall with entrance to cellar on left **Fig. 14** Construction of service stair

**Stair:** The servants' stair is a semi-newel type of painted softwood with chunky bottle-shaped balusters and newel with a ball finial. The treads and risers are covered in linoleum, but the sawn softwood construction is seen in the understair cupboard (**fig. 14**).

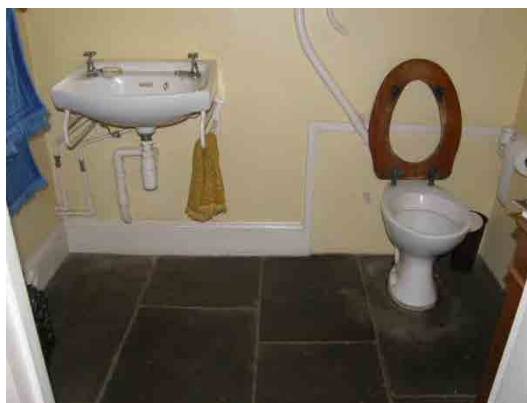
**Fig. 16 WC of c1900 with later hand basin**

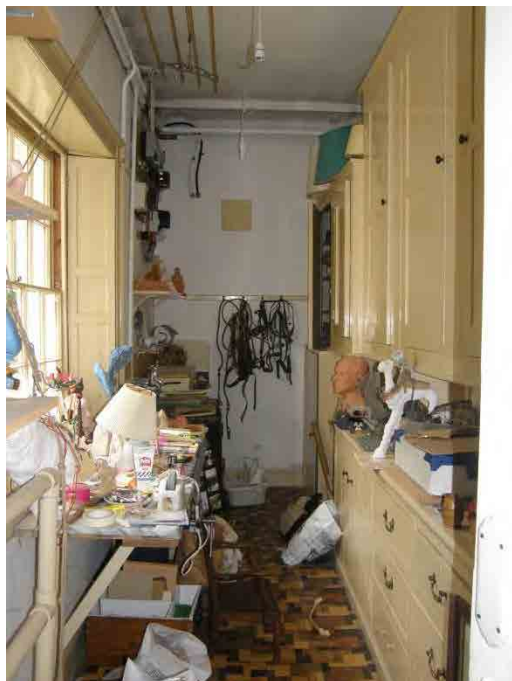
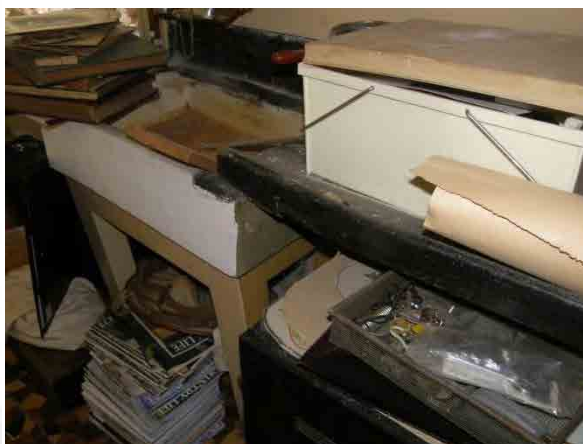
**Fig. 17 China pantry**

**Fig. 18 Belfast sink and drainer**

**Other Details:** Range of possibly c1878 fitted china cupboards on back wall including metal safe (**fig. 17**). Shelf on brackets on front wall with holes for holding curve-bottomed objects. Gate-leg fold-out table in front of window. Old boxing in angle by door probably for wires from servants' bells. Old Belfast sink with leaded draining board and replacement later 20<sup>th</sup> century taps (**fig. 18**).

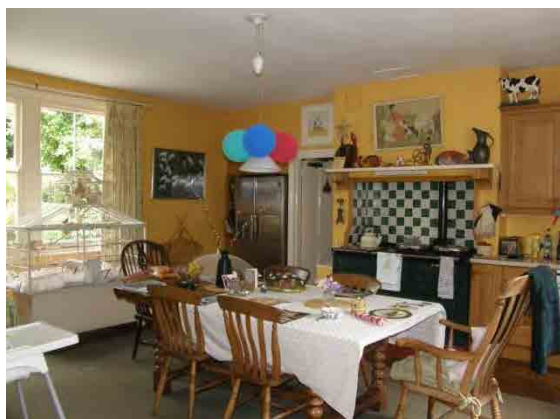
**Fig. 19 Kitchen**

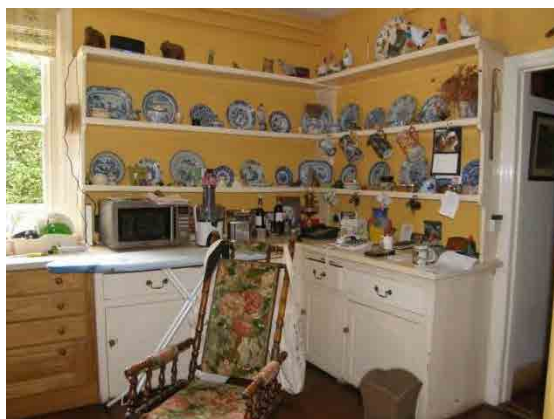
**Fig. 20 Fitted L-shaped dresser**

- W13** (west) As W12.
- Fireplace:** The original hearth has been entirely remodelled in the later 20<sup>th</sup> century.
- Other details:** Good corner dresser with moulded lips on shelf edges for plates. Drawers with drop-loop handles and lower cupboards with fielded panel doors. Wooden knob handles on cupboard doors are modern (**fig. 20**).

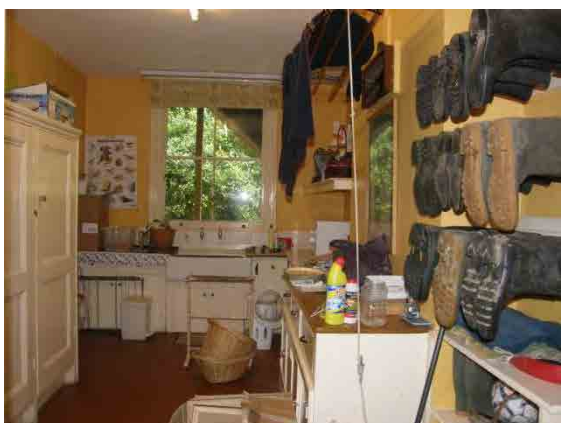
**Fig. 21** Rear utility area

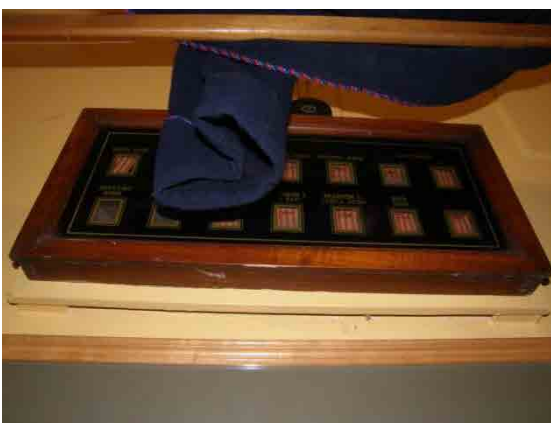
**Fig. 22** Servants' bell in utility area

| <b>Other Details:</b> | Original fittings of c1916 lining walls, including Belfast sink with wooden wrist rest.<br><br>Chimney breast now blocked in by later fittings.<br><br>Servants' bell board high on west wall ( <b>fig. 22</b> ). |

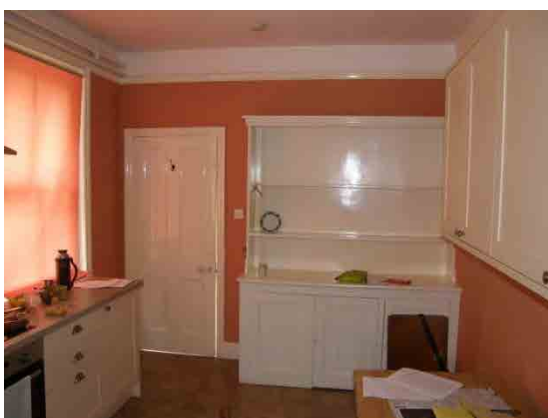
**Fig. 23** Dresser and entrance to side passage

| <b>Other:</b> | Good old dresser with 2 tiers of shelves and sunk panelled cupboards below. Probably c1900 ( <b>fig. 23</b> ). |

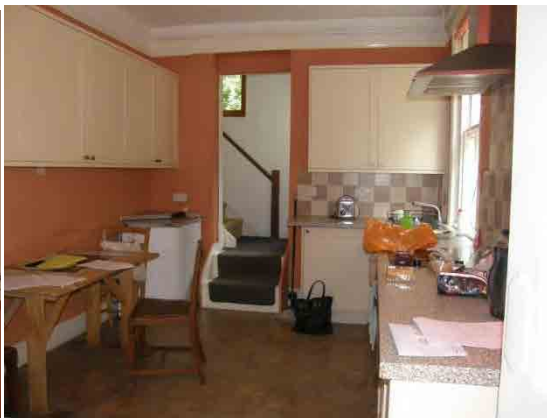
**Fig. 24** Added stair to first floor

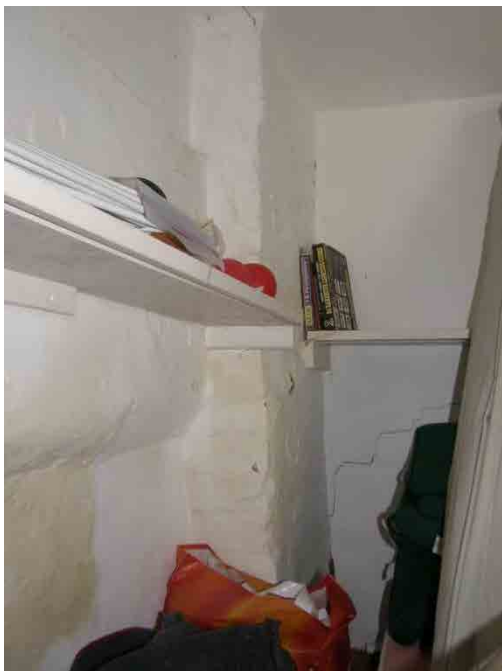
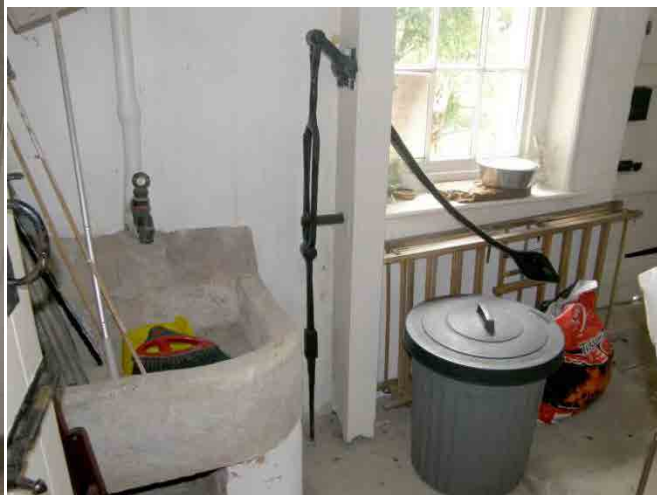
**Fig. 25 Former flue to boiler**

**Fig. 26 Hand pump and stone sink**

This was originally a single wash house with a boiler in front of the former fireplace on the west wall (**fig. 25**). Divided after 1916 into present proportions, and flue blocked.

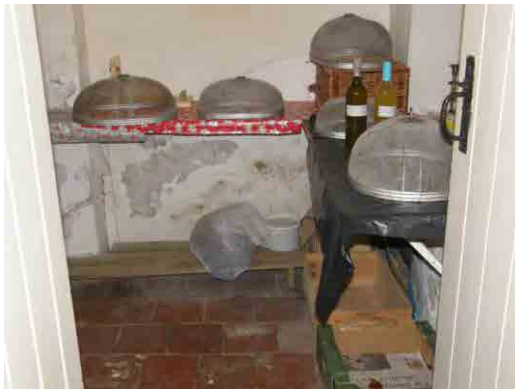
**Fig. 27 Interior of larder**

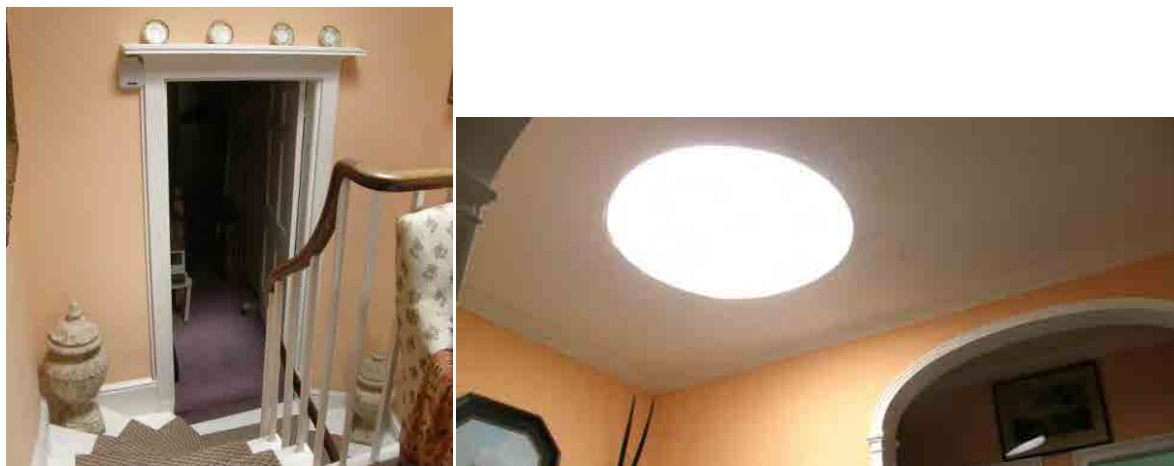
**Fig. 28** Doorway connecting landing to rear extension

**Fig. 29** First floor landing ceiling with lantern

- Ceiling:** Plastered/plain with small moulded cornice. Central lantern above round shaft, staff moulded at base. Single pane of glass replacing earlier lantern (**fig. 29**).
- Walls:** Plastered/plain with small torus-moulded skirting. The side bedrooms are approached through a basket arch with recessed reveals and moulded caps.
- Floor:** Carpeted.
- Door:** **D23** (to rear wing) Later-added reeded doorway, tall with plate ledge over. C1900. This is a remodelling of a doorway that led into a box room originally (**fig. 28**).
- Other Details:** The well is guarded by a continuation of the stick balustrade and mahogany handrail.

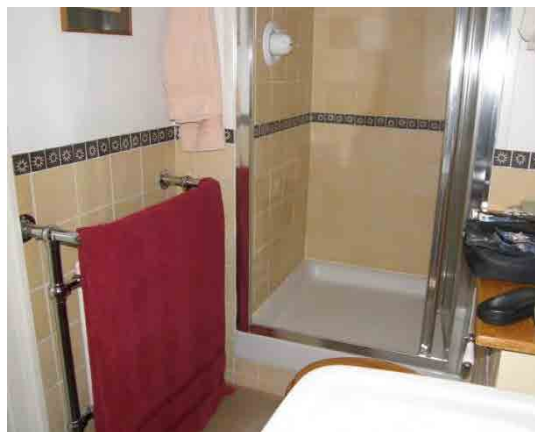
**Fig. 32 2 En-suite bathroom**

| <b>Walls:</b> | As above. Small en-suite bathroom created at one end with modern stud wall, perhaps later 20 <sup>th</sup> century, Incorporates a bookshelf at one end ( <b>fig. 32</b> ). |

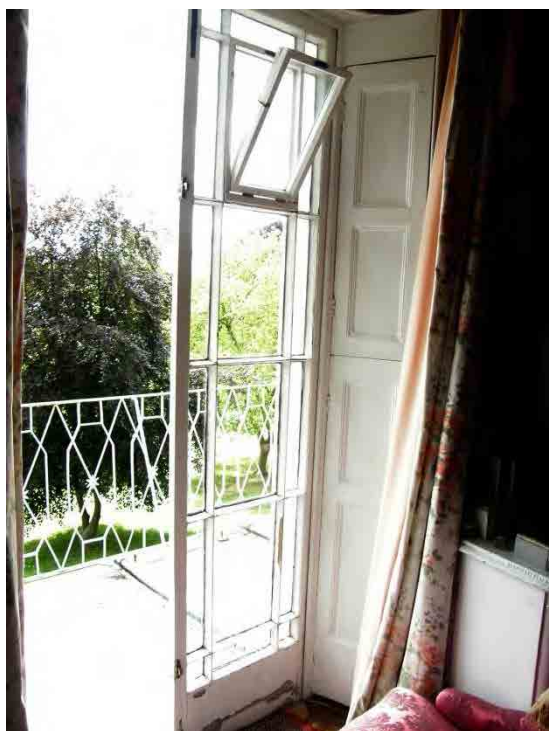
**Fig. 33** French casement door D30

| <b>Doors:</b> | <p><b>D28</b> 6-panel on butt hinges. Replacement knob handles and finger plate. Attenuated ogee arch surround.</p> <p><b>D29</b> (to cup'd) As D21. Possibly added later. The architraves and doors are the same all round.</p> <p><b>D30</b> (to balcony) Full-glazed doors with plain chamfered glazing bars. Margin panes. 2 small infilled sections around the middle of the jambs externally indicate former fixings for shutters or canopies. Full-height sunk panelled shutters in shutter boxes with moulded attenuated ogee architrave surround (<b>fig. 33</b>).</p> <p>The French casement doors give onto a leaded balcony guarded by a geometric iron balustrade. At the intersections on the crossed ribs are cast iron 6-pointed stars (<b>fig. 34</b>).</p> |

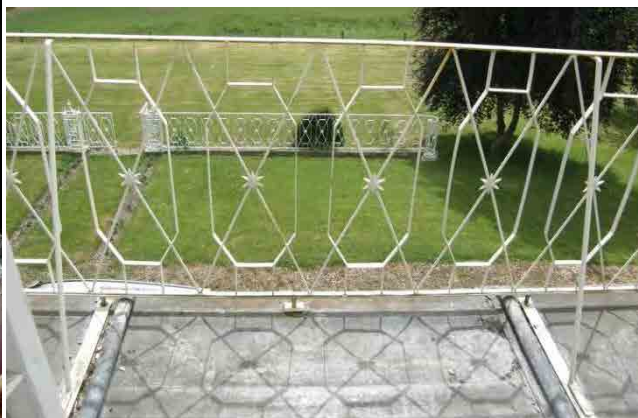
**Fig. 34** View from balcony

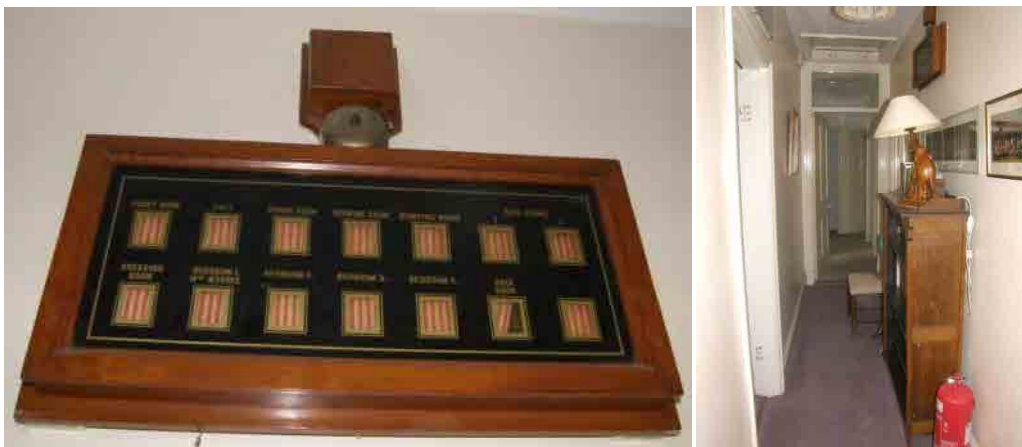
**Fig. 40 Servants' bells**

**Fig. 41 Corridor looking north**

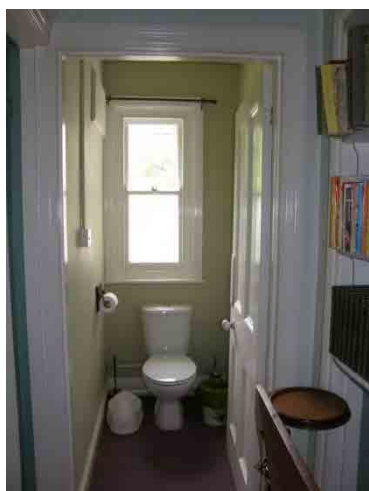
**Fig. 42 WC with blocked doorway to right**

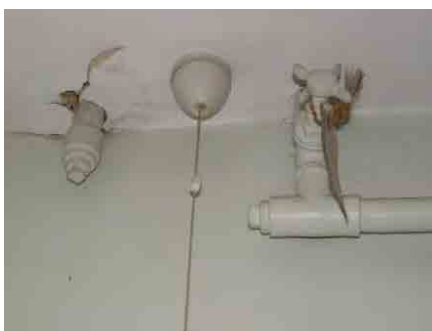
**Fig. 44 Remains of older piping**

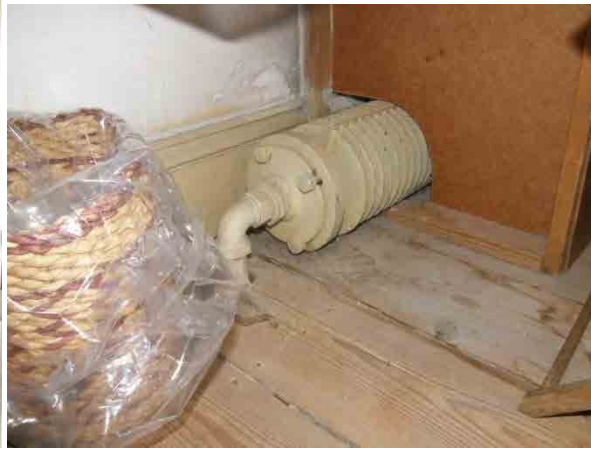
**Fig. 46 Possibly original radiator**

| <b>Other Details:</b> | Room warmed by low, cylindrical radiator of early 20 <sup>th</sup> century date (fig. 46). |

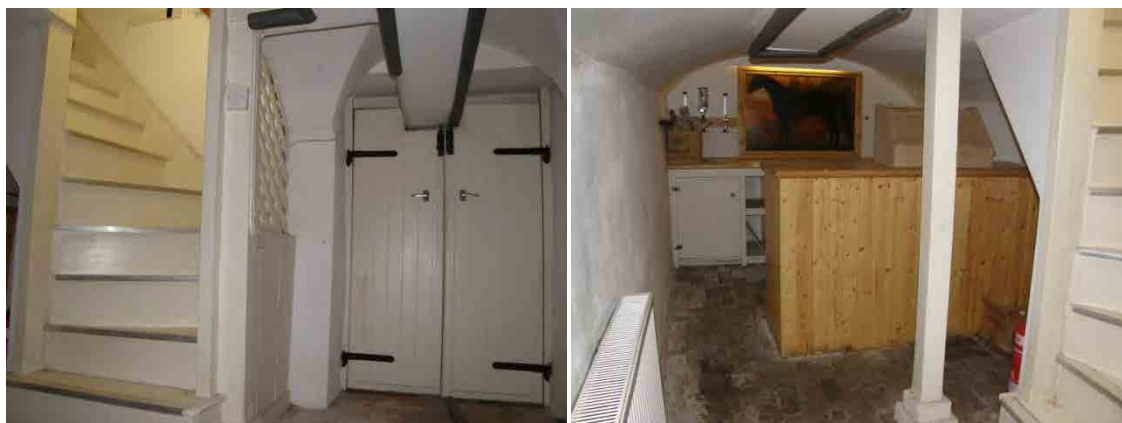
The cellar has been extensively modernised during the present ownership and has been divided into 4 main areas. The enclosed stair appears to be a modern replacement, or has modern linings (**fig. 59**). At the bottom the stair is closed in with a lattice of thick batten. All the rooms have been tanked, with modern linings unless otherwise stated. The west rooms may have housed the original kitchen, though these rooms have been thoroughly remodelled within the last 20 years.

**Fig. 59** Internal cellar stair and modern doors to rooms 5 & 6

**Fig. 60** Bar area (Room 1)

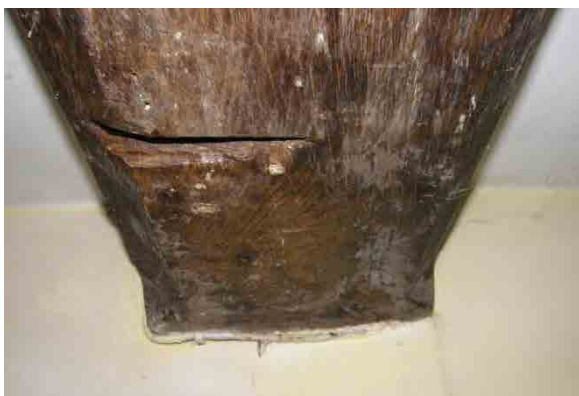
**Fig. 62 Detail of reused C17 beam**

- Ceiling:** Two reused earlier 17<sup>th</sup> century beams with deep chamfers, the east with step and runout stops at the north end (**fig. 62**). New plastered ceiling.
- Walls:** On the south side the partition wall to room 4 has been partly removed, leaving structural piers, to combine with room 3.
- Doors:**
- D51** (exterior) Wide 3-panelled door, planked externally. On strap hinges. Probably c1900. Leads to a stairs to ground floor level from the semi-basement.
  - D52** (redundant internal door) As door to wine bins. On 3 sets of butt hinges.
- Window:** **W32** Modern 3-light timber casement with single panes to light-well covered in metal grille.

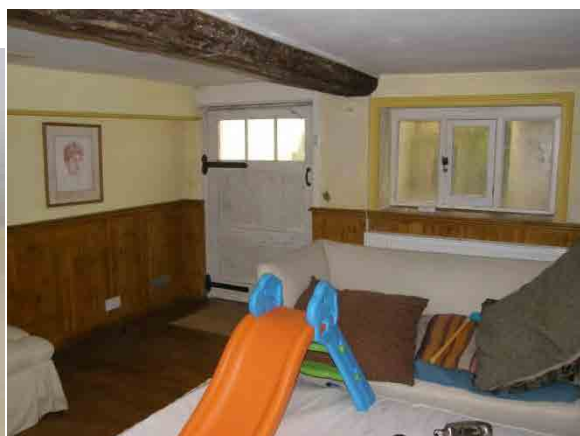
**Fig. 63 Play room (3)**

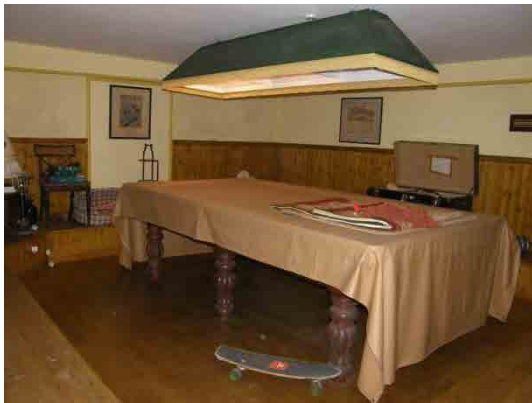
**Fig. 64 Billiard room (4)**

- Floor:** This is sunk well below the level of room 3, with a low ledge around the walls. All panelled over.
- Other Details:** At one time the middle window sashes at the front of the house on the ground floor were able to slide down into the basement to allow direct access to the veranda.

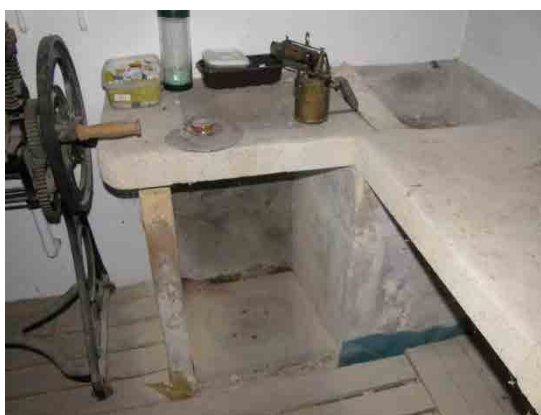
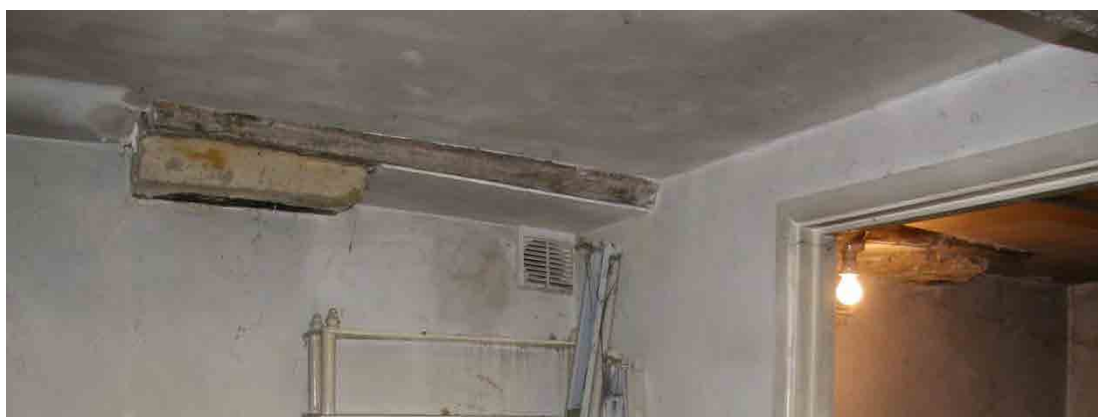
**Fig. 66 Worktops, sink and drain (4)**

**Fig. 67 Stone corbels once supporting the kitchen hearth above**

- Ceiling:** 2 rectangular whitewashed softwood beams, the westerly with cargo marks. Against the east wall are two stone corbels which once supported an upper hearth (**fig. 67**). Nothing above on the ground floor now. The first floor has a fireplace above this position. The floor must have been reinforced at the time to support it.
- Walls:** Plastered/painted. Modern partitions to hide heating plant.
- Floor:** Earth floor now covered in damp membrane and modern timber wide-spaced slats.
- Door:** **D53** (exterior) 3-panel as D51. One large upper pane protected with iron spear-ended lattice. Leads to exterior ground floor level via steps.
- Window:** **W33** As W32.
- Other Details:** Stone work bench similar to wine bins around north wall returning to west. Pierced stone drain (**fig. 66**).

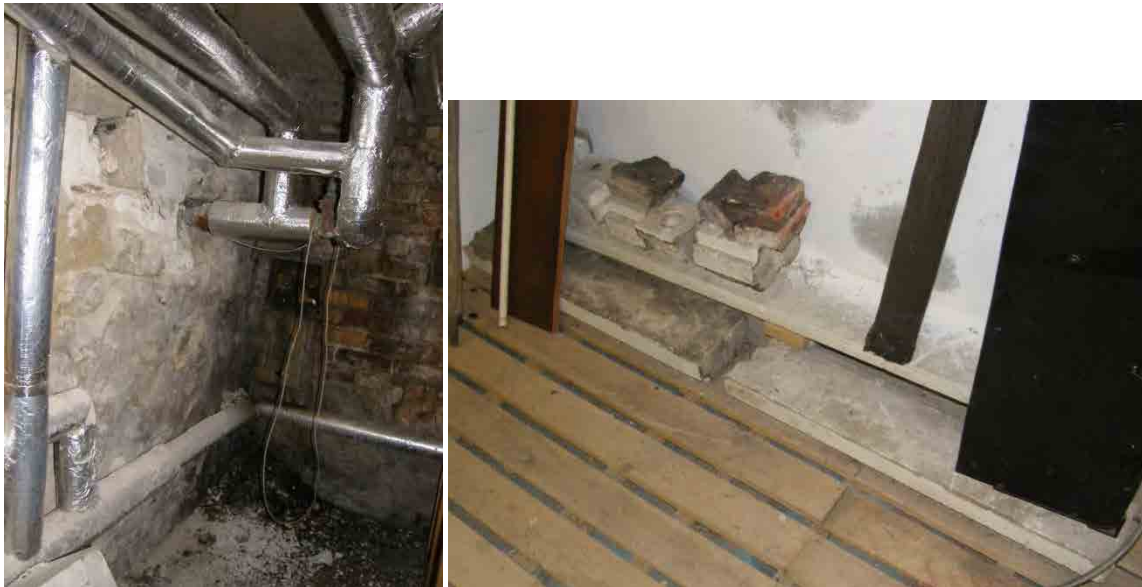
**Fig. 68** Section of unplastered wall in area of heating ducts between rooms 5 & 6

**Fig. 69** Dismantled c1830 fireplace in cellar similar to that in Sitting room (fig. 12)

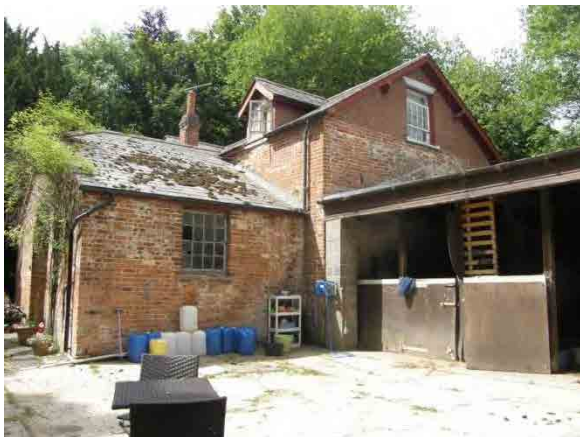
**Fig. 70 Stables from east**

Of Flemish bond brickwork. Unlisted, though main range containing stalls shown on map of 1832. Main range is a 2-storey building under gabled Welsh slate-tiled roof. Low single-storey entrance range at right angles with wide half-hipped roof and basket-arched entrance possibly added in the later 19<sup>th</sup> century. Paved in struck blue paving. To the left of the entry is a tack room with fireplace and tack hooks (**fig. 72**), reached via a diagonally-boarded door under a segmental head (**fig. 73**). To the right is a further tack room with vertically boarded dado and ceiling hook. Lit by 8x8 glazing bar sash.

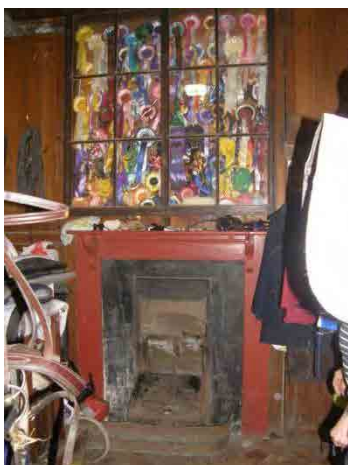
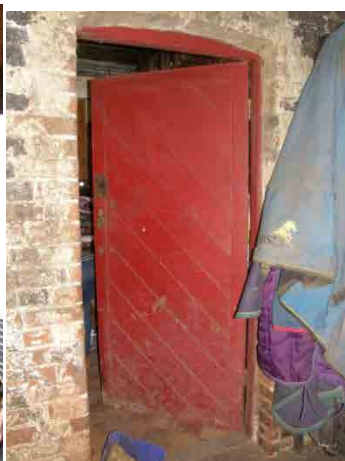
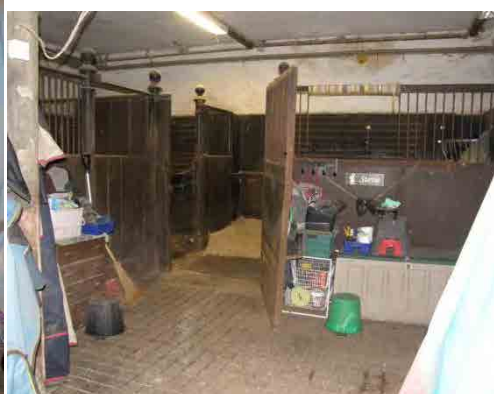
**Fig. 72 Fireplace in tack room Fig. 73 Diagonally-boarded door Fig. 74 Stable interior**

The main stable has 4 loose boxes with iron stanchions, racks and vertical tongue and grooved boarding (**fig. 74**). Vertical shutter runs in grooves between the stable and entrance ranges. In 1987 approval was given to convert the loft into a studio with external staircase<sup>10</sup>.

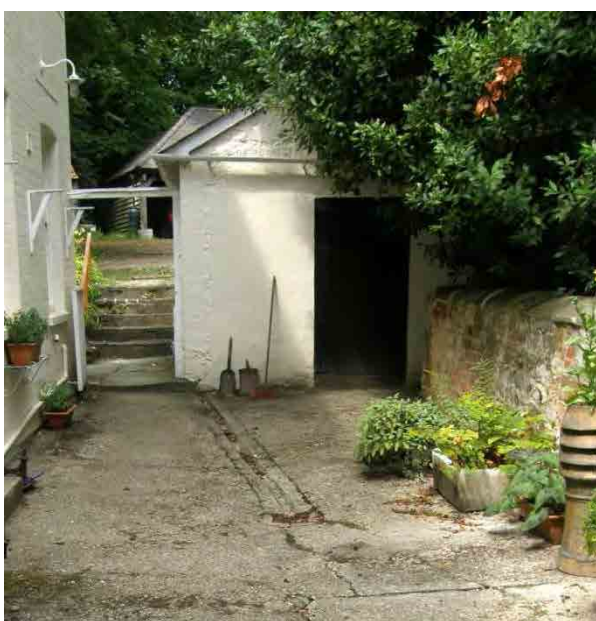
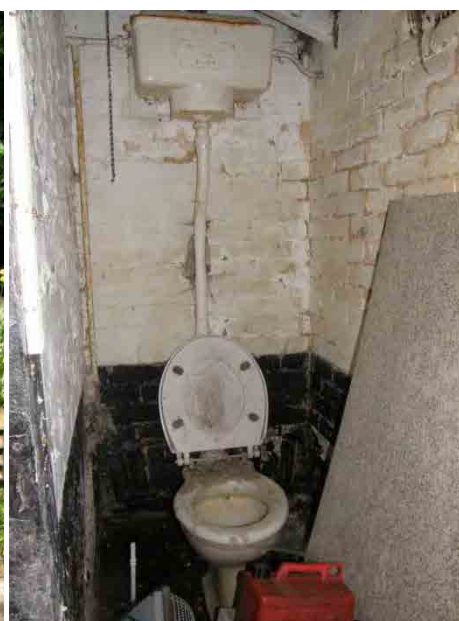
***Fig. 77 Oil store from the east yard***

***Fig. 78 WC attached on east side***

This brick and slate-tiled building does not appear on the Ordnance Survey map edition of 1924, but must have been built soon afterwards. The attached WC still retains a high-level water cistern and sanitary ware.

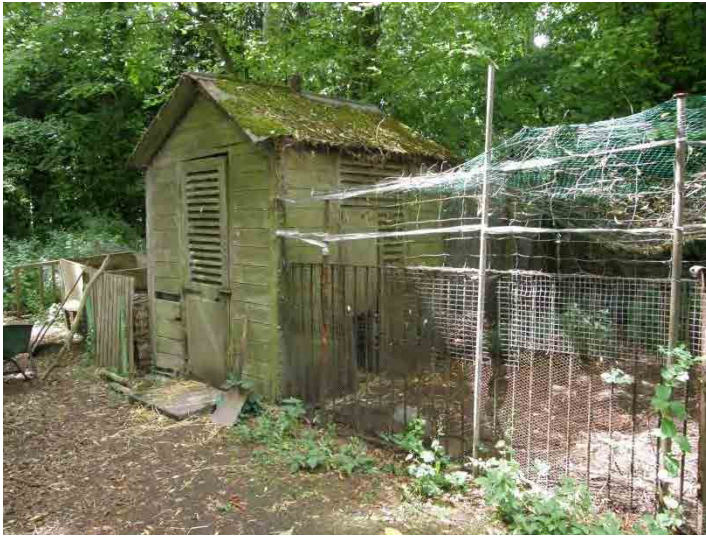
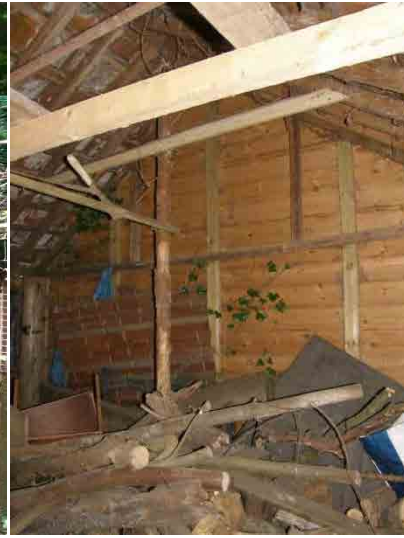
***Fig. 79 Hen house and run***

***Fig. 80 Interior***

To the west is a timber-framed and weatherboarded wood shed with pitched single-roman tiled roof of pre-1881 date. Internal construction shows an internal horizontally-boarded partition. Central timber post rising to support planked ridge directly. Truss-less roof of mid-later 19<sup>th</sup> century. It was once used as a dog kennel<sup>11</sup>.

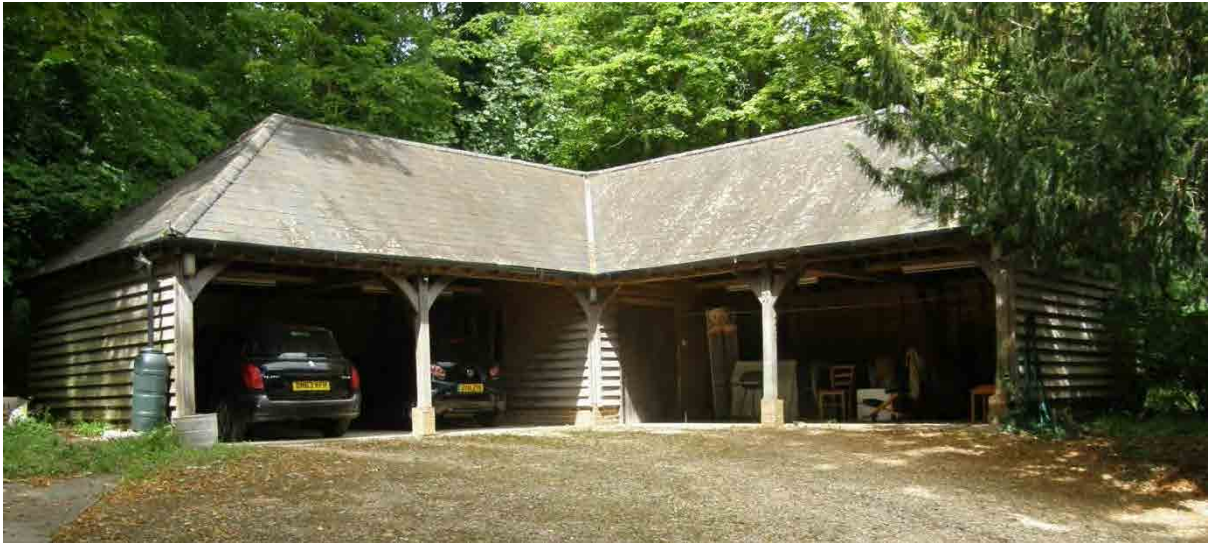
***Fig. 81 Modern garage***

Modern timber-framed and weatherboarded L-shaped garage. Permission to construct this was given in 2002.

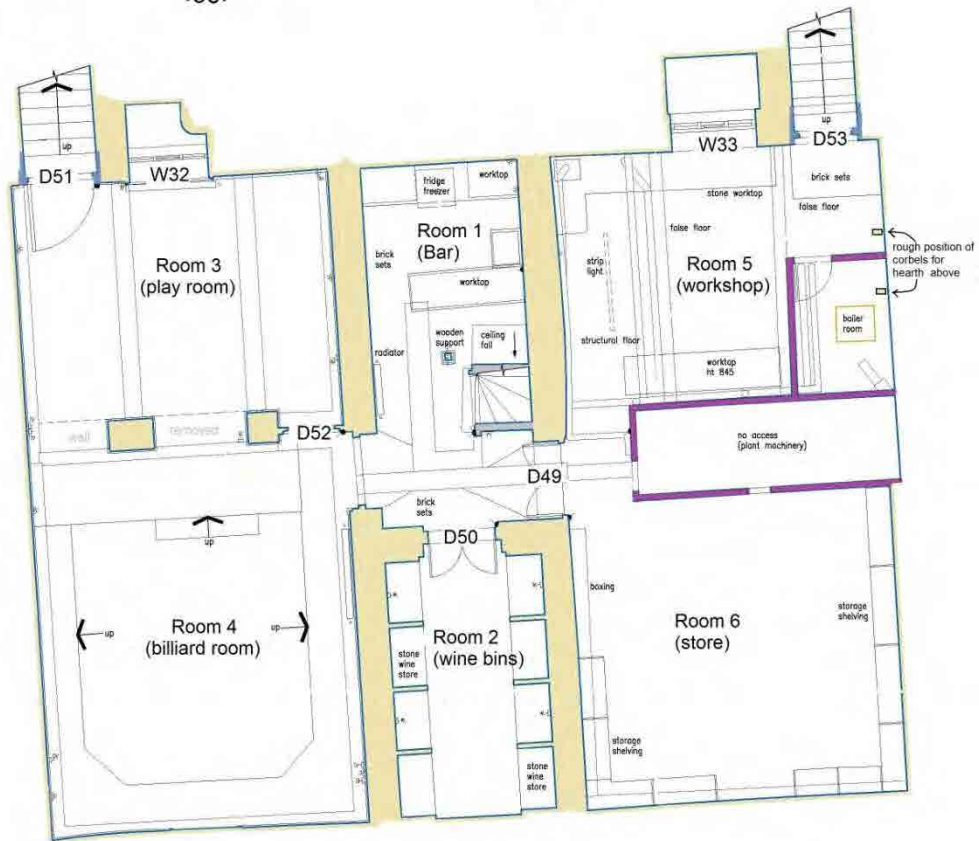
CELLAR

MAPPING HISTORIC FABRIC  
 C.1830  
 Between 1900-1916  
 Early C20

Annotation of Cadplan drawing by Dorothy  
 Treasure  
 Wiltshire Buildings Record  
 July 2017
