# Arboricultural Impact Assessment & Tree Protection Plan For trees on land at Chicklade

Inspected and Prepared by Nick Baxter BSc(Hons) MArborA  
27<sup>th</sup> January 2026

| <b>A new solar farm is proposed</b> | The trees considered in this report are located on land at Chicklade (SP3 5ST). This report identifies the arboricultural impact for a plan to create a new 3 megawatt solar farm at the site. |

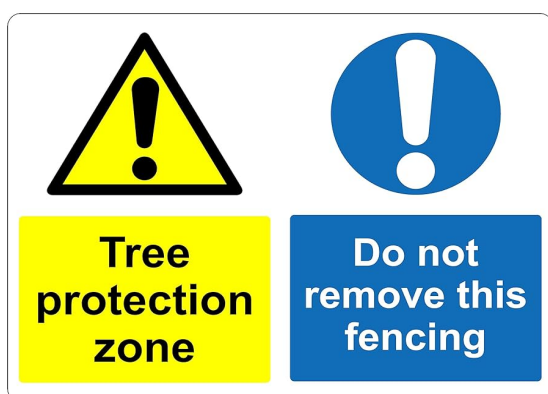
Figure A: An example of signs that should be attached to the fencing.

All-weather notices should be attached to the fencing with words such as: 'Construction Exclusion Zone - No Access'. Throughout the construction period attention should be paid to ensure that barriers remain rigid and complete.
