1 PROPOSED SOUTH WEST ELEVATION  
4 2 S H U R N H O L D

2 PROPOSED NORTH WEST ELEVATION  
4 2 S H U R N H O L D

3 PROPOSED NORTH EAST ELEVATION  
4 2 S H U R N H O L D

4 PROPOSED SOUTH EAST ELEVATION  
4 2 S H U R N H O L D

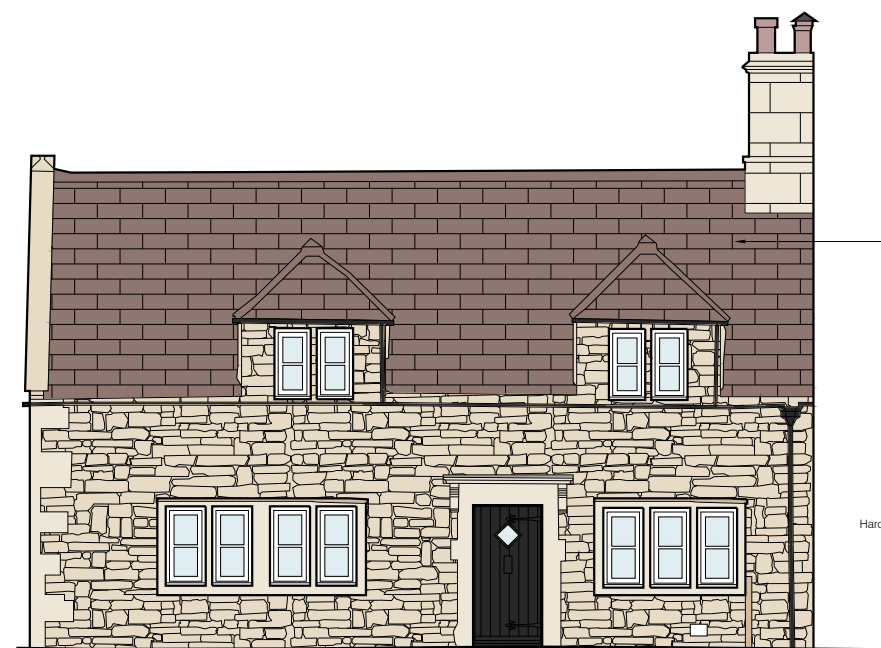
Existing roof tiles to be replaced with tiles removed in good condition from the rear roofscape.

Black cast iron SVP

Glazed roof lantern over

Hardwood timber painted frieze

Hardwood timber painted columns

Hardwood timber painted French Doors

Hardwood timber painted windows with low cills

Cotswold rubble stone plinth

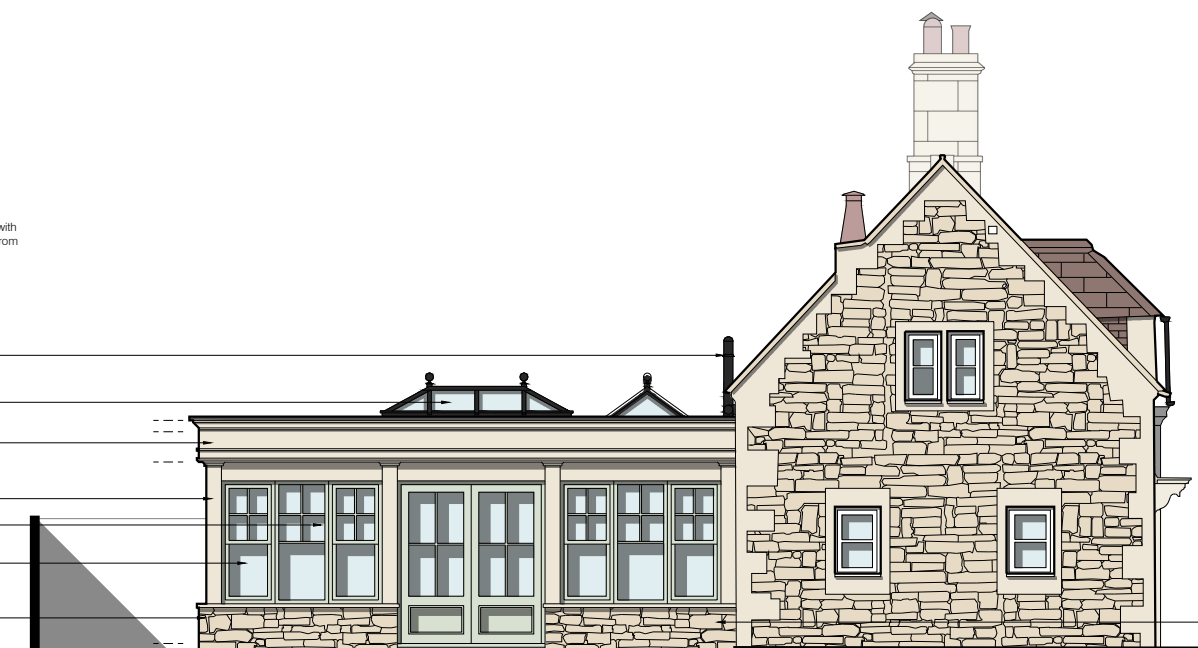
Proposed extension set back from existing building

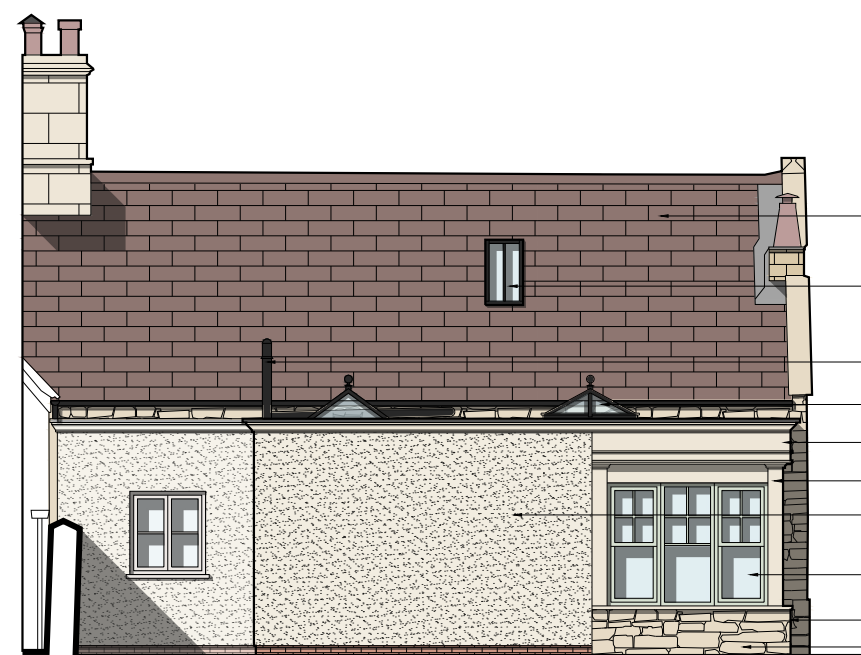
Existing roof tiles to be replaced with 'Bradstone' roof tiles to match neighbouring extension roof. Tiles removed in good condition to be reused on the front roofscape.

Small flush conservation roof window

Black cast iron SVP

Glazed roof lanterns

Hardwood timber painted frieze

Hardwood timber painted columns

Through colour render to less visible elevations

Full height windows with low cills

Proposed extension set back from existing building

Cotswold rubble stone plinth

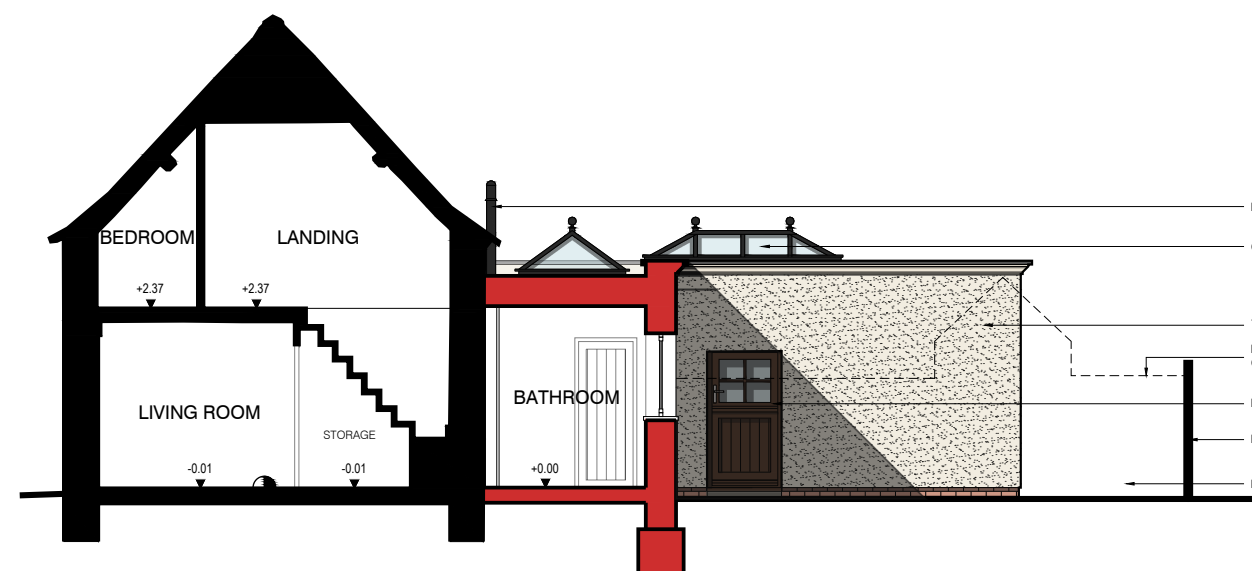
Black cast iron SVP

Glazed roof lanterns over

Through Colour Render

Line of Existing Boundary Fence & Outbuilding Shown Dashed

Existing stable door reused

Existing Boundary Fence Retained

Perimeter Access
