# DEVIZES CASTLE.

Heritage  
Appraisal.

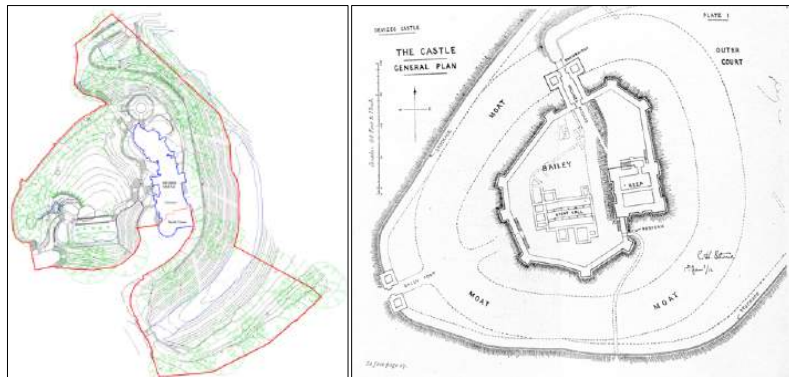
Figure 1 Current plan, & reconstruction of the mediaeval castle (as reproduced in *Devizes Castle, its History and Romance*).

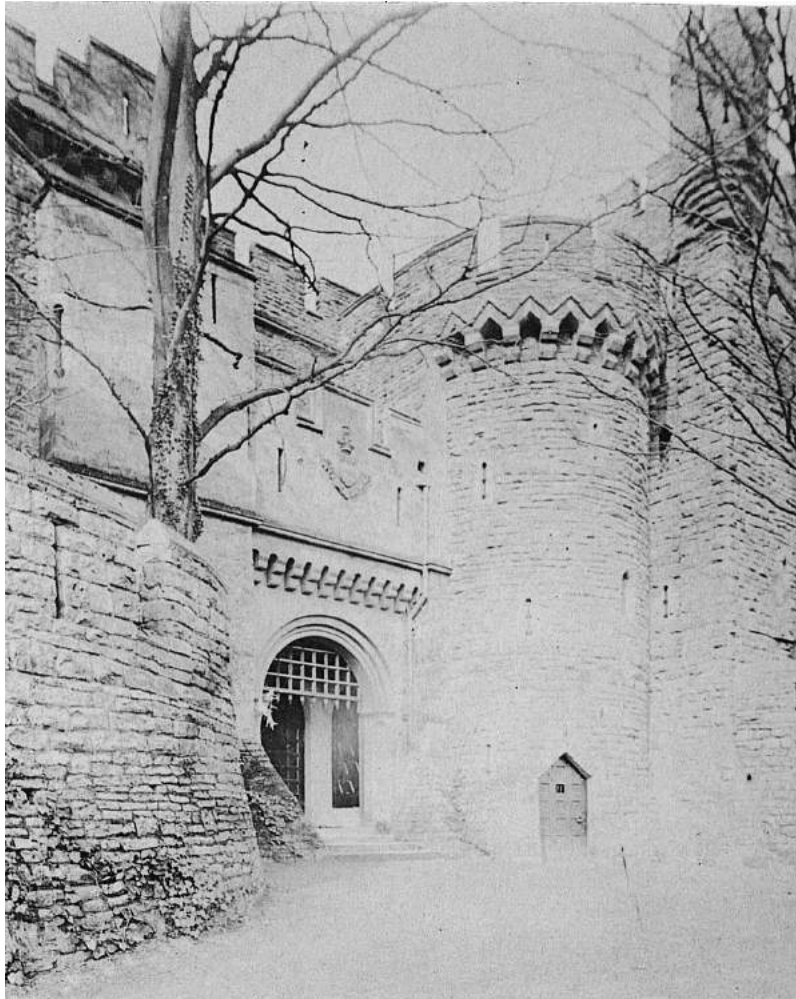
**Figure 6** Photograph of the entrance from the south c.1883, showing Valentine Leach's earlier *Portcullis Gate* embedded in later rock-cut masonry (© Wiltshire Museum, Devizes; DZ/WJ:1983.7725).

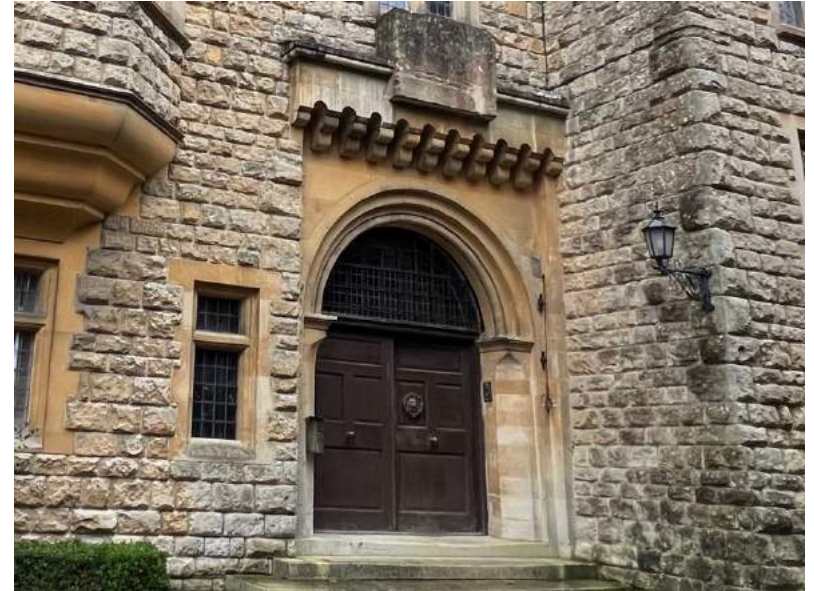
**Figure 7** Current entrance door.

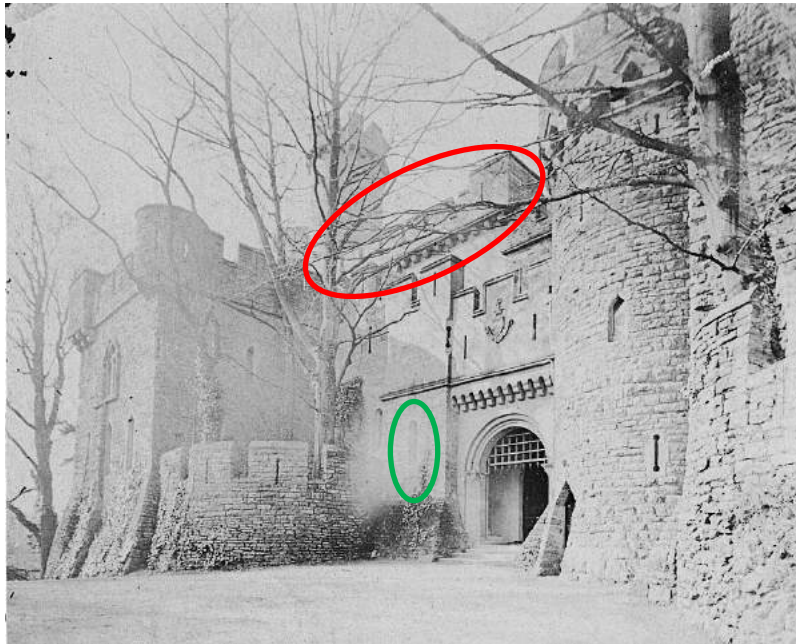
**Figure 8** View of the entrance from the north, from the 1883 sales particulars (© Wiltshire Museum, Devizes; DZ/WJ:1983.7725), window visible in the 1843 sales particulars, eastern parapet of dining room block.

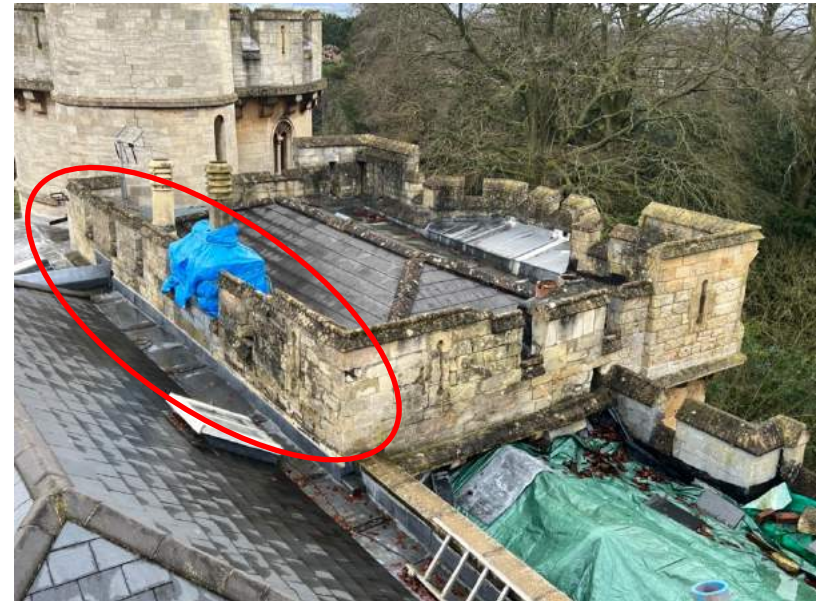
**Figure 9** Eastern parapet of dining room block.

- 5.10 The dining room block was also originally faced in ashlar. The eastern parapet, visible in 1883, still survives, although now obscured by later roofs, & although badly weathered, is ashlar.

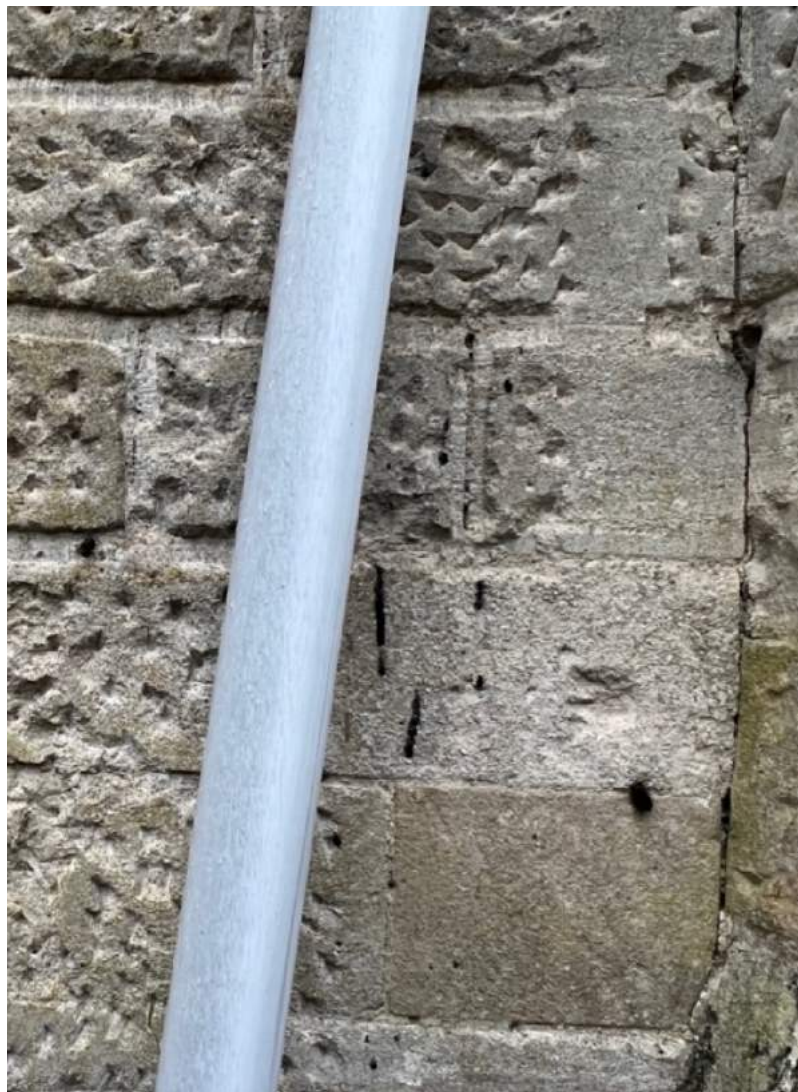
Figure 10 West front of dining room block, masonry to right of bay window.

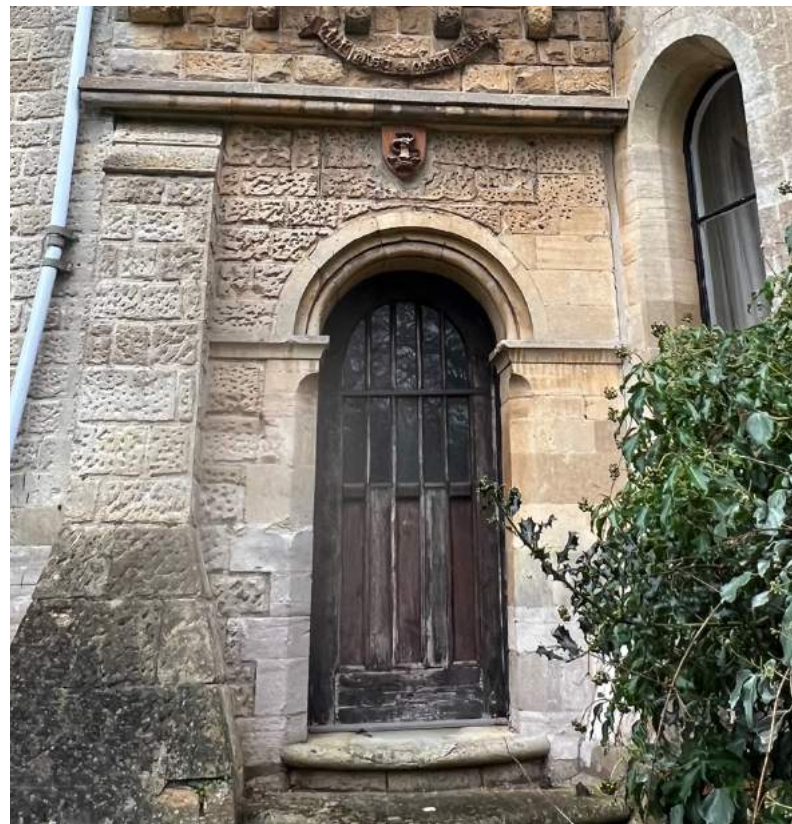
Figure 11 Garden porch, west front.

- 5.12 The adjacent garden porch appears contemporary, & retains ashlar to the right of the door, but it has been hacked to the left; the archivolt & chamfered jamb also resemble the main gate.
- 5.13 Immediately to the right of the garden porch, within the south tower, is another of the simple, splayed, round-headed windows.

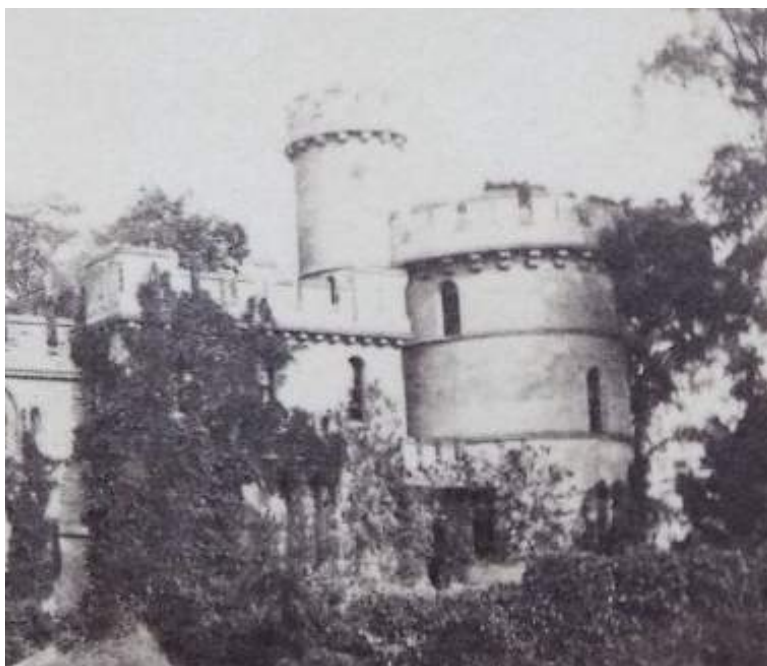
**Figure 12** West front, undated, pre-1883 image, showing the windows of the south tower undivided; this image probably shows the bulk of the 1840s building, at this time comparatively unaltered.

A pre-1883 photograph shows that all the windows in the south tower, & at first-floor in the dining room block, were of this simple, certainly original form; yet by 1888 most had been enriched in a heavier, neo-Norman style.

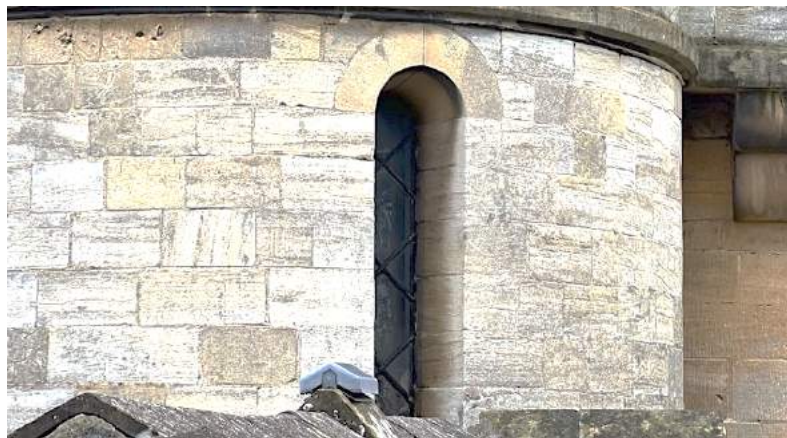
**Figure 14** South tower turret, window overlooking roof of dining room block, with probably original casement.

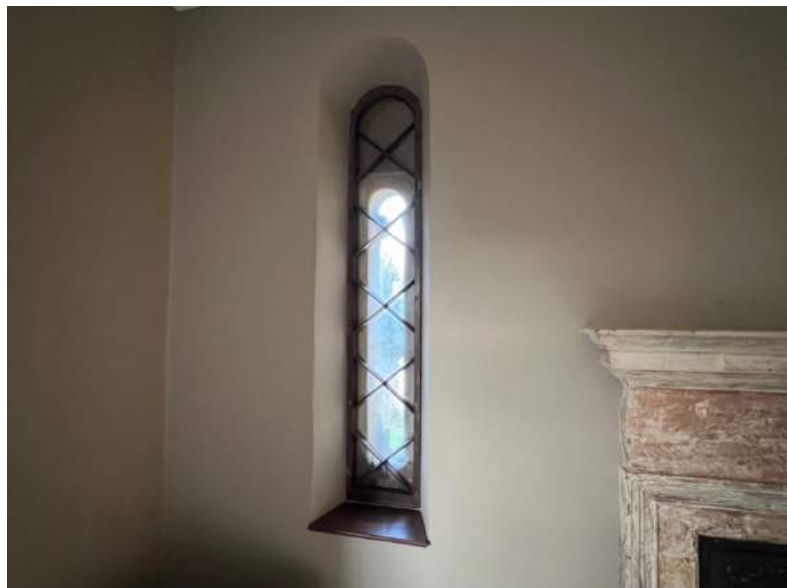
**Figure 15** Probably original casement in first floor of dining room block.

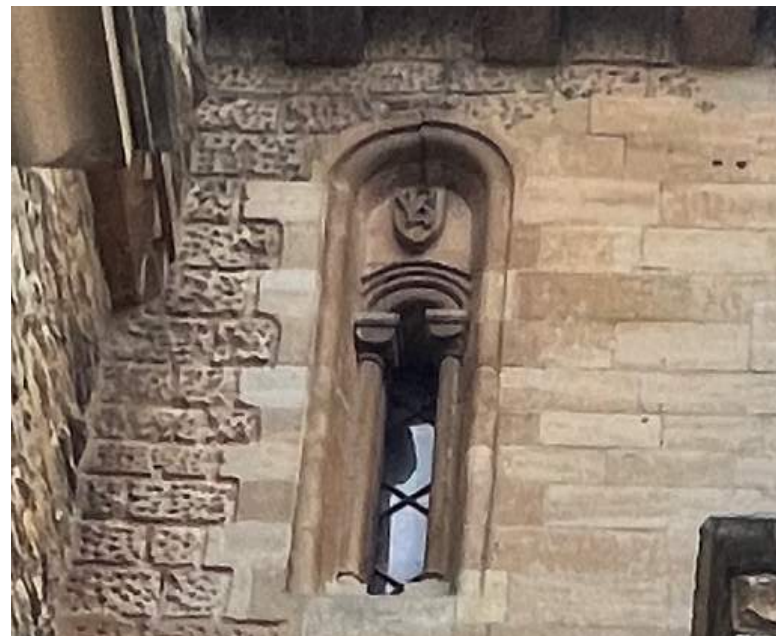
**Figure 16** Subsequently enriched & reduced exterior of window retaining probably original casement.

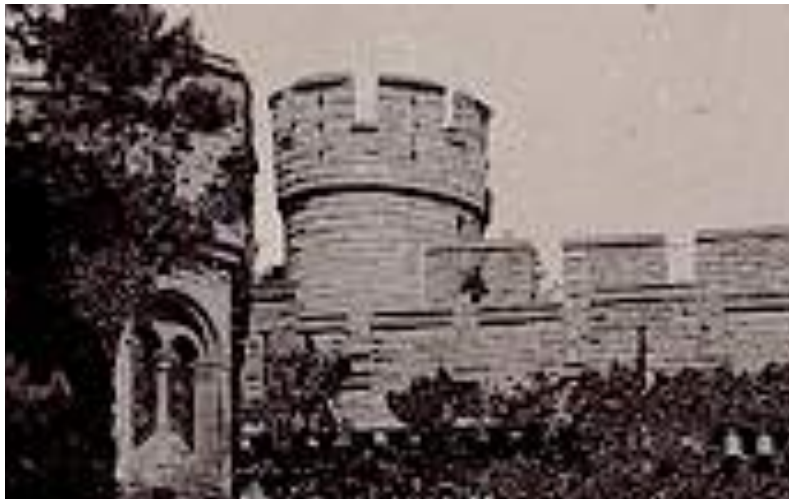
Figure 19 Detail of abutment of turret to parapet of wing to east of gallery in 1888 (© Wiltshire Museum, Devizes; 2022.7013.10).

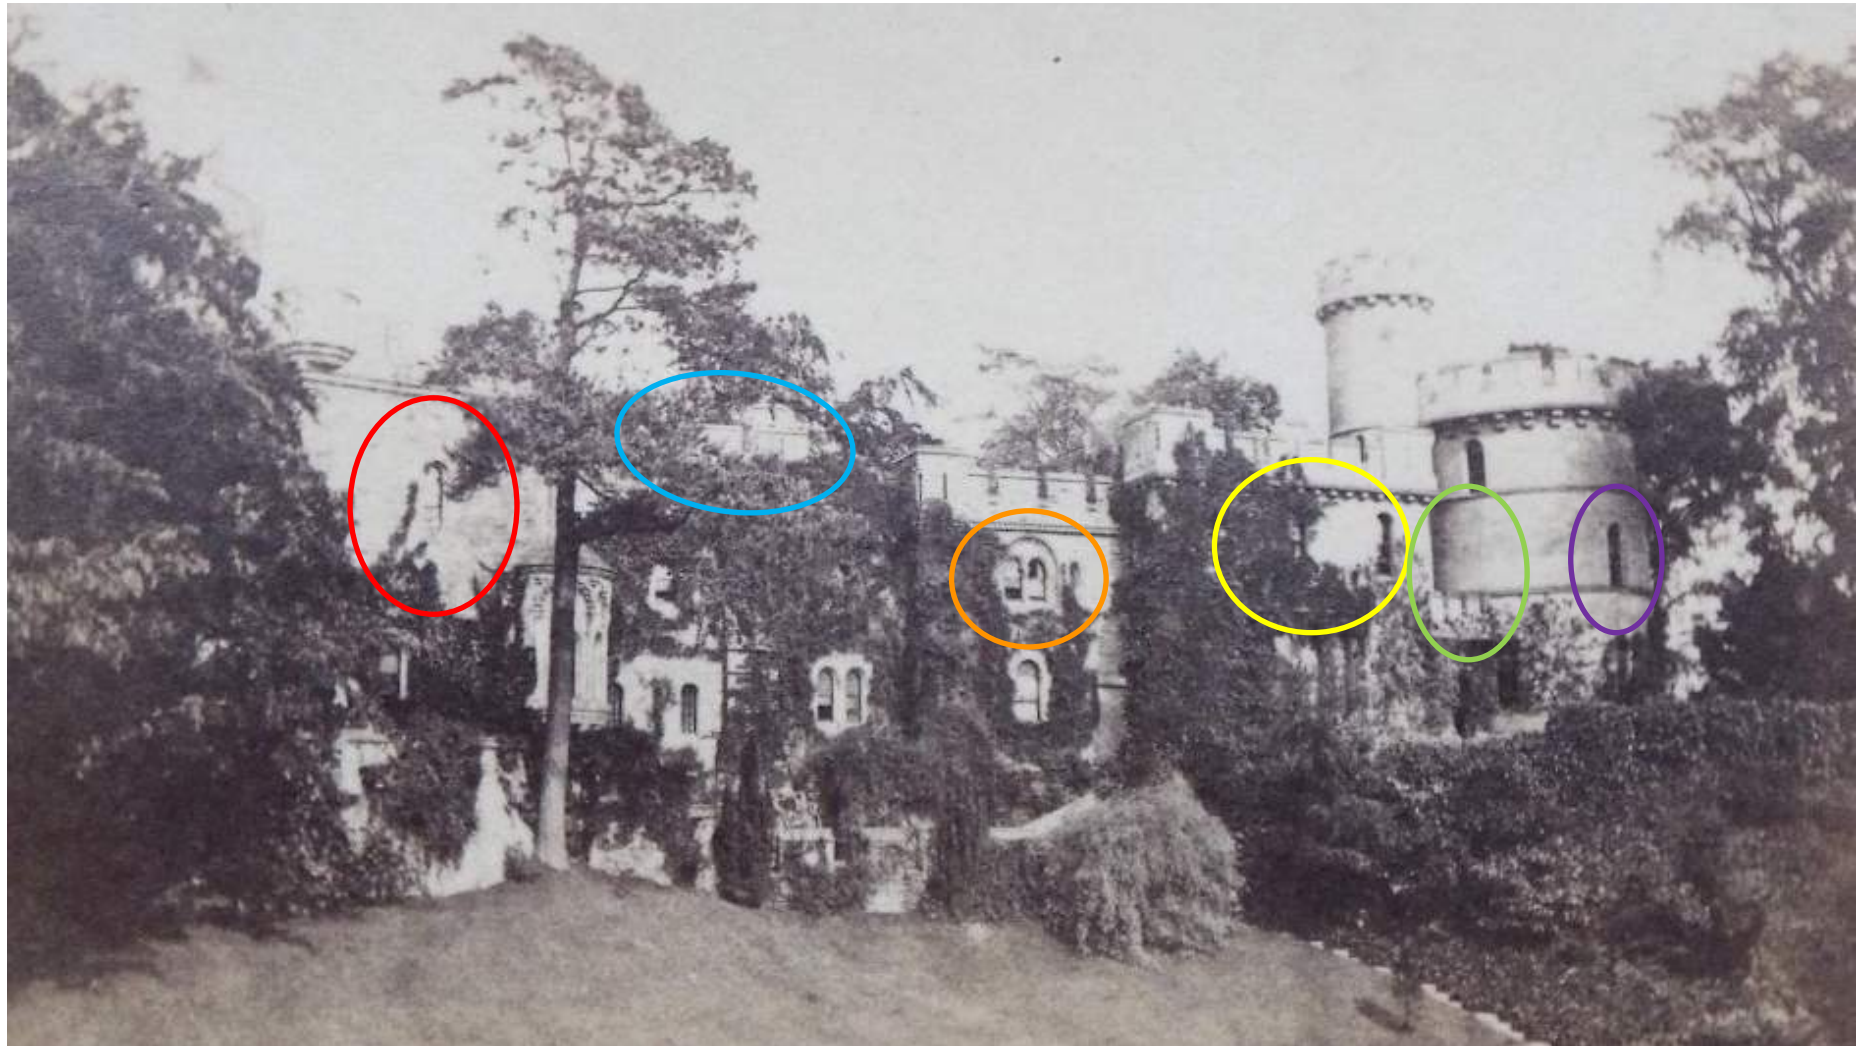
**Figure 20** West front, undated, pre-1883 image, showing Robert Leach's second phase, the parapet of the [wing to the east of the gallery](#) is now clearly visible however, there are no balconies to the rooms above the [drawing room](#), the [dining room](#), & additionally showing that balconies had not yet been added to the rooms over the [ante room](#) & [morning room](#), & still no [Oratory](#).

5.23 However, by 1883, the west front had undergone an extensive series of alterations & enrichment: the third phase. Balconies had been added to the first-floor rooms above the drawing room, the ante room & the morning room; the oratory had been erected over the garden porch; a balcony with an interlaced arcade had been added over the dining room bay & the flanking window had been enriched & reduced with inner arches on colonettes (although the height of the horizontal rails suggests that the earlier windows survived behind); & a central colonette supporting a pair of arches has been introduced into the windows of the south tower.

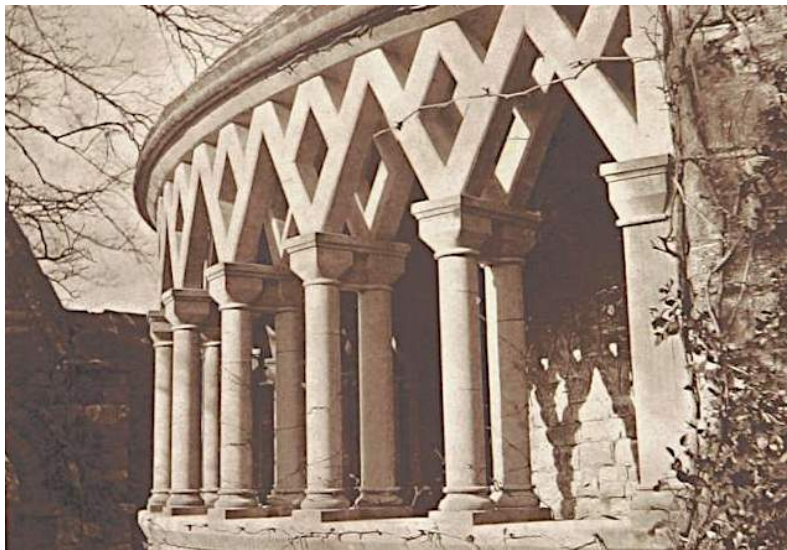
Figure 21 "'Norman Arcade' or Fernery' from the 1883 sales particulars.

5.24 The photographs in the 1883 & 1888 sales particulars show that the house was unaltered between these phases, with the only exception being the fernery (itself second or third phase). In 1883 the tracery of the fernery comprised a series of diagonals, echoing triangular-headed openings characteristic of Saxon architecture.

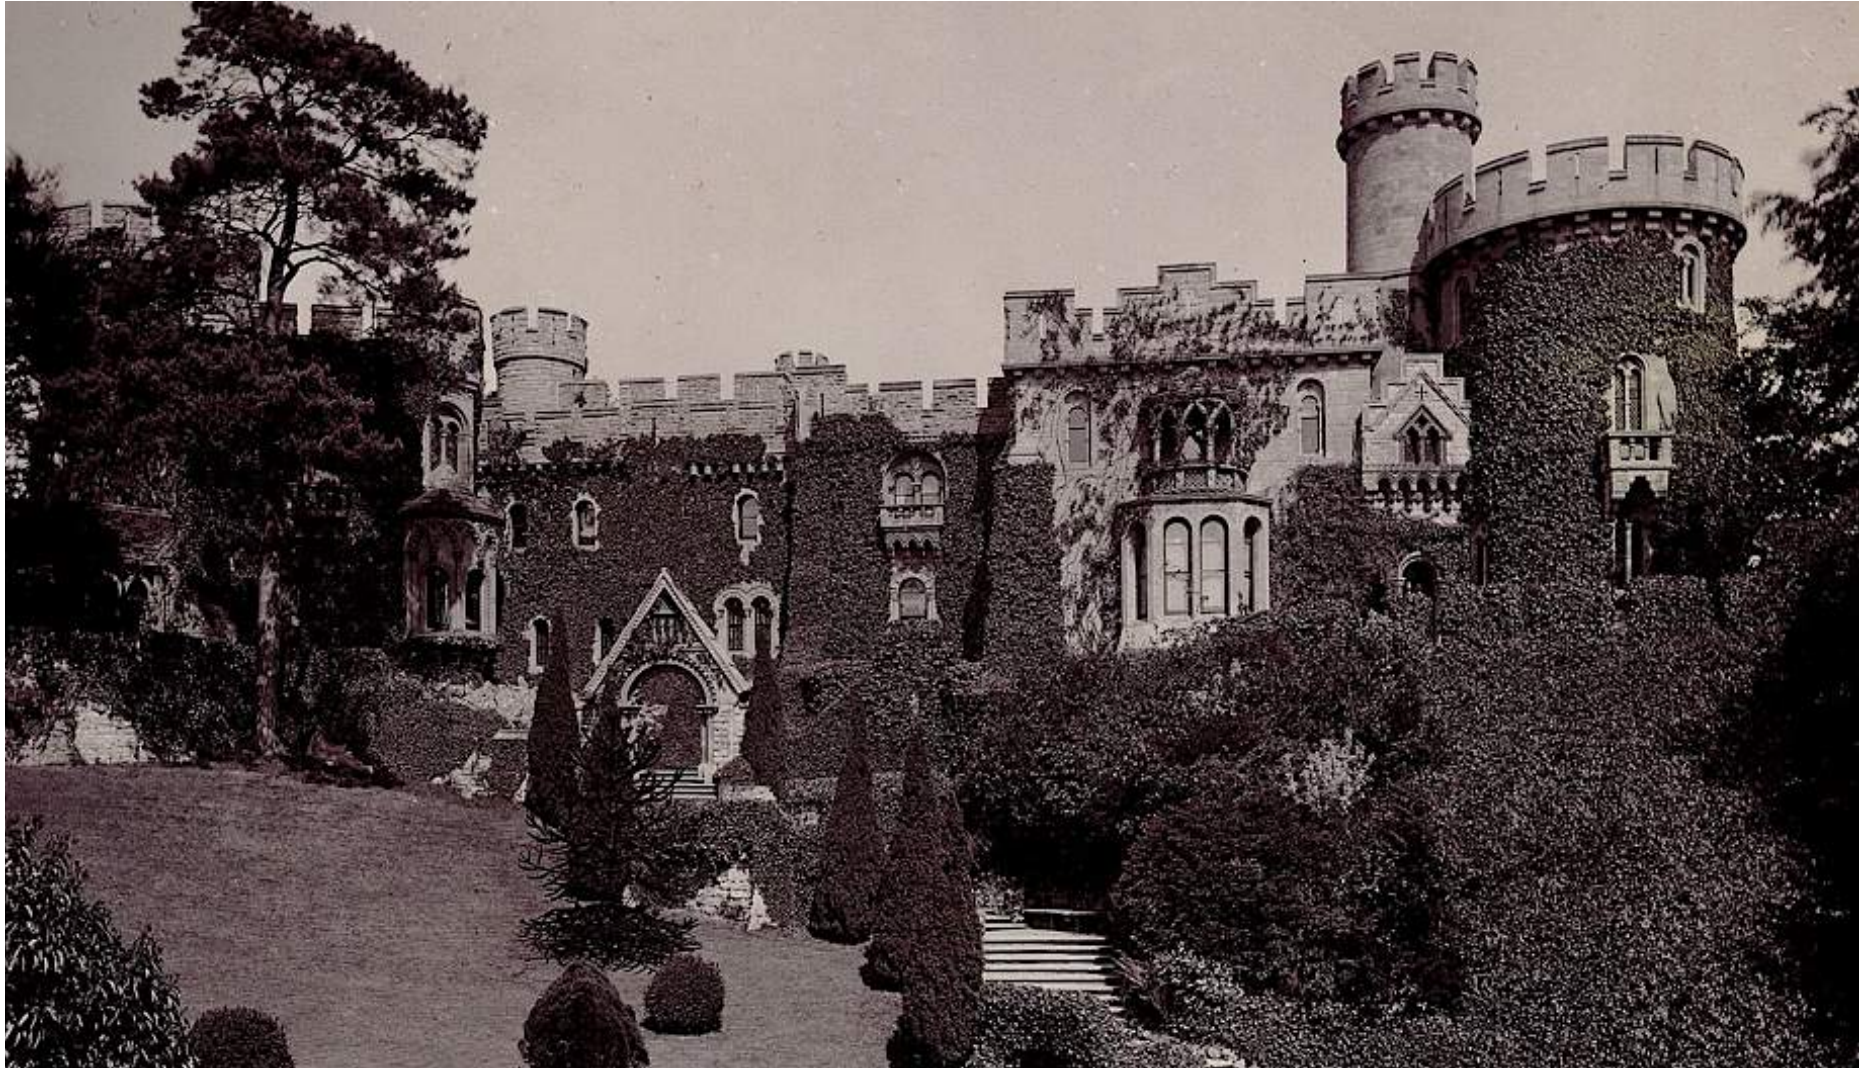
**Figure 23** West front, c.1888, showing Robert Leach's third phase (© Wiltshire Museum, Devizes; 2022.7013.10); the Oratory & balconies have been added, the windows enriched (also the *Ladies' Gate* has been added). The interlaced arches of the fourth-phase Fernery arcade are just visible.

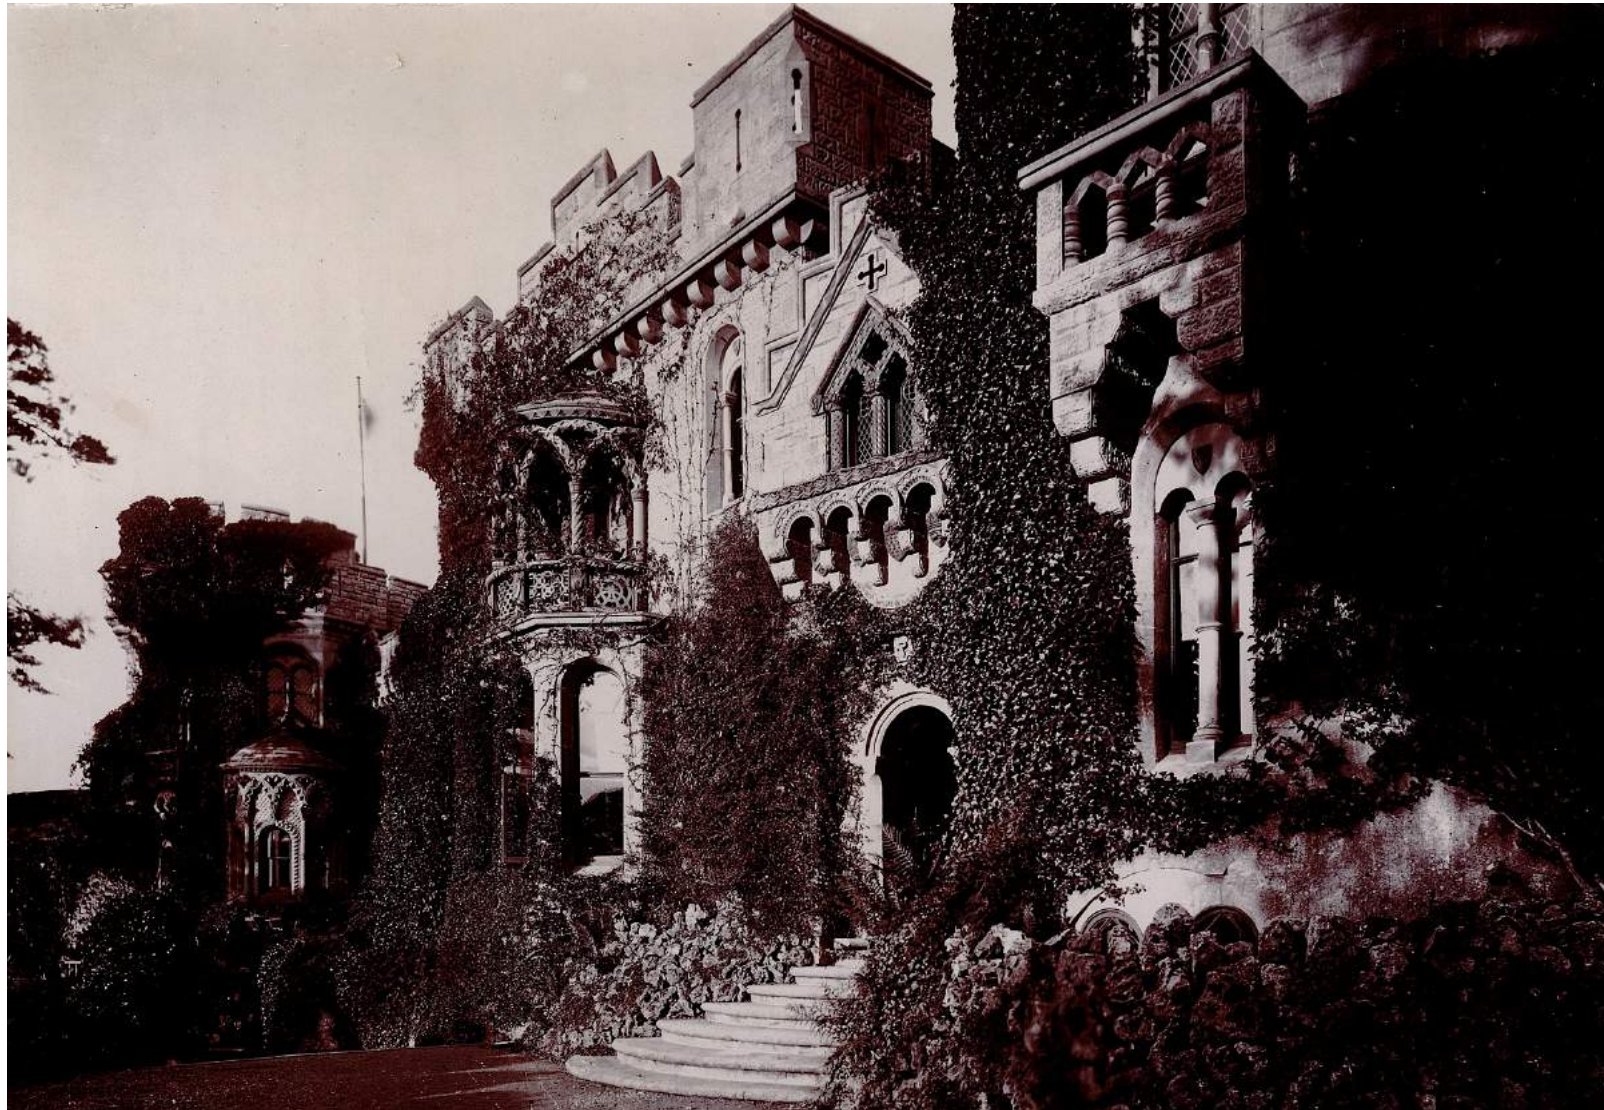
**Figure 24** West front, from the south, c.1888 (© Wiltshire Museum, Devizes; 2022.7013.5), showing the arcaded balcony over the dining-room bay, & the 'Oratory' to the right.

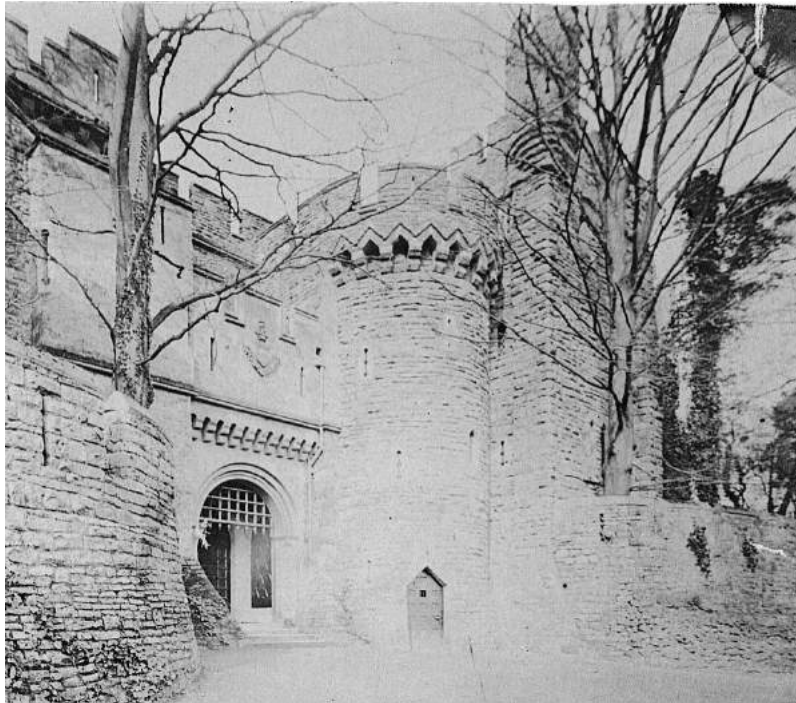
Figure 27 Photograph of the entrance from the south c.1883, showing Valentine Leach's ashlar entrance embedded in later rock-cut masonry (© Wiltshire Museum, Devizes; DZ/WJ:1983.7725).

5.27 To the south of the gate was a curved, crenelated wall, with two mature trees behind. The south-east (*Library/Study*) wing (now part of the South Tower) projects beyond this, & behind rises the ashlar parapet of the dining room block.

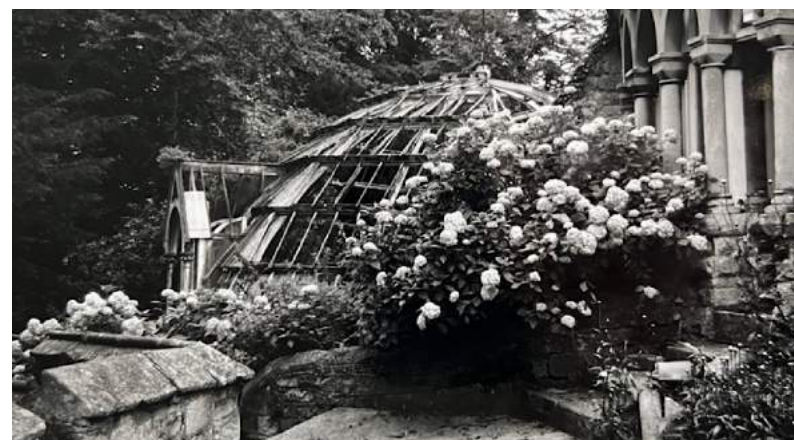
**5.31** At the northern end, beyond the *Ivy Tower*, was the octagonal conservatory, absent in the earliest photograph, but extant by 1883. This comprised a domed, octagonal timber & glass structure over a stone plinth with an internal path of coloured encaustic tiles.

**5.32** Currently, only the masonry plinth, steps & paving survive; the timber & glass superstructure has now been entirely dismantled, although many elements appear to be stored on site. However, the building was surveyed & recorded by English Heritage in March 1989, & an extensive range of photographs & drawn details survive in the Historic England Archive in Swindon (reference BF077986).

**Figure 31** Conservatory & fernery from the south, photographed in March 1989 (Historic England Archive, BF077986 (89/519)).

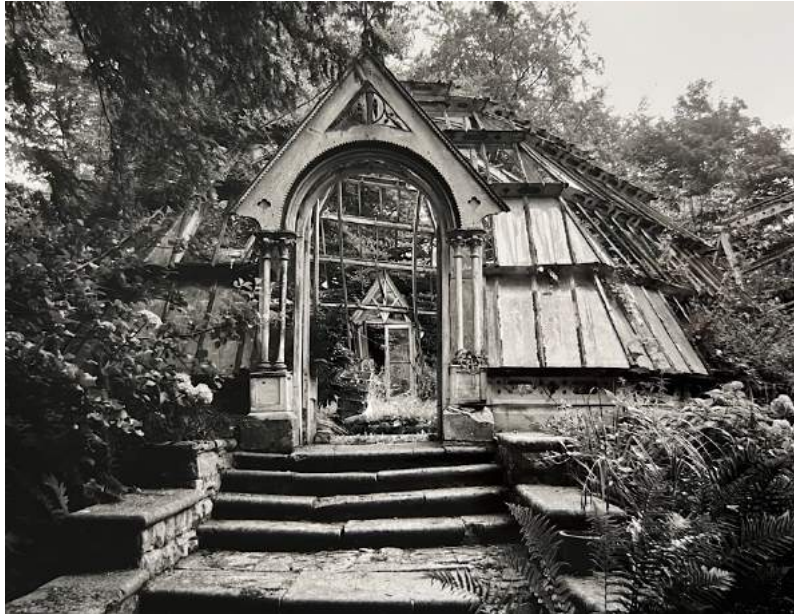
Figure 32 Conservatory, principal (west) door, photographed in March 1989 (Historic England Archive, BFO77986 (89/519)).

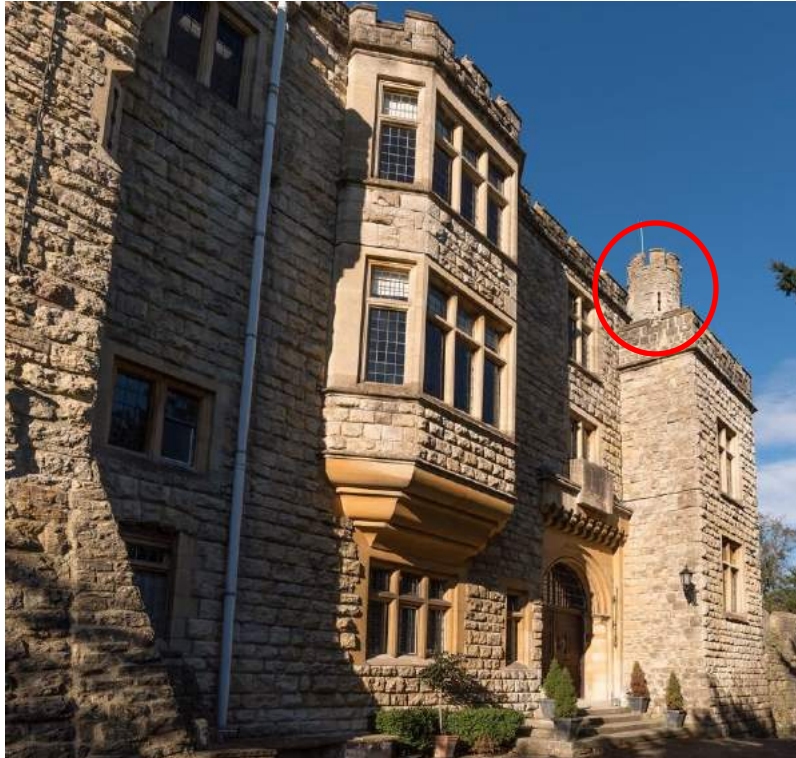
**Figure 38** East front from the south, contemporary view showing Rich extension; the same round turret is encircled on both for reference.

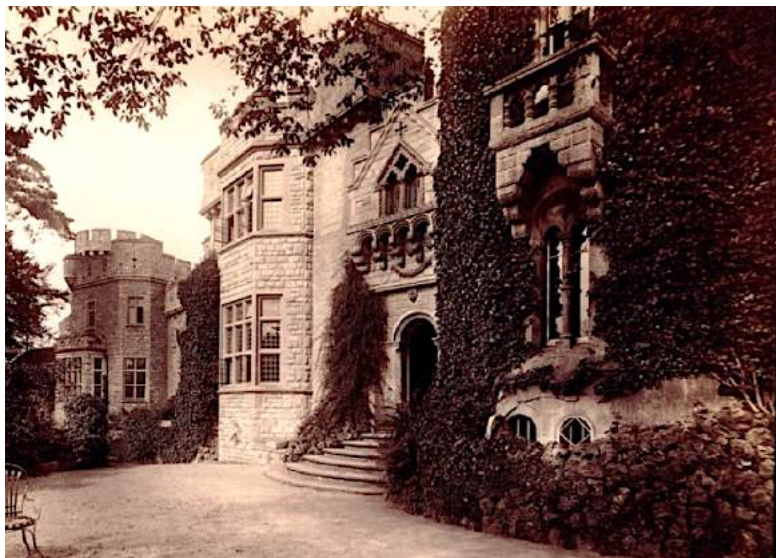
**Figure 40** View north along the west front c.1914 (© Wiltshire Museum, Devizes; 2022.7013.2); the infill of the window to the right of the former arcaded balcony is legible as a patch of lighter, less weathered stone.

5.37 On the drawing room, the *Queen's Oriel* on the south-west corner was entirely removed, & a rectangular bay added on the west side, & the fantastical arcaded balcony over the dining room bay replaced by a two-storey mullioned bay; only the southern end of the elevation, the oratory & the South Tower, retained the original detailing.

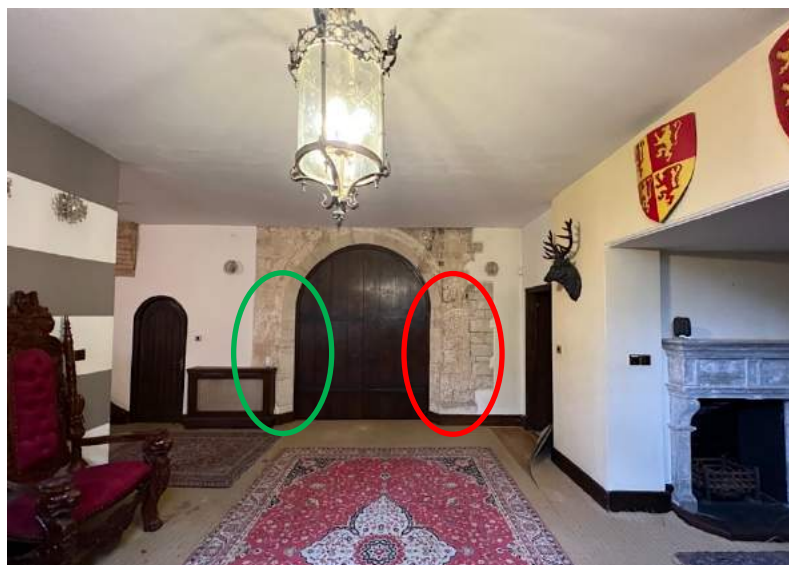
Figure 42 Entrance Hall, facing west.

5.39 The present entrance hall was created when the recession on the east front was infilled for Sir Charles Rich after 1888. The current room is dominated by the large arched opening on the west wall. This appears to be the inner archway visible in the photographs from the 1880s. This archway, despite its visual prominence, does not, nor ever appears to have led to a hall or other high-status space, or to have connected directly with either of the stairs. It is possible that the primary entrances to the house were to left & right, each leading to a stair, & that the central door was for theatrical, aesthetic effect.

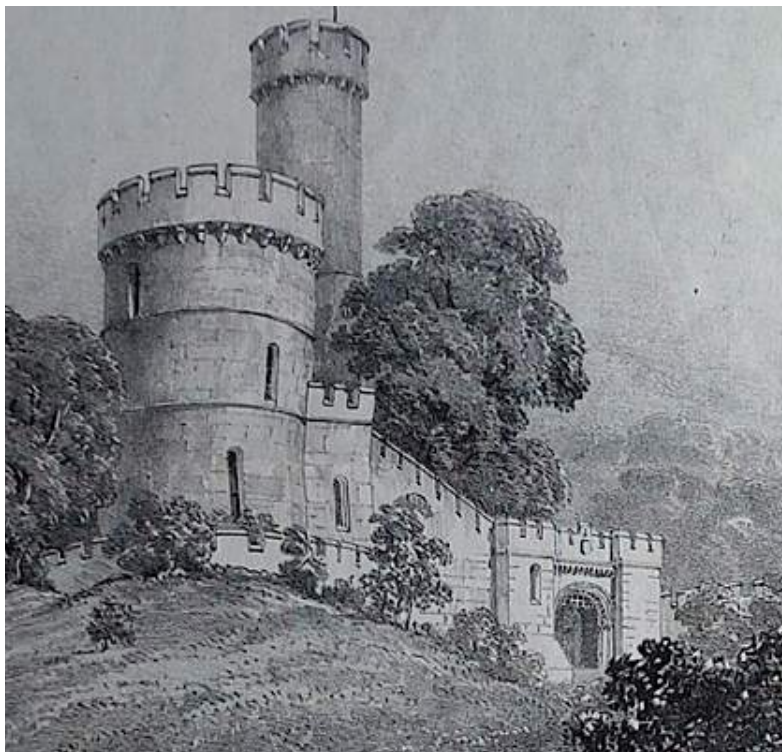
**Figure 49** Detail of 1843 sales particulars (© Wiltshire Museum, Devizes; MSS.2744); the stone stairs would lie immediately behind the angled wall.

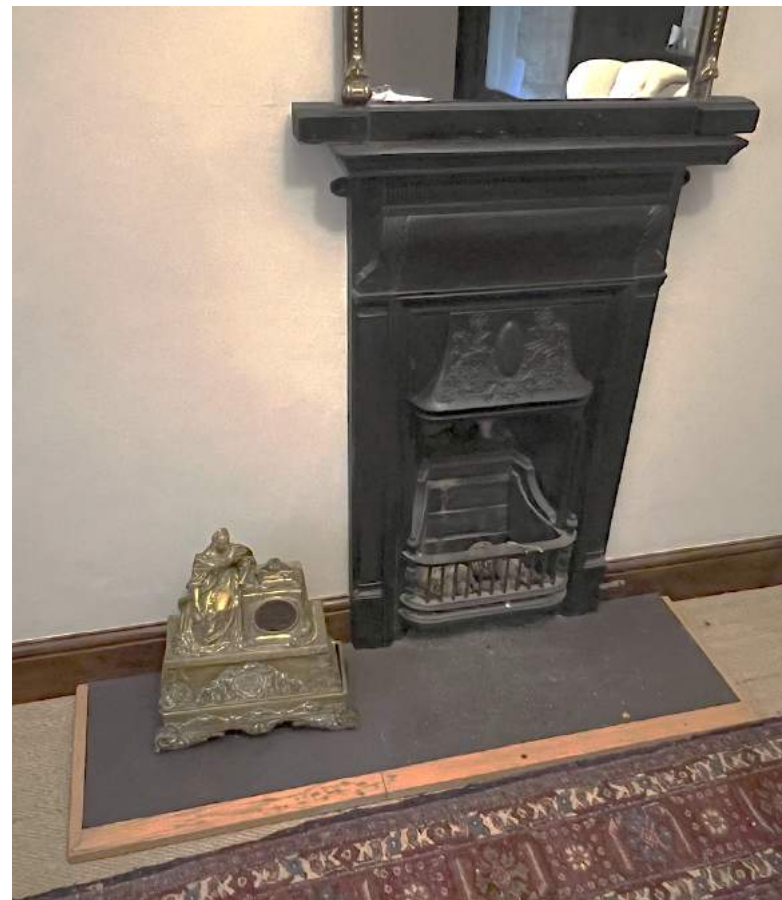
- 5.45 The Inner Hall does contain a cast-iron fire surround that appears to be of similar date; however, this is not *in situ*. The surround sits above a modern raised hearth, & is bolted to the wall with modern cross-head screws. The provenance of the surround is unknown.

**Figure 50** Inner Hall, fireplace.

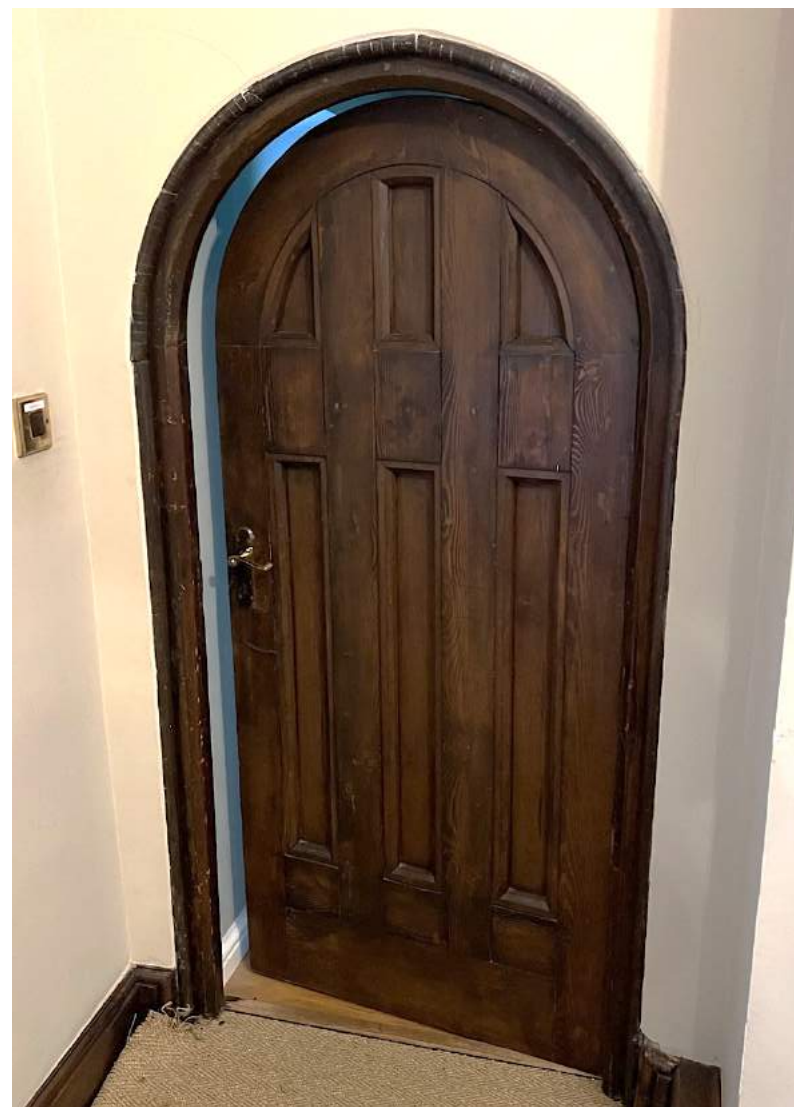
5.47 This door, with a round head, recessed panels to the front, & applied fillets to the rear, is one of a distinct group of doors which otherwise relate to the earlier, Leach building. Consequently, this door & frame appear likely to be reused from elsewhere.

5.48 This group of doors does contain variety, in the number of panels, depending upon the size of the door, & in the presence of an upper horizontal rail, sometimes genuine, sometimes approximated with infill blocks in the panels; on some doors similar blocks are also used to increase the apparent depth of the bottom rail. Several doors retain decorative ironwork on these rails, or evidence of such; one door even has an approximation of such ironwork cut from timber.

Figure 52 Door to cloakroom; outer face.

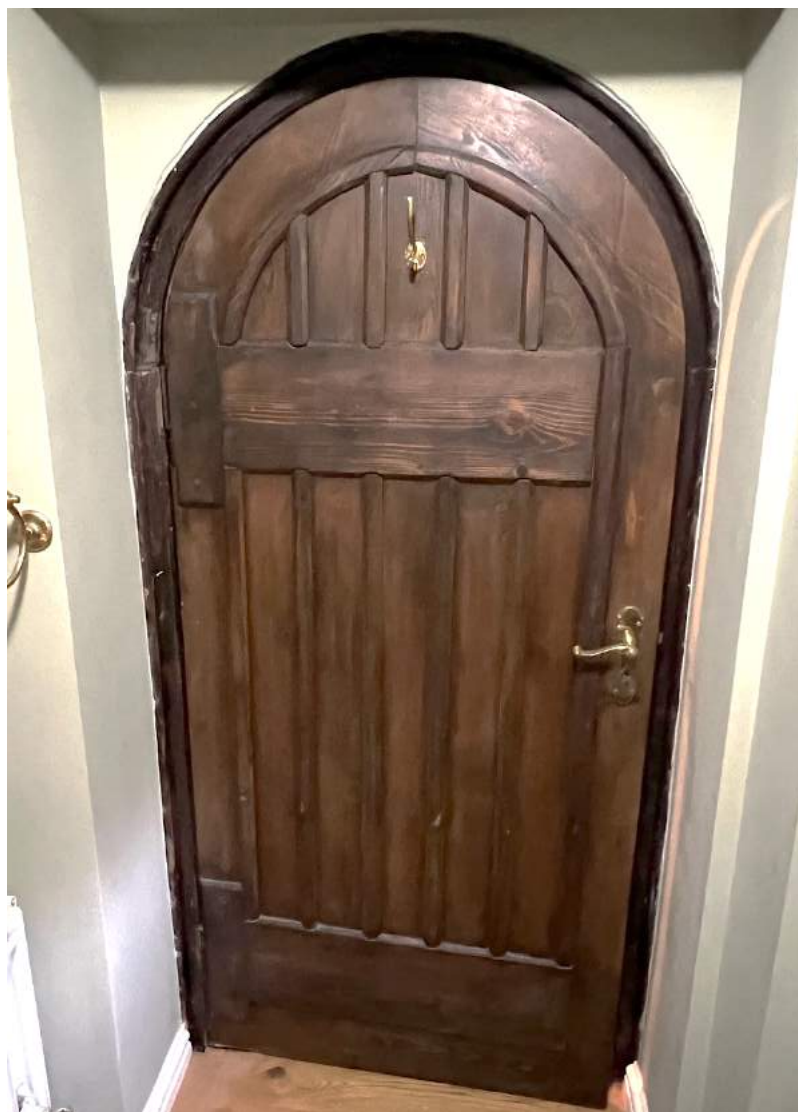
Figure 53 Door to cloakroom, inner face.

- 5.49 This door is one of the variants with the rails created with infill block on the front face. Although the door has been refurbished, scars of applied ironwork are just visible. A number of pieces of decorative ironwork removed from doors in the house are currently stored in the cupboard beneath the main stair.

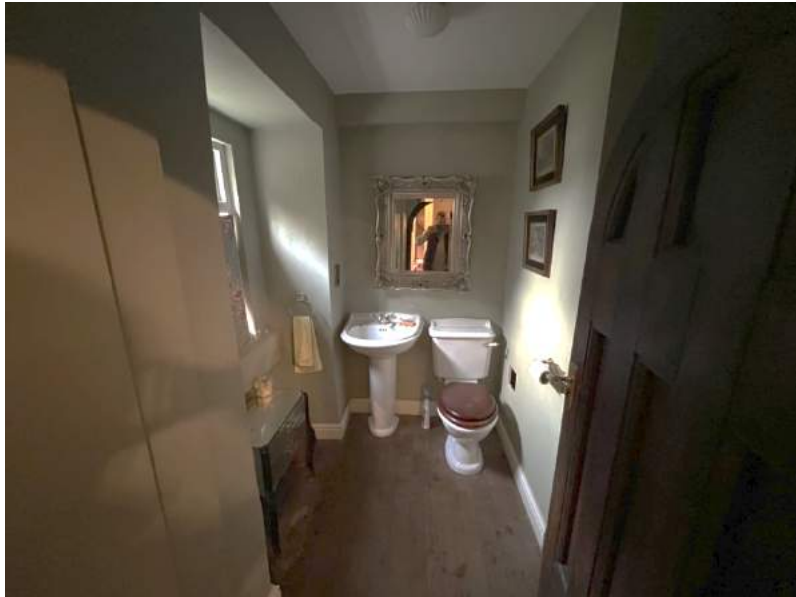
Figure 55 Cloakroom, south.

5.50 The present cloakroom has been created from the base of the back stair with modern plasterboard partitions, & contains no features of interest. The window is modern & internally lies within a larger recess.

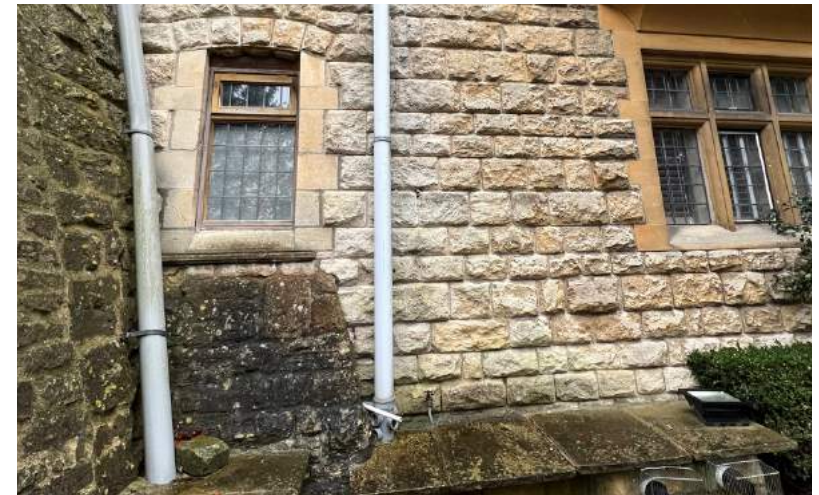
5.51 Externally, the window opening lies beneath a shallow segmental arch; a feature that appears above none of the other windows of the Rich additions. The opening has also clearly been narrowed by the insertion of additional masonry. There

is a substantial batter of stone beneath the window, although this may potentially also be an addition. This would appear to suggest a characteristic luggage/service entrance, & it is depicted as such in a plan from 1989.

Figure 56 Exterior of cloakroom window.

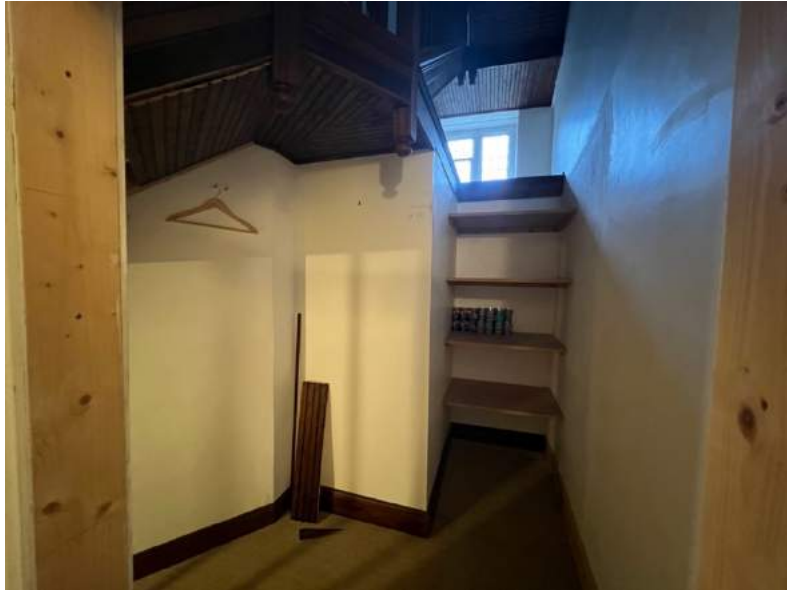
Figure 58 Back stair, facing east.

- 5.52 The back stair rises from the half-landing of the stone stair to a second half-landing on the front of the building where there is a blocked door to the now separate library/study wing, & then rising to the first floor.
- 5.53 The fabric of the stair itself is entirely modern. The level of the blocked door & the mullioned window between lower ground & ground floors indicate that a back stair did rise, in some configuration, at least as far as the half landing.

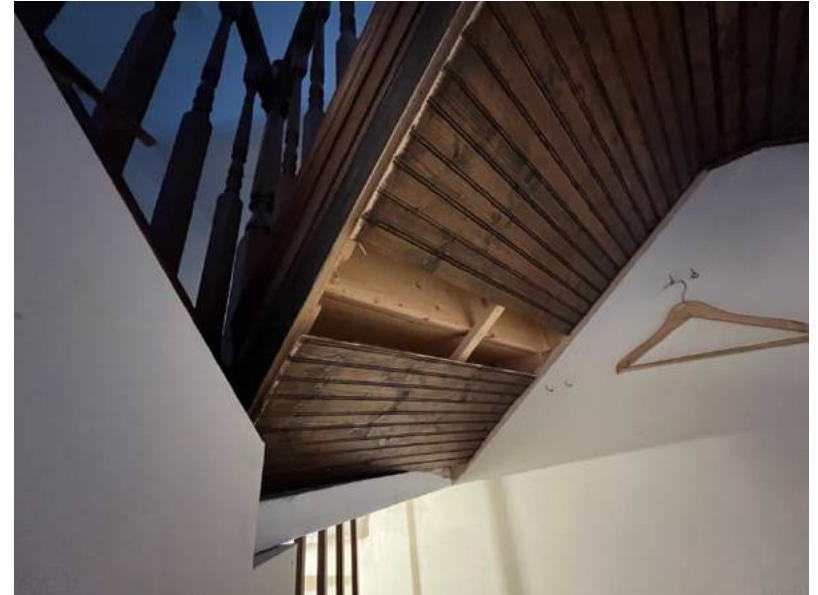
Figure 59 Back stair, soffit showing modern construction.
