# DEVIZES CASTLE.

Heritage  
Appraisal.

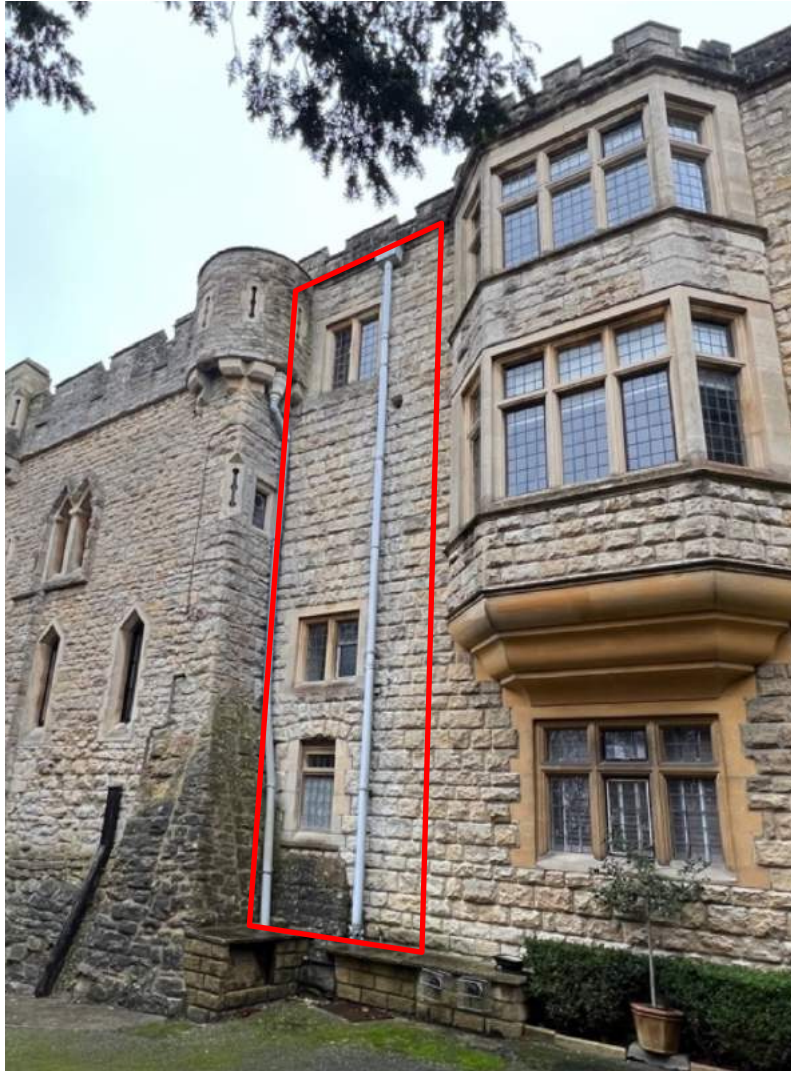
Figure 60 Back stair, external fenestration, showing lower window breaching floor level, but upper window placed normally.

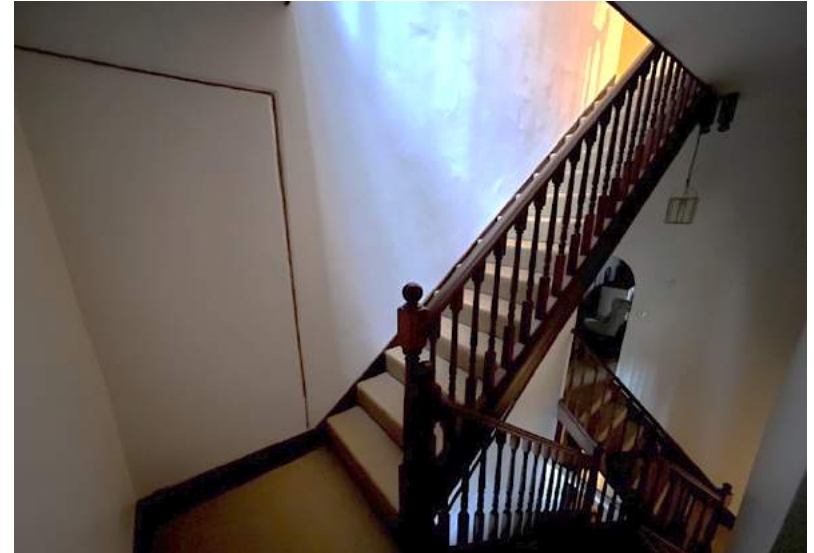
Figure 61 Back stair, half-landing showing blocked door to adjacent wing.

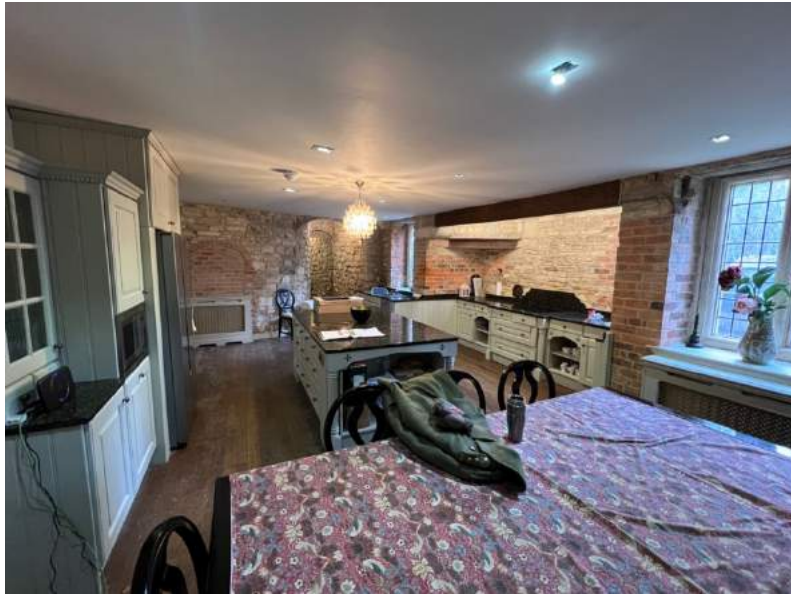
Figure 63 Kitchen, facing south.

5.55 The kitchen lies beneath the dining room, in the original part of the building; given its size & location it is likely that it may have historically performed the same function. No fireplace is currently visible, but the considerable thickness of the east wall would be sufficient to contain a considerable kitchen fireplace behind the present fittings.

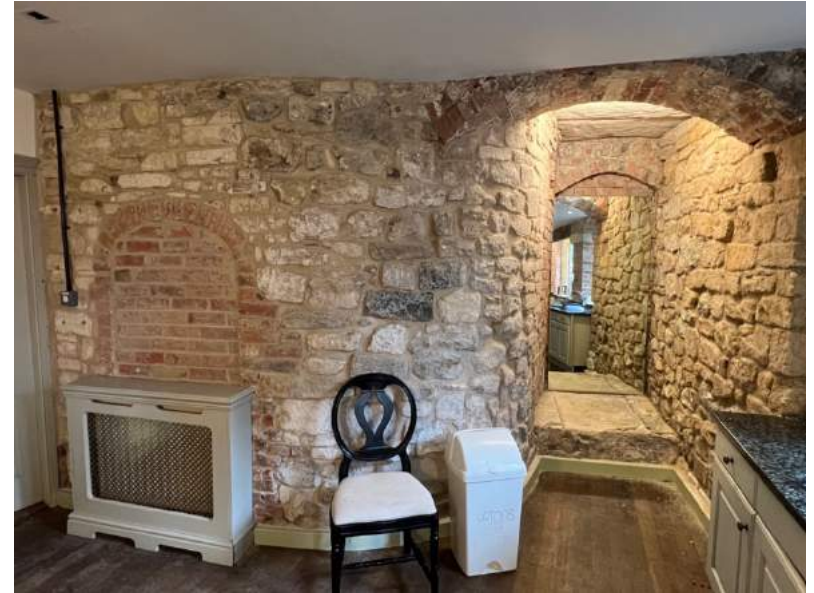
Figure 64 Kitchen, southern end.

5.57 At the southern end there is a recess beneath the garden porch, which ends in what appears to be a blocked opening; however, the brickwork within is set in lime mortar, & is clearly of some antiquity. Behind the radiator is another blocked doorway, which would have led to the spiral turret of the south tower; the blocking within this is modern brickwork with cementitious mortar.

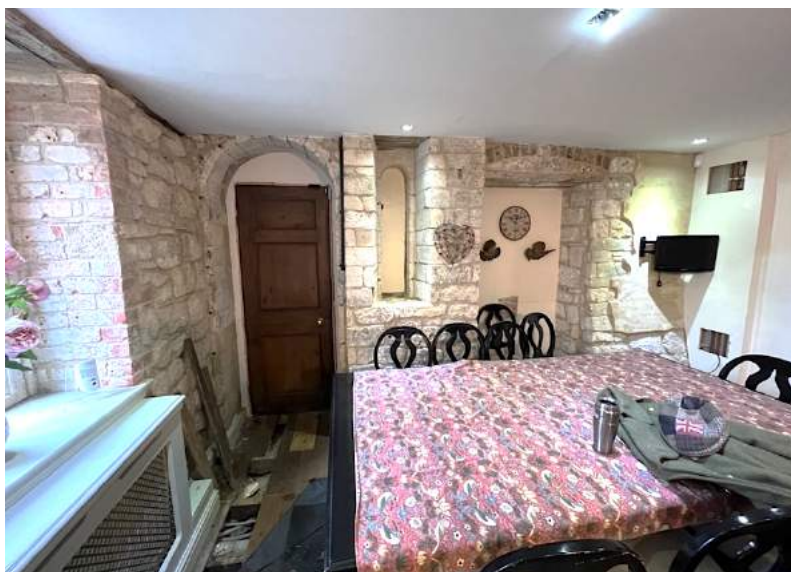
Figure 65 Kitchen, northern end.

- 5.59 The northern end of the kitchen has three openings; to the left an original, semi-circular headed opening contains modern infill & a reused internal door (potentially from the Rich phase). Externally this opening, which is sandwiched between two later buttresses, shows similar construction to many of the windows of this phase, although the opening does not have splayed reveals, suggesting that it was always a door.

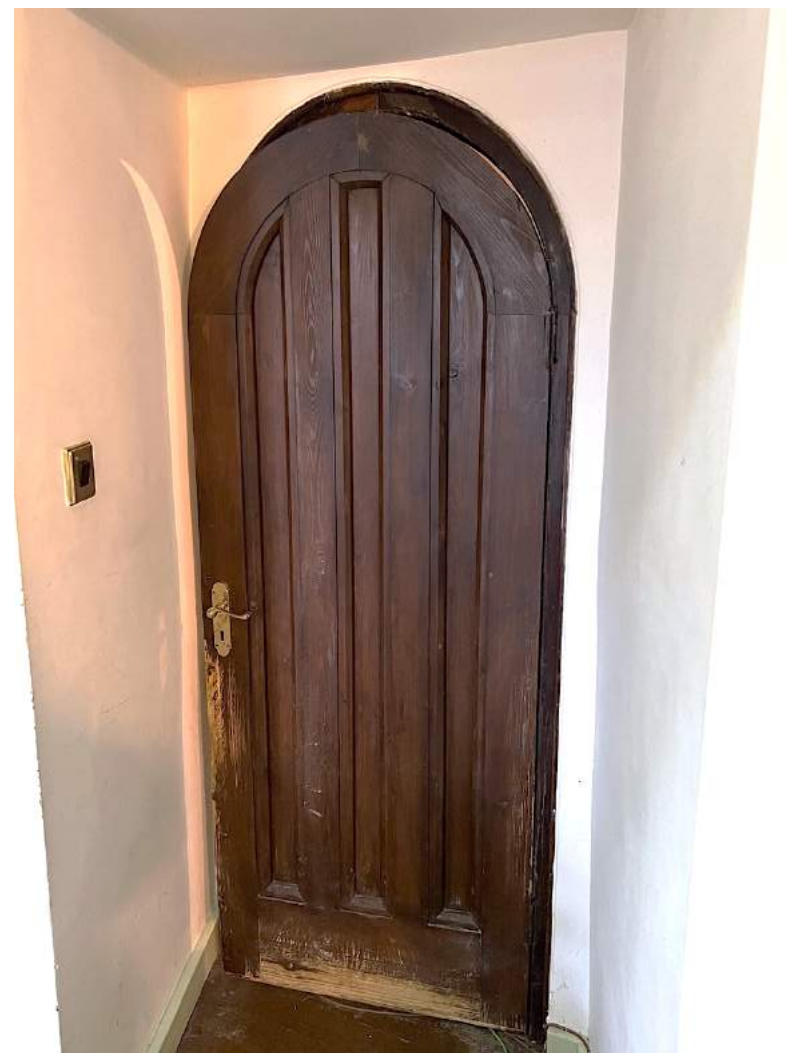
- 5.62 The door from what is now the inner hall is one of the round-headed type, but with no horizontal subdivision.

Figure 67 Kitchen, door from inner hall (kitchen face).

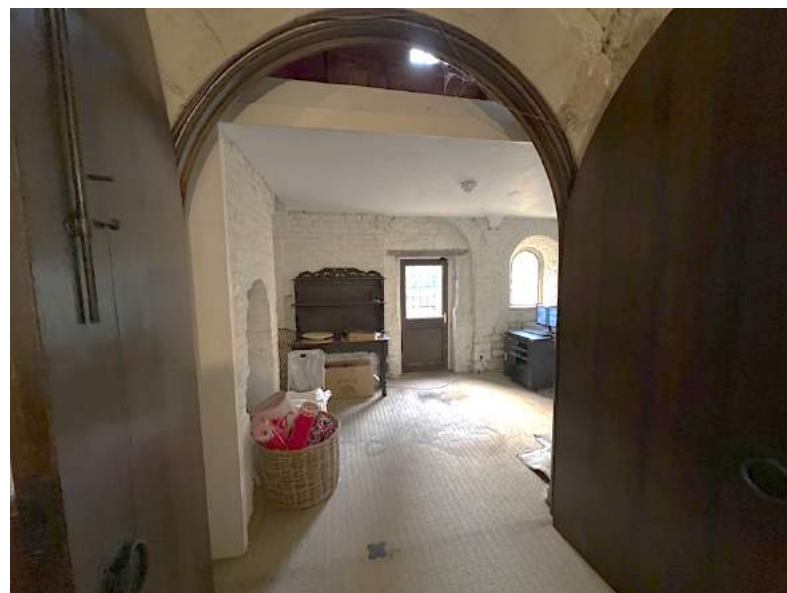
Figure 69 View into the sub-ante room from the entrance hall.

- 5.63 The room beneath the ante room lies behind the double doors from the entrance hall. The room has been stripped of all historic finishes, so there is little evidence as to the rooms historic function. During the Rich phase, the arched opening would have been separated from the hall by a partition, & the room would certainly have formed a part of the service accommodation. During the Robert Leach phase the arched opening was visible directly behind the outer arch of the entrance. However, there is little evidence to suggest that this
