## DEVIZES CASTLE.

### STORES.

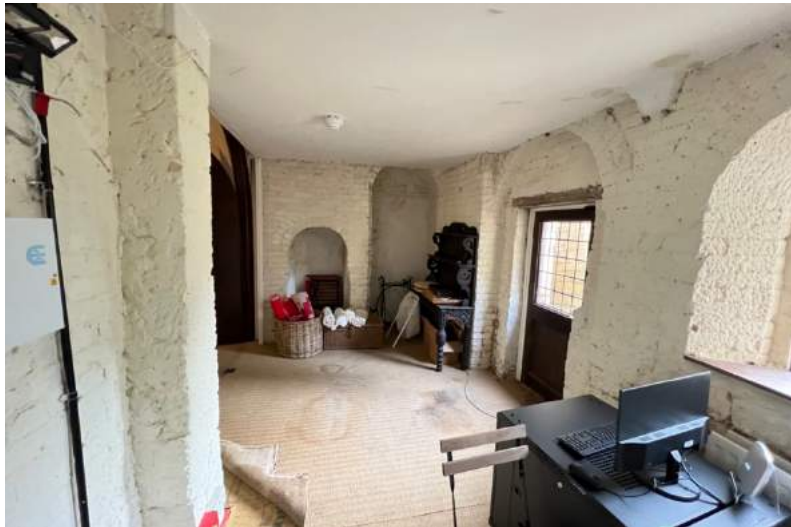
Figure 70 Sub-ante room, facing south.

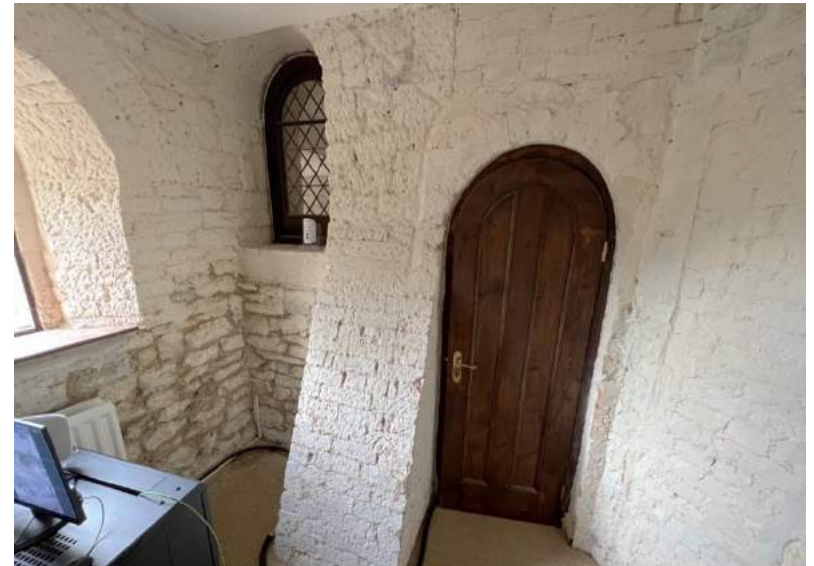
- 5.64 The north wall of the sub-ante room contains a small, round-headed window, & a round-headed door.

Figure 71 Sub-ante room, north wall.

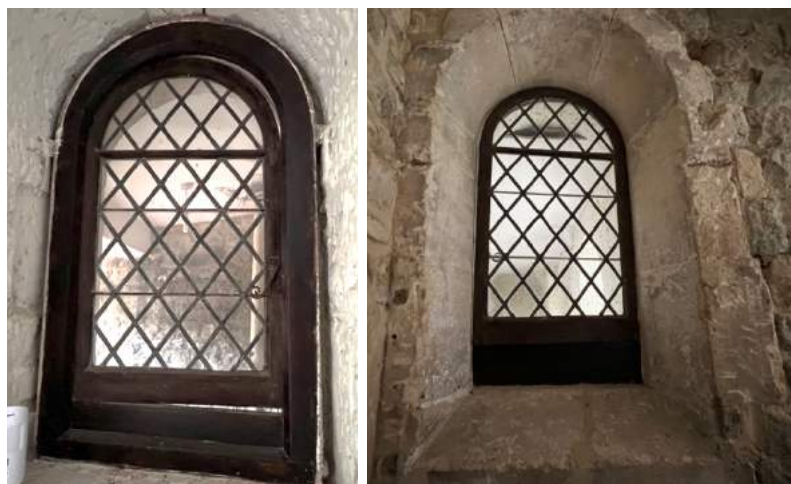
- 5.65 The window currently looks into the surviving store, but the quality of the masonry on the outer face suggests that it was originally external. The window itself appears historic, but is unlikely to be *in situ*, as it is too short for the opening, & only opens several inches before the head of the casement hits the archivolt.
- 5.66 The door in the north wall is another of the round-headed doors, but a narrower one, with two recessed & applied panels, & no horizontal subdivision. The door hangs on modern hinges, but fits the historic frame, & it thus likely to be *in situ*.

Figure 72 Sub ante room, interior & (former) exterior of window in north wall.

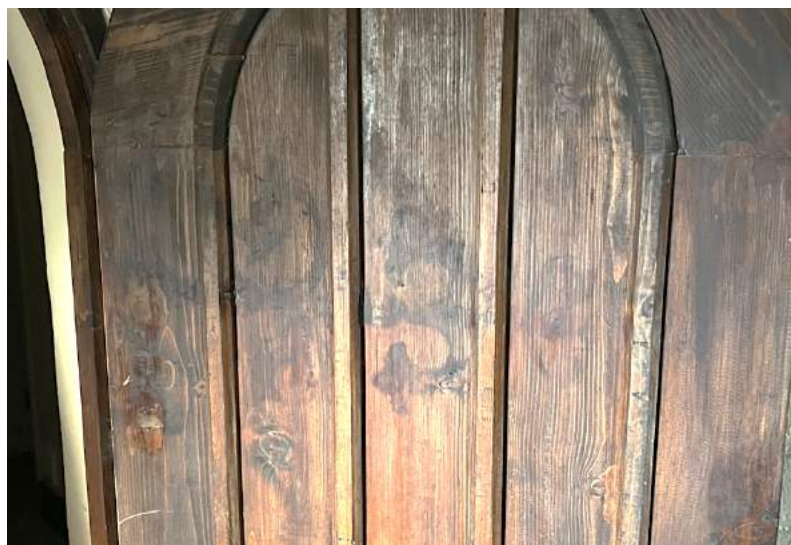
Figure 73 Sub ante room, detail of door in north wall (outside face), showing scars from now-removed decorative ironwork.

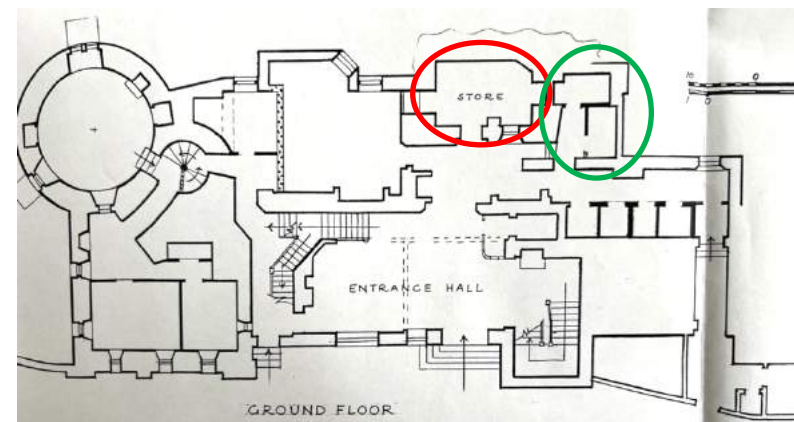
Figure 74 Lower ground floor plan in 1989 (Historic England, BFO77986):  
southern store; northern store.

- 5.67 To the east & north of the sub-ante room were a pair of stores, which are clearly marked on a map of 1981. These are depicted as cellar-like spaces, with no windows, & an external wall with a wavy external edge, as if indicating that they were subterranean/built into a raised bank.
- 5.68 The 1885 Ordnance Survey map shows the stores, but they are depicted as separate from the main house & shaded grey, as ancillary structures, rather than red; the more detailed town map of the same year also show them as distinct structures.

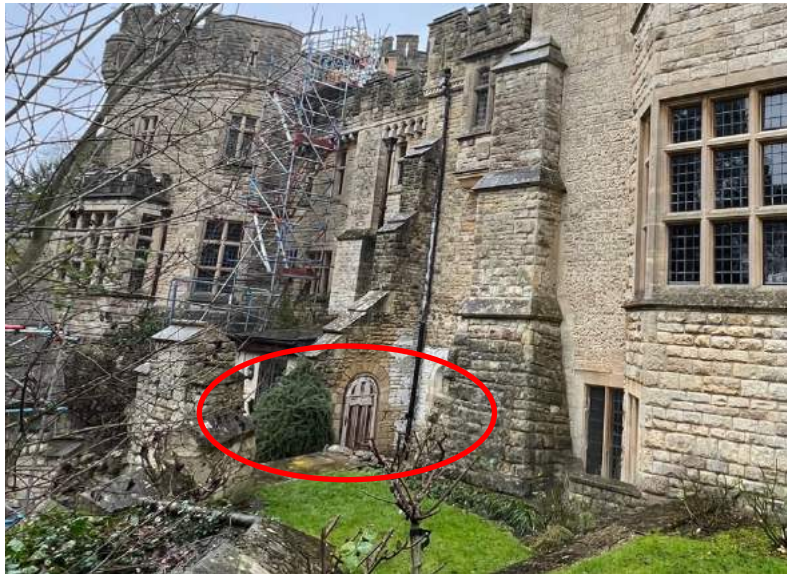
- 5.70 This wall, which has now been reduced to the level of the path, lies in front of the store that has been removed to form a small, sunken terrace (the southern store).

Figure 79 West front, location of lost wall which concealed the now-removed store.

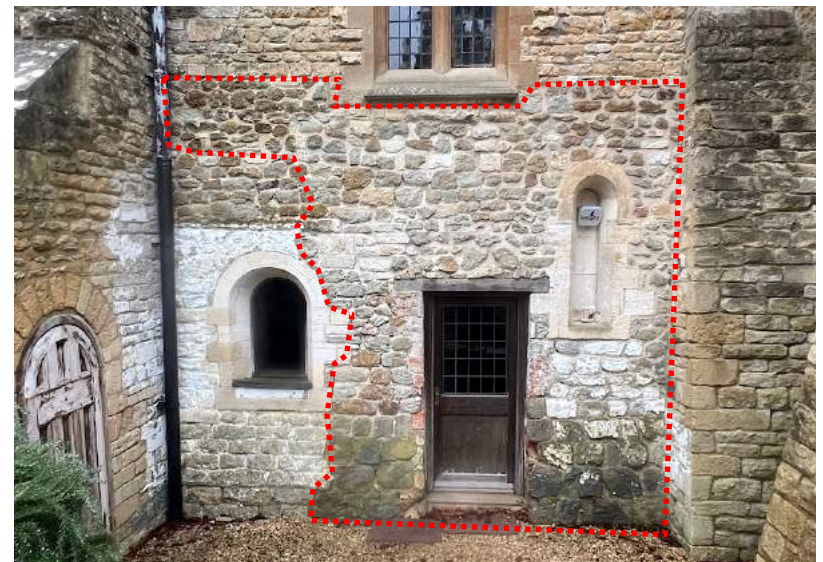
- 5.71 The elevation that has been revealed by the removal of this store indicates that it was a later addition, presumably as part of Robert Leach's second phase (possibly a basement area that was subsequently roofed), as the round-headed window to the sub-ante room appears *in situ* within well-coursed masonry, & was clearly intended to be external. However, much of this

elevation is masonry that is poorly coursed, if at all, suggesting extensive disruption. The doorway that lies within this area appears entirely modern. The blocked window to the right is historic, but it both sits within the area of disruption, & backs onto a solid mass of brickwork which appears to be contemporary with the anteroom wing, suggesting that it may have been relocated from elsewhere.

Figure 80 Façade exposed by removal of southern store; area of disrupted masonry highlighted.

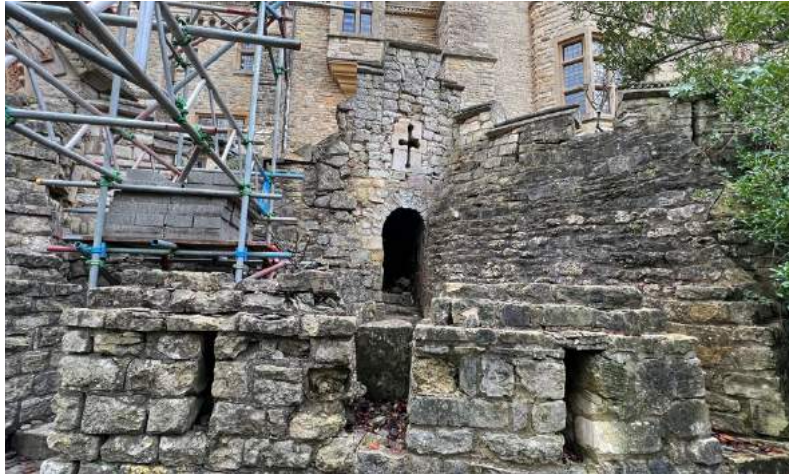
- 5.72 This store/former area appears to have had direct access to the garden through the now-blocked tunnel beneath the garden path, although light is still visible through the blocking.

**Figure 81** Entrance to tunnel beneath garden path.

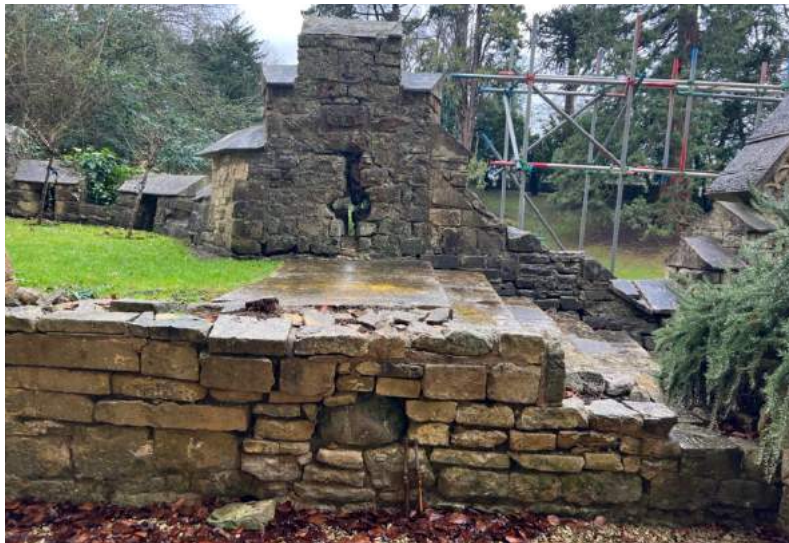
**Figure 82** View from east; the tunnel runs directly beneath the paved stone landing, with light visible through the masonry in the foreground.

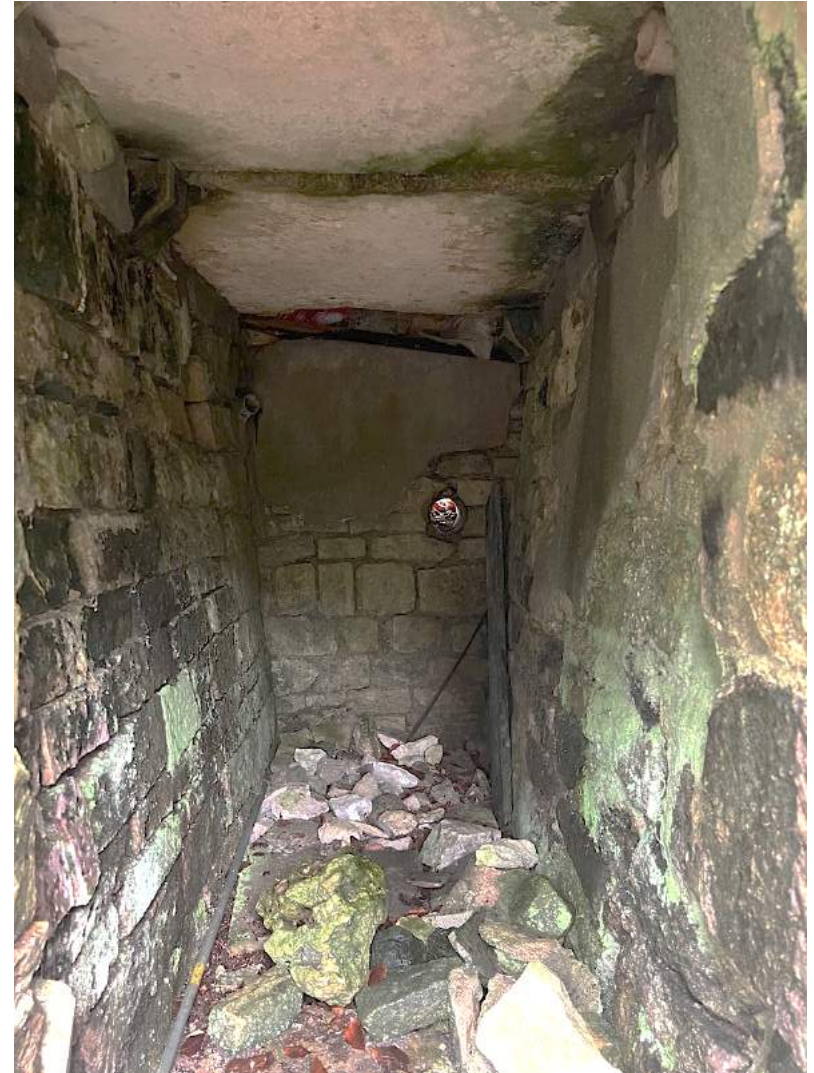
**Figure 83** View into tunnel, the underside of paving stones form the ceiling, & light visible through the blocking.

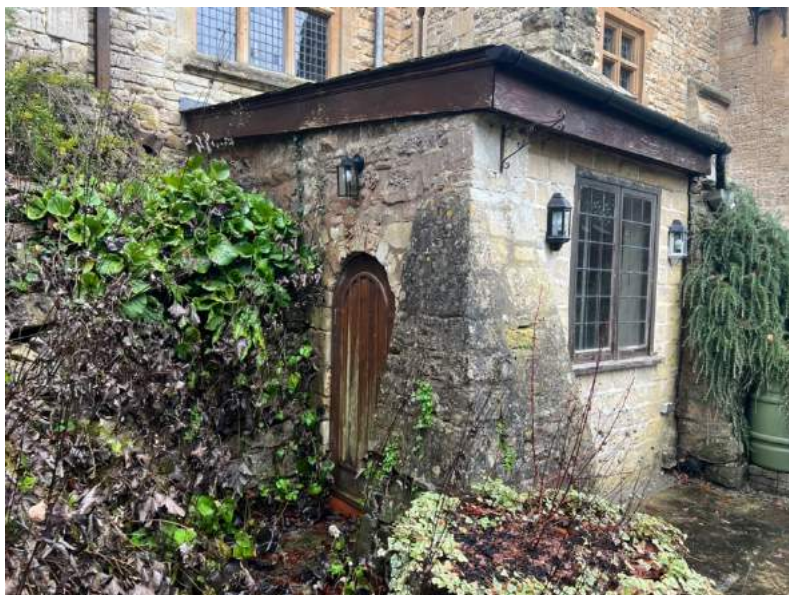
- 5.73 The store to the north of the sub-ante room survives, albeit with a modern replacement roof, & the original west front, which was unfenestrated but otherwise unrecorded, rebuilt with a modern window.

Figure 84 Northern store, from the north-west.

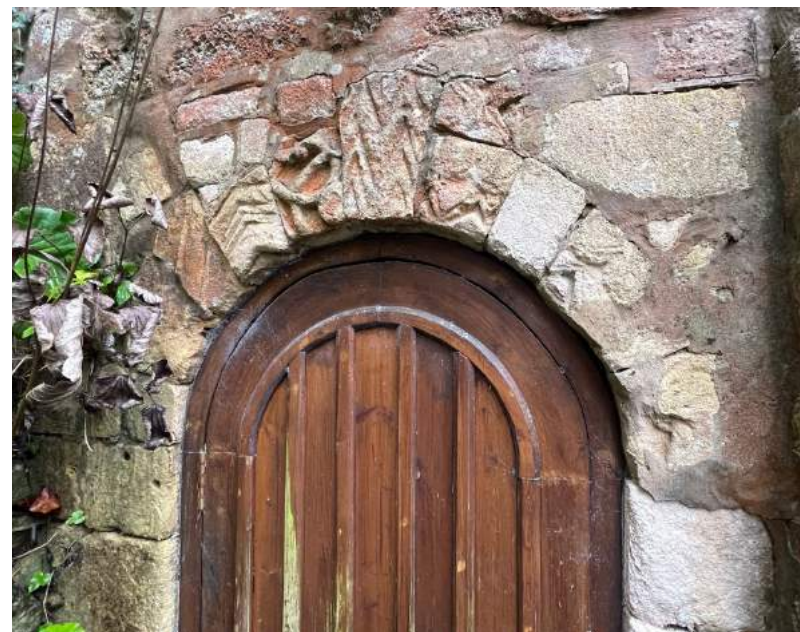
- 5.74 The north & south walls are, however, historic. The north wall contains an opening whose head is formed from salvaged

Romanesque masonry. This masonry is likely to have come from the Church of Saint John; this was altered and extended in 1862-3, & stones from the west front were purchased by Robert Leach for use at the castle<sup>3</sup>; more of these salvaged stones remain visible in the garden walls flanking the *Bishop's Gate* (originally called *Saint John's Gate*).

Figure 85 Northern store, north door.

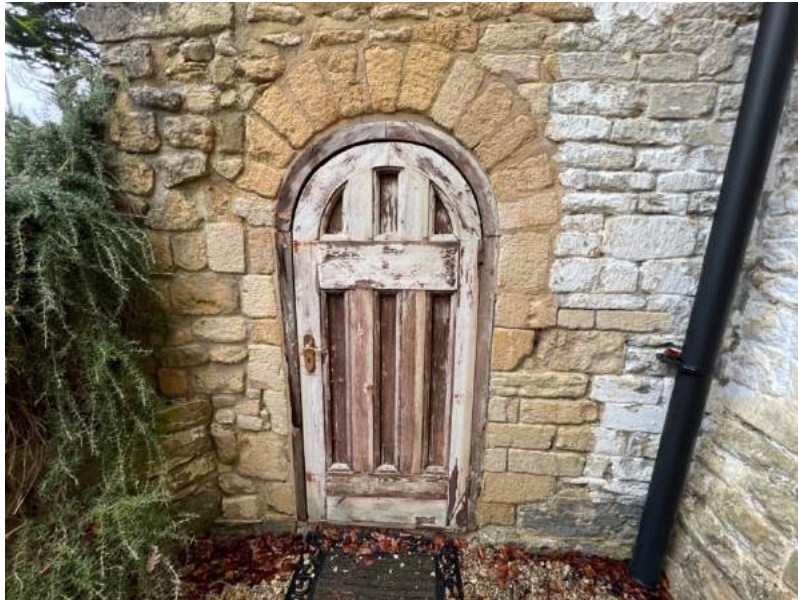
- 5.75 The door within this opening copies the historic doors, but has applied fillets to both side, with no recessed panels, & may possibly be a modern copy.

Figure 86 Northern store, south door.

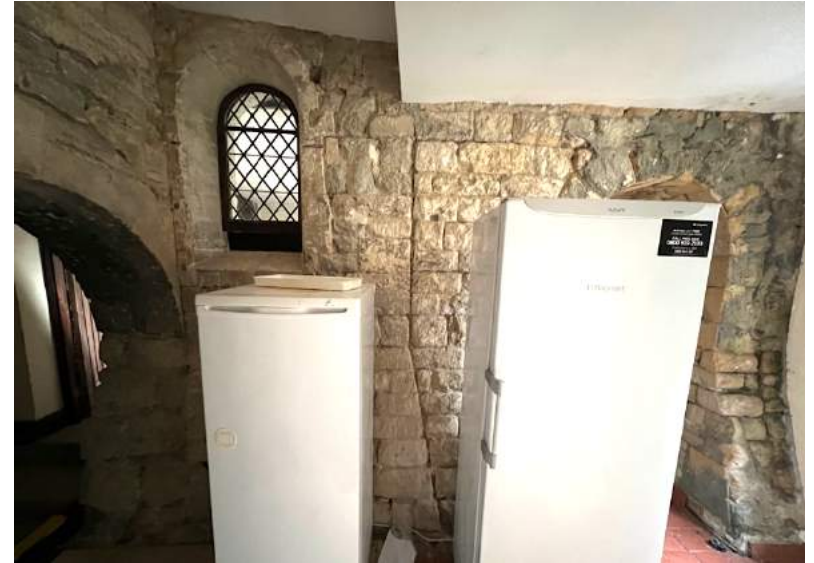
- 5.76 The arched head of the opening within the southern wall has far more crude masonry than is characteristic, which may suggest some level of alteration, although the archivolt visible internally appears historic; the door within it appears historic, albeit potentially not *in situ*.

Figure 87 Northern store, south wall.

- 5.77 From within the northern store it is clear that the southern wall is an addition, as the corner of the ante-room block is clearly expressed. The store opens from the adjacent corridor by way of an arched opening. This arch of finely jointed ashlar voussoirs appears integral to the wall, & thus original to this part of the building. The semi-circular arch rises directly from the battered footings of the adjacent walls, echoing a horseshoe arch. This would have made the archway difficult to infill with door or window, & the result would be uncharacteristic; it is possible that the corridor within, whilst running beneath the building, was not enclosed, but open in the form of a tunnel.

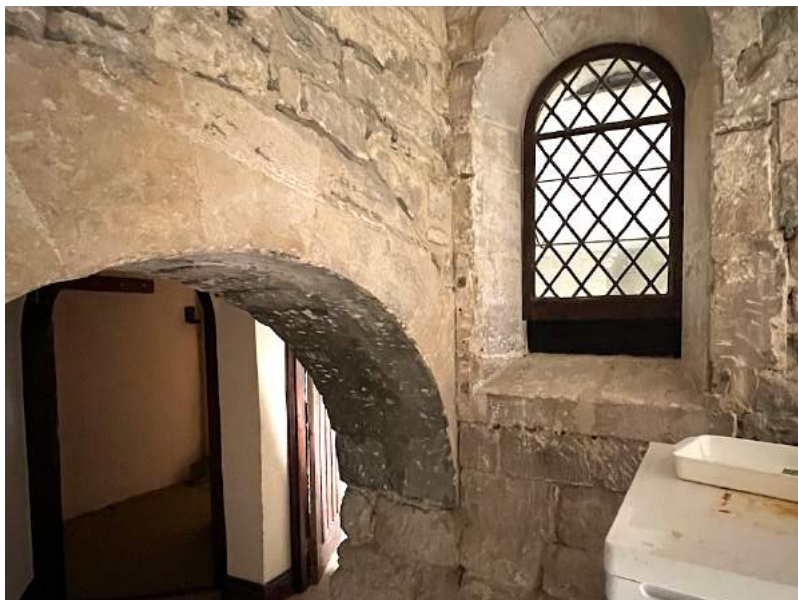
- 5.78 Internally, the store has a modern quarry-tile floor, apparently upon a concrete slab, & no other historic fittings.

Figure 88 Northern store, entrance from adjacent corridor.

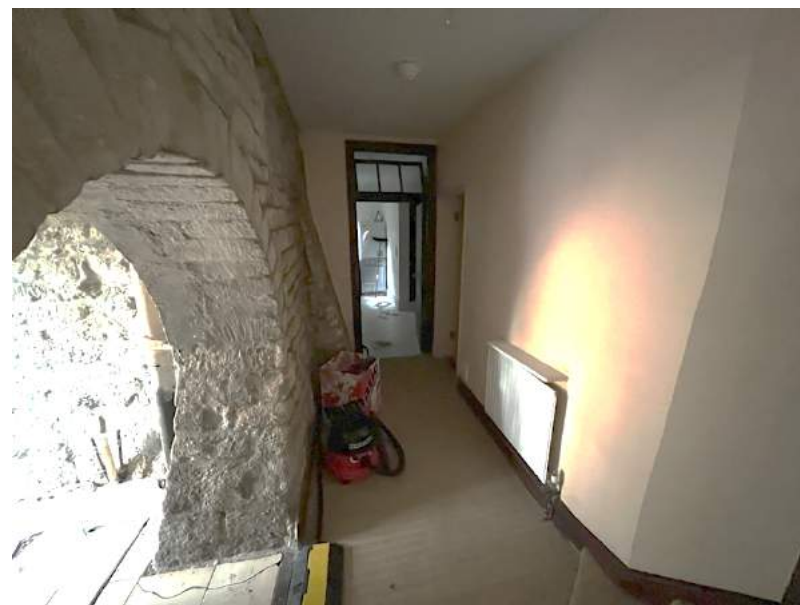
Figure 89 Corridor, facing north.

- 5.79 The corridor runs along the inside of the west front, originally linking to the service entrance to the north. Along its west side are a series of subsidiary enclosed spaces, which, whilst heavily altered, appear potentially historic in origin.
- 5.80 The corridor has been truncated half way along its length by a door with a fanlight; whilst the style of these are traditional, they in fact appear to be modern replicas, presumably to enclose the modern laundry that was formed at the northern end.

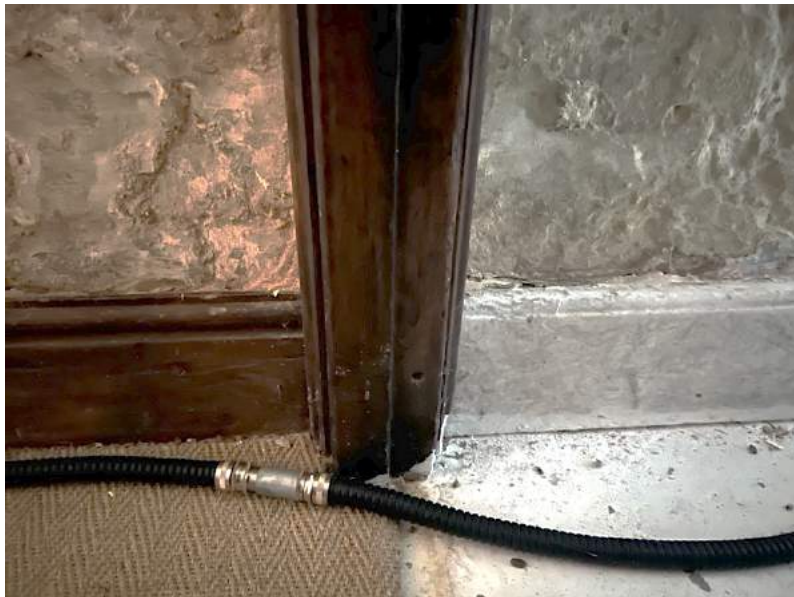
- 5.81 The skirting varies to either side of this wall; to the south is a brown-stained skirting that appears, like the wall, to be modern. To the north is a painted timber skirting with a simple ovolo-moulding. This painted skirting appears historic; however, it continues unbroken across the now-blocked rear entrance, which, from the rear, is exposed concrete blockwork.

Figure 90 Corridor, details of skirtings to either side of modern dividing wall: modern skirting to south/left; historic (Rich phase) skirting to north/right.

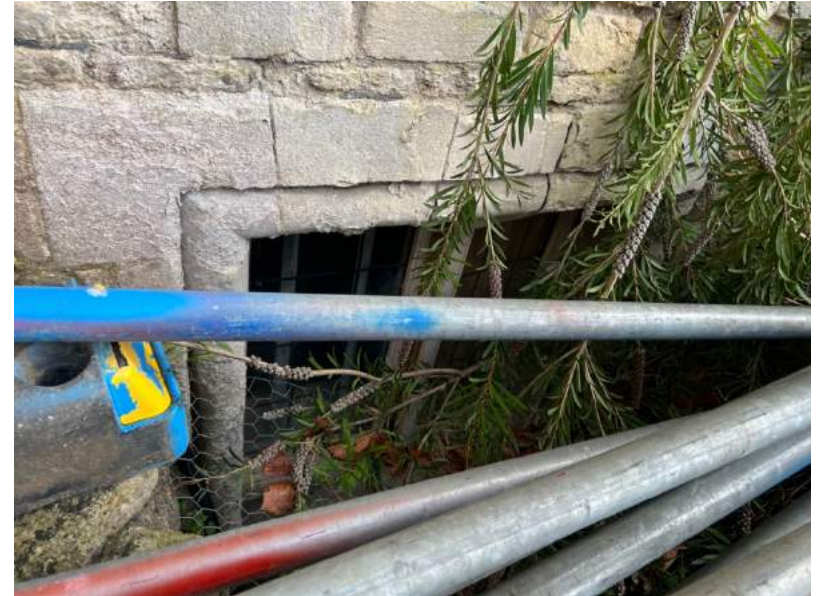
- 5.82 At the northern end of the corridor is a window into a small well. Whilst the timber casement does not appear historic, the

stone surround, with a simple Romanesque roll moulding clearly dates from Robert Leach's time (probably first phase).

Figure 91 Corridor window.

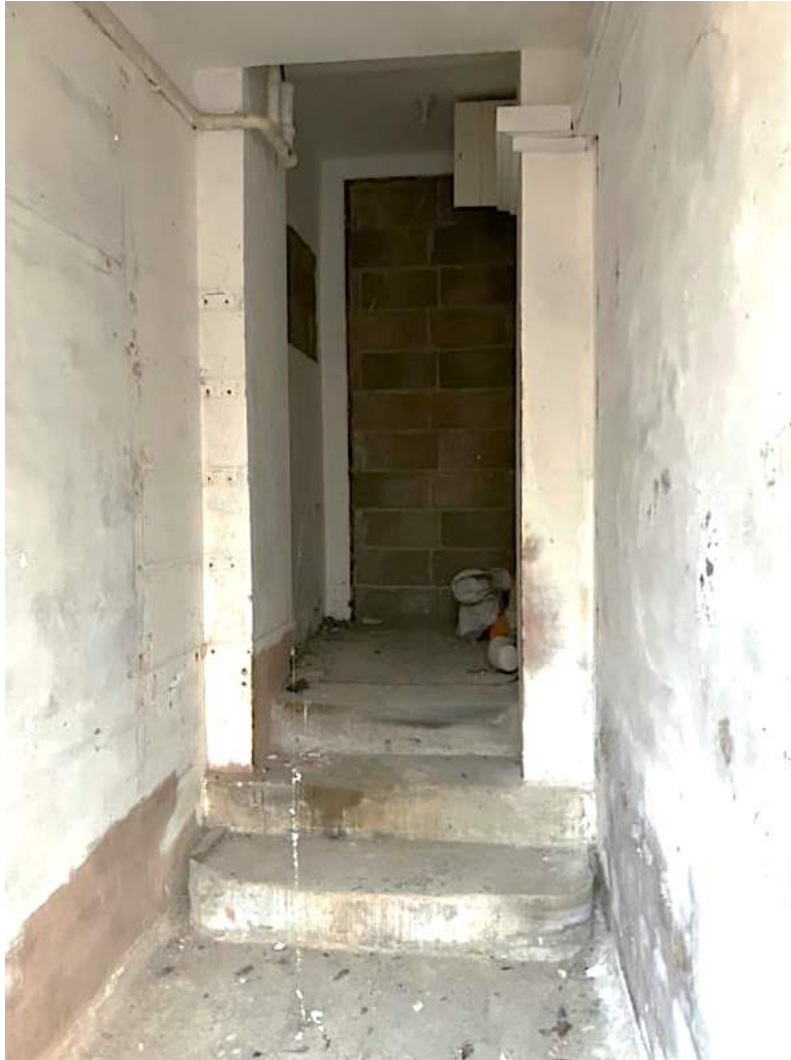
- 5.83 Beyond the opening that is blocked, a passage led to a gate in the retaining wall onto the drive; this passage appears to have been open-air, but has been partially covered by the 20-century bathroom, & the remainder enclosed with polycarbonate sheeting. A room opens to the north of this passage, which is brick-lined & has a flat, concrete roof; this may, possibly, date from the Rich alterations.

Figure 92 Former northern service entrance.

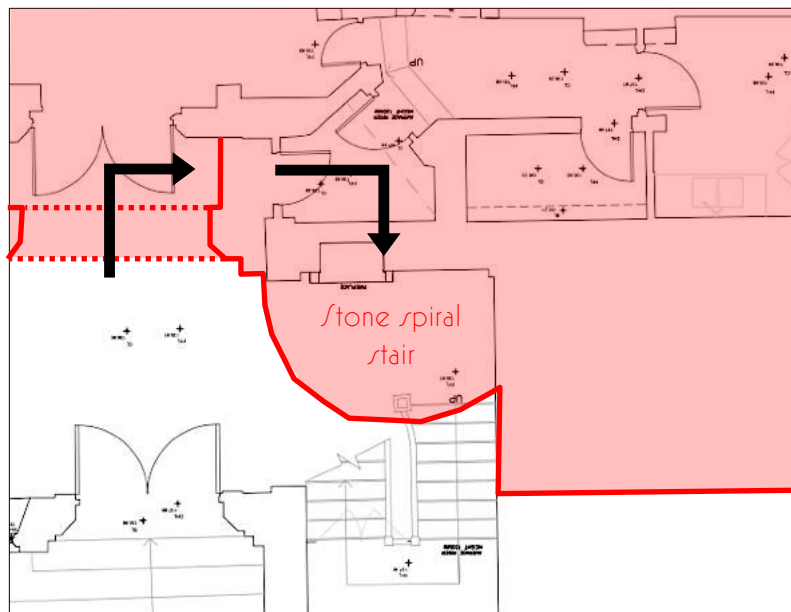
Figure 94 Relationship of lobby to historic entrance & spiral stair.

5.84 The lobby comprises a curious polygonal space at the southern end of the corridor, & now links it to the entrance hall; the lobby has a shallow brick vaulted ceiling, which is considerably lower than the adjacent ceilings, but whose purpose is currently unclear. The door between the lobby & the corridor is an historic, round-headed door; that to the entrance hall appears potentially a Rich-phase door, but set into a modern plasterboard wall.

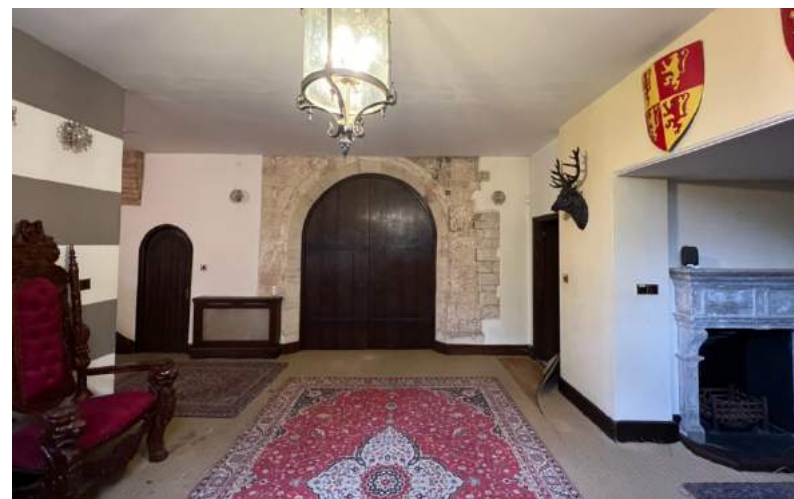
Figure 95 Door to lobby from entrance hall.

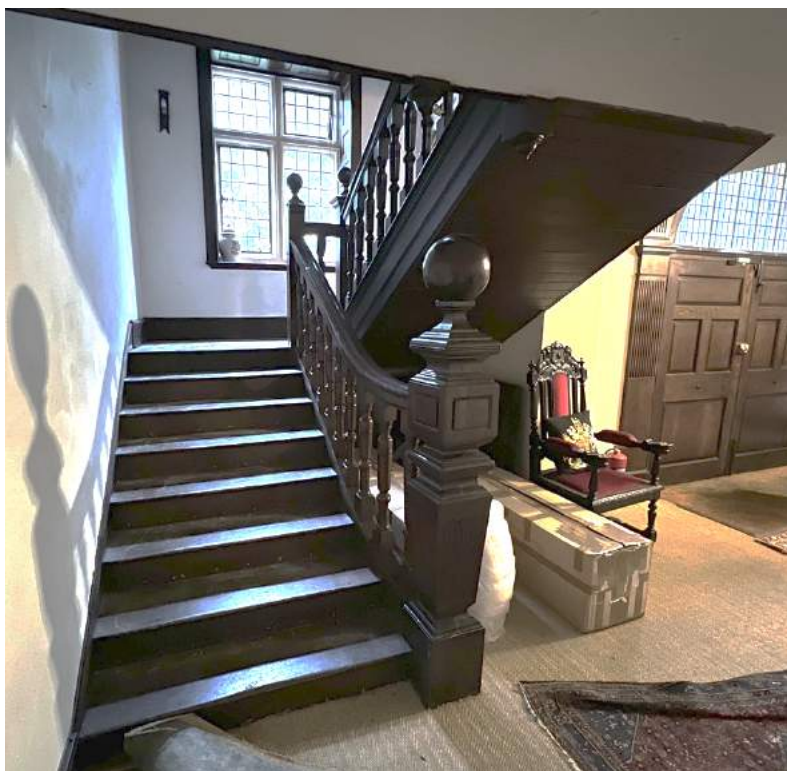
Figure 97 Principal stair.

- 5.86 The principal stair built by Sir Charles Rich replaced the stone spiral that formerly stood in this location. The new stair comprised a timber stair in an early-17<sup>th</sup> century style around a shallow well, opening from the entrance hall, & rising up to first floor. Apart from some limited damage to newel caps, the stair appears little altered.

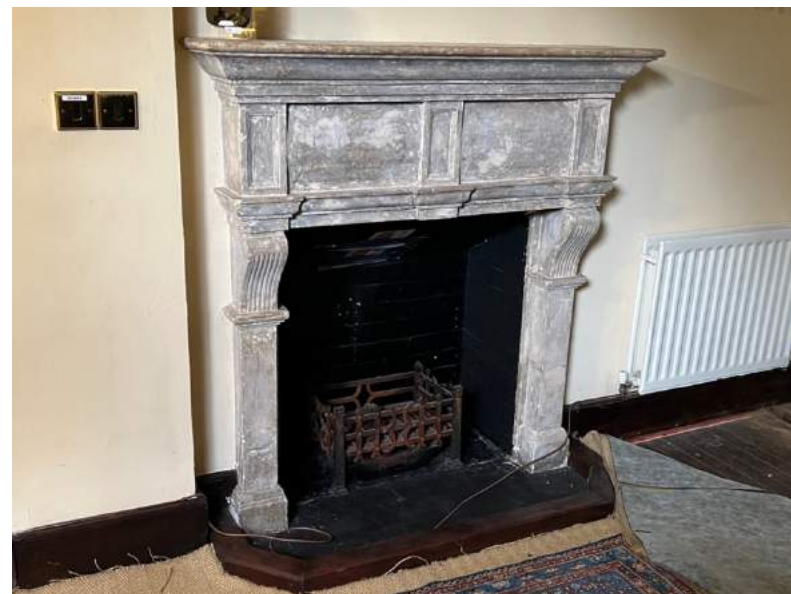
- 5.87 The fireplace at the foot of the stair is also 17<sup>th</sup>-century in style (albeit more continental than English in appearance), but appears potentially salvaged.

Figure 98 Fireplace at foot of principal stair.

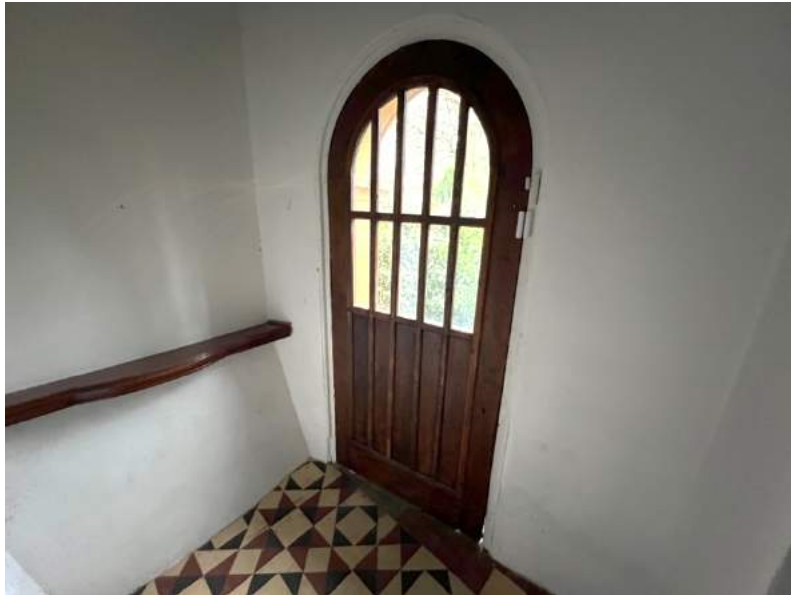
Figure 100 Lobby (garden entrance).

- 5.88 The lobby which comprises the garden entrance lies to the south of the dining room, between it & the circular morning room (now in separate ownership), within the original Goodrich building for Valentine Leach. The room has a decorative tiled floor, & the plaster on the walls is lined to resemble ashlar blocks (which occurs elsewhere in the house, including in areas altered by Sir Charles Rich). There is no evidence currently visible to suggest a doorway to the morning room, although there may have been a door to the turret.

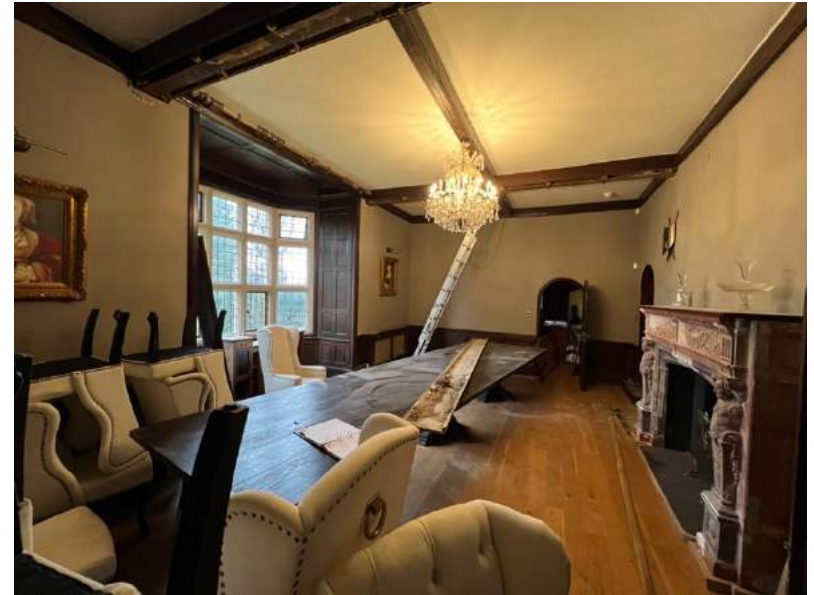
Figure 101 Dining Room, facing north.

- 5.89 The *Dining Room* also forms part of the original building, & its general form, a rectangle with a canted bay, appears little altered, although the bay originally contained four round-headed, windows, with fixed upper light, & a side-hung casement in the lower. The window was rebuilt in its current form by Charles Rich after 1888. The two transverse beams across the ceiling contain iron I beams: the I beam was only invented around the middle of the 19<sup>th</sup> century, & these are therefore likely to have been inserted when the bay was rebuilt.

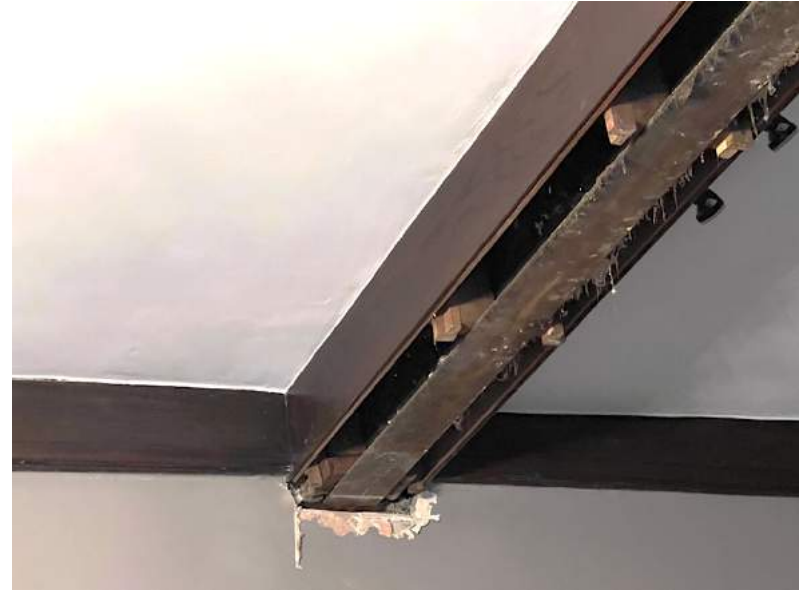
Figure 103 *Dining Room*, detail of ceiling construction.

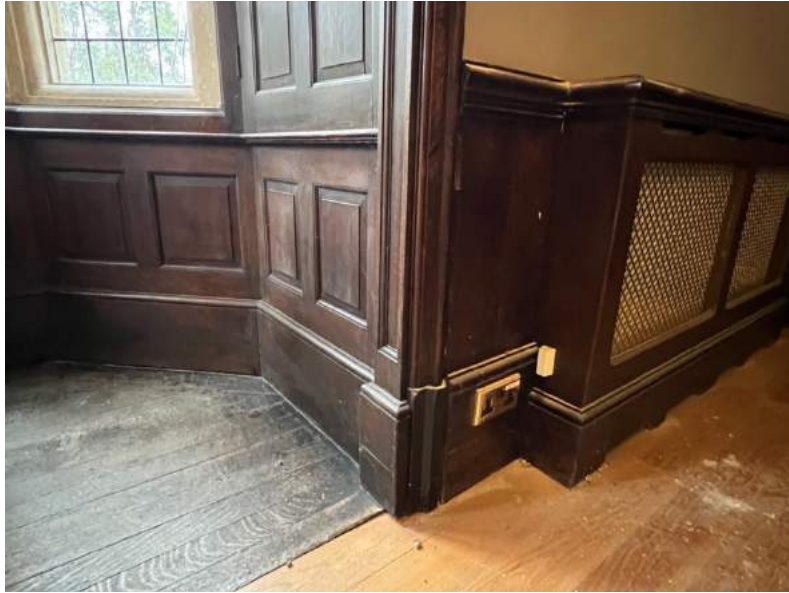
Figure 104 Dining Room bay, detail of linings.

5.90 The timber linings within the bay window appear to be contemporary with it, as do the floorboards. However, the wainscotting around the remainder of the room has been pieced together from fragments that do not fit the available space properly, & which are clearly salvaged from elsewhere. The skirting & dado appear modern, suggesting that the wainscotting was installed in the 20<sup>th</sup> century, probably when the flooring in the main part of the room was also replaced.

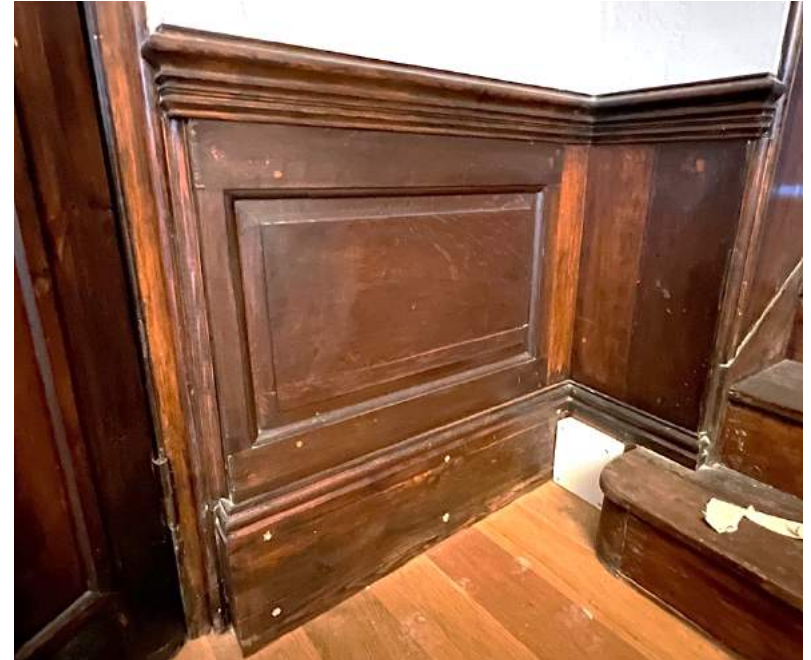
Figure 105 Dining Room, wainscot.

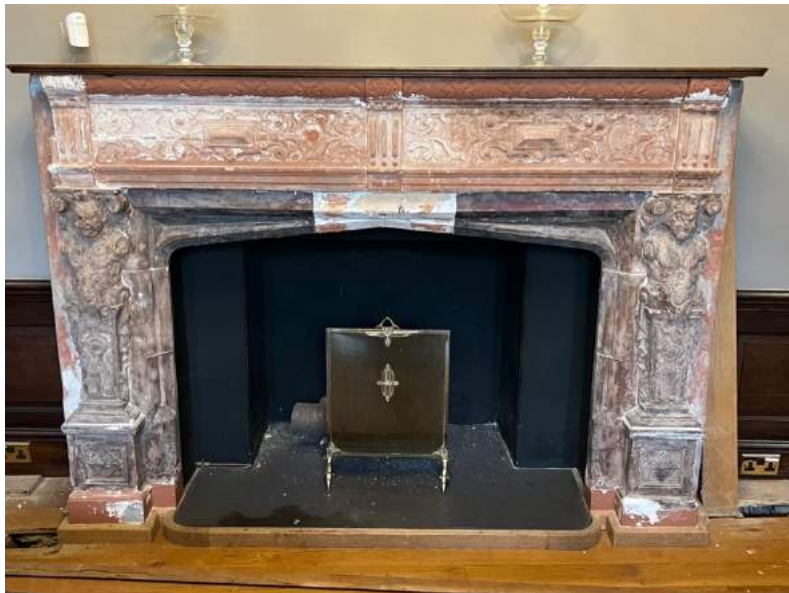
5.91 The current dining room fireplace comprises an unconvincing compilation of various architectural fragments of unknown provenance, & is clearly also 20<sup>th</sup> century. However, in 1994 a fireplace from the castle, decorated with Robert Leach's initials & the date 1869, was sold at auction in London. The scale & richness, apparently incorporating short pilaster shafts of a polished marble, would suggest that it probably came from a principal room. The fireplace in the *Morning Room* was described as being arched in the 1883 & 1888 sales particulars;

Figure 106 Dining room, fireplace.

5.92 However, as both the *Dining Room* & the *Morning Room* lie within the earlier building, this fireplace itself would have been a replacement of an earlier surround.

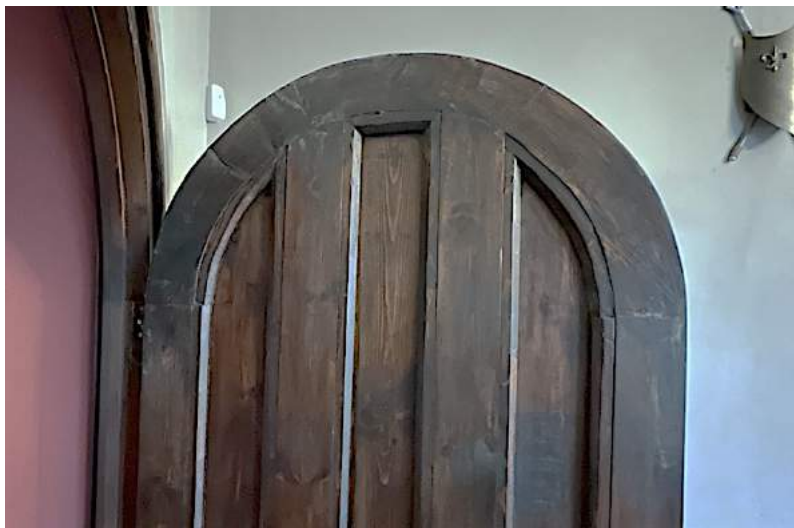
5.93 The *Dining Room* contains four doors, of which three comprise the round-headed type, with three recessed panels on one side, & applied fillets creating five vertical panels on the other. The doors to the lobby & the ante room have unbroken vertical panels on both sides, however the door to the back stair has inserted blocks in the recessed panels to approximate a horizontal rail, & more to increase the height of the bottom rail; this variant may possibly have been intended to receive decorative ironwork. None of these doors retain any historic door furniture.

Figure IO8 Door between *Dining Room* & *Ante Room*.

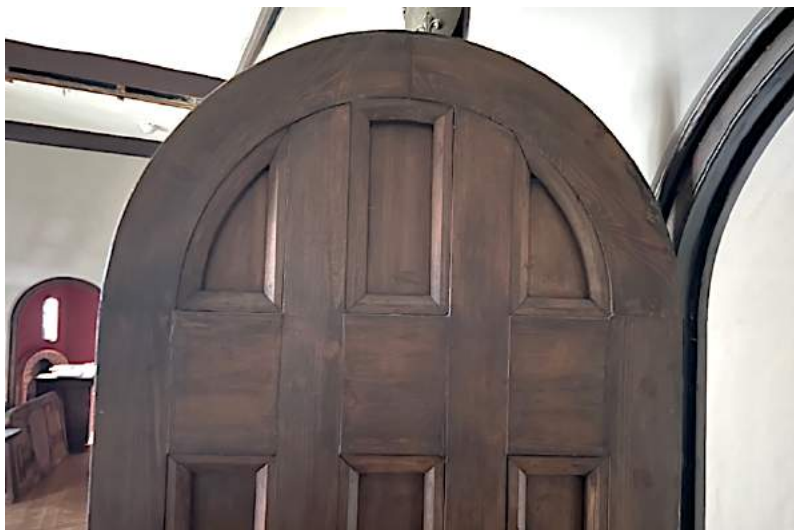
Figure IO9 Door between *Dining Room* & back stair.

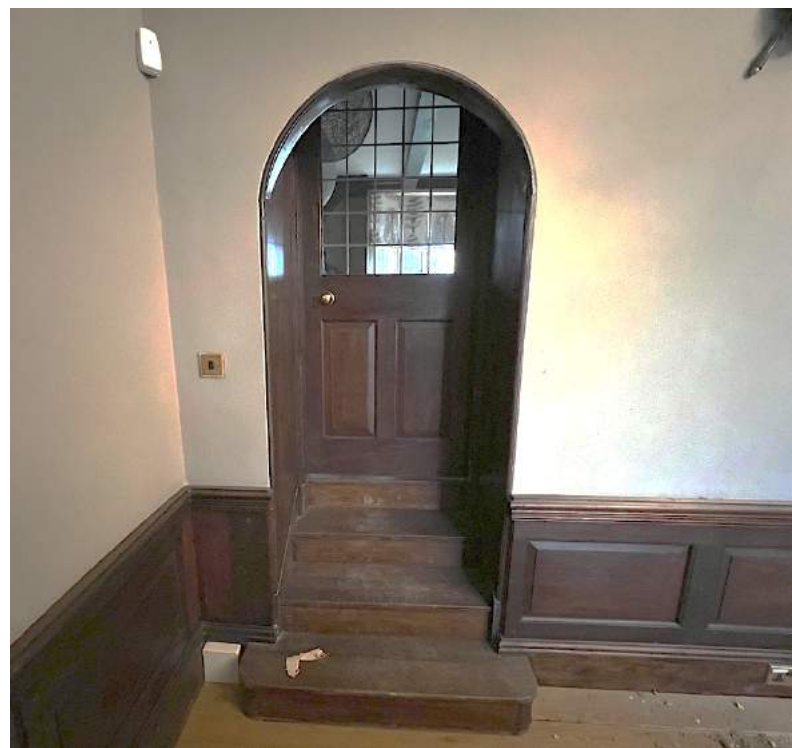
5.94 The fourth door, that to the Sir Charles Rich's Billiard Room is contemporary with this room, & is flat-headed, but set back behind an arch-headed opening. It is unclear whether the arched opening & steps pre-date the Rich phase, as the *Long Passage* which previously ran behind this wall was several steps higher, & led to a stair, above the stone stair, that rose to first floor.

Figure IIO Doorway between *Dining Room* & Billiard Room.

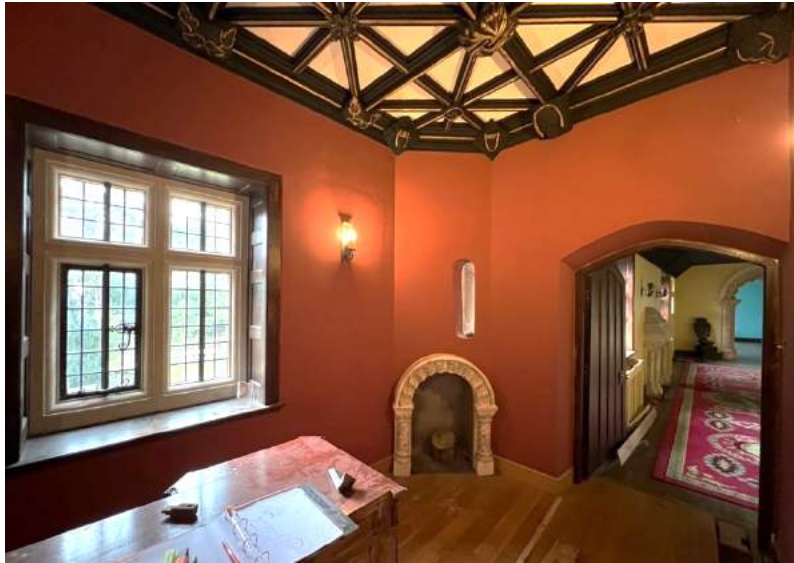
Figure III *Ante Room, facing north-west.*

- 5.95 The *Ante Room* forms part of Robert Leach's first phase, & retains its original ceiling, which incorporates salvaged elements of a timber ceiling of possibly 16<sup>th</sup> or 17<sup>th</sup> century origin, but of unknown provenance.
- 5.96 The chimneypiece is original, with a semi-circle of chevrons over colonnettes, & retains evidence of red paint. The window dates from the Rich alterations, the original was Romanesque in style, with a round head, plate glass beneath the chord & diamond panes & possibly with a central motif above.

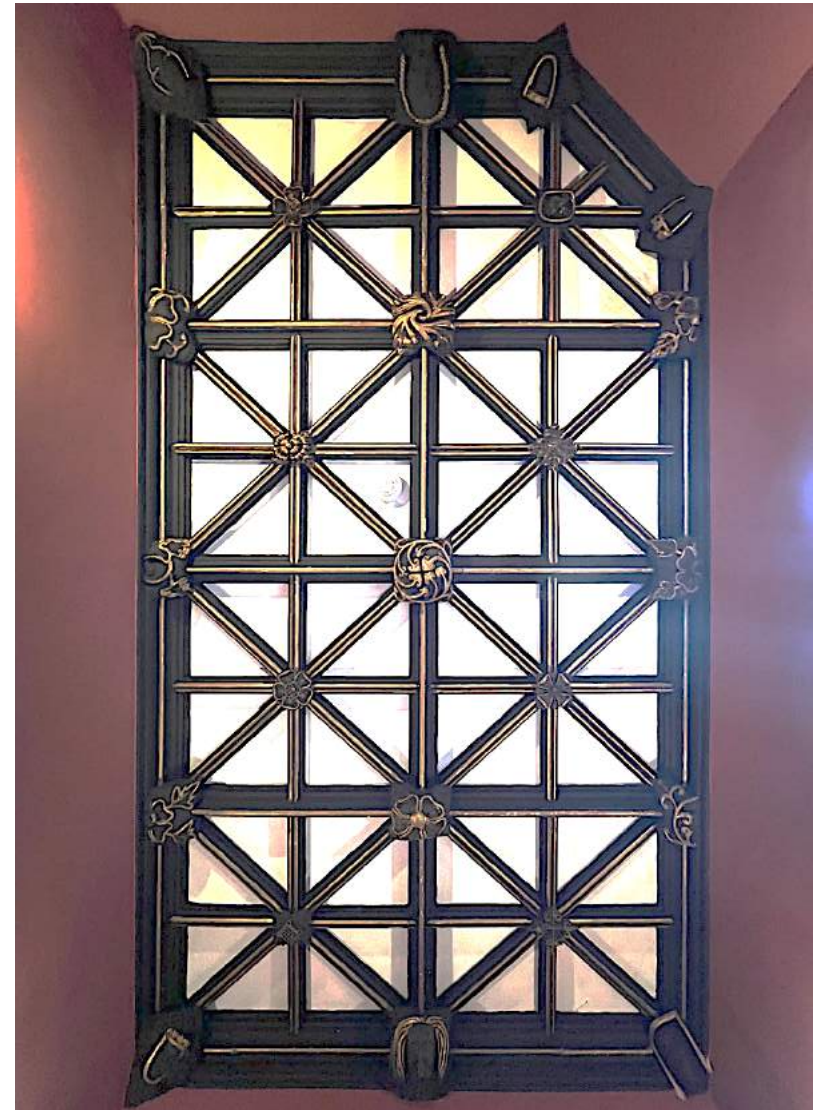
Figure II2 *Ante Room ceiling.*

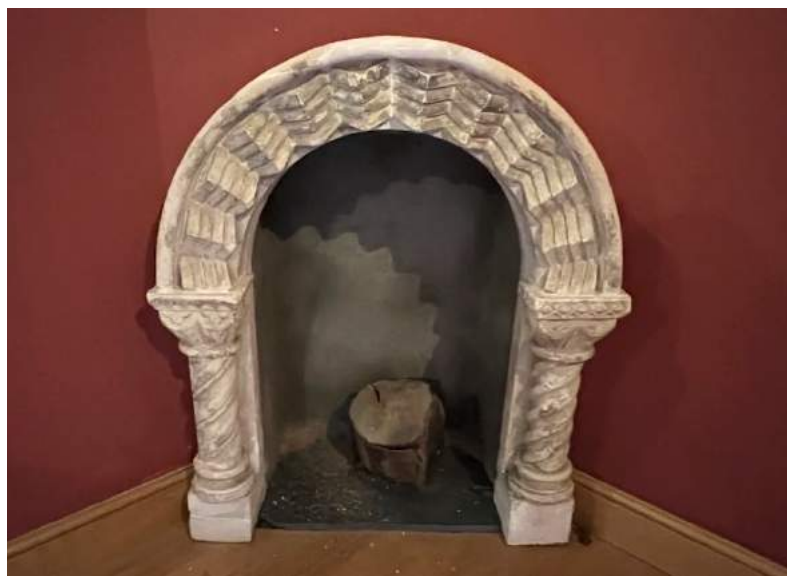
Figure 113 *Ante Room* fireplace.

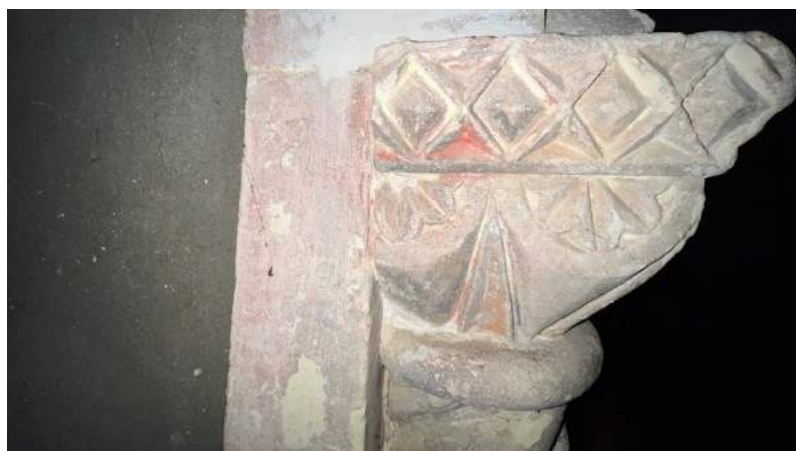
Figure 114 Detail of right-hand colonette showing evidence of polychromatic decoration.

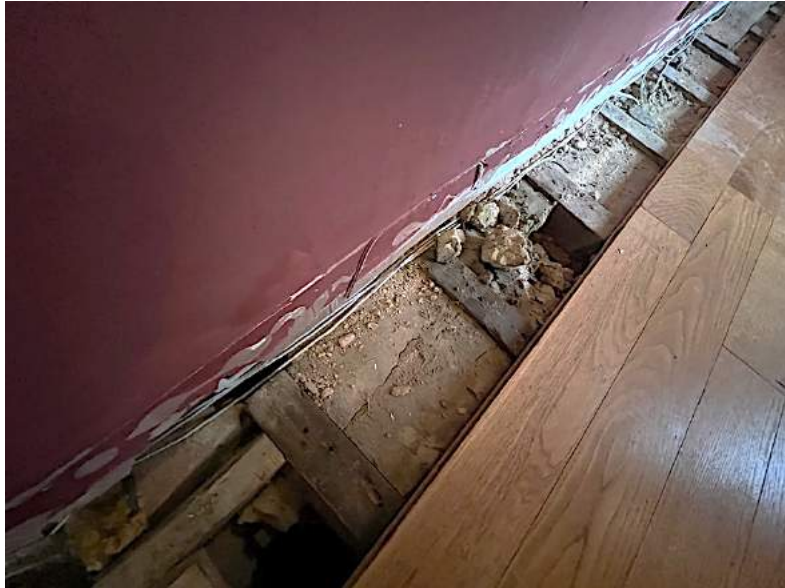
- 5.97 The floorboards & skirting are modern, but beneath there is pugging, solid like a lime-ash floor, on boards suspended on battens between the joists. Where the arch of the original door rises above the floor, the plaster has been stripped to expose it.

Figure 116 Pugging beneath *Ante Room* floor.

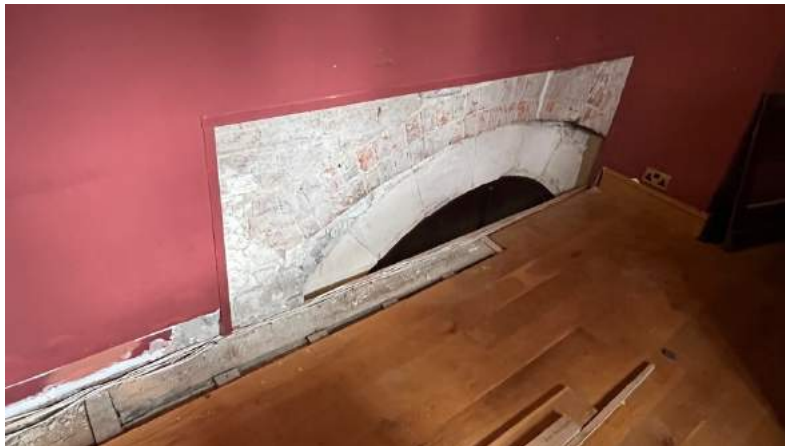
Figure 117 Rear of entrance arch.
