## DEVIZES CASTLE.

### STORES.

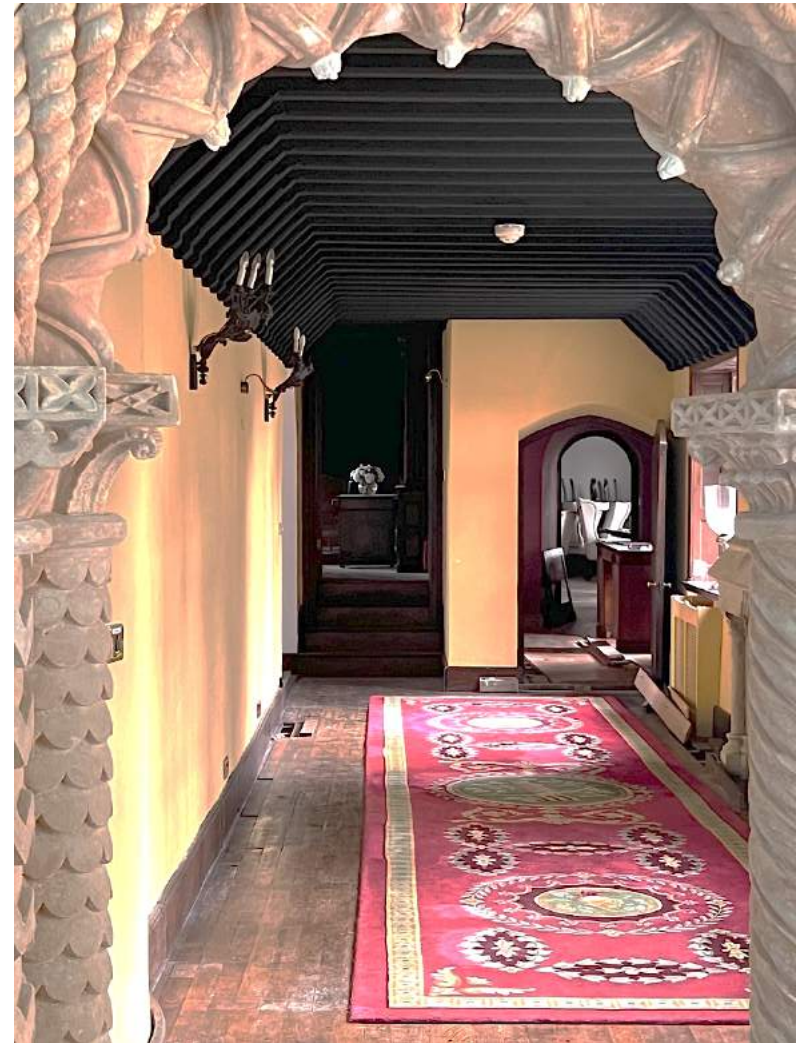
Figure 118 *Gallery*, facing south.

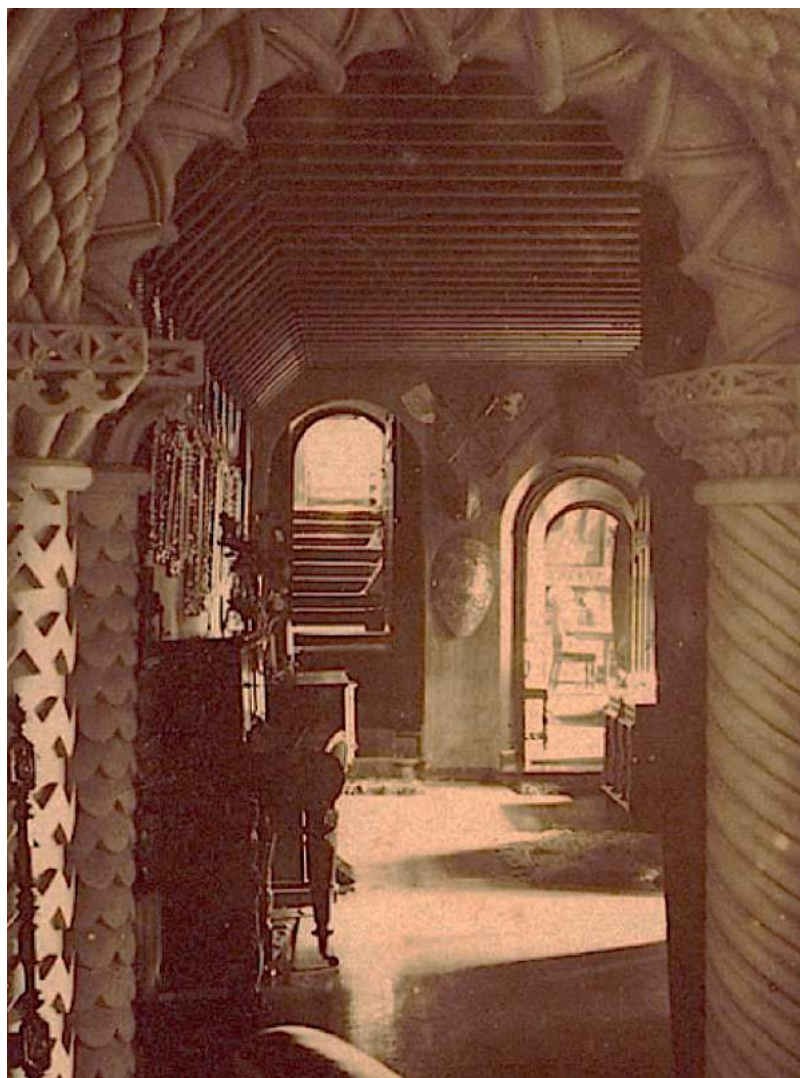
Figure 119 Gallery, facing south, c.1880 (© Wiltshire Museum, Devizes; DZ/WJ:1983.7492).

5.98 The north door of the ante room opens into the *Gallery*; this door currently comprises a shallow, two-centred arched head, although a photograph from the 1880s clearly shows that this door with a characteristic semi-circular head. To the left of this, where the billiard room now sits, was the '*Long Passage*' up five or six steps that started in line with the ante room wall, through a second arched opening that also appears to have aligned with that to the ante room. This would have left a narrower width of wall on the east, abutting the adjacent spiral stair, which could only have been accessed by way of a single door, rather than the broad arch of the Rich-phase.

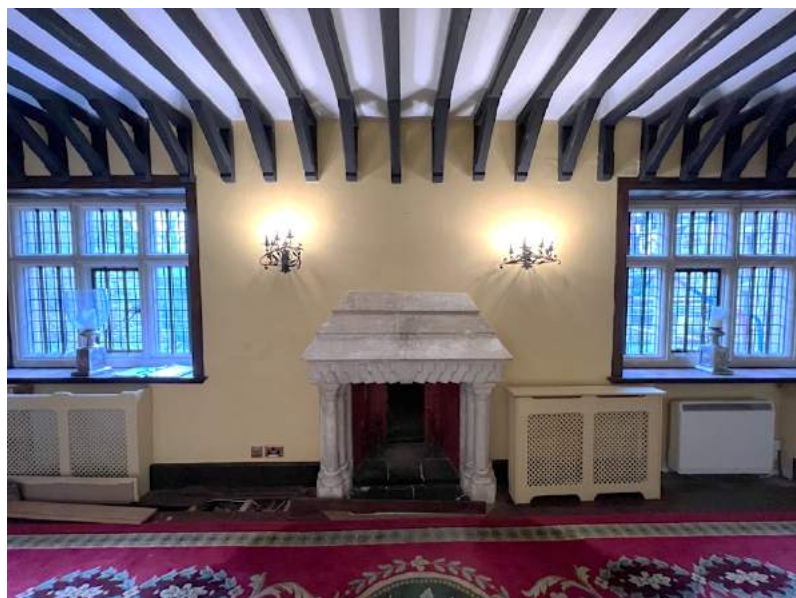
Figure 121 *Gallery, west wall.*

5.99 The ceiling, with exposed, braced joists is original. The two mullioned windows symmetrically placed around the fireplace date from the Rich phase; the original windows were not symmetrical. The southern end of the gallery has a two-light window, the northern end has two separate single-light windows. The windows were placed at different levels, despite the fact that they lit the same room, presumably for external theatrical effect. The doorway that opens to the garden from the gallery from the north end of the gallery is 20<sup>th</sup> century.

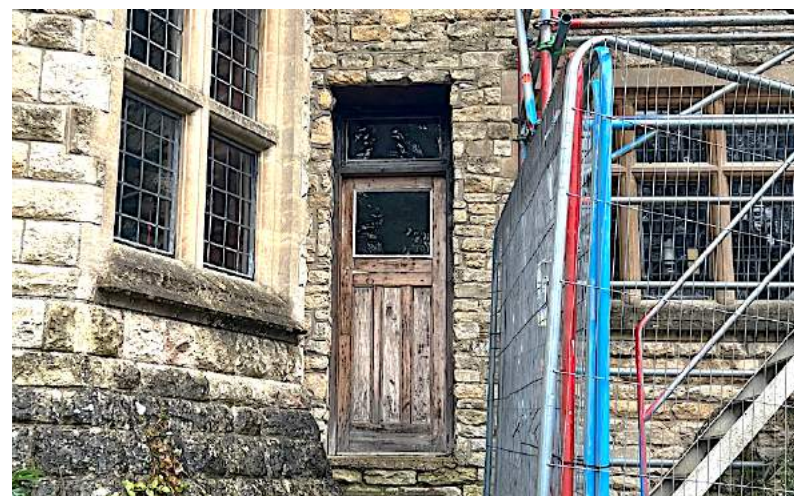
Figure 123 External door to *Gallery*.

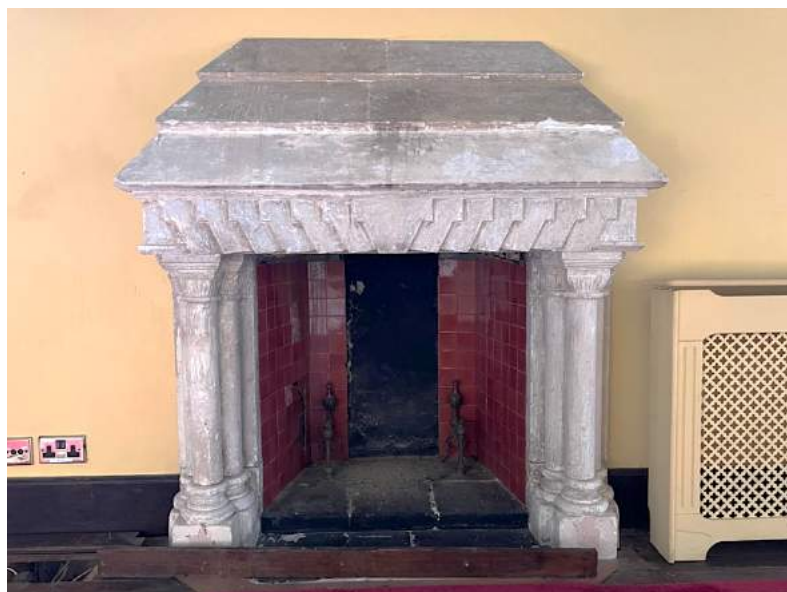
Figure 124 Gallery fireplace.

5.100 The fireplace is original, & retains fragments of paint, including blue. The door from the *Gallery* to the turret stair is round headed, but one of the variants with an expressed, & on this door raised horizontal rail with a decorative end, & a shadow of now-removed decorative ironwork. This door retains an original iron drop handle on a quatrefoil backplate.

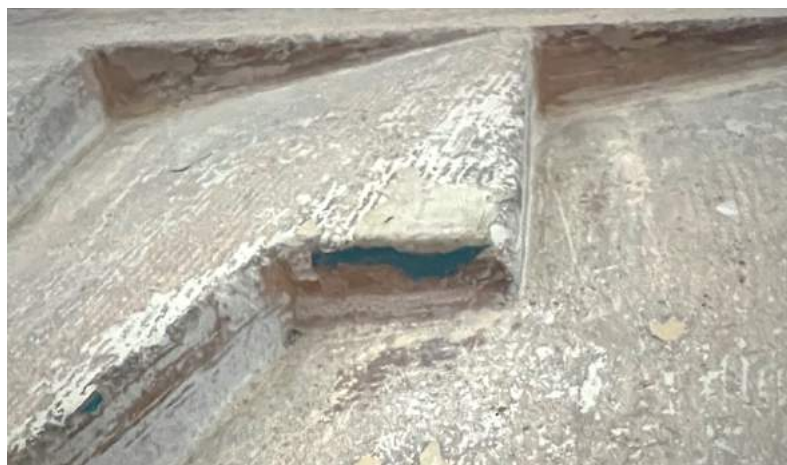
Figure 125 Fragment of blue paint surviving on Gallery fireplace.

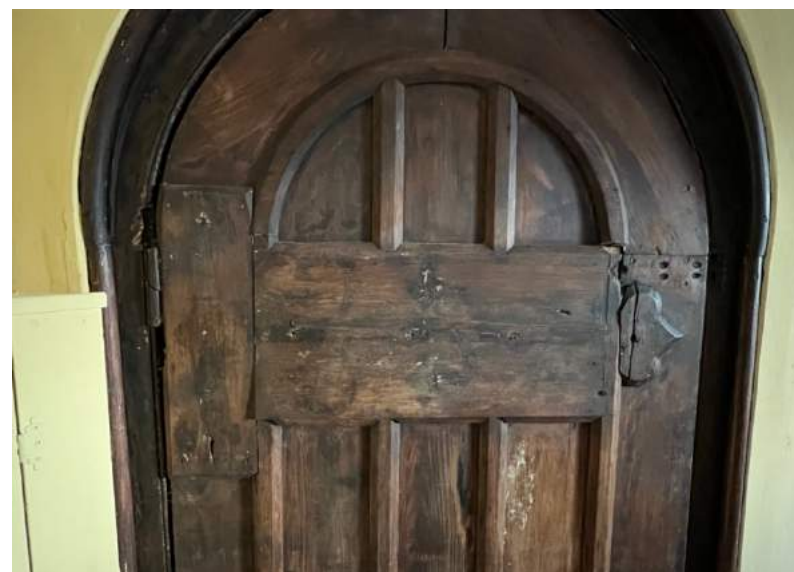
Figure 126 Detail of door from gallery to turret stair.

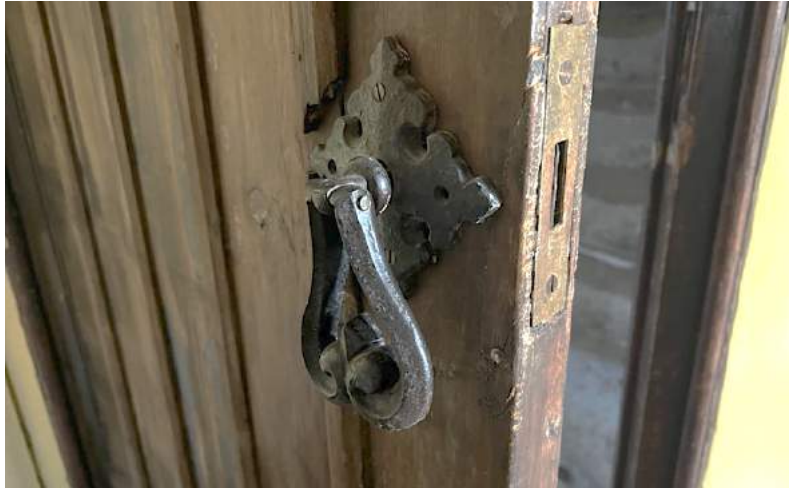
Figure 127 Detail of handle on door to turret stair.

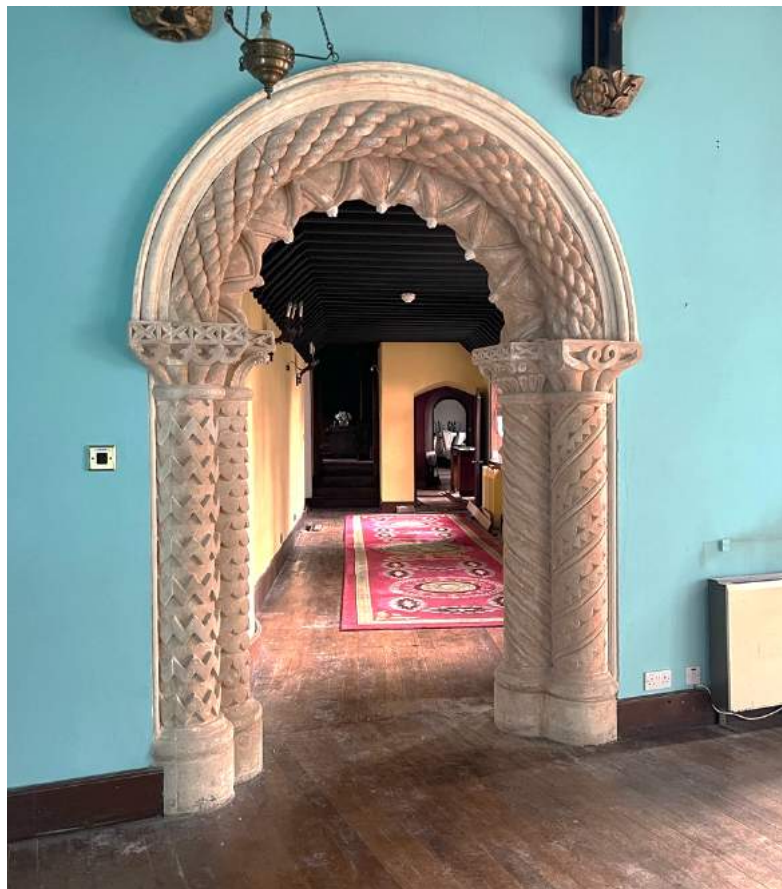
Figure 130 Drawing room, entrance to the gallery.

5.102 The *Drawing Room* is the best recorded room in the house, both photographically, & through the descriptions in the 1880s sales particulars.

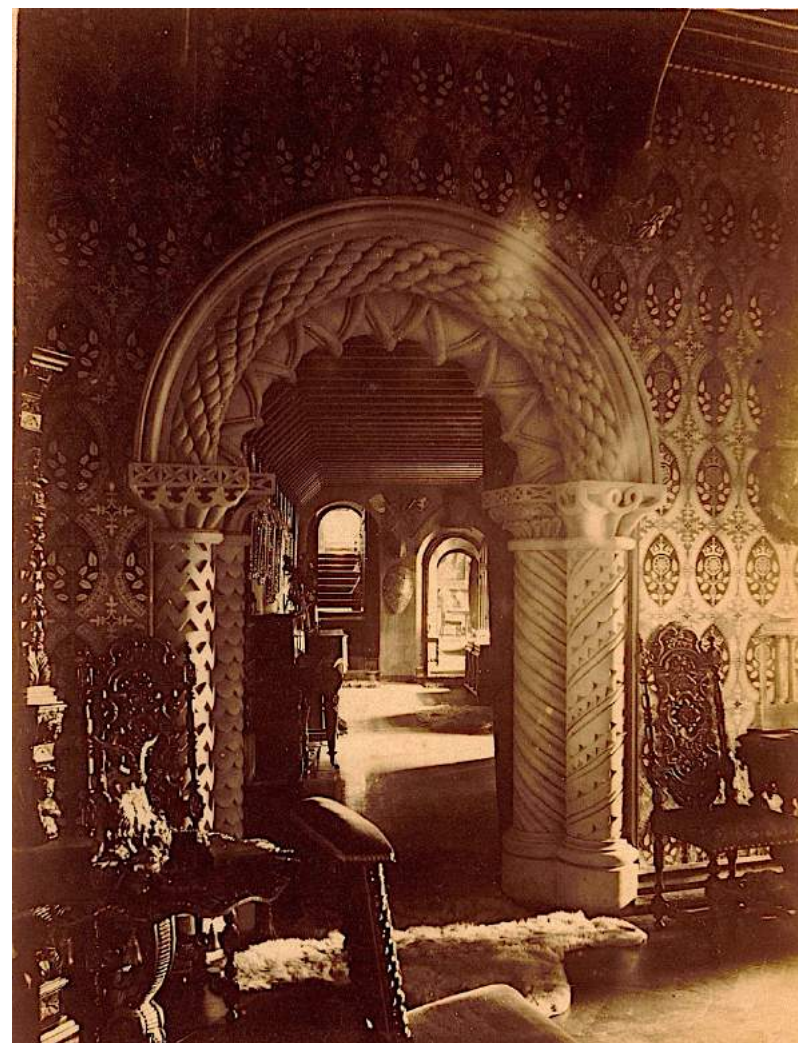
Figure 131 *Drawing Room*, entrance to the gallery, c.1880 (© Wiltshire Museum, Devizes; DZ/WJ:1983.7492).

- 5.103 The richly-carved Romanesque archway to the gallery is little altered. No indication of painted decoration is discernible in the old photograph, although fragments of blue paint survive at the centre of a number of fleurons.

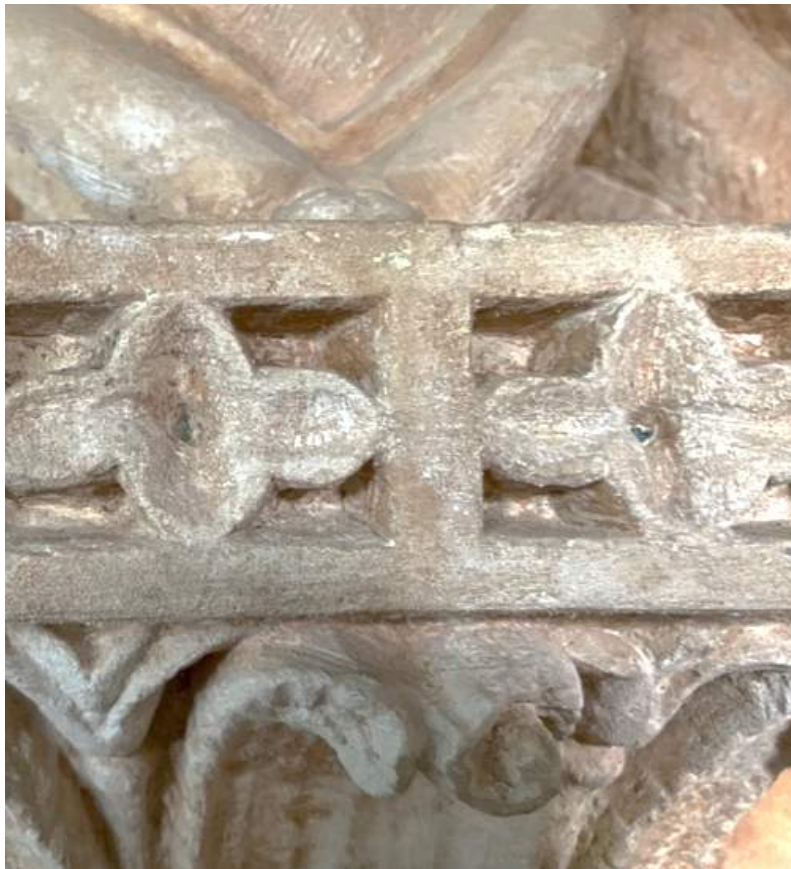
Figure 132 Detail of the abacus of the eastern jamb of the arch.

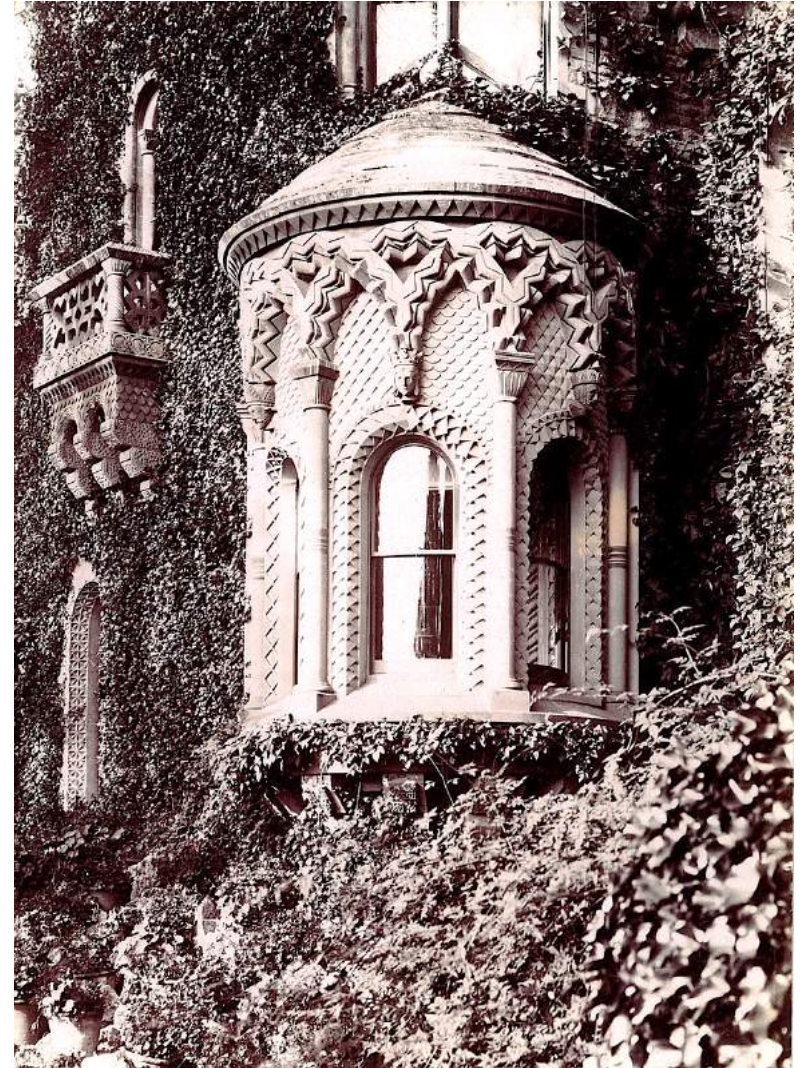
Figure 136 *Queen's Oriel, c.1880* (© Wiltshire Museum, Devizes; DZ/WJ:1983.7493).

- 5.106 To the west, the *Drawing Room* was lit by way of a single-light, round-headed window where the present, Rich-phase, bay stands, & on the canted south-west corner was the projecting *Queen's Oriel*.

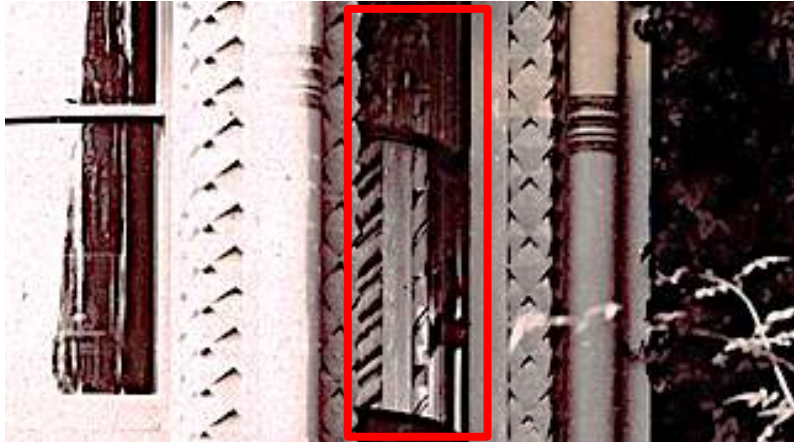
**Figure 137** Detail showing carved reveals of internal opening to *Queen's Oriel* through *sash* window (© Wiltshire Museum, Devizes; DZ/WJ:1983.7493).

- 5.107 The 1883 sales particulars confirm that the oriel was up several oak steps, & historic photographs indicate that the opening into the oriel had carved columnar jambs matching the opening to the gallery, & probably supported as similar arch.
- 5.108 To the right of the fireplace is a richly carved screen, which may be the '*sliding panel*' that led through to the *Fernery* & *Ivy Tower*. This appears to be corroborated by the presence of what appears to be a blocked doorway in the lobby between the tower & the *Fernery*, that would relate to the position of this screen. The current *Fernery* door, as well as the skirting & shutters, date from the Rich phase.

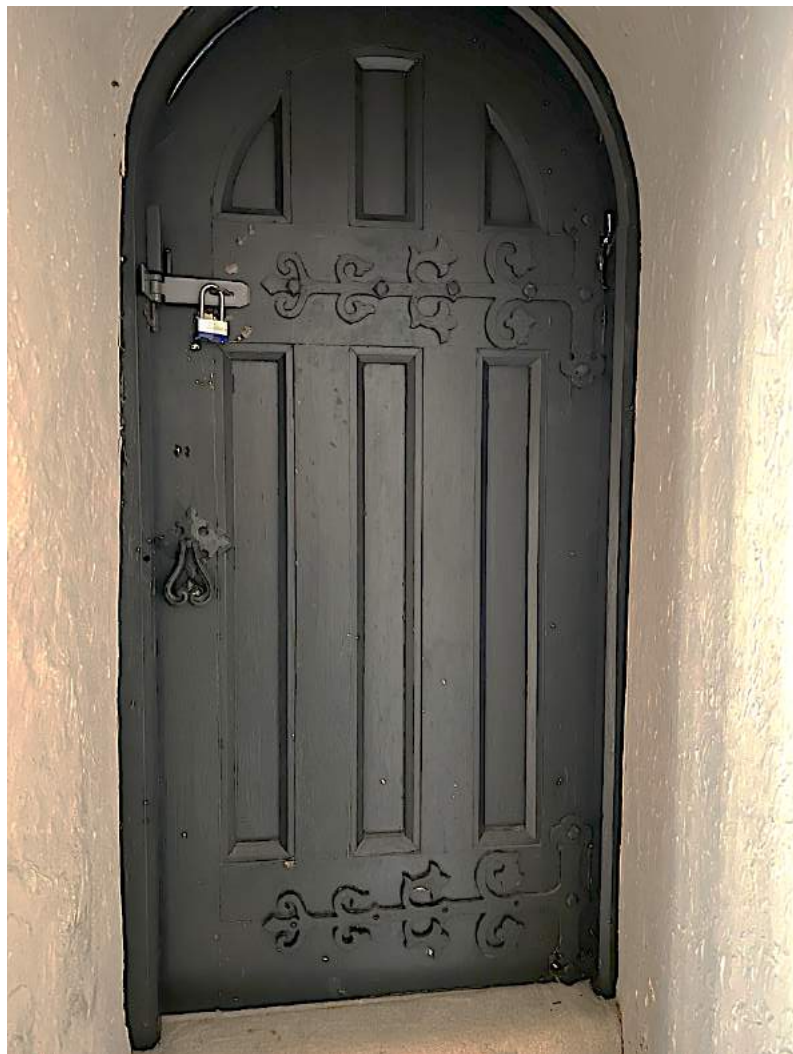
Figure 140 Door to *Secret Chamber* from *Fernery* lobby.

- 5.109 The *Secret Chamber* opens from the *Fernery* lobby through a round-headed door, which retains both original handles & the applied decorative iron hinge straps.

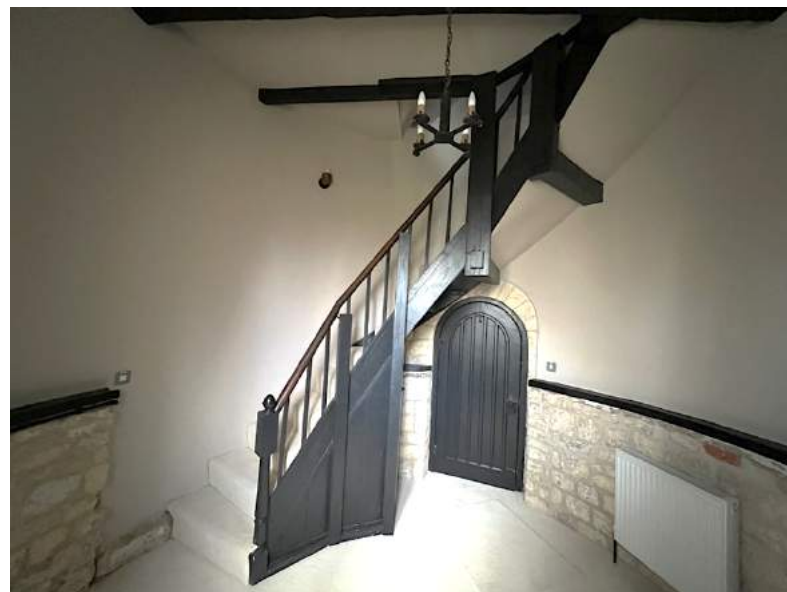
Figure 141 *Secret Chamber*, facing south-west.

- 5.110 The *Secret Chamber* lies in the base of the *Ivy Tower*, the 18<sup>th</sup>-century windmill, the stone base of which may, possibly, have mediaeval origins.
- 5.111 A timber stair winds up the south-west side, heavy & rustically constructed. The main ceiling beam is placed off-centre, as though being placed specifically to accommodate the stair; this

raises the possibility that the stair may, in origin, be the 18<sup>th</sup>-century windmill stair, although the newel & handrail are 19<sup>th</sup> century.

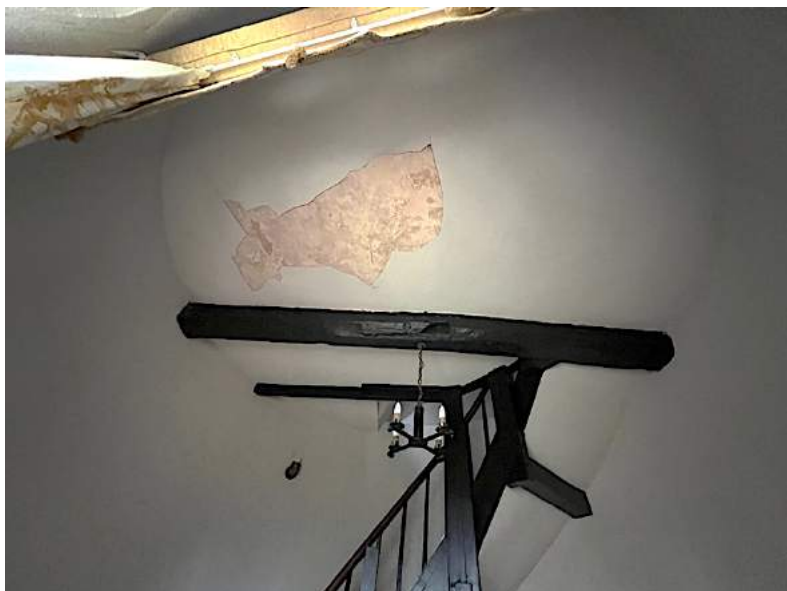
Figure 142 *Secret Chamber, ceiling.*

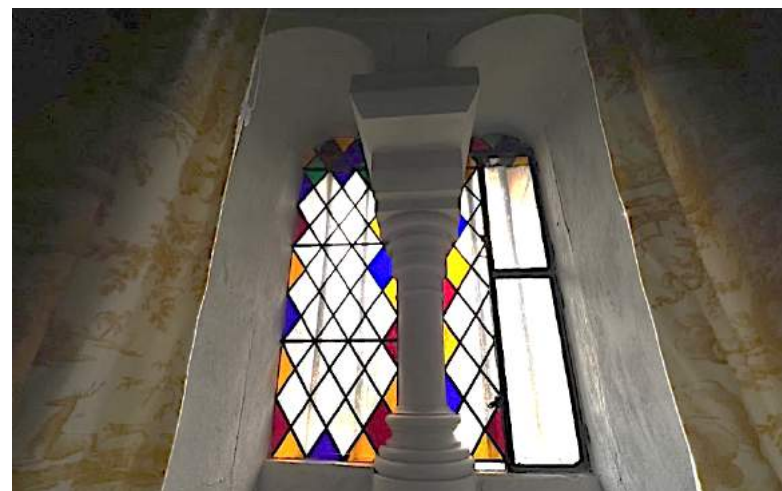
5.112 The window, with some coloured glass appears historic, potentially contemporary with the incorporation of the tower into the house in Robert Leach's first phase, as does the Romanesque fireplace. This surround retains the bases of missing colonnettes & iron cramps to hold them at the top. These probably supported an applied archivolt; fragments of both colonnettes & an archivolt survive beneath the main stair.

Figure 143 *Secret Chamber, window.*

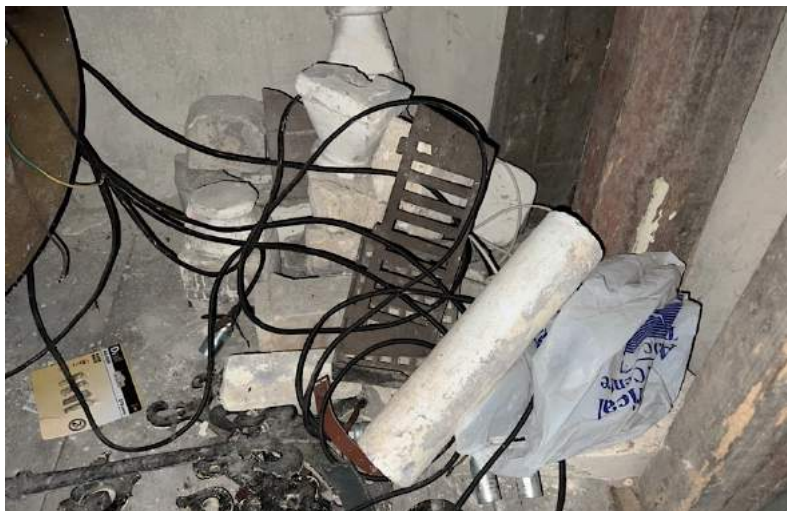
Figure 145 Fragments of masonry, some potentially from the *Secret Chamber* fireplace.

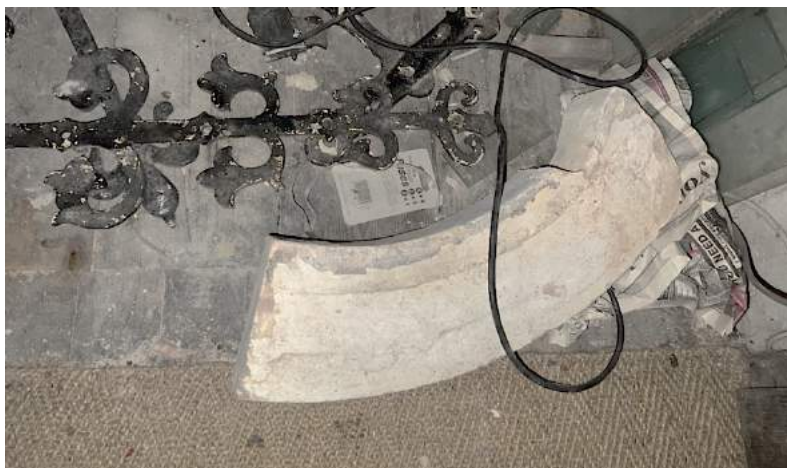
Figure 146 Fragment of archivolt, potentially from the *Secret Chamber* fireplace.

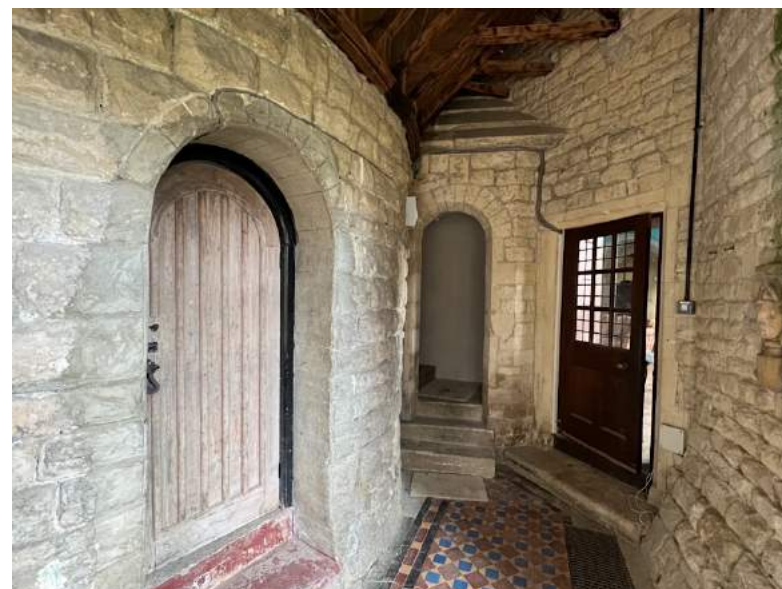
Figure 147 *Fernery*, southern end.

- 5.113 The *Fernery* was added to the castle in Robert Leach's second phase, abutting the angled lobby between the drawing room & *Ivy Tower*, with the arcading altered between 1883 & 1888. The *Fernery*, originally open, was glazed by Sir Charles Rich, at which time the heating pipes were added, disrupting the western border of the tiled floor, & the door from the drawing room was moved. The door in the eastern wall into the inner, flat-roofed room is a modern opening, although the door & frame themselves are historic, & reused from elsewhere.

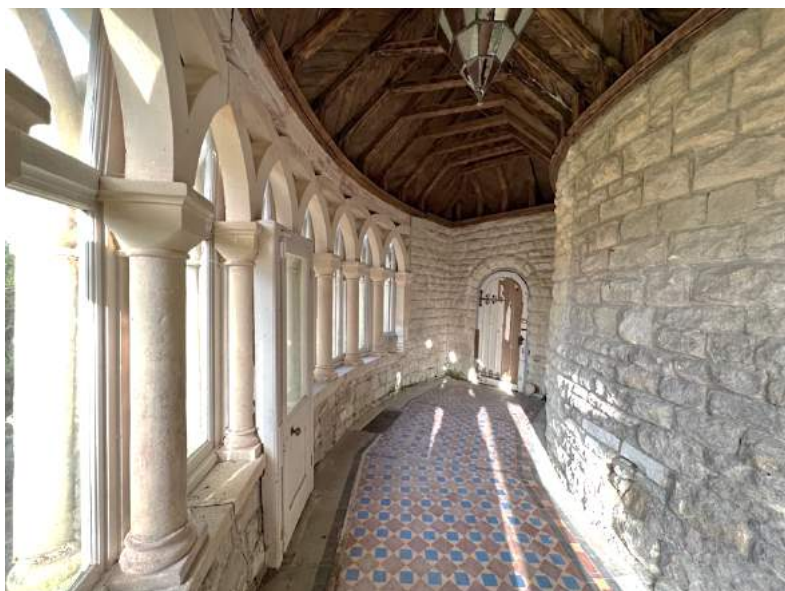
Figure 148 Fernery, facing north.

- 5.114 The room behind this door has a modern flat roof; however, it is depicted as enclosed in the early O.S. maps. Prior to the creation of the current door, the only potential means of access to this space would be through the external wall where there is currently a modern window.

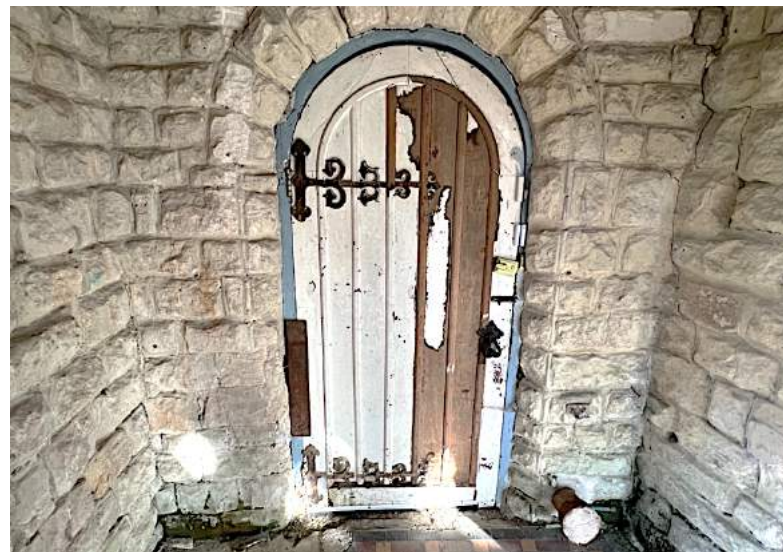
Figure 149 Fernery, door at southern end (to former *Conservatory*).

- 5.115 At the northern end of the fernery is the door to the now-dismantled *Conservatory*. This is another historic, round-headed door with original handles. However, the applied decorative hinge straps, whilst of the same design as the iron examples that survive on other doors, are actually timber.

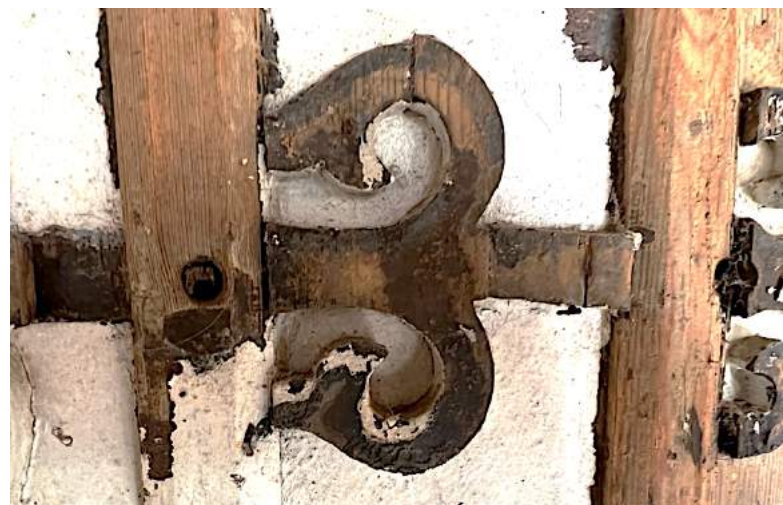
Figure 150 *Conservatory* door, detail of applied timber strap hinges.

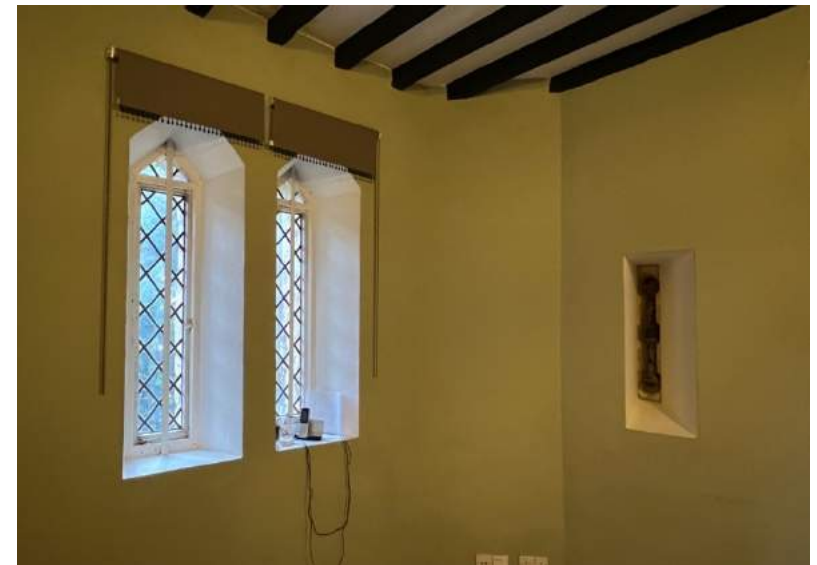
- 5.117 The room is part of Robert Leach's second phase, with triangular-headed windows, containing original timber casements with diamond pattern leaded glazing. A lancet on the southern wall is angled to clear the original spiral stair, but was blocked by the larger current stair.

Figure 152 *Cloak Room*, windows & blocked lancet.

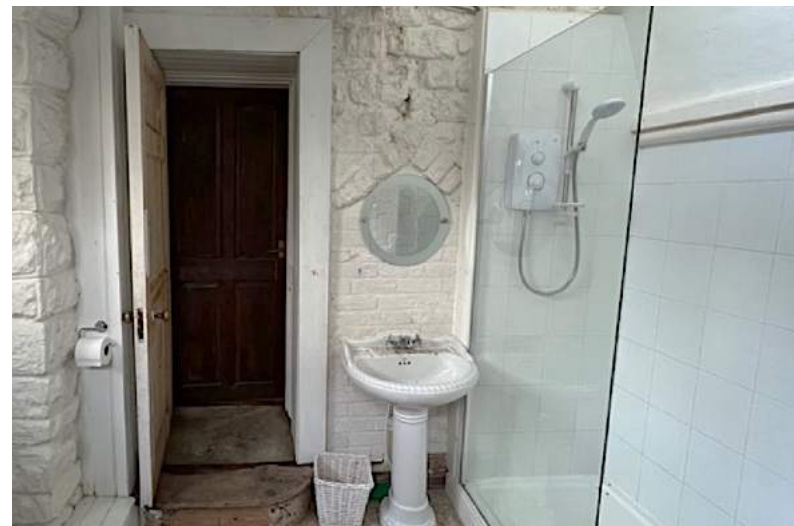
5.119 To the north of the cloak room is a modern, flat-roofed extension containing a bathroom. This extension is accessed through a modern door opening, although immediately adjacent to this is a low, triangular-headed opening blocked by modern brickwork. This extension has also enclosed the formerly-external door at the foot of the turret stair, with elaborate bracing, similar to that shown on the main doors in the 1880s photographs.

Figure 154 Modern bathroom door, with blocked opening to right.

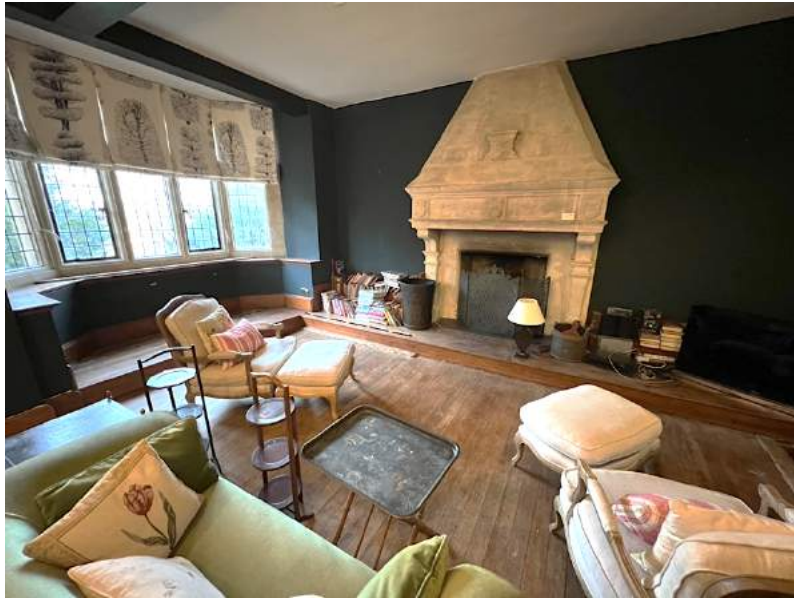
Figure 156 Billiard room, facing south-east.

- 5.120 The Billiard Room (identified in the 1914 sales particulars as *Billiard Room or Banqueting Hall*) was added to the castle by Sir Charles Rich after 1888. The form of the room, with a raised platform at the fireplace end for spectators (often fitted with banquettes), is a characteristic form for late-Victorian billiard rooms. The large fireplace in a 16<sup>th</sup>-century French style appears to be original, as does the flooring.

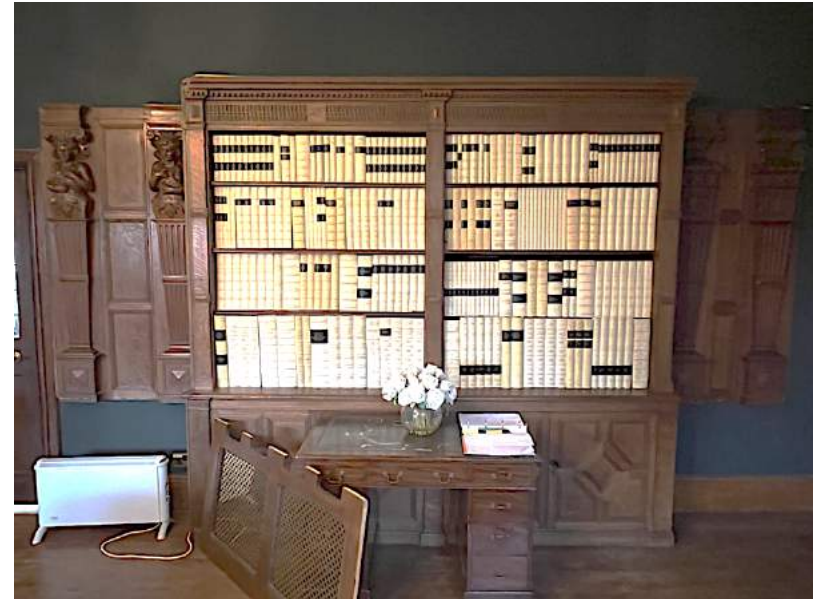
- 5.121 The two bookcases are fragments of a library designed to fit a different configuration, & are certainly salvaged modern insertions. The flanking portions of panelling with estipite pilasters & female herms are fixed to the walls with cross-headed screws, & float visually unsupported; they are clearly also salvaged insertions.

Figure 157 Bookcase & panelling on western wall.

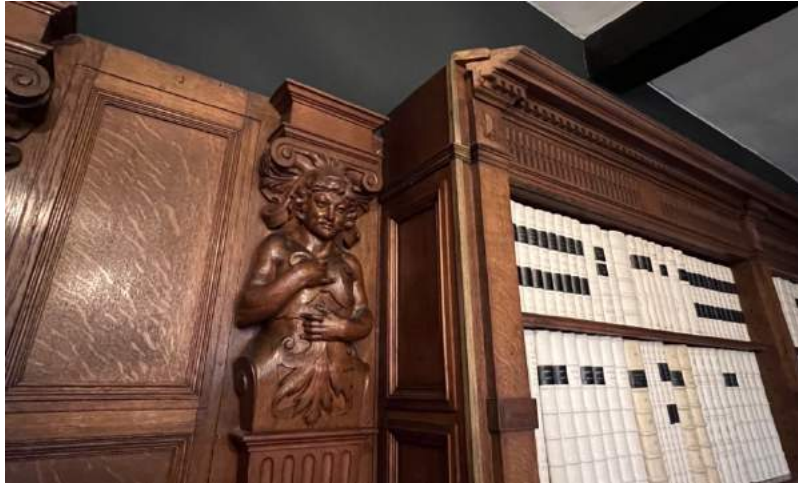
**Figure 158** Detail of bookcase, showing mitred cornice from different configuration.

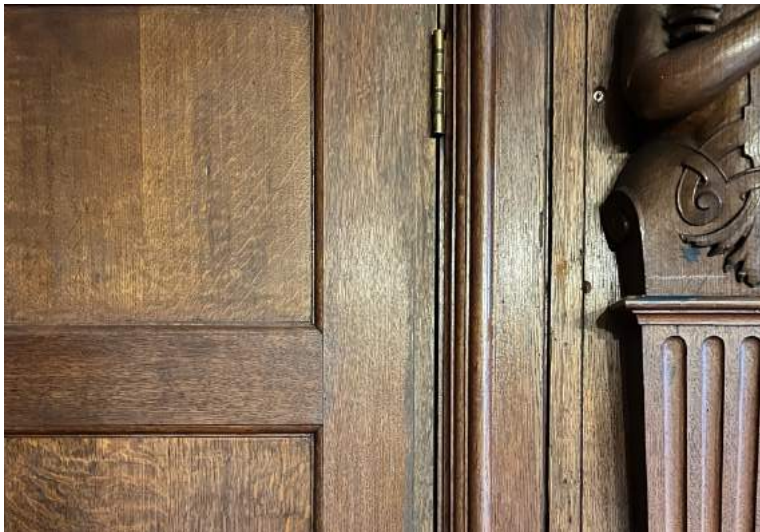
- 5.122 The main door to the library also appears to be salvaged, as it has been made wider to fit the opening, by the addition of a fillet to the hanging stile.

**Figure 159** Detail of door, showing widening fillet added to hanging stile.

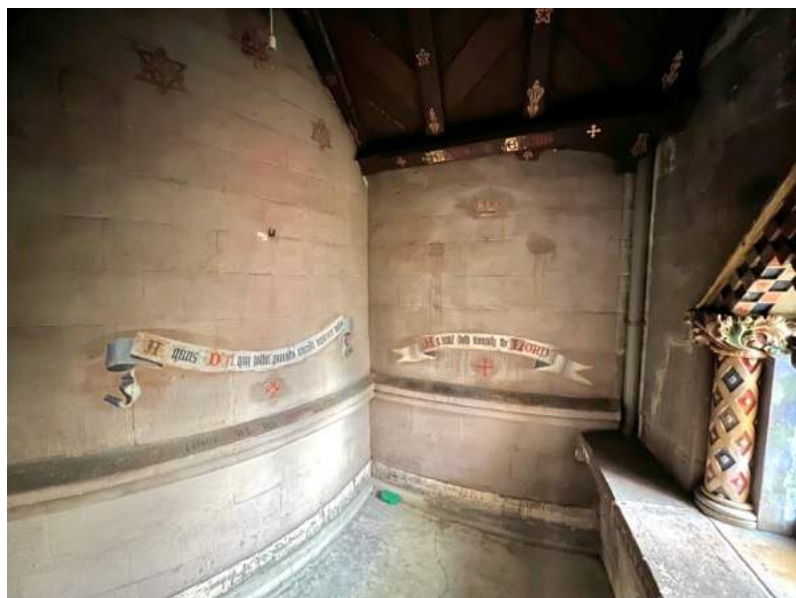
Figure 161 Oratory, facing south.

- 5.124 The *Oratory* was built during Robert Leach's third phase, above the garden porch that comprised part of Valentine Leach's original building.
- 5.125 This is the only room to retain its original décor, with painted inscriptions & devices, & decoration on the exposed roof structure. The window retains sumptuous colouring of gold, red & blue, & contains coloured glass.

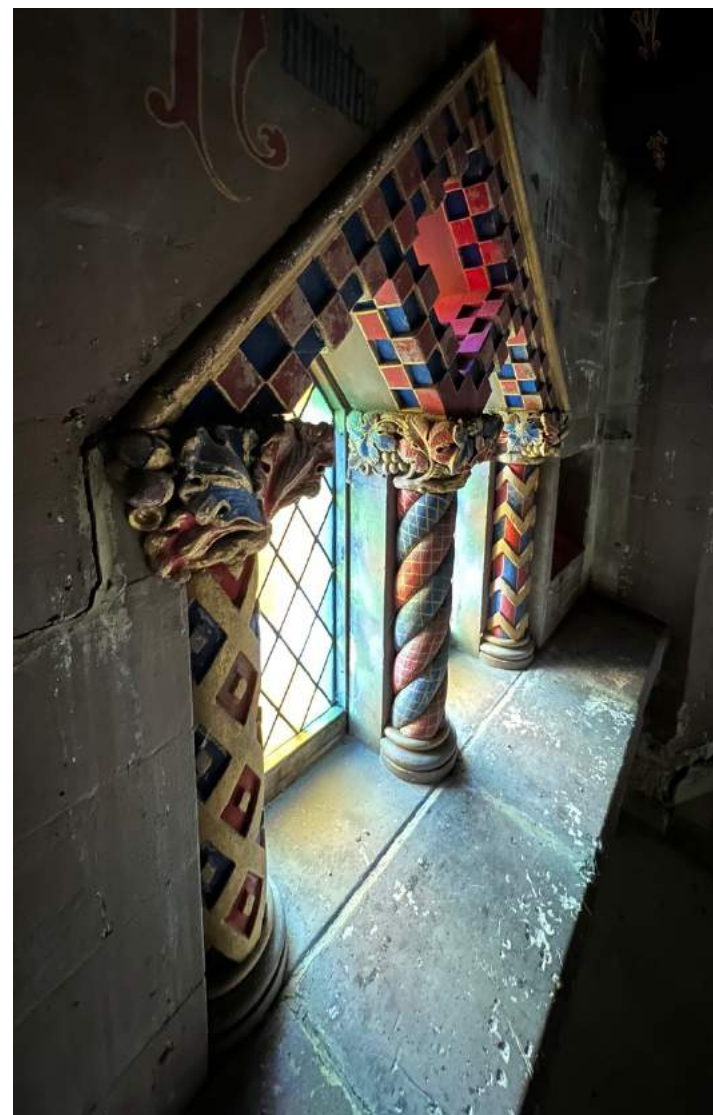
Figure 162 Oratory window.

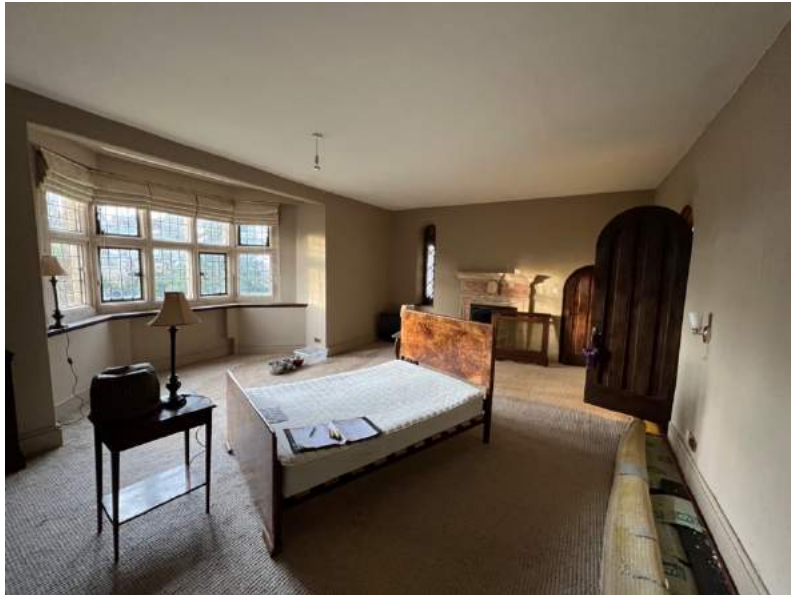
Figure 163 Bedroom over Dining Room, facing north-west.

5.126 The 1888 sales particulars appear to indicate that the present room may have comprised two rooms at this time, the bedroom, &, probably between this & the *Oratory*, a dressing room. The original fenestration of the west front, with three windows, would have accommodated this. The removal of two of these windows by Sir Charles Rich would suggest that the present room was formed at this time.

5.128 This room has been heavily refurbished, & has a modern plasterboard ceiling & modern skirting; however, the room does retain an historic fire surround, & three of the round-headed doors.

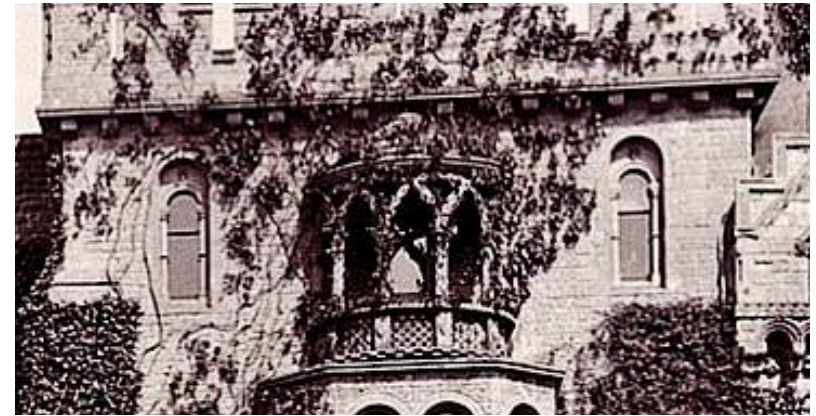
Figure 164 Detail Bedroom over Dining Room window, c.1888 (© Wiltshire Museum, Devizes; 2022.7013.10).

5.127 The balcony was added over the middle window, & the side windows enriched under Robert Leach's second phase. It is unclear whether this balcony was accessible or purely decorative; the only balconies to survive are on the South Tower, & these were decorative only, & placed in front of the pre-existing window opening.

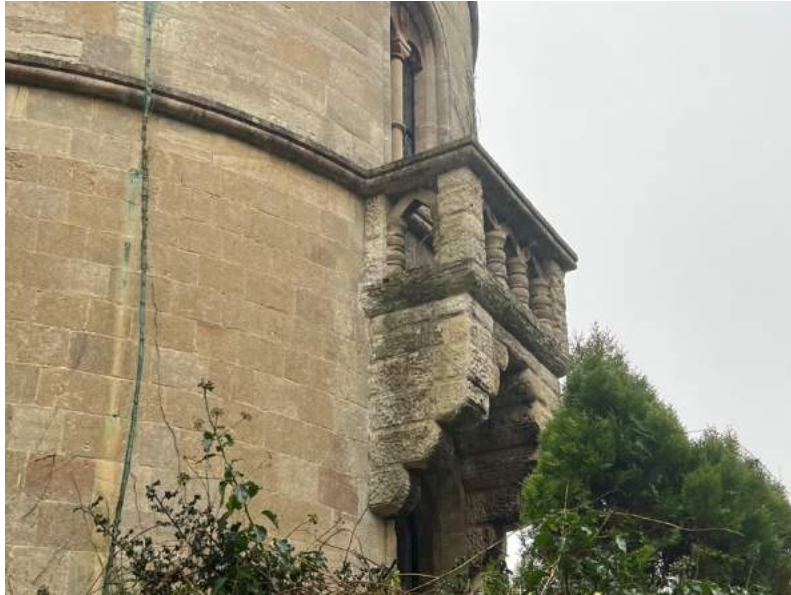
**Figure 165** South tower, showing decorative balcony placed in front of pre-existing (albeit enriched) window.

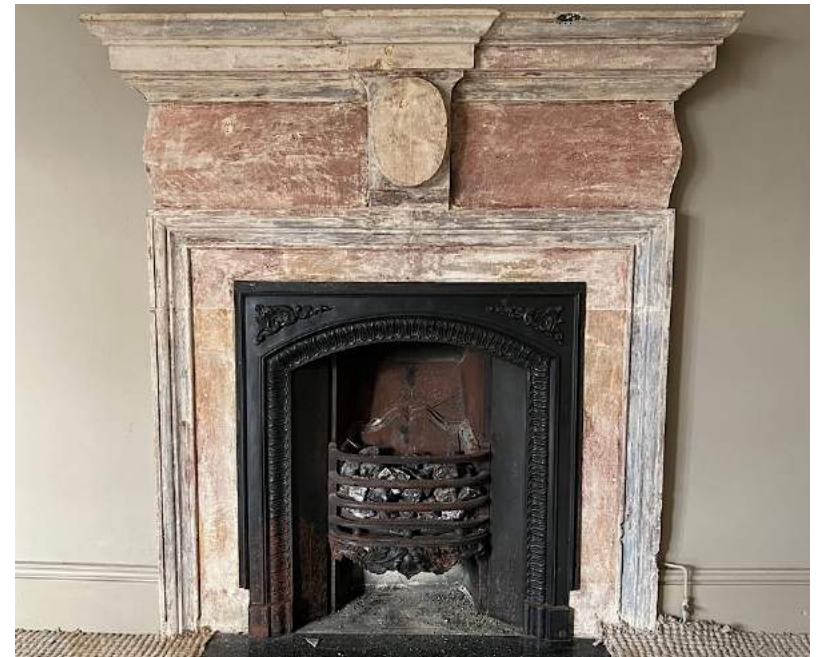
has clear evidence of polychromatic painting. The iron grate sits atop the modern, black granite hearth, & whilst potentially reclaimed, is clearly a modern installation.

**Figure 166** Bed Room over Dining Room, fireplace.

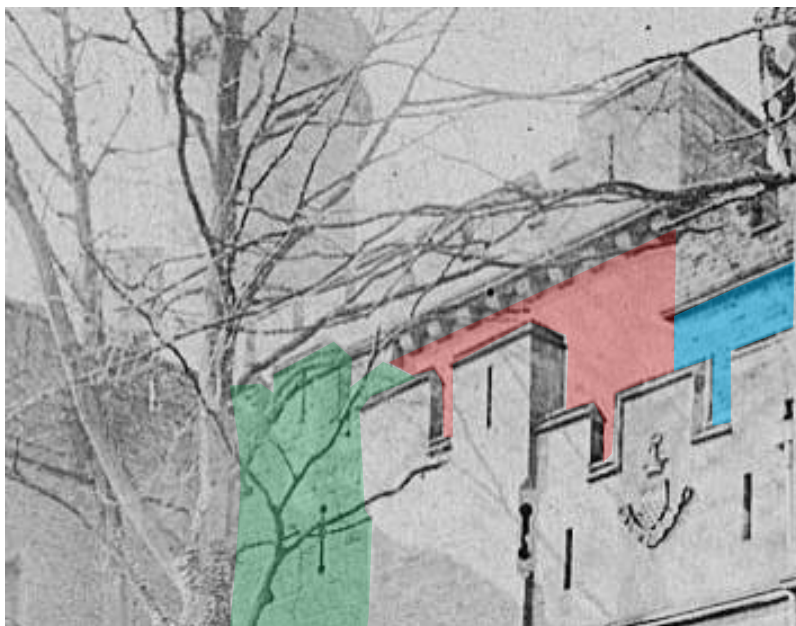
- 5.131 Prior to the Rich extension, the northern half of this wall was external, only the southern end overlapped with the head of the stair that rose from the southern end of the gallery.

Figure 167 View of the entrance from the north, from the 1883 sales particulars (© Wiltshire Museum, Devizes; DZ/WS:1983.7725), wall of stair down to gallery, wall of Bed Room over Dining Room; wall of Boudoir.

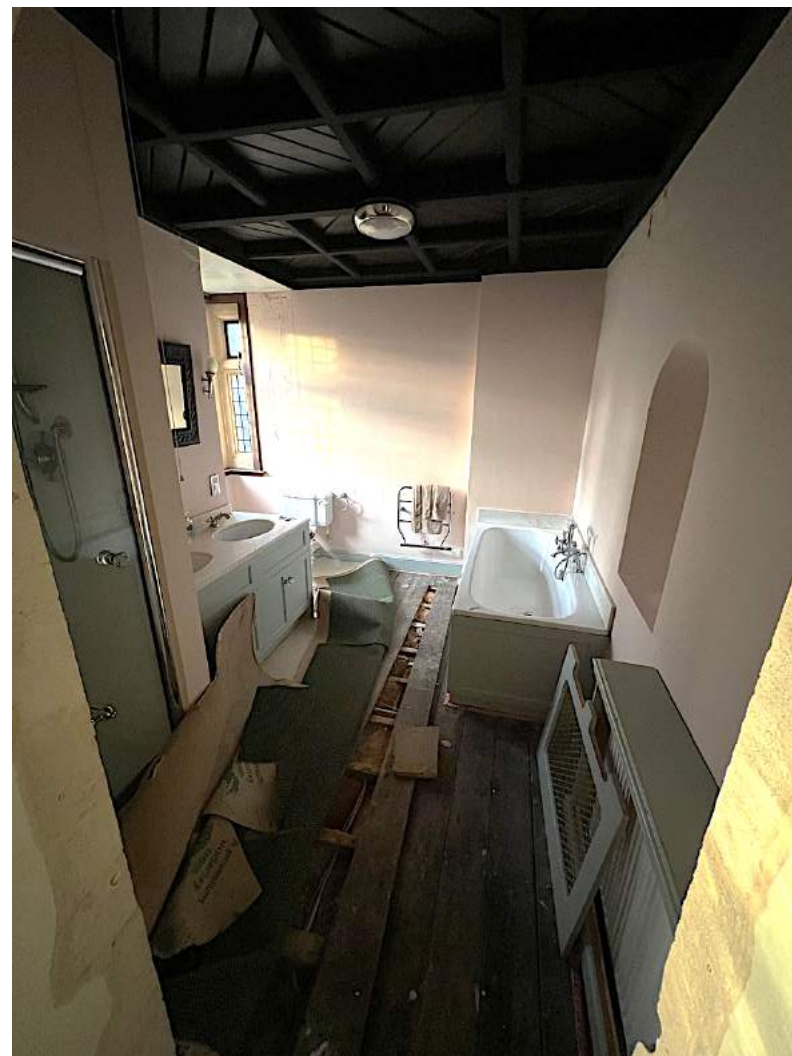
Figure 168 Southern half of former Boudoir, facing north.

5.133 The *Boudoir* also appears to have been adjacent to this bedroom, suggesting that it occupied the space above the *Ante Room*, which is now divided by a plasterboard partition into two bathrooms.

5.134 The larger, southern bathroom takes up two-thirds of the former *Boudoir*, including the central window, a Rich-phase oriel; this replaced a Romanesque window with a decorative balcony.
