## DEVIZES CASTLE.

### STORES.

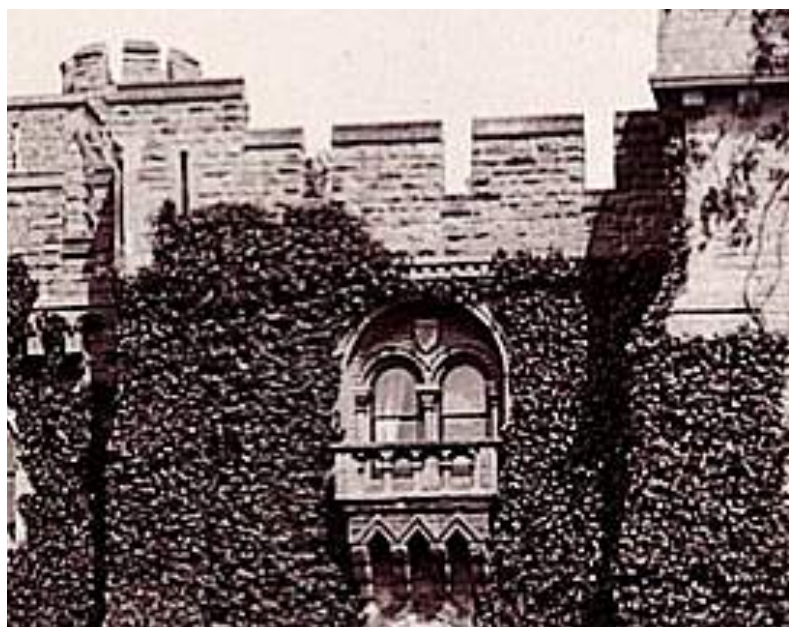
Figure 169 Detail of *Boudoir* window, c.1888 (© Wiltshire Museum, Devizes; 2022.7013.10).

5.134 The larger, southern bathroom takes up two-thirds of the former *Boudoir*, including the central window, a Rich-phase oriel; this replaced a Romanesque window with a decorative balcony.

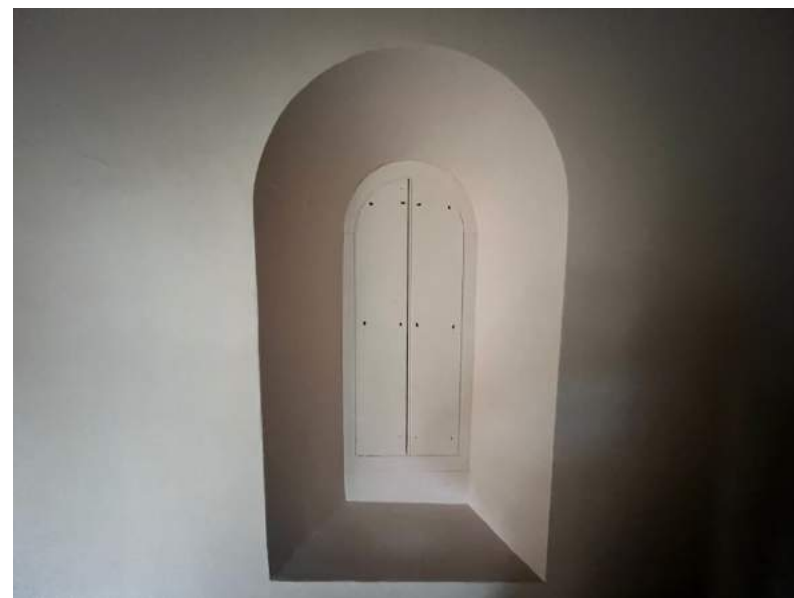
Figure 170 Former window in the east wall of the *Boudoir*.

5.135 The *Boudoir* was also lit by a small, now-blocked window in the east wall, which would also have been external prior to the Rich extension; this window appears to retain its original frame..

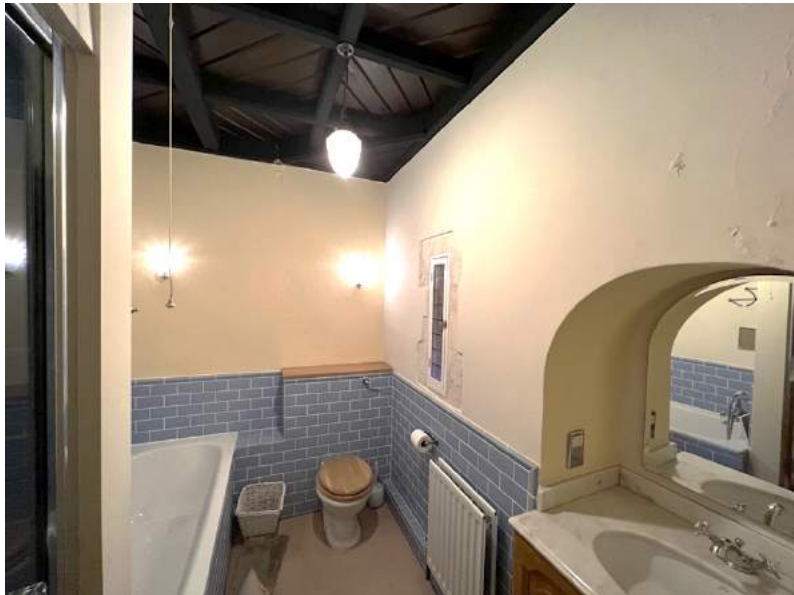
Figure 171 Northern half of former *Boudoir*, facing west.

5.136 The northern portion of the room is lit only by a small, angled lancet, & is entered by a round-headed door just off the head of the main stair; this door appears historic, & would also have been near the head of the earlier spiral stair. There is a low arched recess in the northern wall. The inventory in the 1888 sales particulars states that, amongst other furnishings, the *Boudoir*

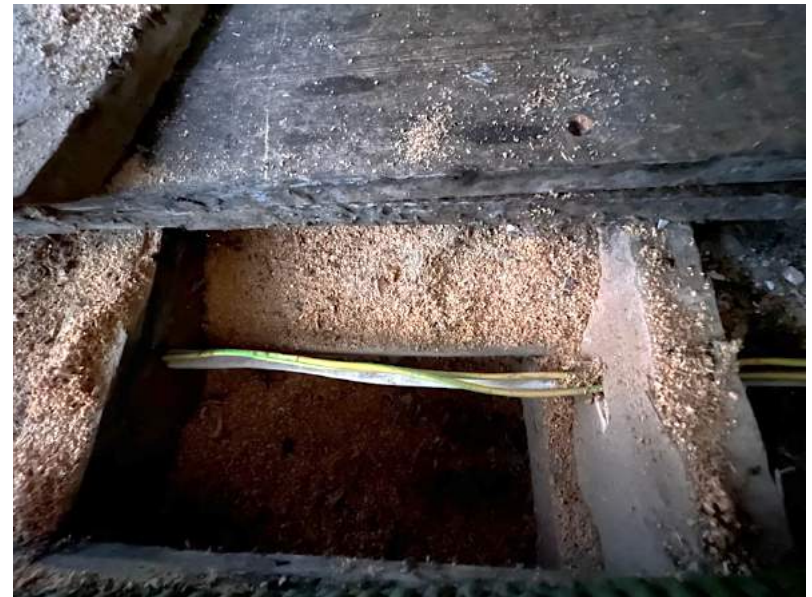
Figure 172 *Boudoir* floor construction, showing thick layer of sawdust pugging on pugging boards between the joists.

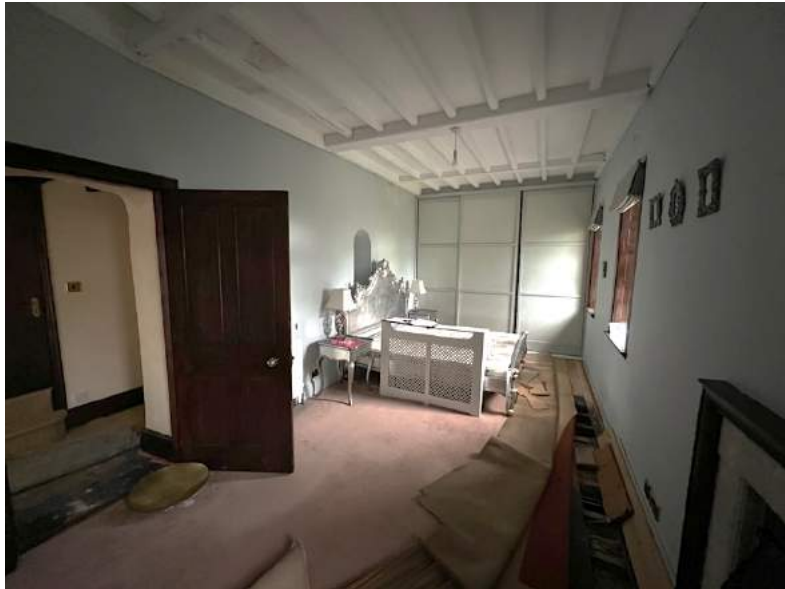
Figure 173 Bedroom (above the *Gallery*), facing south.

5.139 The identified merely as '*Bed Room*' in the 1888 sales brochure appears to correspond the bedroom that survives above the gallery. This room is currently entered through a door in the east wall; but this doorway is crudely cut through the lined plaster in the passage outside, plaster that continues into the suspended Rich extension, & thus the door is a 20<sup>th</sup>-century insertion. The door itself may date from the Rich phase, but has been rehung (the hinges being attached to the frame with modern cross-head

screws). The architrave is a modern, machined dado moulding that has been stained dark brown.

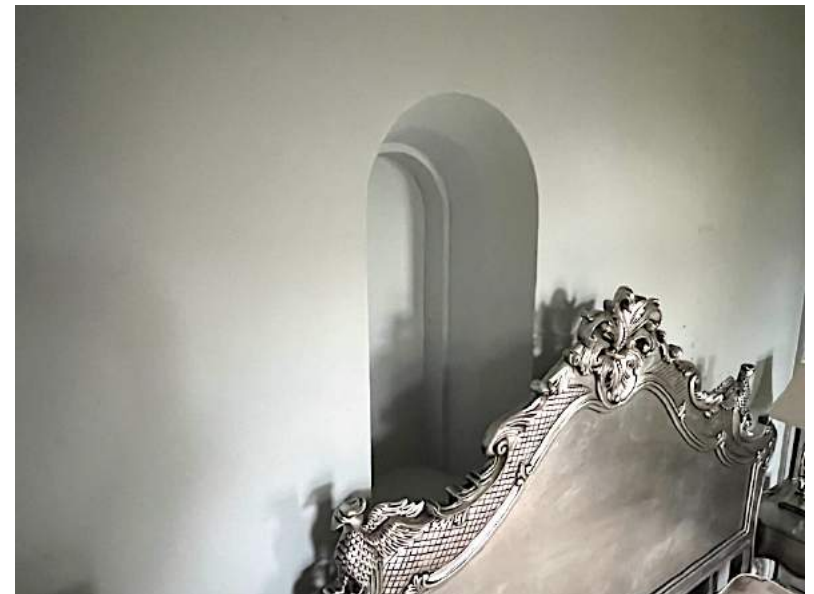
5.140 There is a scar from a now-blocked doorway on the eastern end of the north wall; it also seems likely that there would have been a door on the southern wall, as before the suspended Rich extension there would have been no other way to link the two halves of the building at this level.

Figure 174 Bedroom (above *Gallery*), blocked window on east wall.

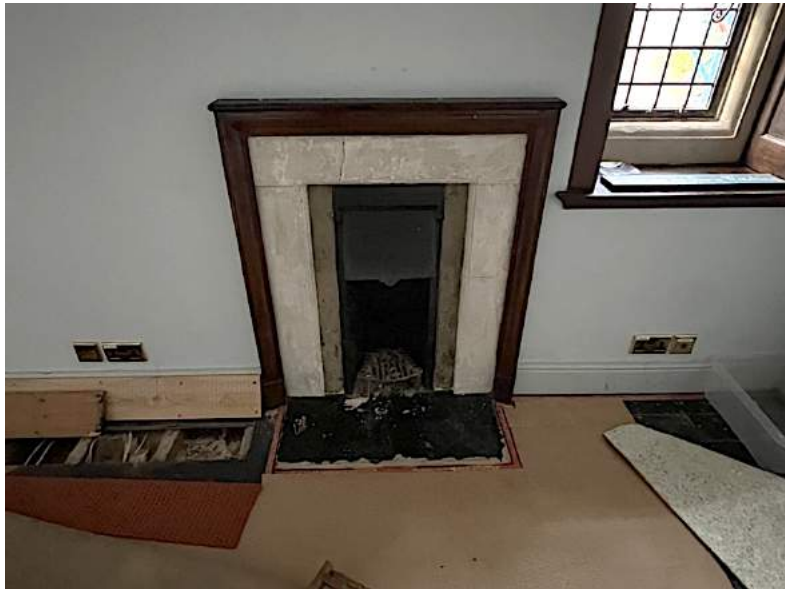
Figure 175 Bedroom (above Gallery), fireplace.

erection of the east wings in his second phase. The date of the ceiling is unclear; the chamfered joists are supported by transverse structures that are boxed in, potentially suggesting that they may be iron beams. The windows & the fireplace date from the Rich phase; the skirtings are modern.

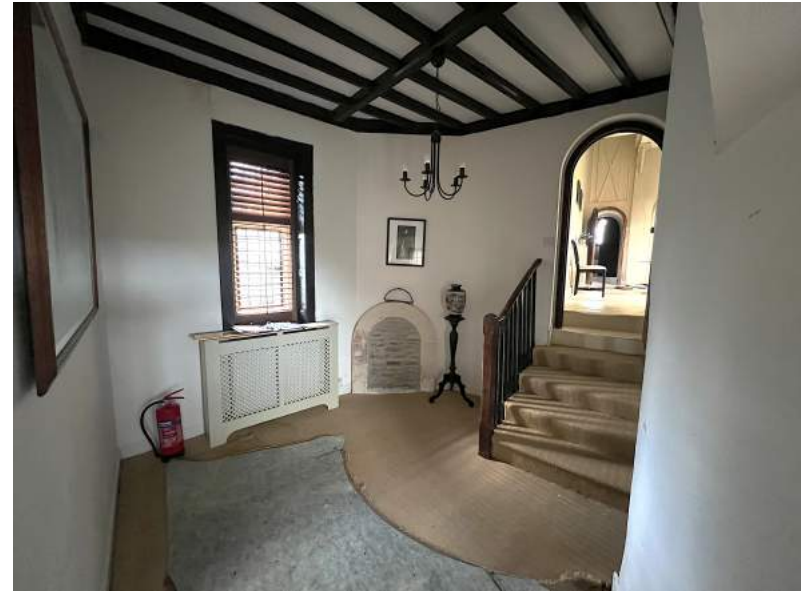
Figure 176 Passage and Stairs, facing north-west.

5.142 The *Passage & Stairs* lies above the northern end of the gallery, & retains a short flight of steps up to the drawing room wing. Both the door at the head of these steps, & the small door to the right of this (at the head of the turret steps) are the round-headed type. The former door retains the original quatrefoil backplate, although the handles are now brass knobs; these knobs may be later replacements, but the consistency in the rooms above the drawing room may suggest that they are original, & reflect the slightly lower status of the first floor. There is a small, round-

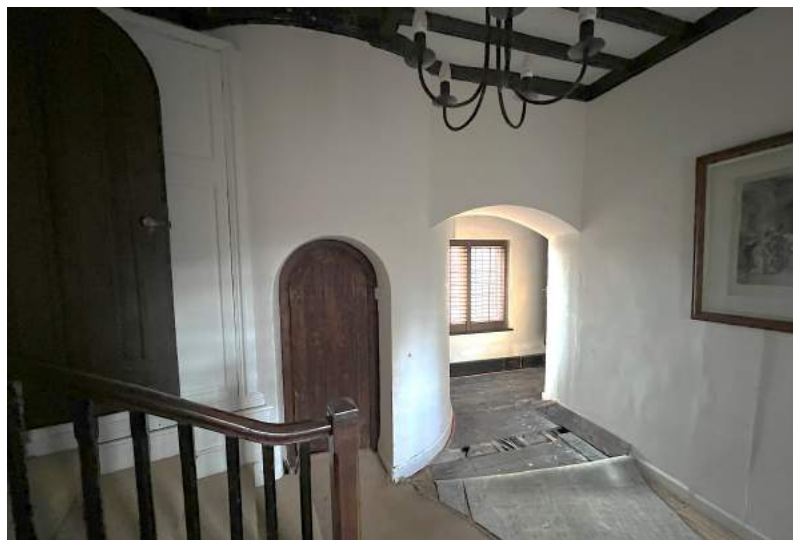
**5.143** A segmental arch on the east wall, to the right of the turret leads through the original external wall into the suspended, Rich-phase addition which created a passage to bypass the adjacent bedroom; this extension blocked the lancet at the head of the turret stair. The west window was also replaced at this time.

**5.144** This room retains historic skirting with a simple chamfered moulding, from the Rich phase, potentially from the Leach phase, & its original floor.

**Figure 177** *Passage and stairs, facing south-east.*

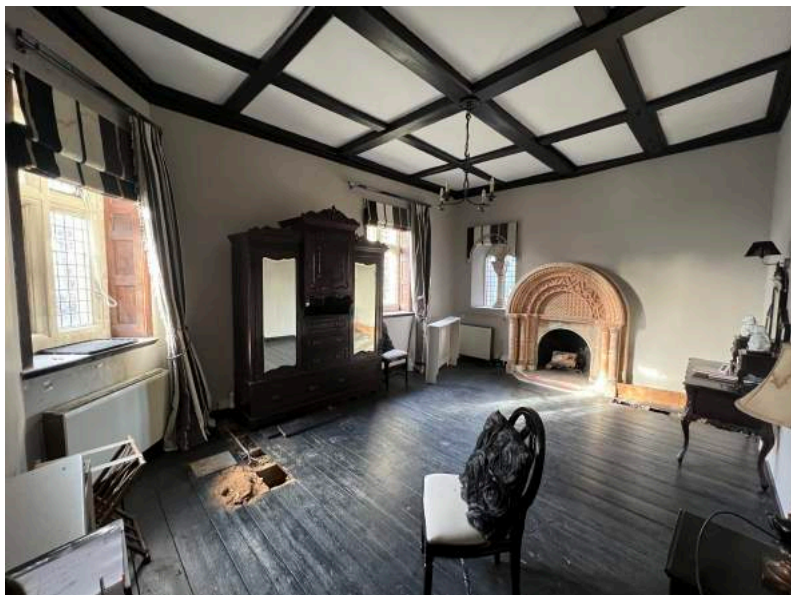
Figure 180 *Bed Room over Drawing. Room, facing north-west.*

- 5.145 The *Bed Room over Drawing Room* is entered though an original round-headed door, also with an historic brass knob on a quatrefoil backplate; this door also retains the applied decorative iron straps, although the lower one is damaged.
- 5.146 The room itself appears, apart from the alteration of the west & south-west window during the Rich phase, substantially in its original, Robert Leach form.

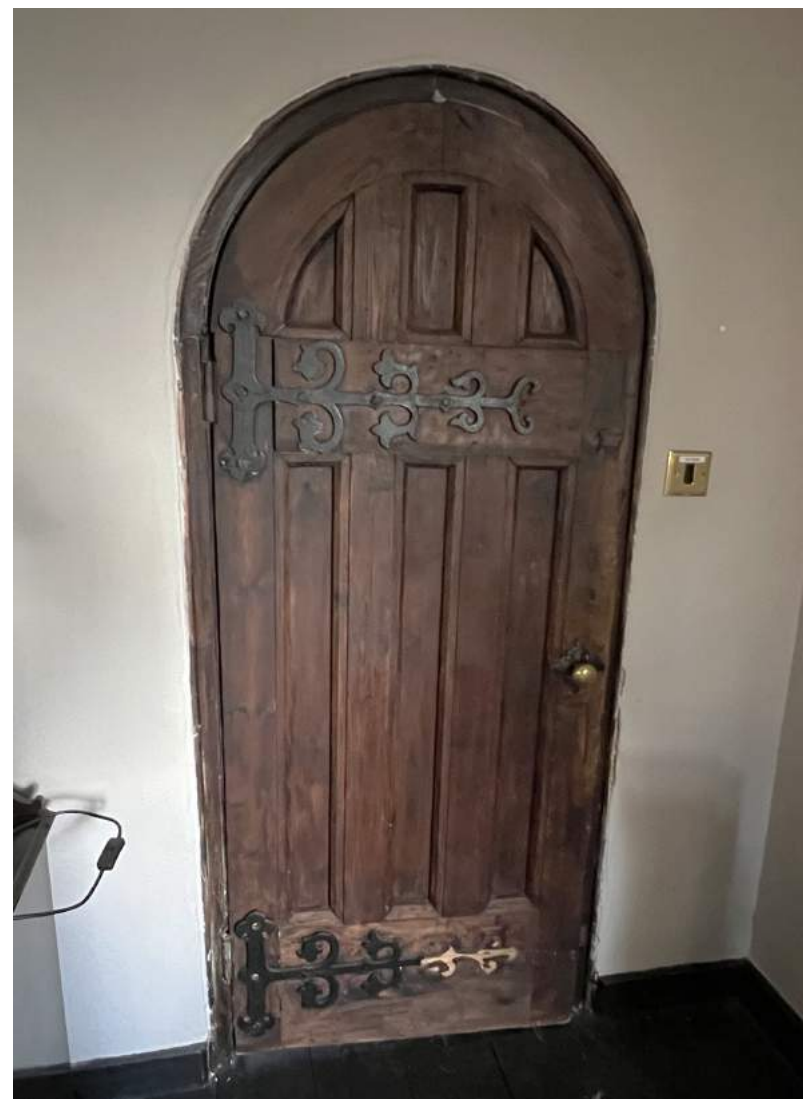
Figure 181 *Bed Room over Drawing Room, door.*

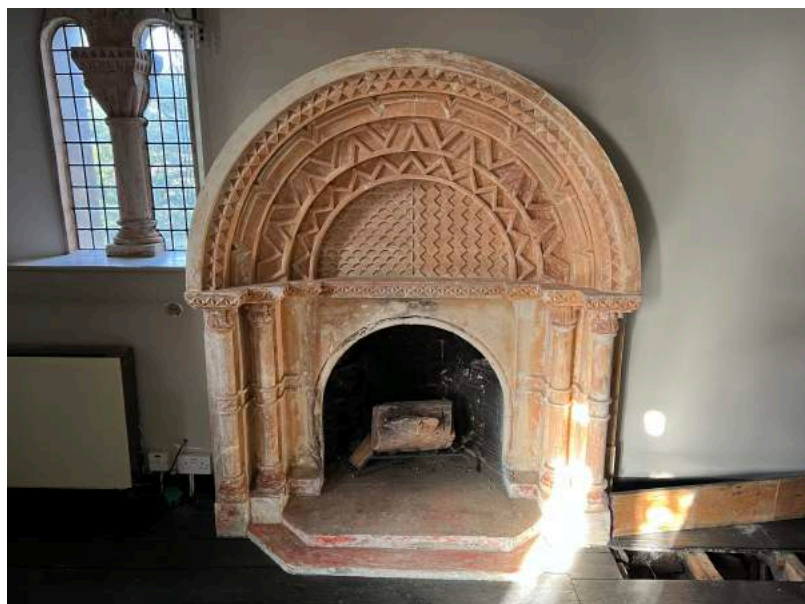
Figure 182 Bed Room over Drawing Room, fireplace.

- 5.148 This fire surround also has fragments of polychromatic (blue, red & possibly a deep gold/yellow) decoration. There were originally three pairs of colonnettes supporting the receding archivolt, but the inner pair are now missing.
- 5.149 To the right of the fireplace a small Romanesque window which also retains evidence of red & blue paintwork.

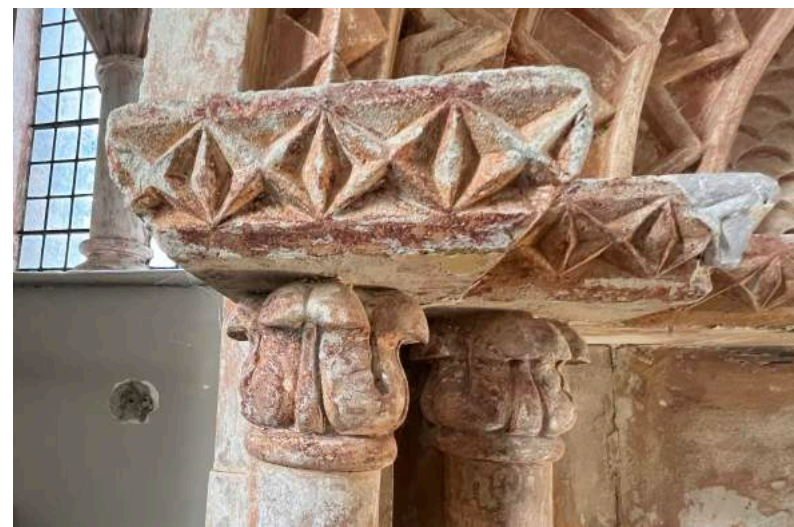
Figure 183 Detail of fireplace; capital of left jamb.

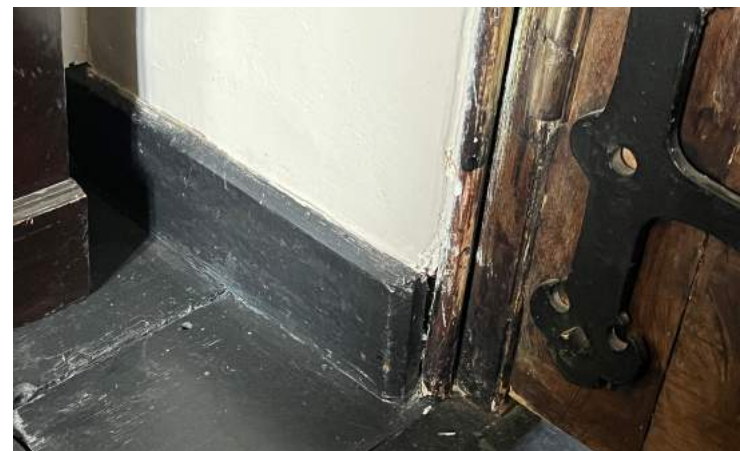
Figure 187 Detail of skirting.

5.150 The room appears to retain its original floor, with pugging beneath the floor boards, although the latter have unfortunately been painted black. The room also has a simple, chamfered skirtings that also appear original.

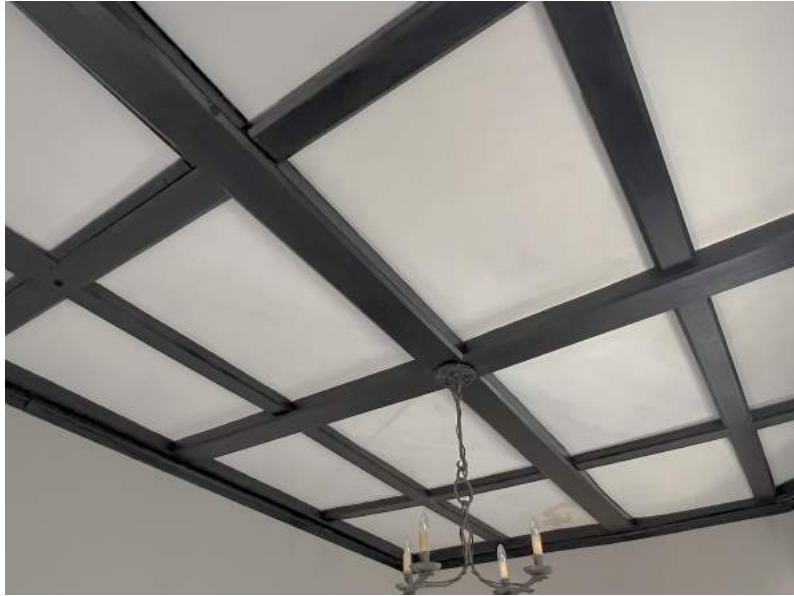
Figure 188 Bed Room over Drawing Room, ceiling.

5.151 This room appears to have a potentially original ceiling, with a cruciform of principal beams, with subsidiary cruciform beams in each quarter; however, all these beams are formed from boxing, & it is currently unclear what is within the boxing.

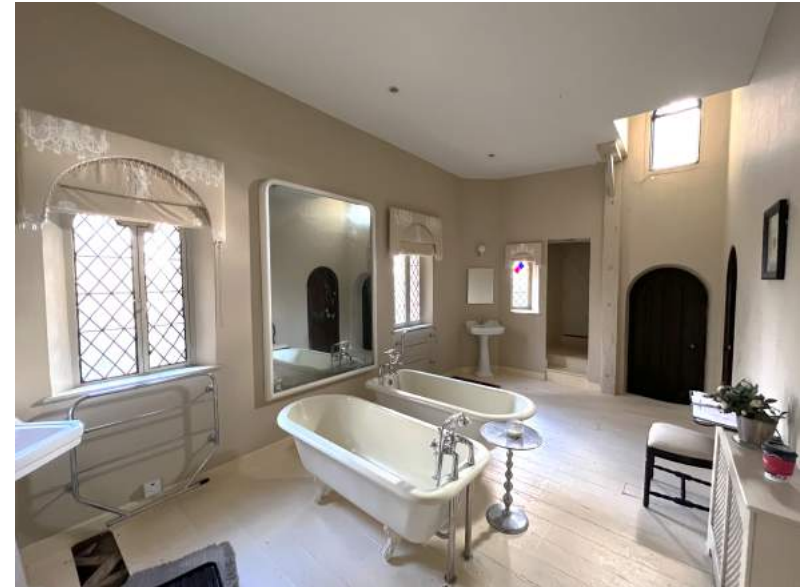
Figure 189 Dressing Room & Lady's Maid's Room (now bathroom), facing south-east.

5.152 The area above the north of the drawing room appears to have formerly comprised two rooms & a top-lit corridor, but now is a single bathroom; this may explain the different detailing in the two windows (one has a single opening casement, the other has two), which both appear original (Robert Leach first phase). Both openings comprise two arches, which appear to have been intended to rest on a central colonette, although there is no evidence of any colonette ever having been installed, & leaving the central impost appearing awkwardly unsupported.

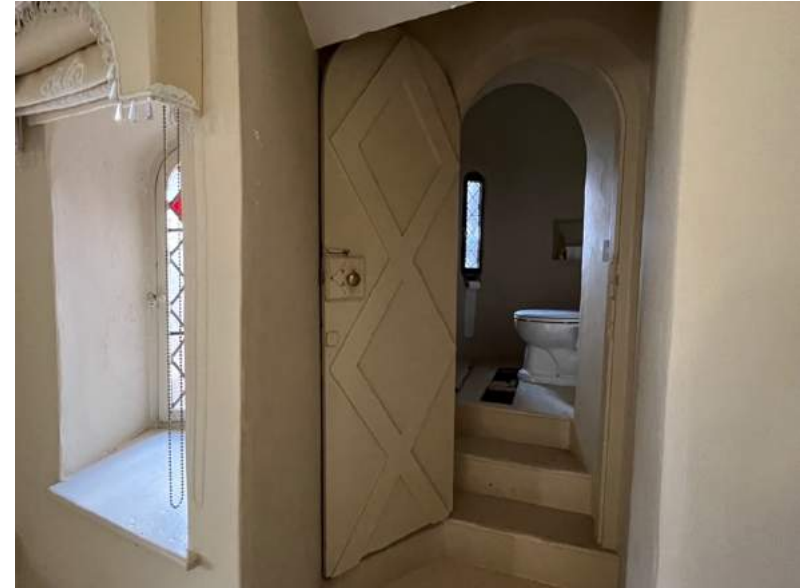
Figure 191 Door to turret closet.

- 5.155 The turret closet, now containing a lavatory, is situated above the turret stair, & is consequently raised up several steps, & entered by a round-headed vertical plank door with diagonal bracing, all of which appears original. The closet is crowned by a shallow brick dome.
- 5.156 The door through to the north/*Ivy Tower* is of the standard round-headed type that has no horizontal upper rail; the ceramic door handle is modern.

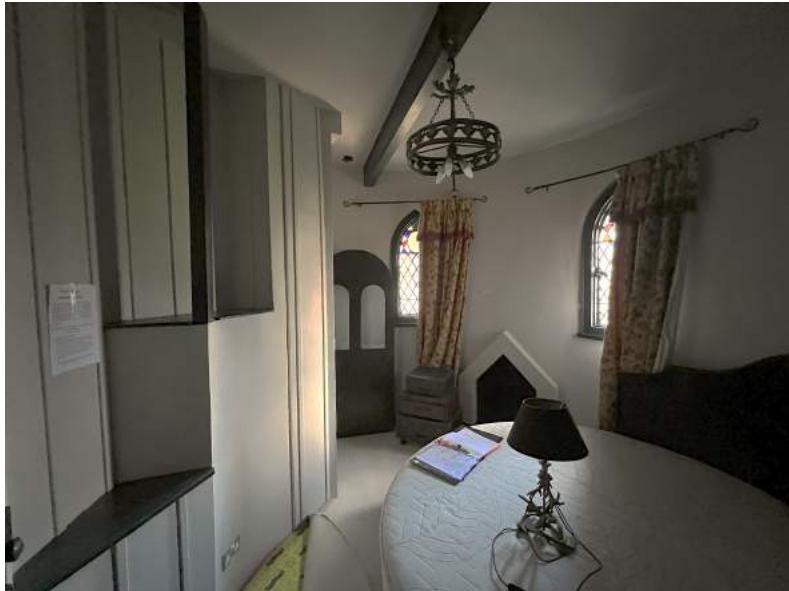
Figure 192 Second Bed Room in Ivy Tower, facing north.

5.157 The *Second Bed Room in Ivy Tower* (so-called to differentiate it from *Top Bed Room in Ivy Tower*), has a vertically-boarded stair enclosure projecting on the southern side. This, & the stair within, appear historic, & the two doors within it are round-headed & therefore probably the work of Robert Leach.

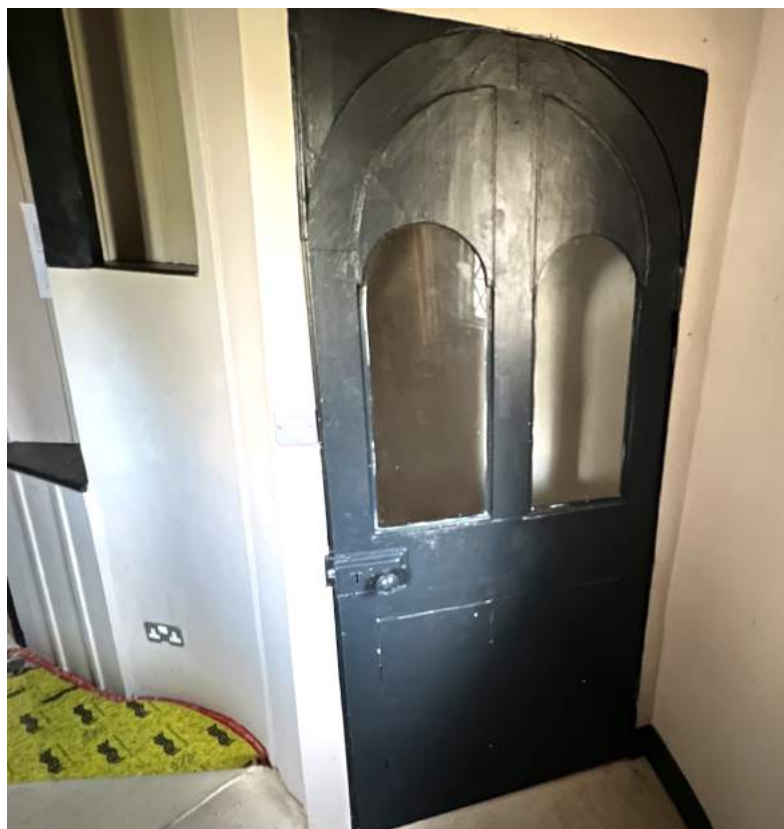
Figure 194 Door to stair down to *Secret Chamber/Museum Room*.

construction is likely a reflection of the lower status of this room. The door to the stairs down to the *Secret Chamber/Museum Room* below is a round-headed, four-panel door, with two round-headed lights inserted within the upper panels. The door is clearly historic, & whilst of differing construction to other doors in the house, the round head would appear to indicate that it is also likely to be the work of Robert Leach.

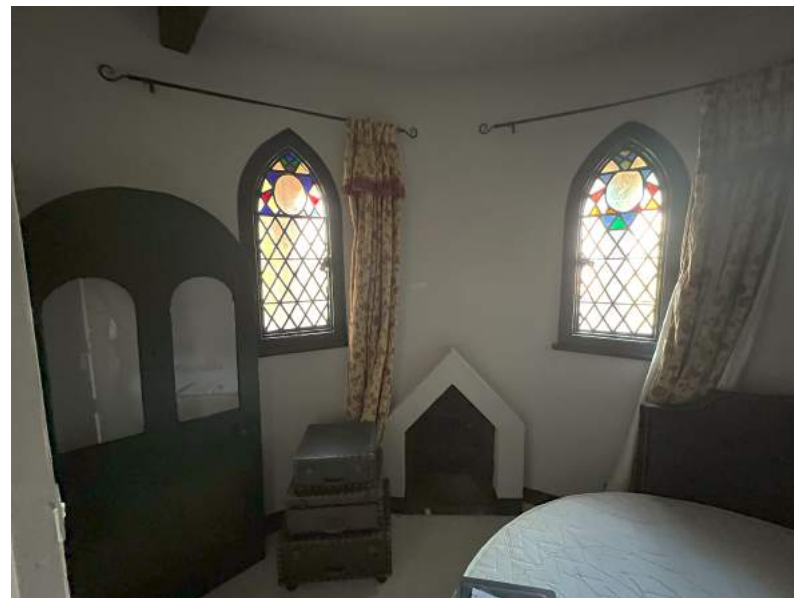
Figure 195 Fireplace & windows.

- 5.159 The room also has a triangular-headed fireplace, probably ascribable to Robert Leach's second phase, flanked by a pair of partially coloured glass windows. The fire surround is very plain, with no obvious evidence of lost enrichment. This room also

appears to retain its original floor structure, & a lath-&-plaster ceiling.

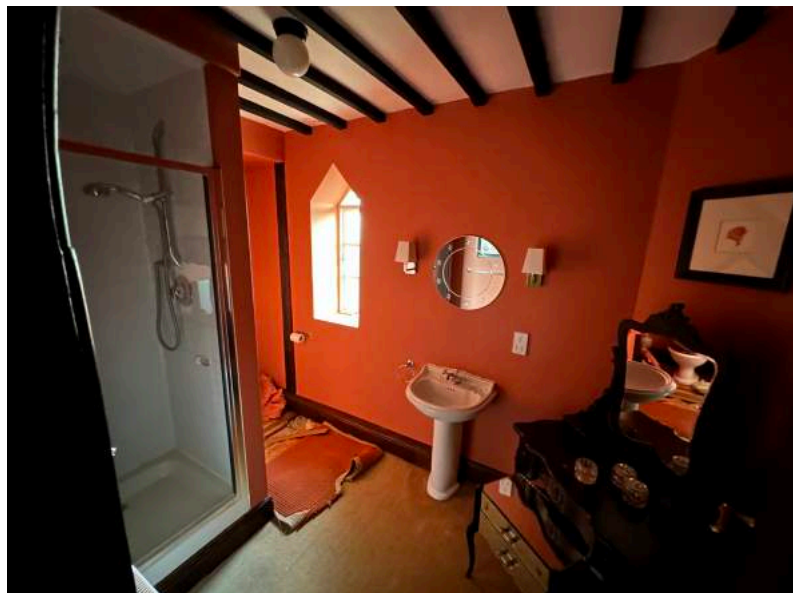
Figure 196 *Front Bed Room, now a bathroom.*

- 5.160 The *Front Bed Room* lay within the northern of the two east wings erected in Robert Leach's second phase, in what is now another bathroom. With the exception of the modern shower enclosure, the room appears to occupy its original extent.
- 5.161 The corridor to the west of this room, prior to the projecting Rich extension, would not have linked through to the Passage and Steps, but would have finished just after the door to the second-floor room above the *Front Bed Room*.

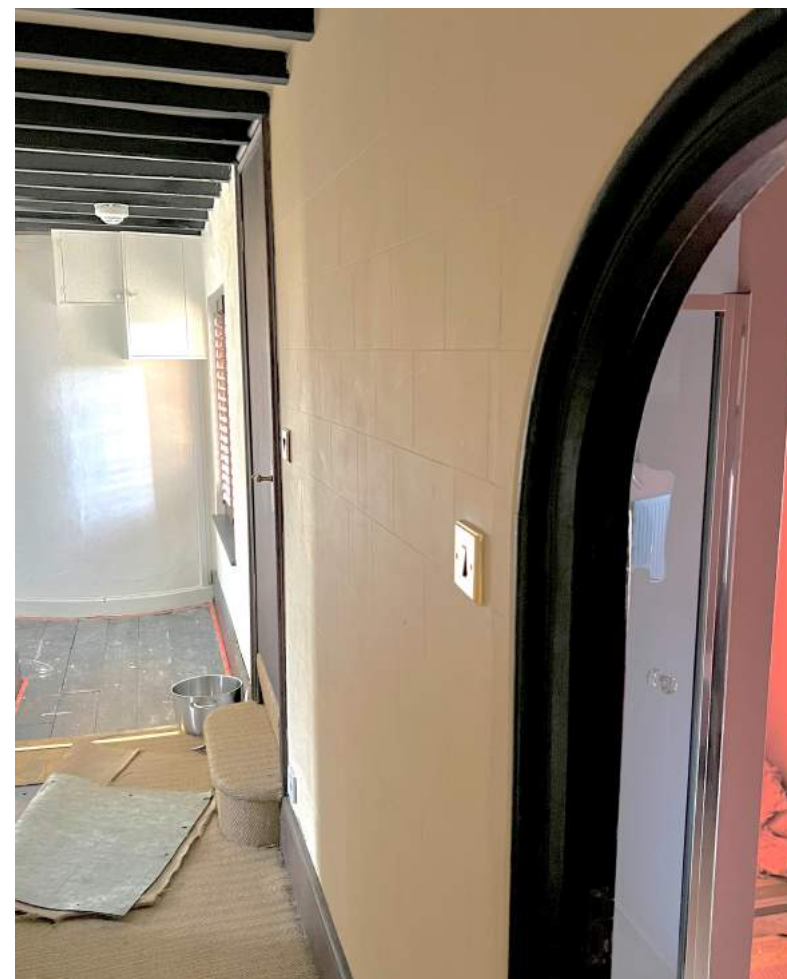
Figure 197 *Corridor & partition to west of Front Bed Room.*

- 5.162 The ceiling joists in the Rich addition resemble those in the rest of the corridor, but do appear slightly thinner, as if copied to

match, rather than being contemporary, suggesting that the joists in the remainder of the corridor date from the original construction of this wing; both these joists, & those within the room, are neatly stop-chamfered indicating that the dividing partition is contemporary. This appears to be supported by the door to the room, which is a typical, round-headed type with no upper rail, & the fact that the stairs to the second-floor room, the structure of which is not currently visible, are lit by a lancet that would clash with the level of the second-floor structure, thereby suggesting that there was originally a stair in this position. The door & architrave to this stair is modern. The lining of the plaster of the corridor to resemble ashlar continues into the Rich extension, & therefore was added at this time.

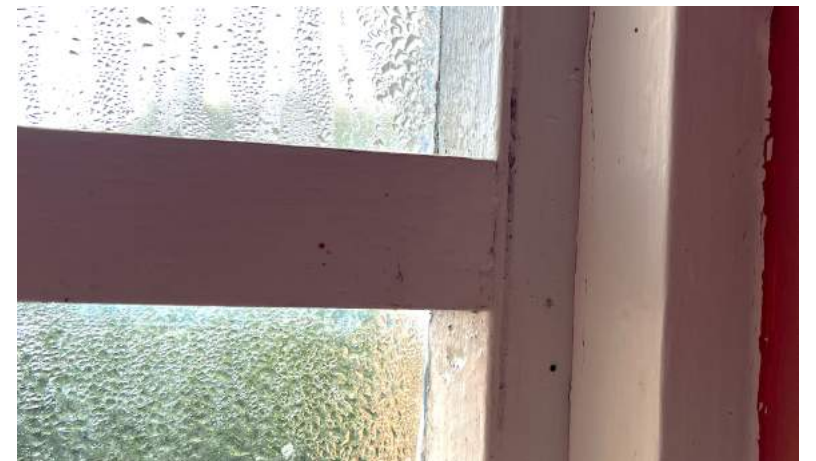
5.163 The Front Bedroom retains an historic timber opening casement within its east window, although this has lost its original leaded glazing, & two very crude modern glazing bars have been added. These have severely harmed the appearance of the historic casement, which consequently looks superficially modern, but which could easily be restored. This room retains an historic floor, with pugging between the joists. A diagonal wall across the south-east corner may originally contained a small corner fireplace.

Figure 199 Detail of casement, showing crudely inserted glazing bars.

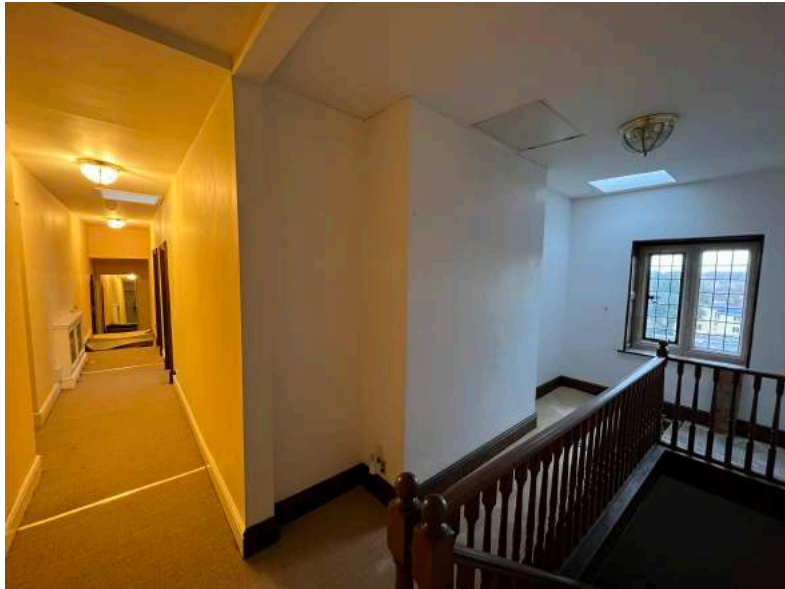
Figure 200 Rich-phase corridor & back stair.

- 5.164 The Rich addition comprised a corridor & two bedrooms above the billiard room, & probably the upper part of the back stair, linking though to the now-separate south tower.
- 5.165 The corridor comprises a plain space, with modern skirtings. The two doors to the bedrooms have possibly reused doors, but modern frames & architraves that match those to the stair above the *Front Bed Room*, & the Bedroom (above the *Gallery*), both of which are also modern.

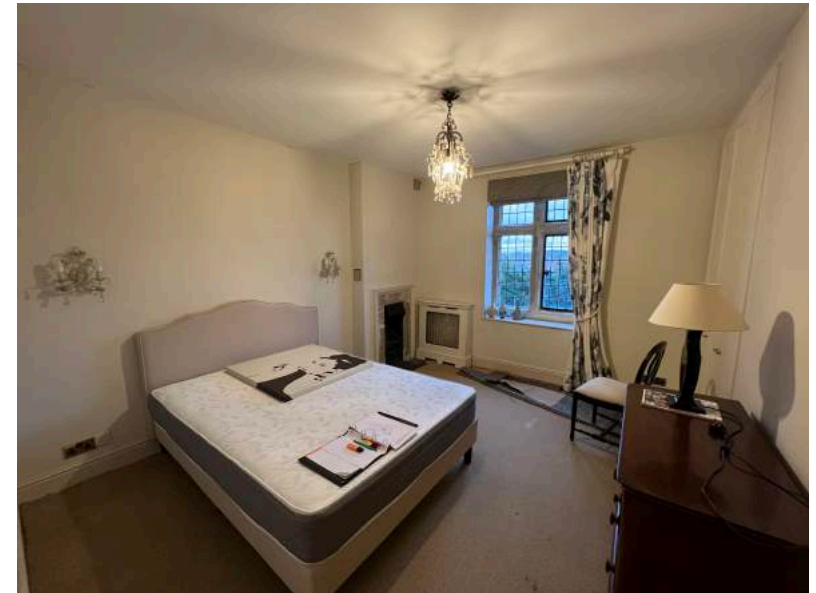
Figure 201 Northern bedroom above Billiard Room.

- 5.166 The two bedrooms above the Billiard Room are separated by a modern plasterboard partition that dog-legs to accommodate built-in wardrobes to either side. The skirtings in both rooms are modern, & the southern room also has modern coving.
- 5.167 Both rooms retain original fireplaces, although in the southern room, the grate has been removed, leaving only a plain stone surround.

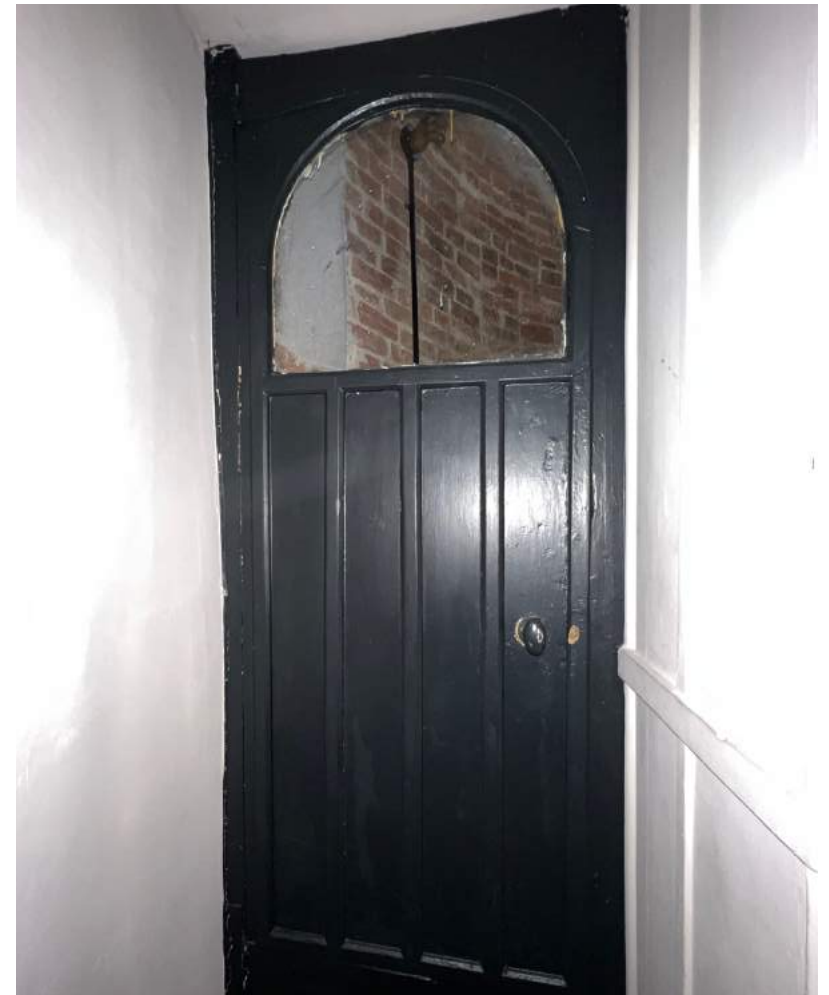
Figure 204 Door to Top Bed Room in Ivy Tower.

5.168 The door to the *Top Bed Room in Ivy Tower*, like the adjacent door to the *Second Bed Room in Ivy Tower*, is a vertically-boarded door, braced on the rear, with applied fillets on the front to match the other Leach-phase doors. This door is square-headed, but the fillets form a semi-circle, the upper portion of which is now glazed, but which was probably originally solid. The door appears contemporary with the adjacent door, & like it, the cruder design appears to reflect the lower status of the room beyond.

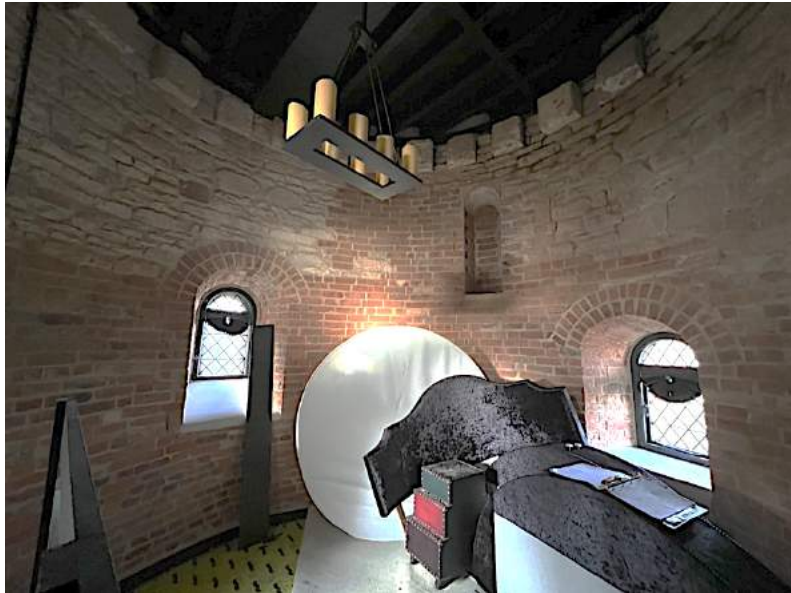
Figure 205 Top Bed Room in Ivy Tower, facing north.

5.169 The top bedroom itself has been stripped of all plaster in order to reveal the masonry, clearly exposing the red brick of the 18<sup>th</sup>-century windmill, & the stone top that appears, from the 1843 sales particulars, to have been added by Valentine Leach.

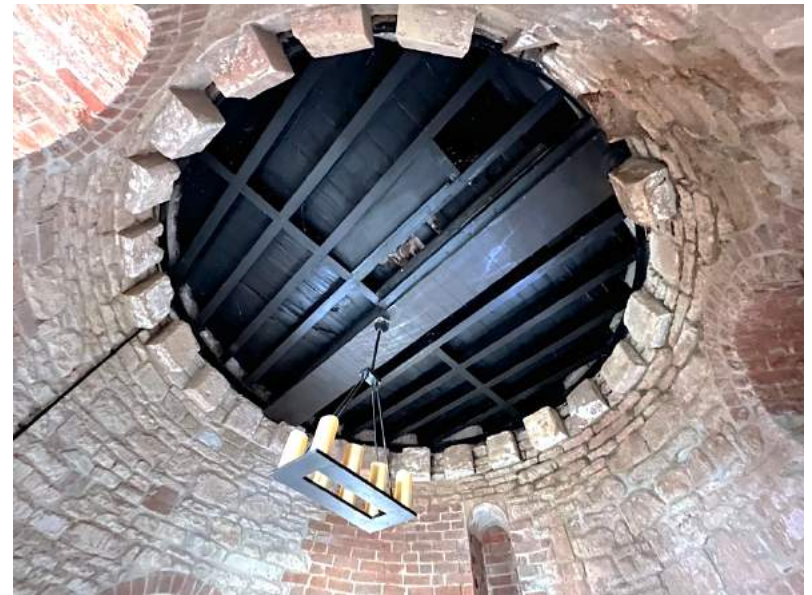
Figure 206 Top Bed Room in Ivy Tower, ceiling.

5.170 The visible roof structure comprises a series of plain joists with little to give any indication of potential date.

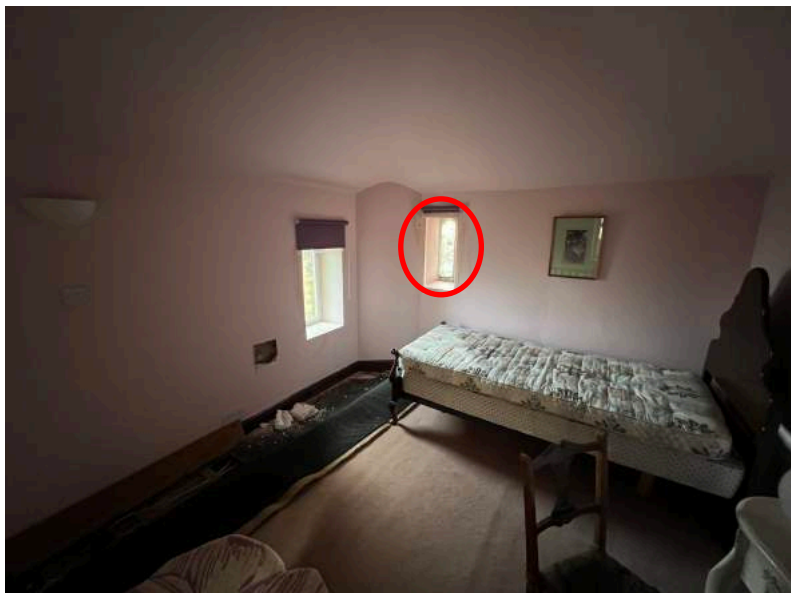
Figure 207 Room above *Front Bed Room*, window visible on 1883 image.

- 5.171 The room above the *Front Bed Room* is not readily identifiable with any of the remaining rooms listed in the 1888 sales particulars.
- 5.172 The room has an historic floor structure with pugging, although the skirting is modern, & the vaulted ceiling is gypsum over plasterboard. There is a diagonal across the south-east corner which may suggest a corner fireplace, although no evidence of a hearth structure is visible.

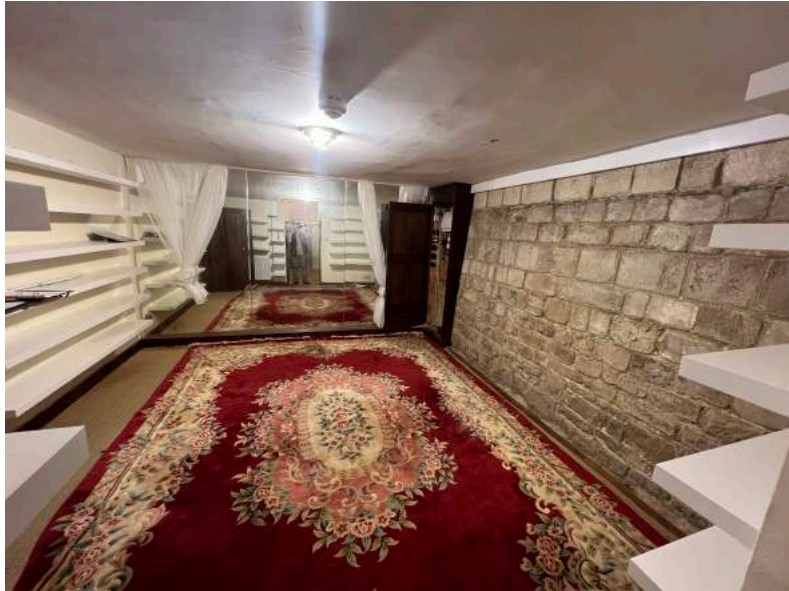
Figure 209 Cellar, northern room facing north.

5.173 The cellar comprises two rooms & a passage beneath the Rich wing. The skirtings, doors & architraves are all modern. However, the eastern wall, unlike the remainder or the brick-built cellar, is a battered wall of large, neatly-coursed stones.

5.174 This wall does not relate to the Leach phase, as it would have been beneath the forecourt at this time, where photographs show no above-ground structure.

5.175 It is thus possible that this wall may be a fragment of the mediaeval castle which survived below ground until exposed during the construction of the Rich extension. The approximate position & orientation would appear not inconsistent with such a hypothesis.

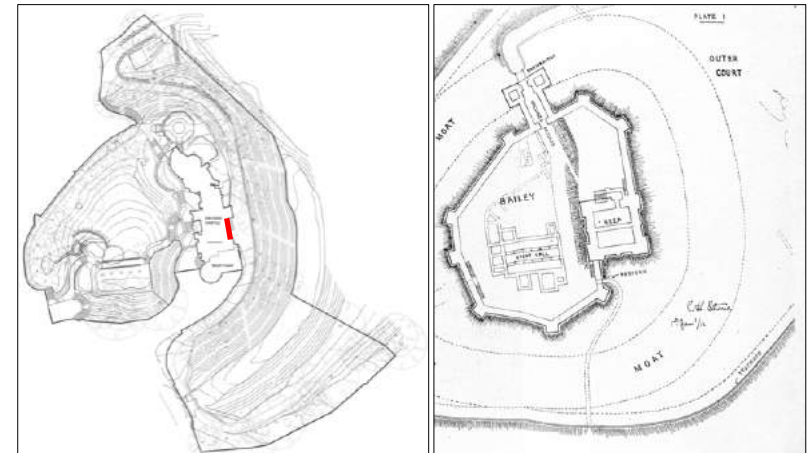
Figure 210 Current plan, & reconstruction of the mediaeval castle (as reproduced in *Devizes Castle, its History and Romance*): location of cellar wall.
