**HAWTHORN FARM,  
MARDEN, WILTSHIRE**

**PROPOSED NEW HOUSE**

**PROTECTED SPECIES SURVEY  
&  
MITIGATION STRATEGY**

**Final Report**

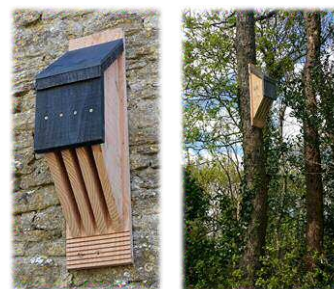
- ❖ Four mid-ridge capping tiles installed on the new house so as to have a void underneath. The void will be enclosed leaving a 20mm slot beneath. Two ridge tiles will be located on the north-west roof slope and two raised ridge tiles will be located on the south-west roof slope; and
- ❖ Two bat boxes installed on mature trees within land under the ownership of the applicant. Given the occasional contact with migrating/foraging barbastelle bat during the surveys, the bat boxes will be the Vincent Pro that are specifically designed to target barbastelle bats. The bat boxes will be installed as far above the ground as possible, and orientated either south-east or south-west to receive partial sunlight. The boxes will be installed by the licenced bat ecologist.

External lighting will be avoided adjacent to or directed at the entrances to the bat roosting features.

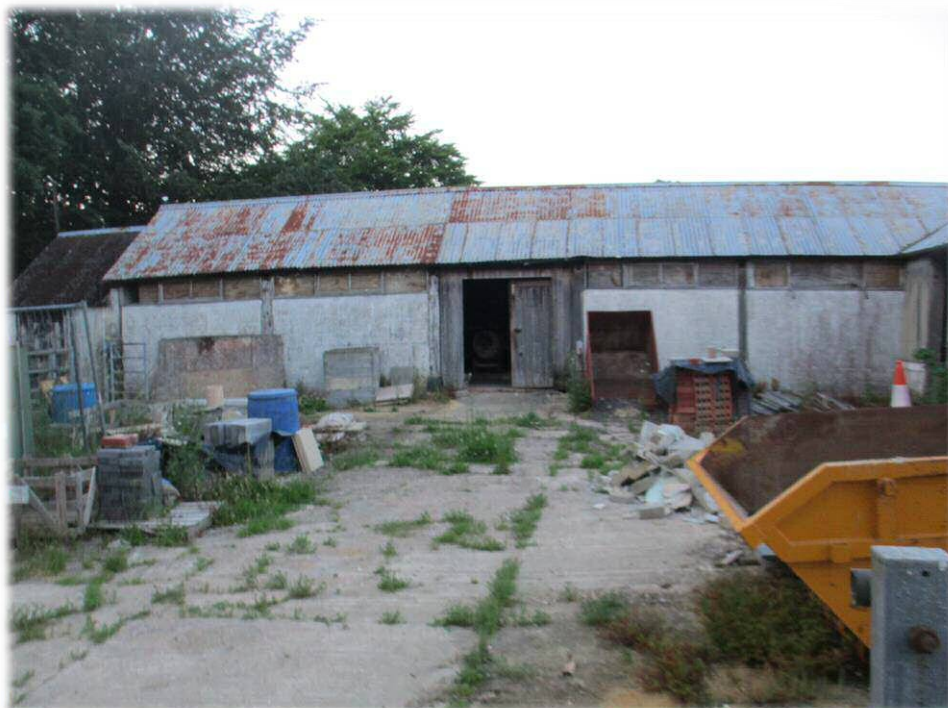
Building 1a exterior

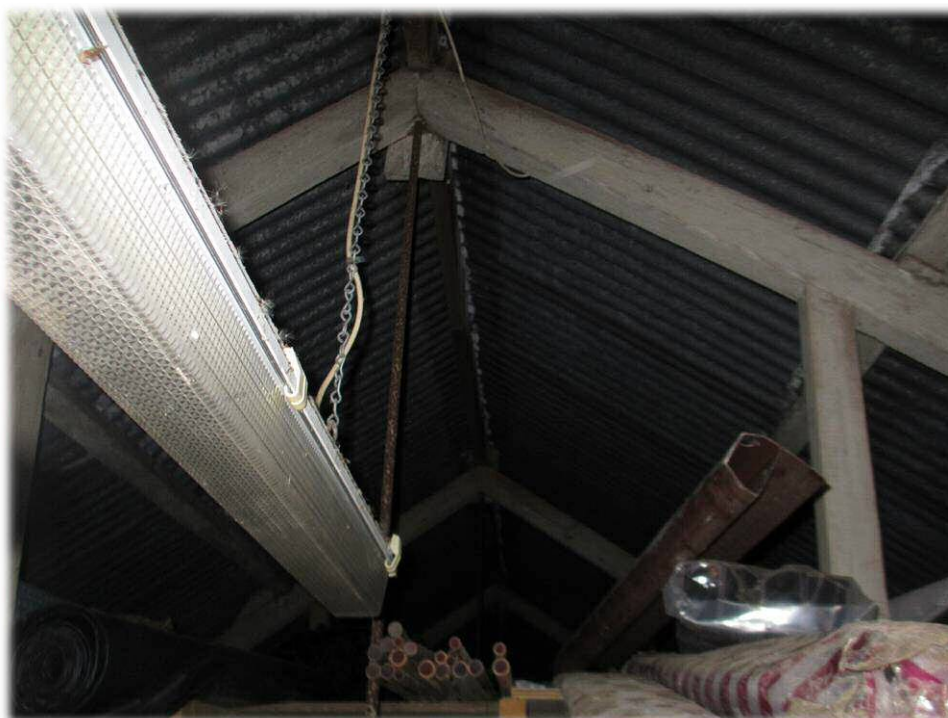
Building 1a has no external recesses, a few internal recesses associated with the western gable end wall of the main building and internal wall of the western extension that crevice-dwelling bats could potentially use, and exposed roof timbers that free-hanging/clinging bats could exploit. There are flyways into the building interior associated with the slatted vent and a gap over the main door. However, the building interior largely provides sub-optimal conditions for roosting bats being light and suffering disturbance, and the roof structure/timbers are extensively webbed.

Building 1a roof structure

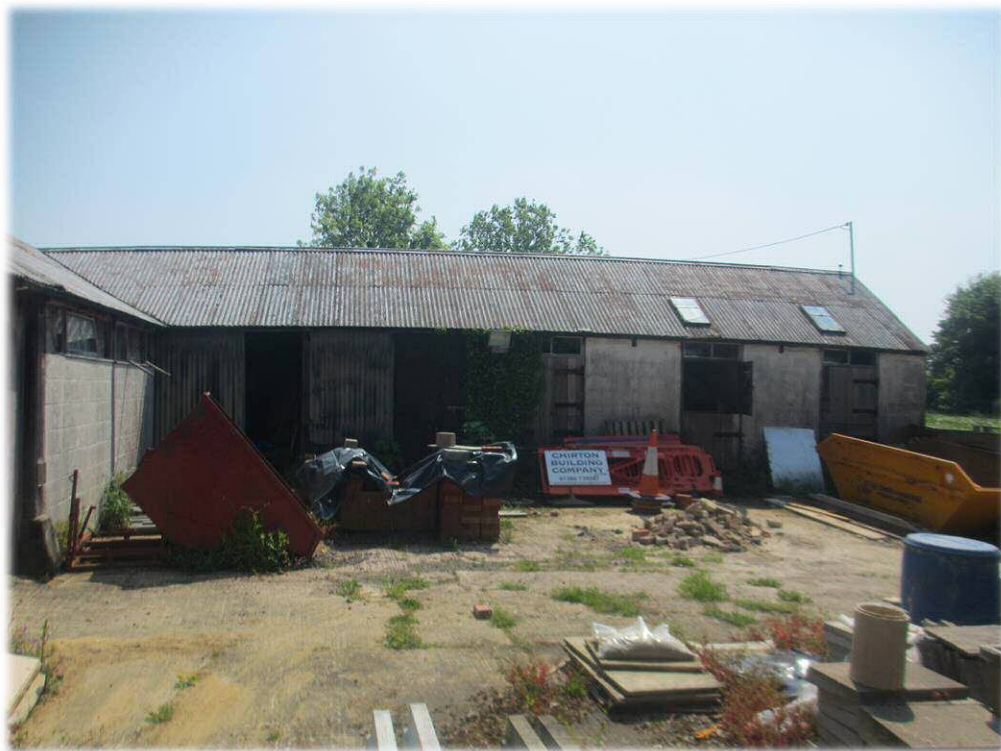
Building 1b exterior

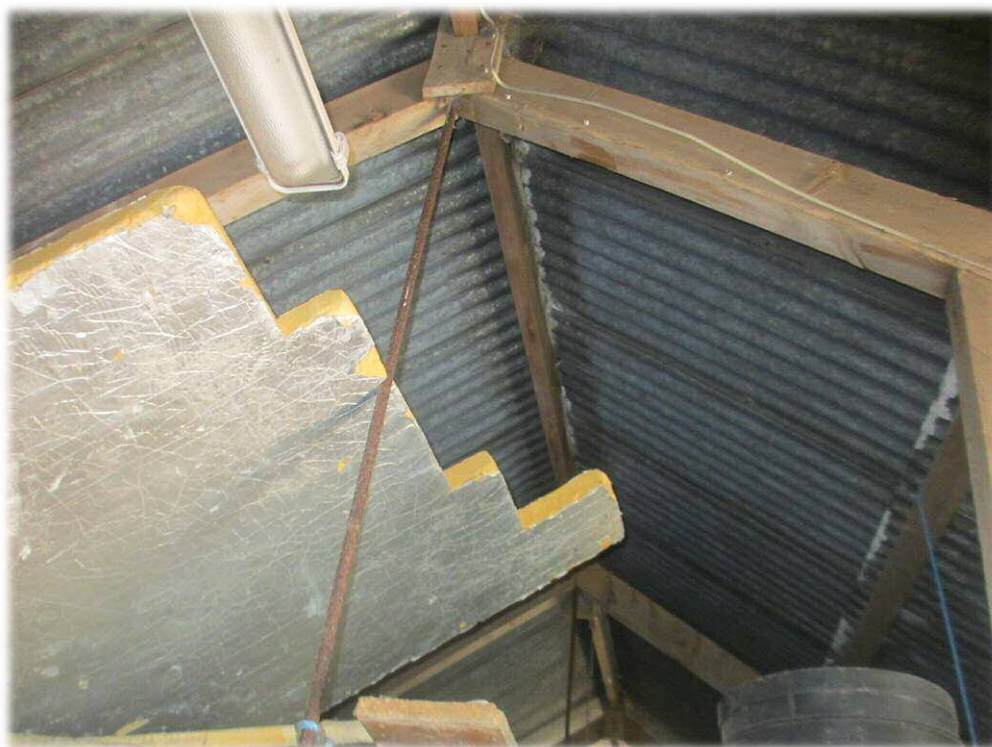
During the Phase 1 survey approximately 50 scattered bat droppings were found on the internal southern end wall and on surfaces below the wall, with another approximately 100 droppings on the floor and surfaces under the ridge beam in the middle of the building. Urine droplets were also visible on surfaces at the base of the southern end wall. Based on visual diagnostics of the droppings it is considered that these could be from a combination of pipistrelle (*Pipistrellus* sp) bat, brown long-eared (*Plecotus auritus*) bat and Natterer's (*Myotis nattereri*) bat. Three samples: one of larger droppings and one of smaller droppings from southern gable end; and one from central part of building directly under ridge beam, were sent for DNA analysis (see Section 3.7). In addition, there were accumulations of large yellow underwing moth and small tortoiseshell wings on surfaces at the base of the southern gable end wall and within the middle section of the building under the central ridge beam. This is a common feature of brown long-eared or Natterer's bat feeding roost.

Building 1b does not support current bird nesting activity, but there are five old swallow (*Hirundo rustica*) nests associated with the roof structure.

Building 1b roof structure

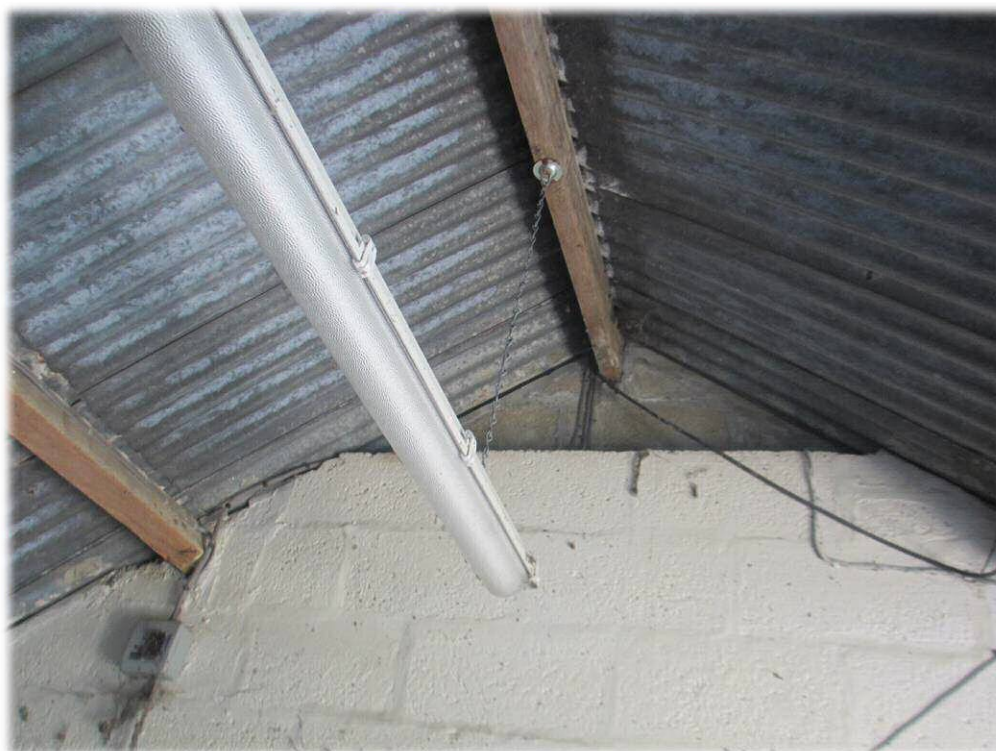
Building 1b provides no external recesses for bats to potentially exploit, but does have exposed timbers that perching/hanging bats could potentially use and there are available flyways into the building interior. The southern gable end wall is constructed from concrete blockwork (with small internal cavities), which can be accessed from the building interior or exterior, and as such could be used by crevice-dwelling roosting bats. However, the building interior largely provides sub-optimal conditions for roosting bats being light and draughty, the

- ❖ Building 1b. Four brown long-eared (*Plecotus auritus*) bats were observed light-sampling within the building from 21:40 (33 minutes after sunset). Bats were observed entering the cavities at the top of the southern gable end wall. Bats emerged *via* the open doorway. Bats emerged between 21:50 and 22:29 (43-82 minutes after sunset), with bats routinely returning to the building interior, and one bat was still in the building at the end of the survey.

Building 1b southern gable end blockwork wall

Immediately prior to demolition the building interiors, especially the cavities associated with the western gable end wall (Building 1a), the southern gable end wall (Building 1b) and the roof apex will be inspected (in the daytime) by the NE licenced bat worker. If bats are found the licensed bat worker will capture and move the bat(s) to the pre-fabricated bat box.

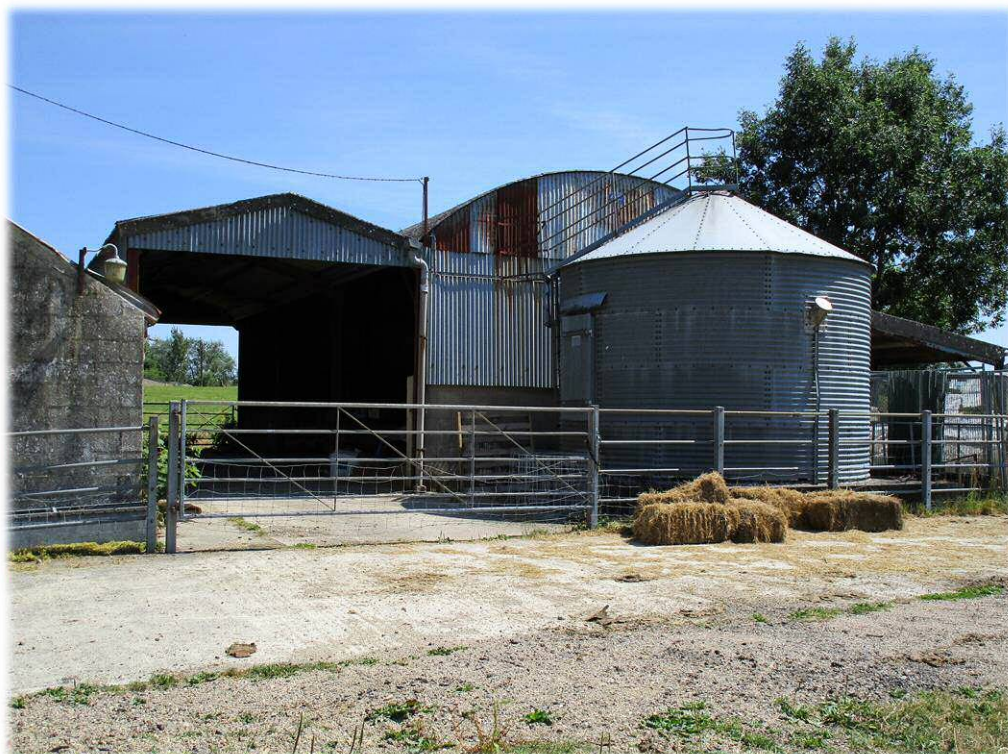
Buildings 2, 3 and 4 are totally unsuitable for bat roosting being modern open barns or sealed grain silo with no internal/external recesses. No evidence of bat roosting or other bat activity (no live bats, no dead bats, no droppings, no urine staining, scratching or oil staining, and no feeding remains) was found within or outside Buildings 2, 3 and 4, which are classed as Category 1 (not a roost).

Buildings 2-4

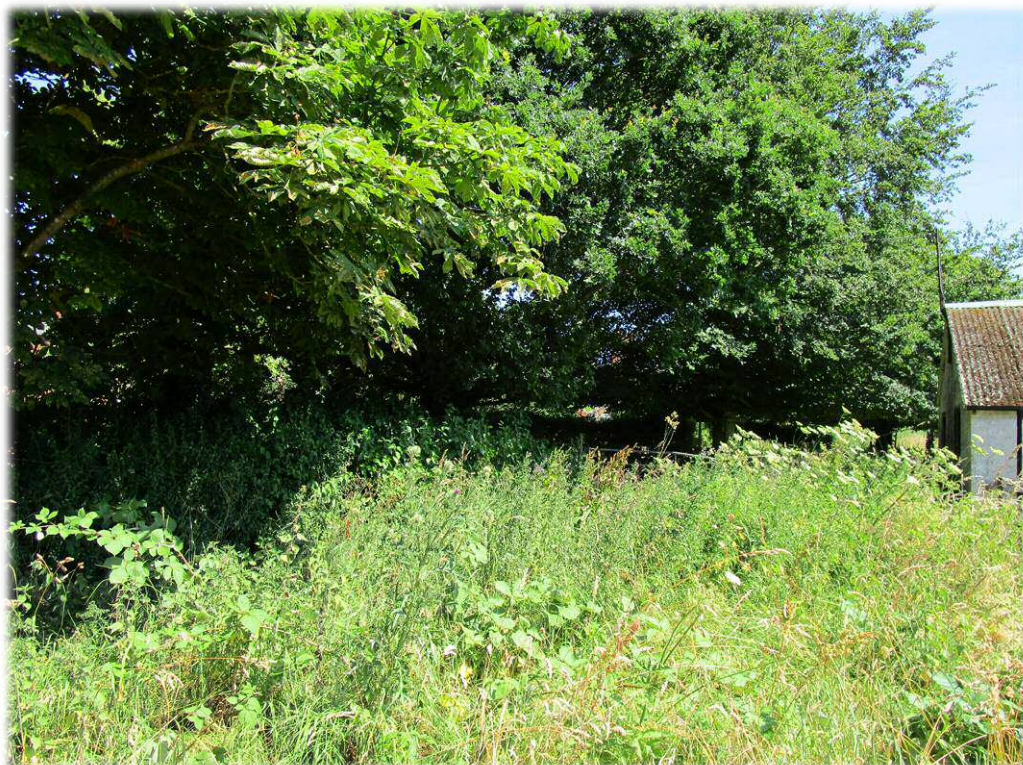
Roadside trees to immediate west of the buildings
