**43 Herd Street**  
**Marlborough SN8 1DG**

## **DESIGN & ACCESS AND HERITAGE STATEMENT**

**Document No: 1360-HR-A-HS-XX-01**  
**Rev 01**

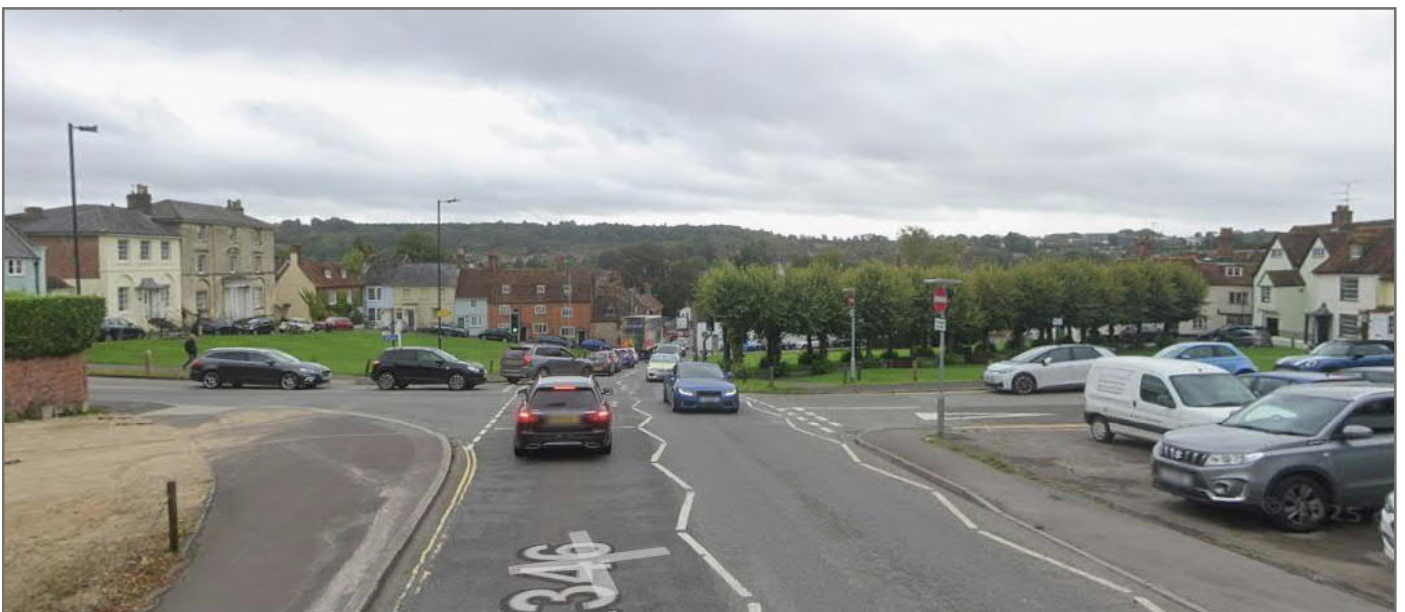
Image 5: View south from 'viewing point' (Google Maps, 2023)

2.2.1 The detailed townscape study of the immediate area to The Site indicates there are views from (cntd) outside No.43 downhill in a southerly direction across The Green (refer to green arrows adjacent The Site location in Image 4) - refer to Image 5, below. 43 Herd Street forms part of the backdrop to The Green when looking north, an open landscape space of heritage significance.

- experienced in the view south from the north side of The Green: refer to Image 5.
  - the group of buildings of which 43 Herd Street forms part of and the ability to view these from the open space of The Green

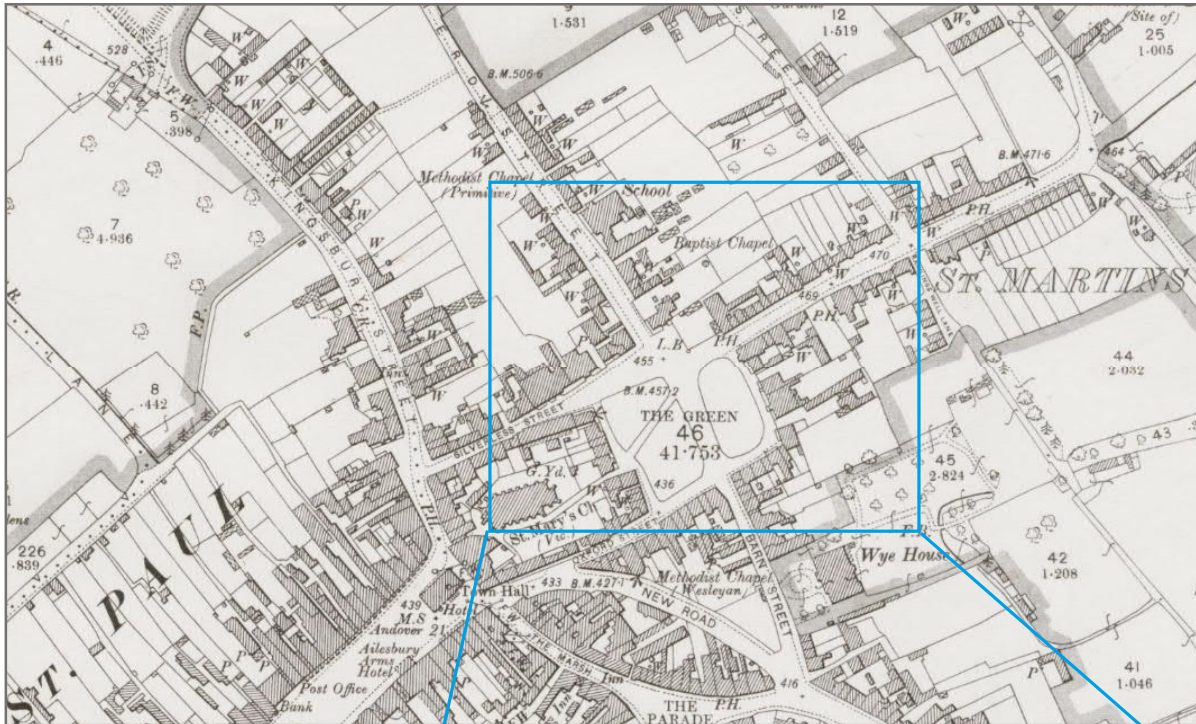
Image 7a: Extract from OS map second edition 'Wiltshire XXIX.9'. Revised: 1899, published: 1900. (National Library of Scotland, 2026).

2.3.2 The map of 1899 shows the same cluster of 4no. cottages forming an 'L'-shape: with current day No.s 39 and 43 facing onto the street, and 2no. cottages accessed via the communal access route from the main street. A circle with a 'W' is indicated to the plot which represents a well shared by the 4no. cottages.

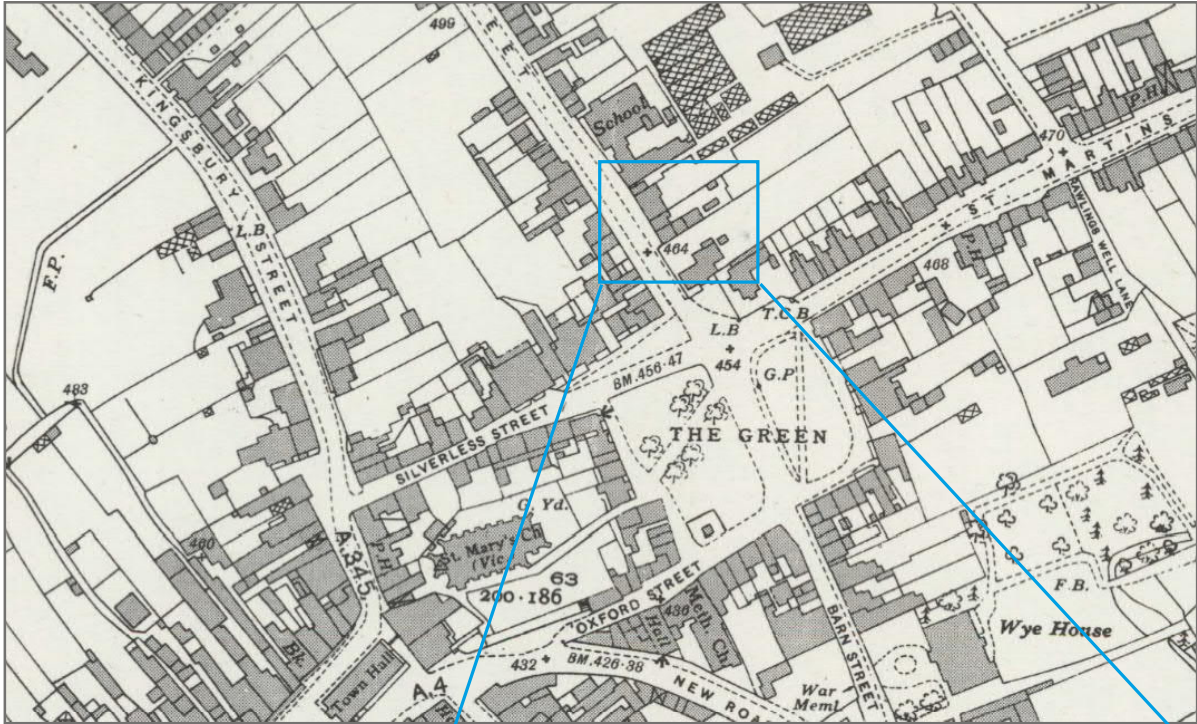
Image 9a: Extract from 'Wiltshire XXIX.9'. Revised: 1943, published: 1947 (National Library of Scotland, 2026).

2.3.4 The 1943 OS map indicates no change to the previous three editions.

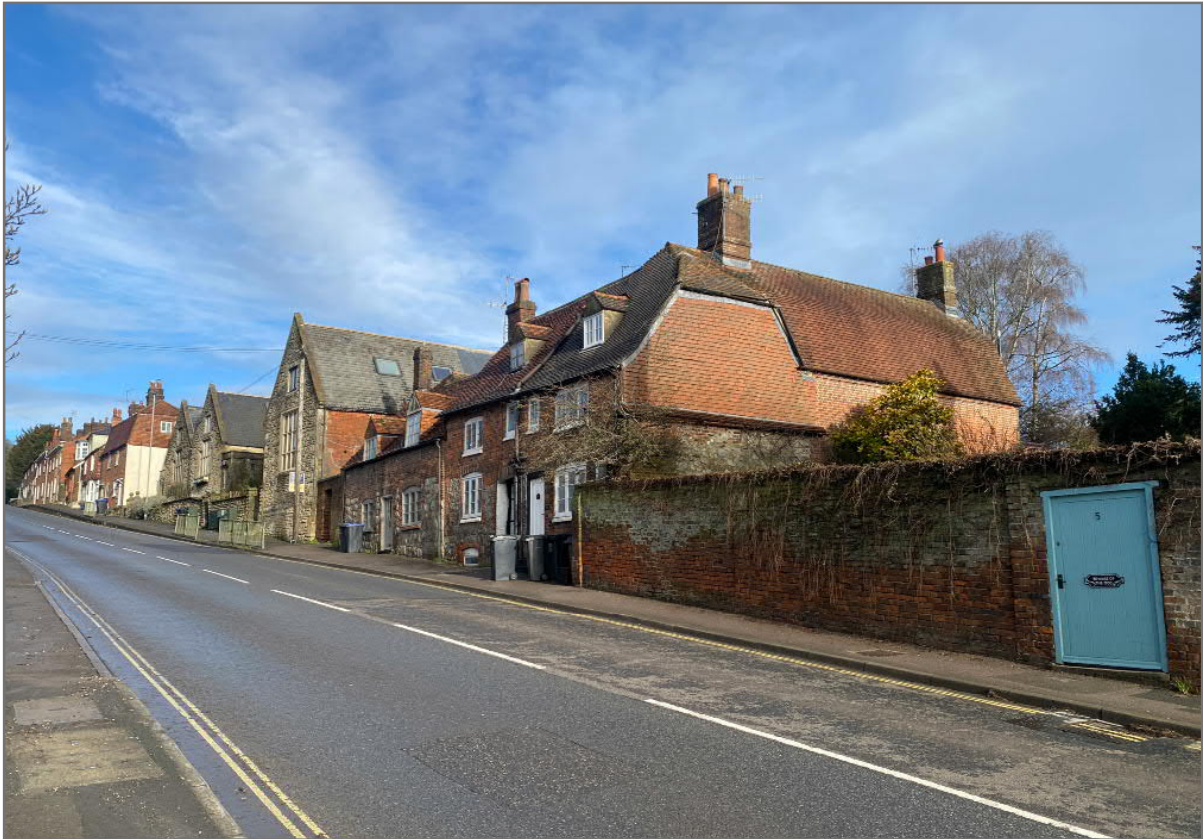
Image 13: View of south elevation of No.43 and No.41 behind

When compared to No.s 39 and 40 which have retained sarsen stone and bricks of a pre-standardisation size to their ground floors, it could be concluded No.43 had undertaken a substantial re-facing to both floors, compared to one floor of the neighbouring properties. Sarsen stone and brick are visible to the ground floor of the south elevation of No.43 (refer to Image 13); the first floor of the south elevation is of hung clay tiles.

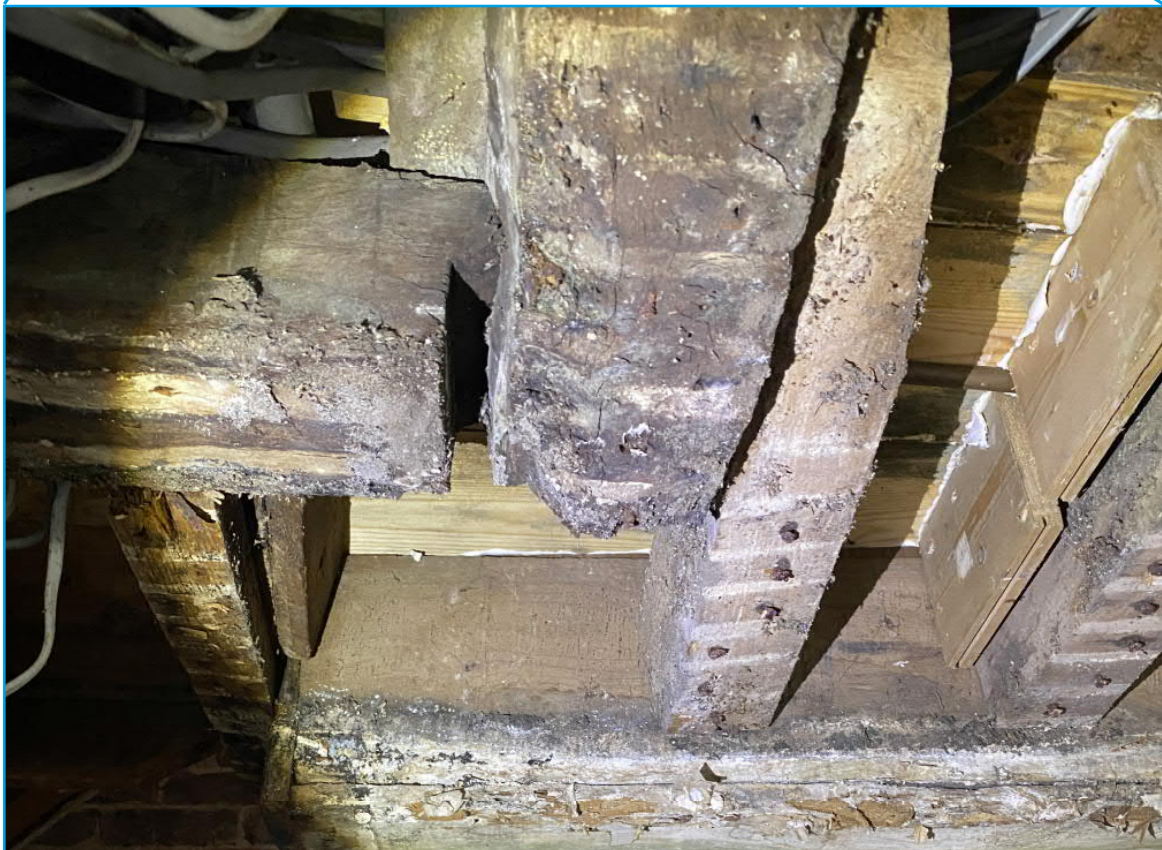
Image 22a: View of underside of staircase

Image 22b: Detail view of underside of staircase

(cntd) The condition of the existing timber floor construction (refer to Images 22a and b, and those within the Engineer's report) has been reviewed by a Structural Engineer to assess for the minimal degree of intervention necessary to achieve a safe domestic use floor in a manner appropriate to the historic timber frame:

- a) 3no. new oak beams and one new post at the staircase are proposed to be inserted, all co-dependently connected together to relieve the current supported load. This will secure the staircase and floor for safe use.
- b) 2no. existing joists that are inadequately supported - refer to Image 45, and to Image 23 - proposed to retain as much original fabric as possible whilst providing sufficient strength for domestic use.
- c) 5no. existing joists that are inadequately connected to the main downstand oak beam are proposed to be secure with new joist hangers - refer to Image 25a and b - proposed to retain as much original fabric as possible whilst providing sufficient strength for domestic use.

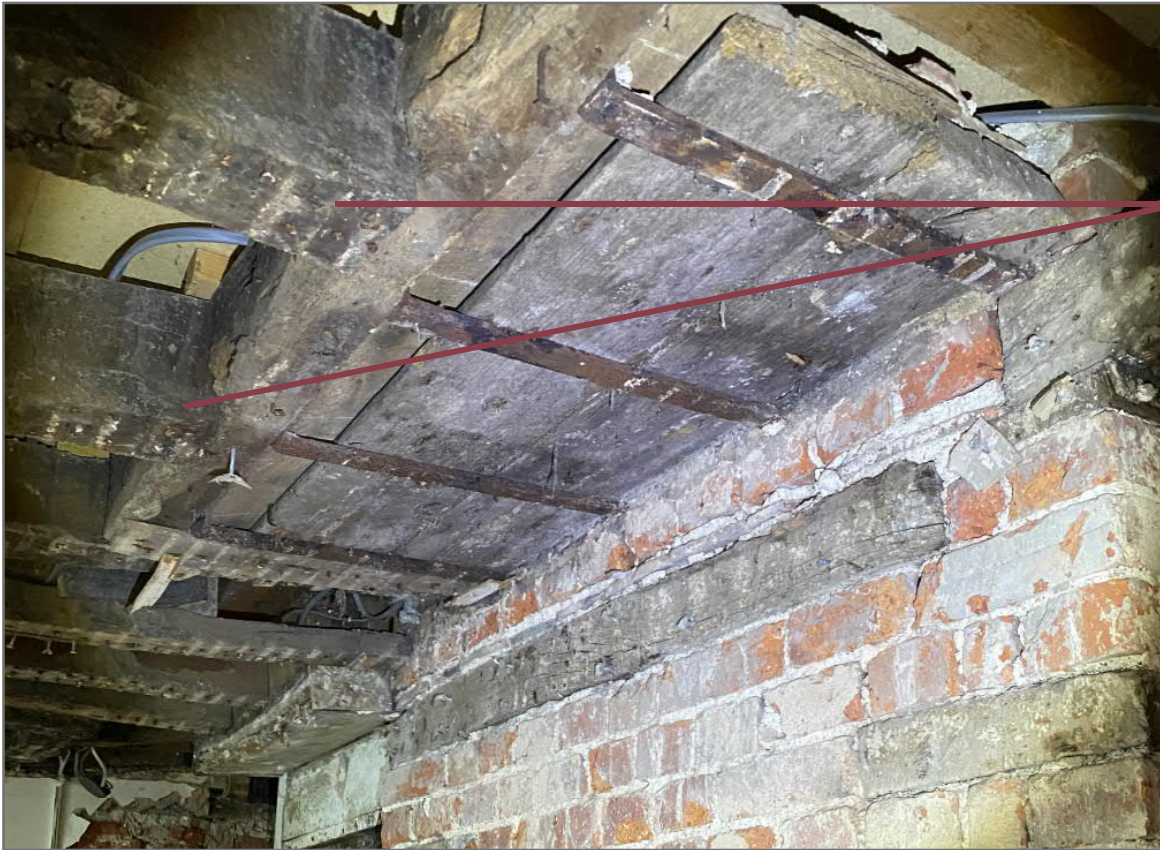
Image 23: View of underside of First Floor hearth

Joists  
to be  
retained  
and  
realigned  
- refer to  
descrip-  
tion in  
para.  
4.2.1b

b) At the location of bare internal brickwork: at the staircase; to the partywall with No. 41; the flank wall of the chimney breast - refer to Images 23, 24, 27-29, 36 and 39. 2no. 6mm coats of hemp lime plaster is proposed to be instated to the internal brickwork. The brickwork has been uncovered for over 6 months to allow it to dry out from the impact of the water damage. The hemp lime plaster would provide a durable and more flexible finish to these highly trafficked areas compared to NHL2. The base coat would be 6mm of 'base lime' hemp plaster; the second coat would be 50% 'base lime' hemp plaster with 50% 'top lime' hemp fine plaster (non-hydraulic). (Both by Ty-Mawr). A mineral paint would be applied.

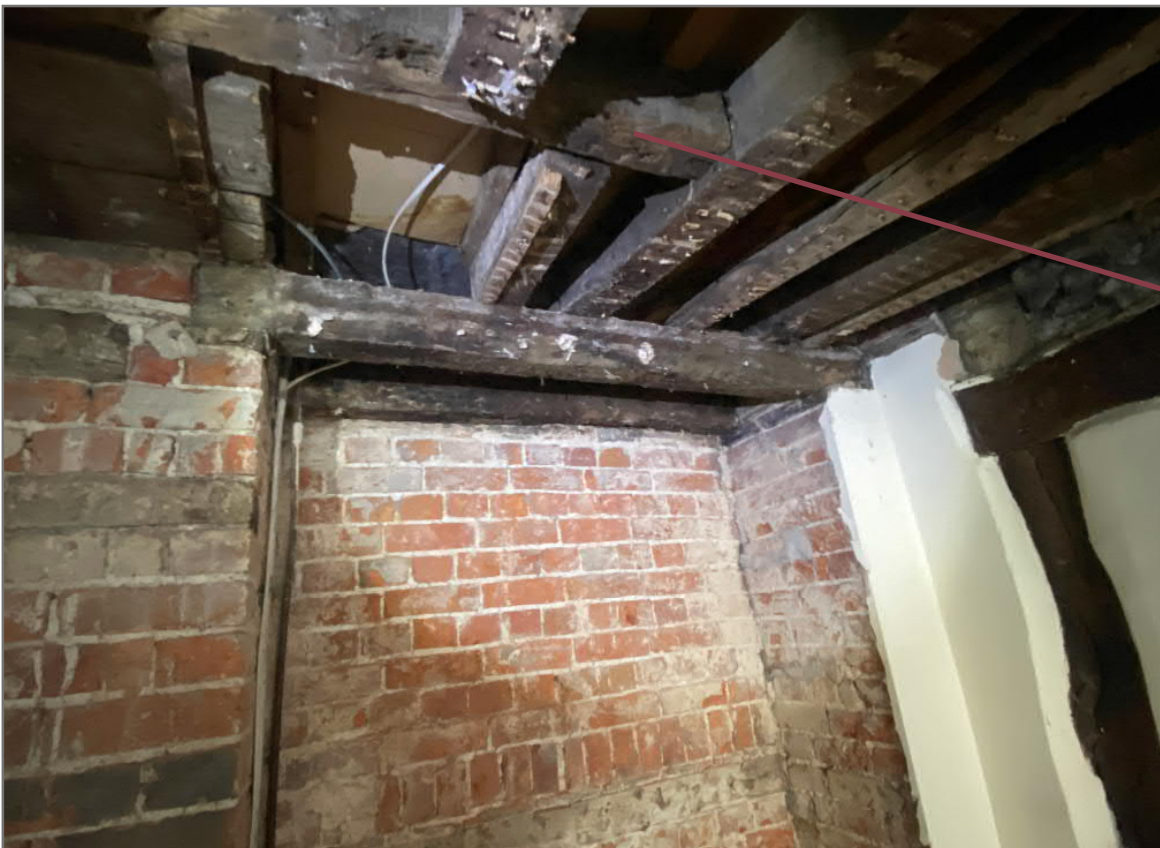
Image 24: View to RHS of chimney breast at ground floor, facing east

Trimmer  
beam  
spans in  
front of  
hearth

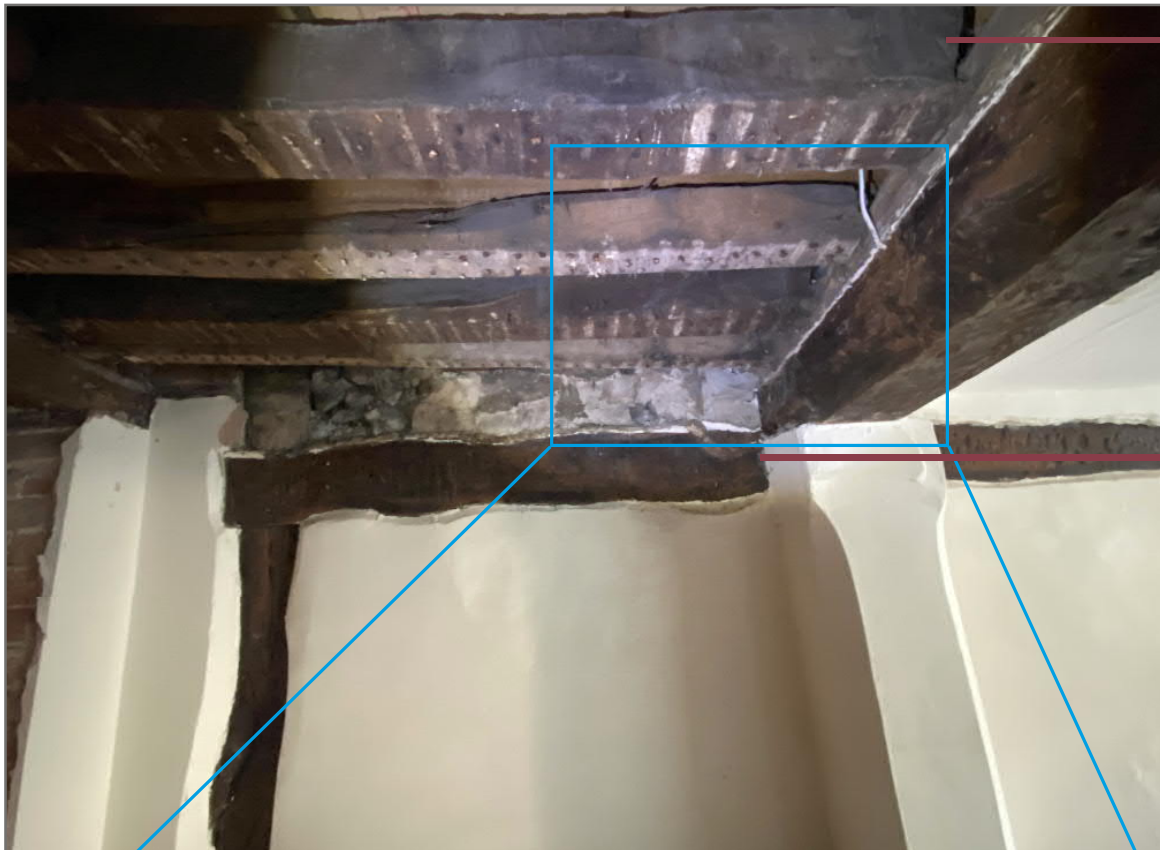
Image 25a: View of underside of floor to first bay adjacent to chimney breast

5no. timber joists to this area require to be secured with hangers - refer to description in para. 4.2.1c

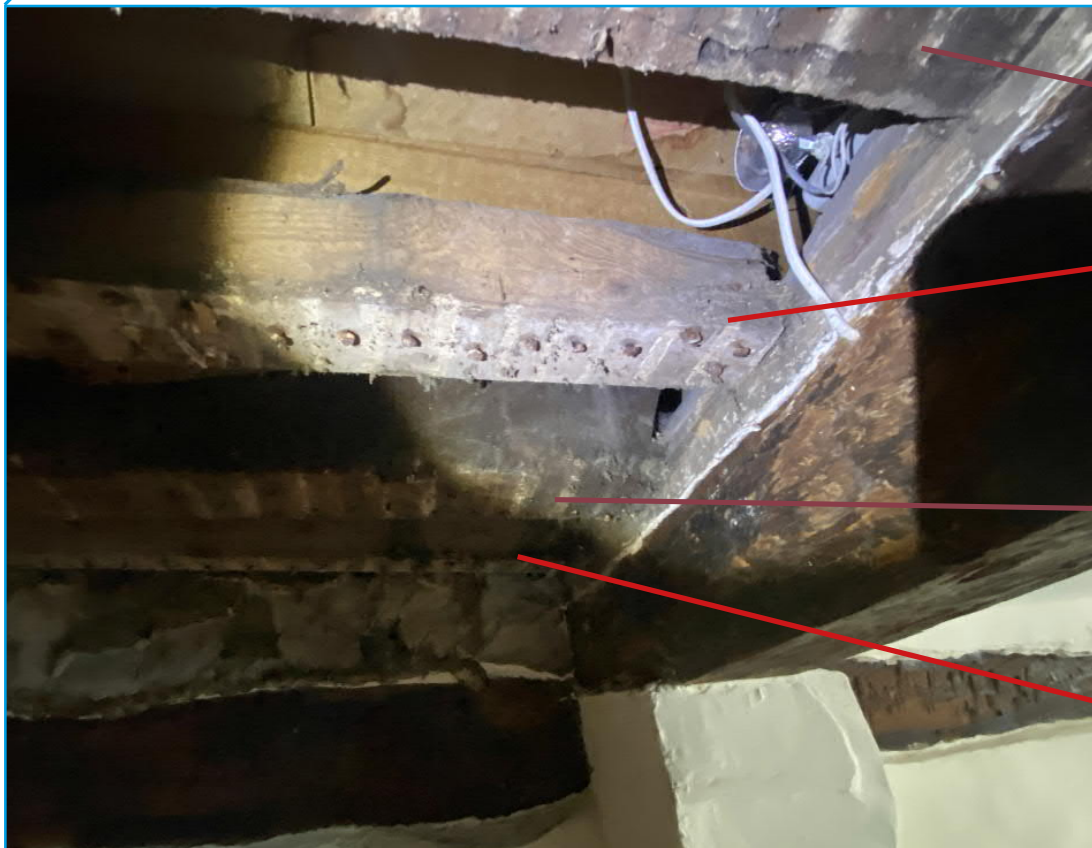
Image 25b: View to RHS of chimney breast at ground floor, facing south

Original timber

Late C19 timber inserted

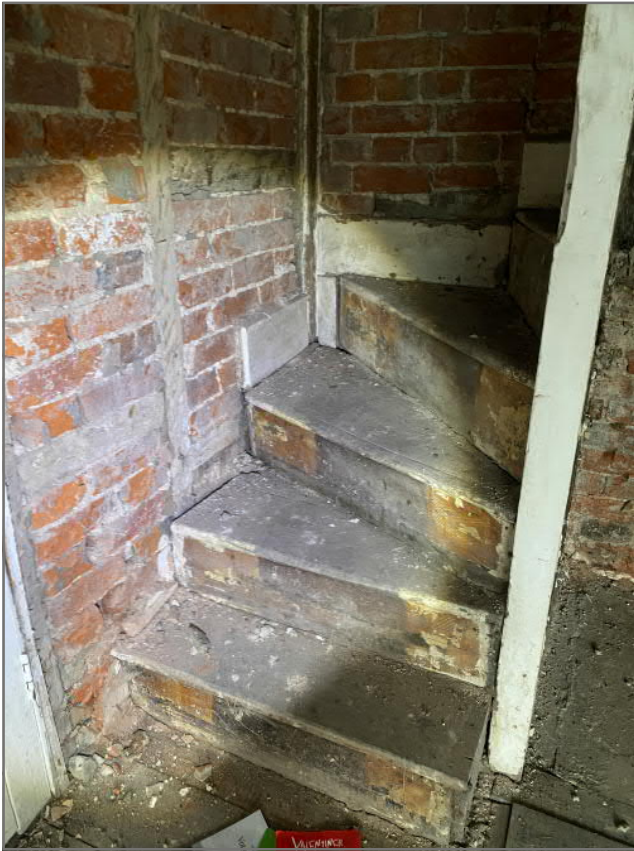
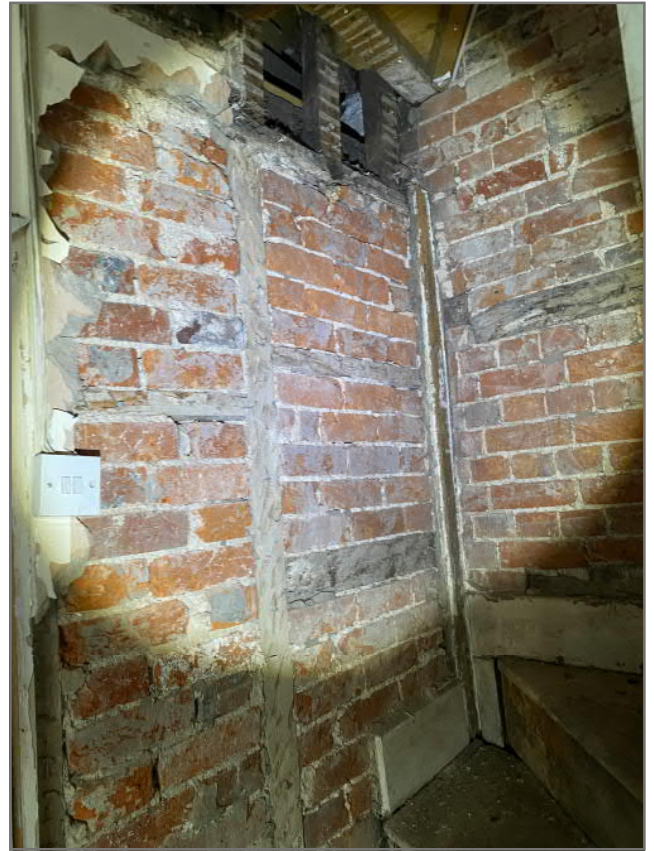
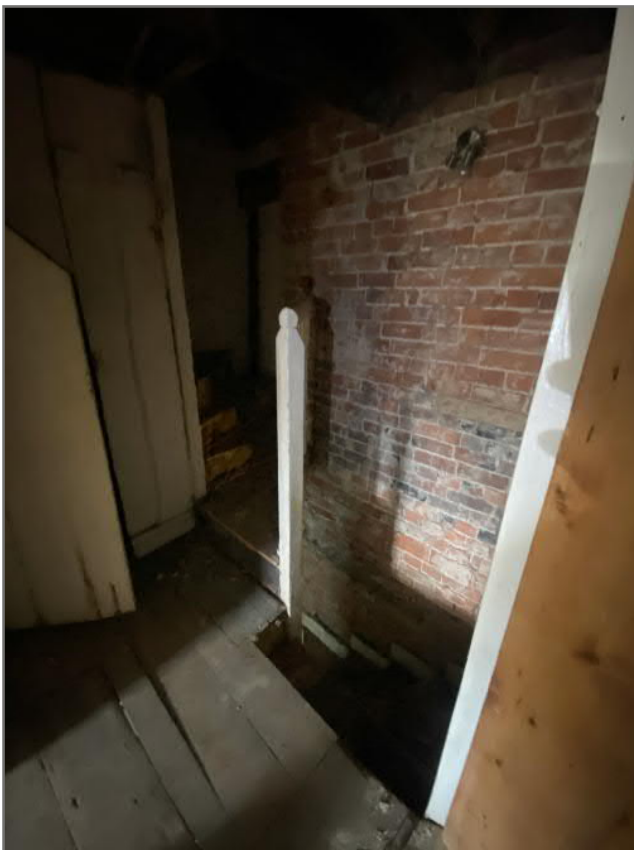
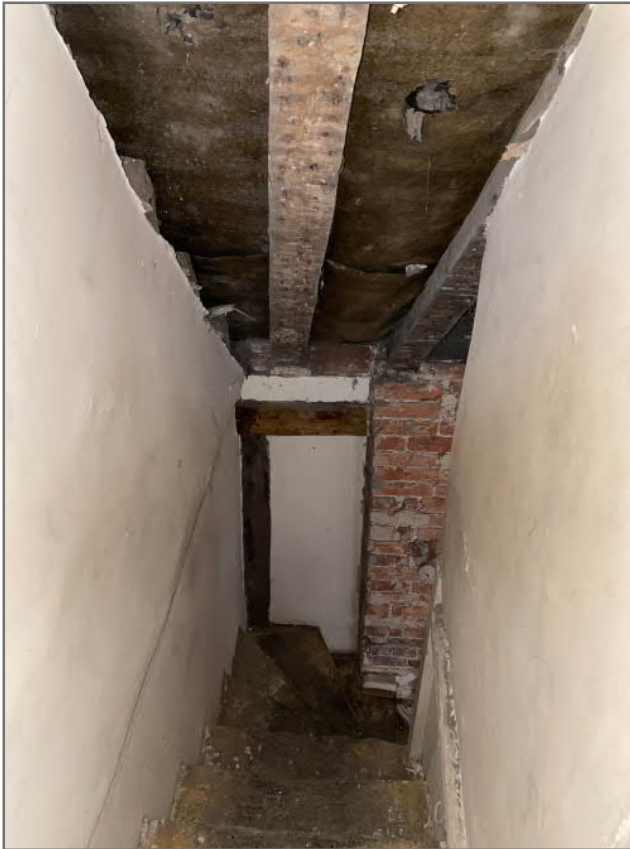
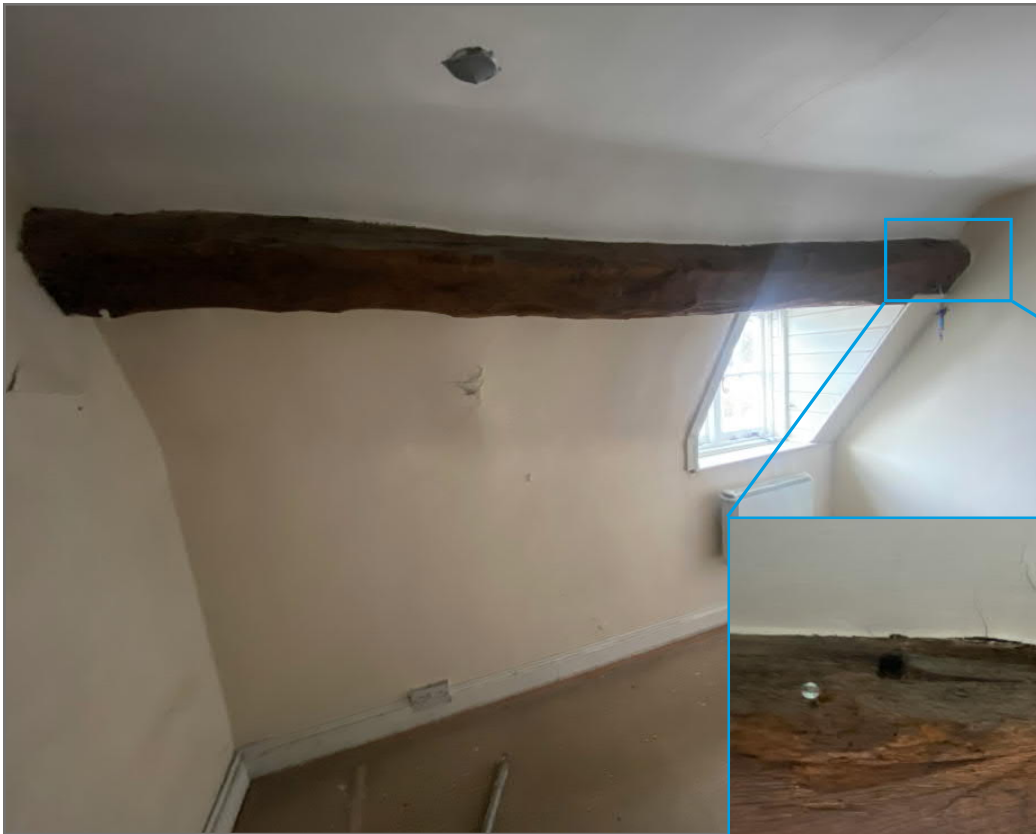
Image 27: Staircase at Ground Floor

Image 28: Stairwell at Ground Floor

Image 29: View at First Floor of staircase/well

Image 36: View towards east elevation from attic floor

Image 39: View west of purlin in bedroom

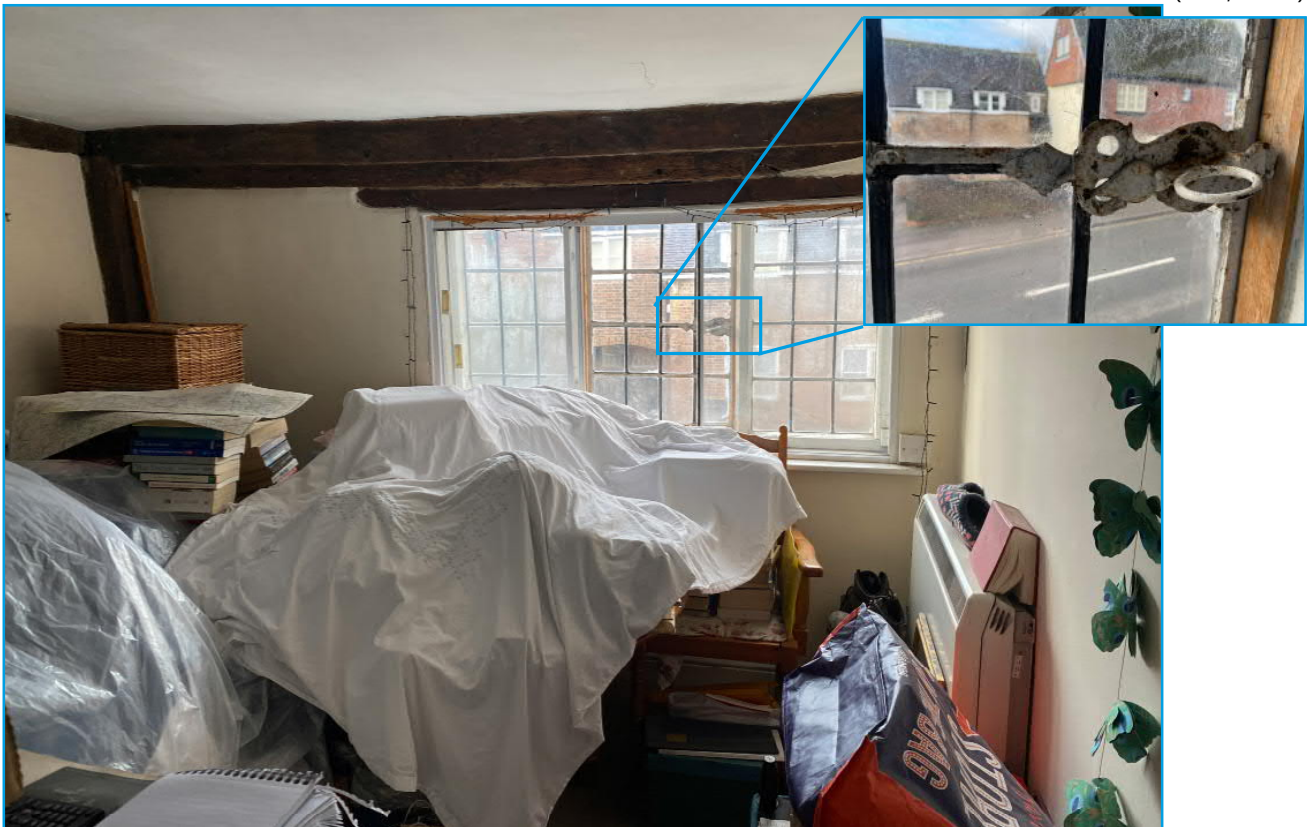
Image 32: View at First Floor facing west towards Herd Street

- the large profile timber frame: the spine beams at the Ground Floor and directly above at the First Floor, and the two purlins to the roof
- the common rafter roof construction that lies parallel to to Herd Street
- the casement window and ironmongery (Image 32)
- the plank and batten door with ironmongery (Image 35) - albeit this is may have been instated from a different building

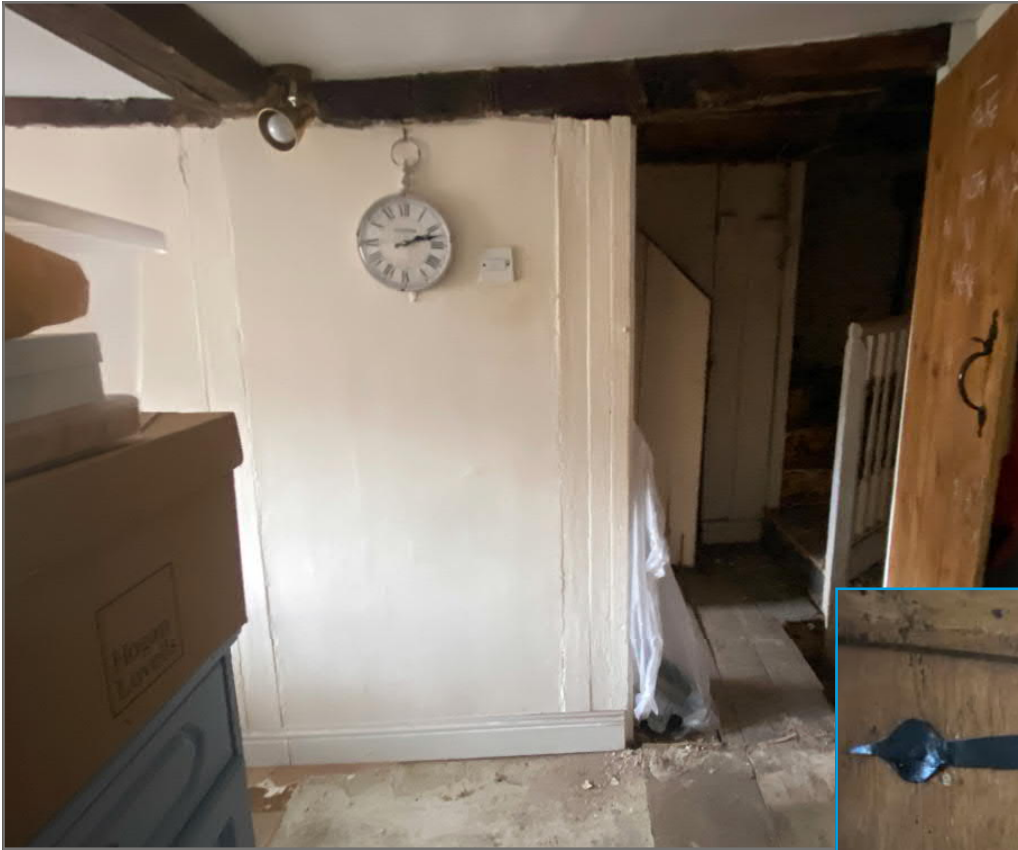
The two strap hinges have little taper in their length and an elegant spearhead end. Hall (2005) advises this style is found from the C16 or earlier to the mid-C18. This design is similar to a mid-C17 example from Gloucestershire.

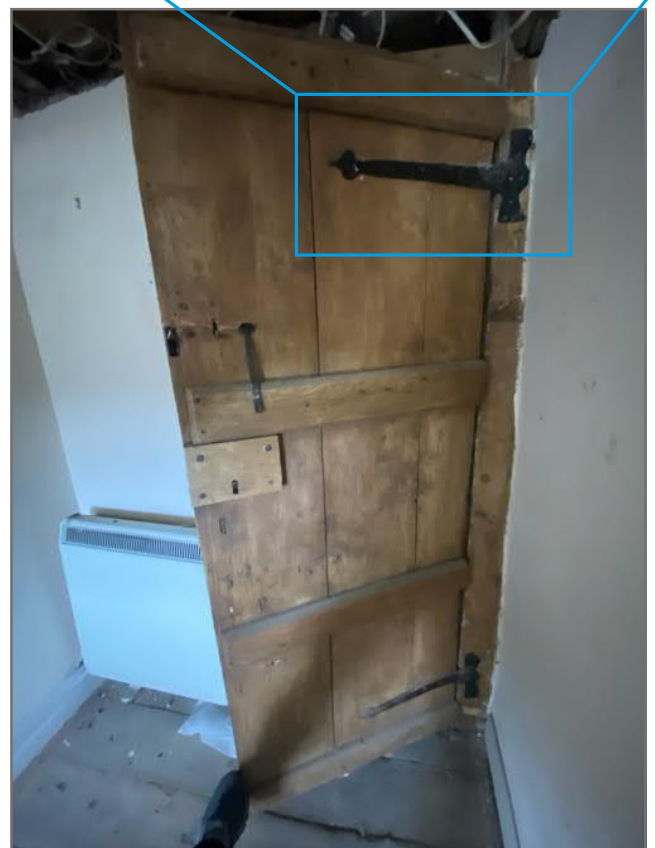
Image 35: Plank and batten door with planks of irregular widths at First Floor - common prior to C19

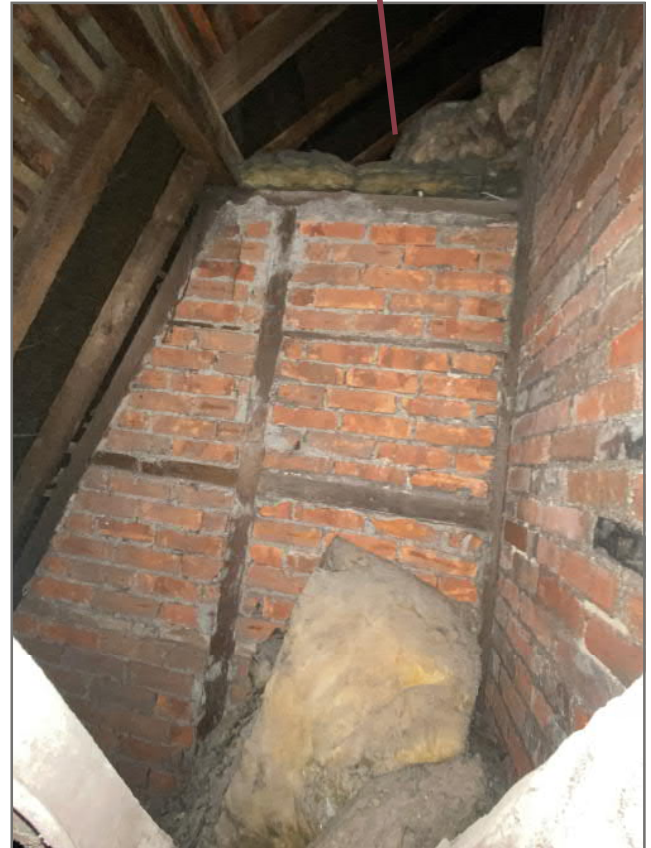
Image 37: View into attic space of east elevation -  
partywall with No.41

Proposed location of fire-  
board to partywall

The damaged wall and ceiling finishes that have been removed revealed the property is not protected from the spread of fire from its two adjacent neighbouring properties.

As a matter of due diligence for the long term protection of both No.43, but also for the wider group of adjacent properties, it is proposed to install a 15mm plasterboard fireboard wall system on a softwood timber frame to these vulnerable locations. These materials can be cut accurately to size to adjust to the non-linear heritage materials. The firestopping shall be completed with fire sealant to the perimeter of the boards. These materials could be readily removed in the future if future generations wished to replace them.

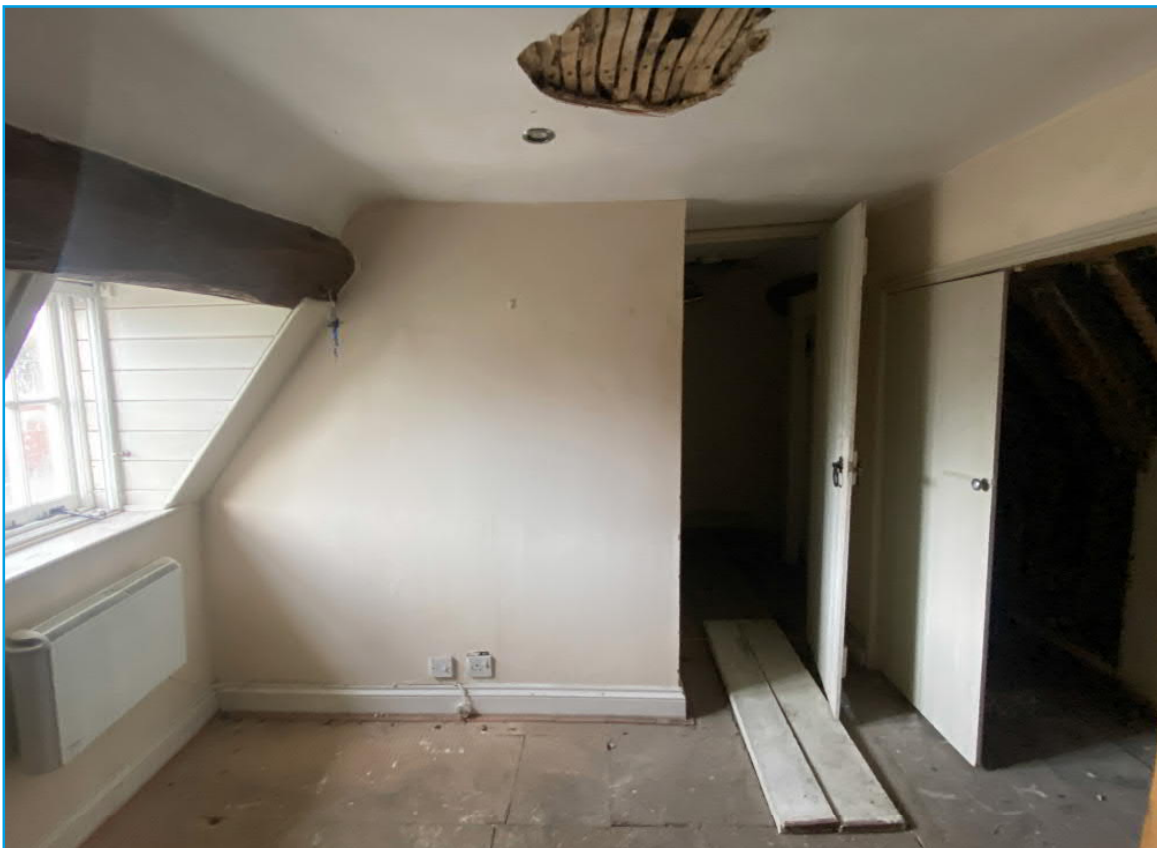
Image 38: View north at Attic Floor

c) Lime plaster has fallen from the ceiling laths in the attic bedroom (refer to Image 38). This appears to represent an area of plaster that has lost its 'key' to the laths beneath - which are very dry - and has become inherently unstable. It is proposed to carefully remove the loose 'live' plaster to allow an inspection of the laths beneath. Where the gaps between the laths are either too large or too narrow to support an appropriate key for lime plaster these will be adjusted - the gaps should be 6-8mm wide. Any new fixings shall be of stainless steel; any new laths shall be of oak.

The proposed finish for resultant patch repair(s) is 'base lime' hemp plaster to match the depth of the adjacent plaster. This would then be over-skimmed with a 3mm renovation lime plaster to the remainder of the ceiling to create an even finish onto which a mineral paint can be applied.

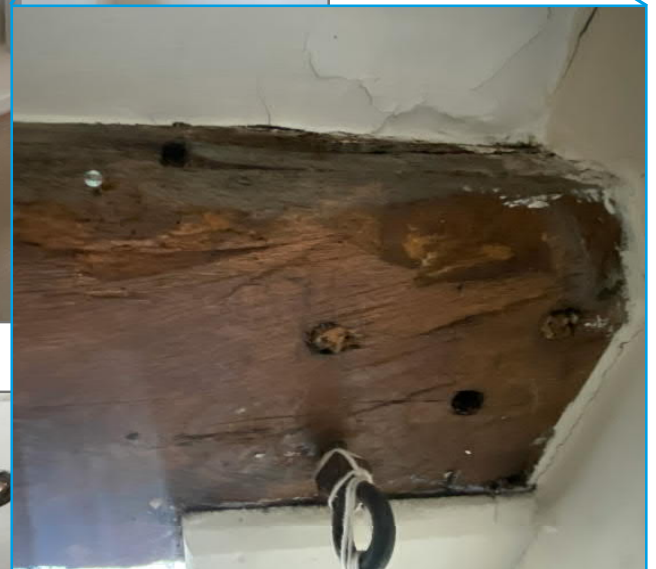
Joint at purlin  
approximately 2/3  
along the length  
- a 'bridled scarf  
joint' (CBA, 1989)

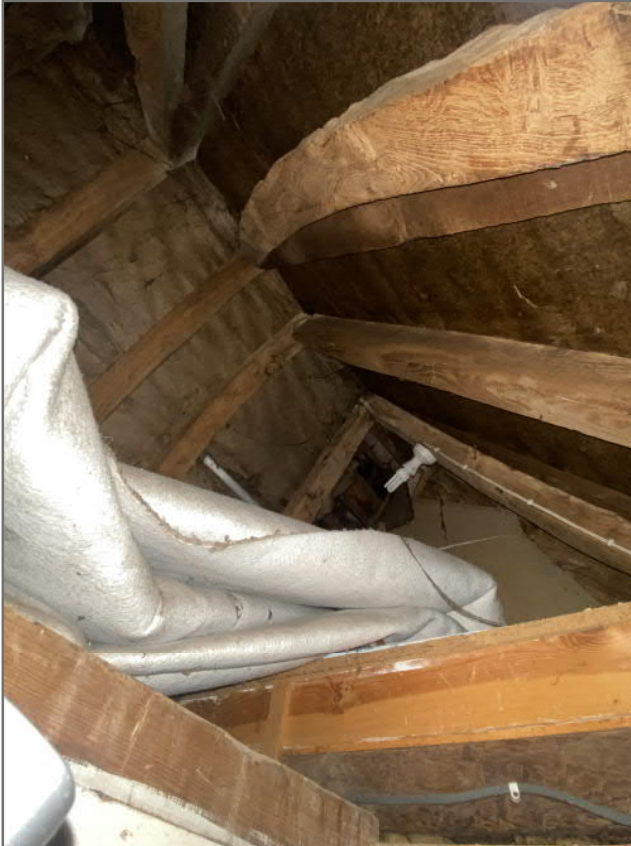
Image 41: View into roof space - common rafters with bridled joints (no ridge beam)
