LUS24212

**LUS24212 - Latimer Manor, West Kington, Chippenham, Wiltshire, SN14 7JQ – Compensation for bats**

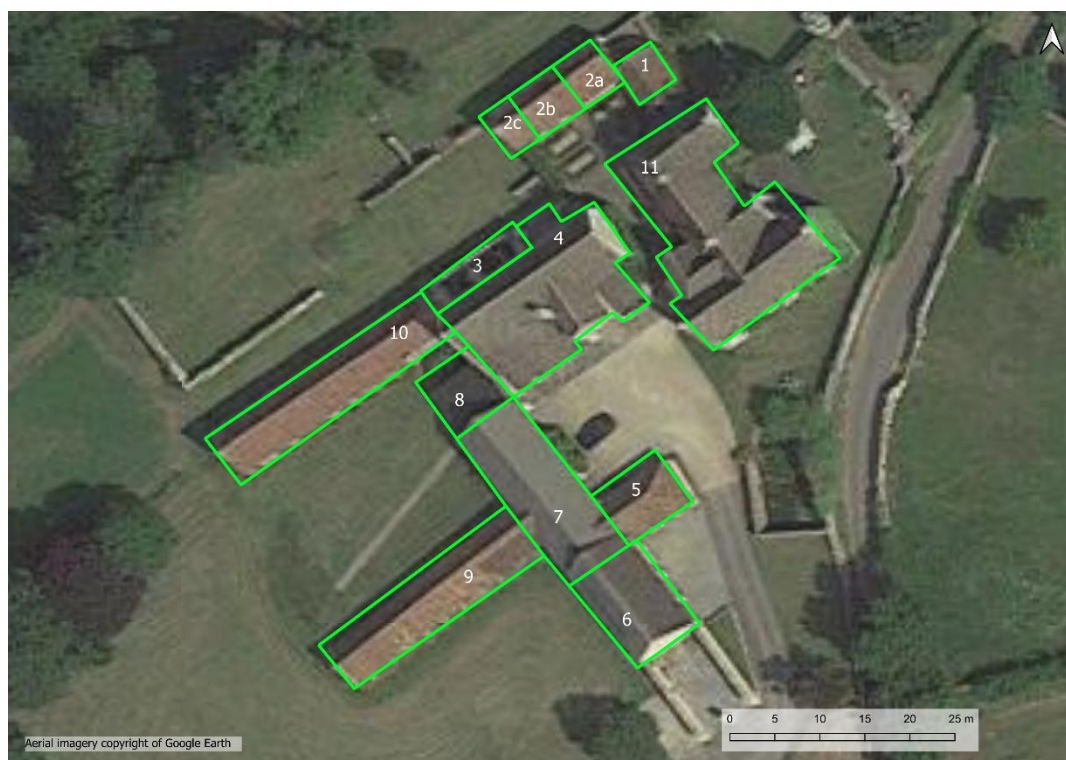
**Figure 2: Building map**

- 1.2 The Proposed Development will result in the removal of the habitats within the Site and placement with solar panels and hardstanding. Following a Preliminary Ecological Appraisal (PEA), a full suite of emergence surveys was conducted on the buildings within the Site. The building numbers can be found in **Figure 2**. The bat emergence surveys returned a total of six roosts were present within the Site (**Table 1**).
