# **ECOLOGICAL IMPACT ASSESSMENT REPORT**

## **AVONSIDE, MELKSHAM, SN12 8BT**

## **CREATE REAL ESTATE**

Document Ref: WWE25110 EcIA | 18/09/2025

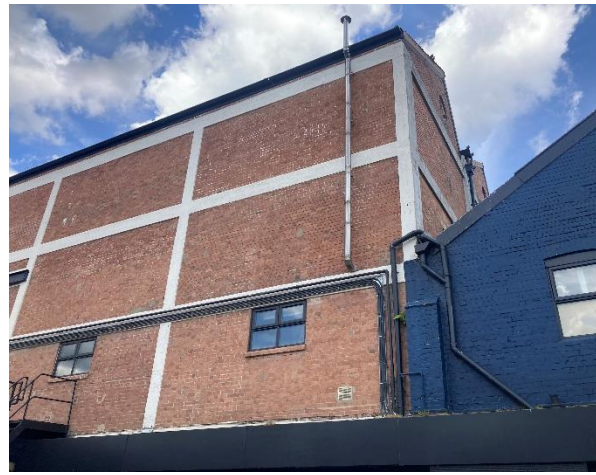
**Figure 12 - Condition of the external brickwork of the main building.**

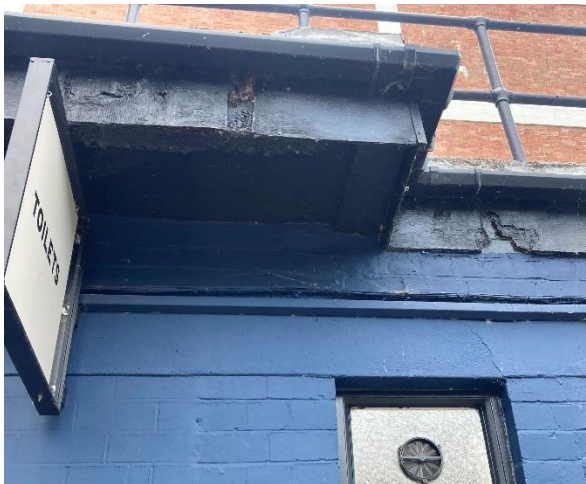
| Riverside single storey element | Wooden horizontal beam above the toilet block is rotten in places (Figure 12). Brick work in good condition and windows flush to the building. | Demolition |

**Figure 13 - Rotten woodwork on the toilet block on the south side of the main building.**

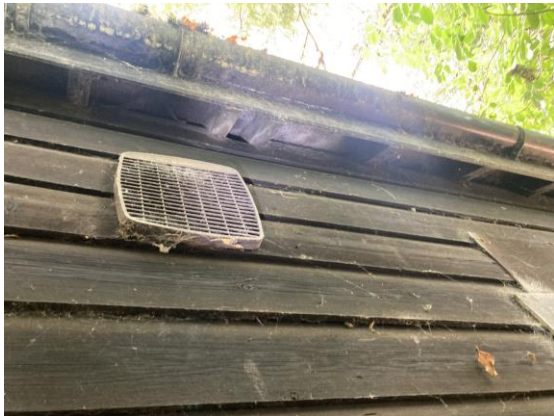
**Figure 17 - Gaps in the soffit.**

- 4.6 No roosts were identified within the onsite buildings during the PRA/emergence surveys. Therefore, a European Protected Species Licence (EPSL) for bats will not be required from Natural England. However, due to the large number of features present within the Scott's Gym building and the extensive use of the building by bats as a commuting feature, it is recommended that this building be removed under supervision of a bat licenced ecologist. And under precautionary working methods. The working methods will include a general inspection/ inspection of features for signs of use by bats immediately prior to demolition, using a endoscope to inspect hard to reach features where necessary.

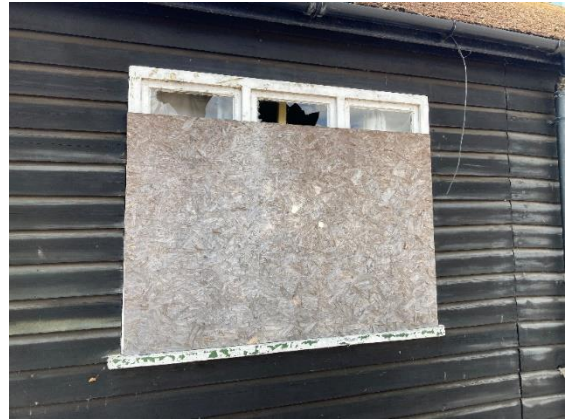
| Scott's gym | Tree line to southeast leading to river. Potential bee nest on southwest side. Wooden cladding in poor condition with holes and lifting panels. Bird droppings odour inside. Boarded windows. Broken window and cavity wall behind cladding. Moss-covered roof with few tile gaps. | Demolition |

**Figure 16 – Scott's Gym, broken window.**
