## **Ecological Impact Assessment**

Ansty Manor  
High Street  
Ansty  
Salisbury  
SP3 5QD

**January 2026**

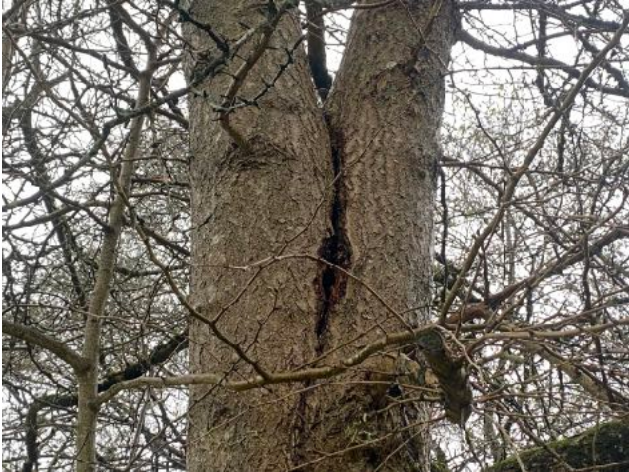
**Image 7:** Potential crevice suitable for bats in ginkgo tree in the northern side of the garden.

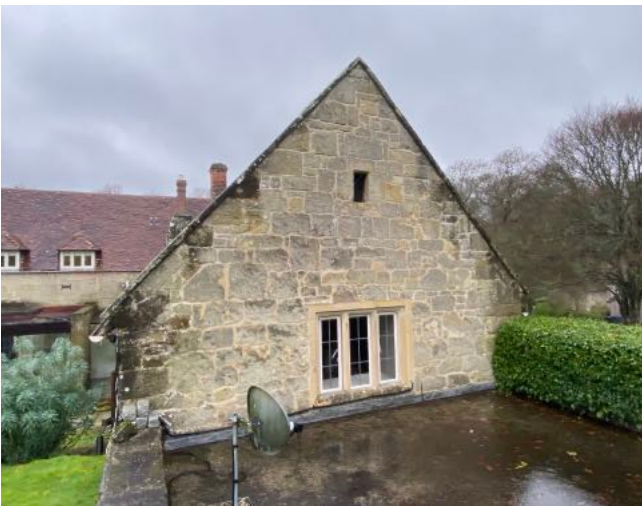
**Image 15:** Western gable end with meshed open window.

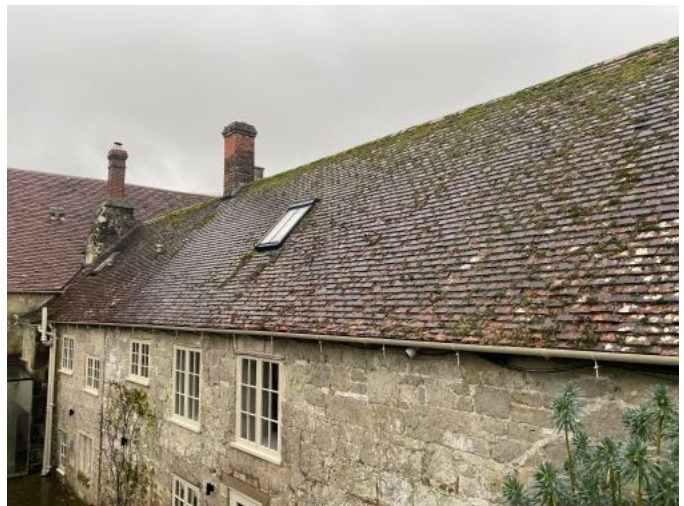
**Image 16:** Northern aspect of B2's roof.

- 5.19. B2 also had a brick tiled roof and one gable end on the western aspect. The roof was mostly in good condition with minimal slipped or damaged ridge or roof tiles. One missing

tile and potential crevice under a ridge tile was recorded on the southern aspect of B2 near the central chimney above the small loft void (L2). The verge tiles on the western gable were in good condition and the wooden soffit board was sealed apart from one crevice recorded on the northern aspect near L2 likely suitable for a crevice dwelling bat. An additional crevice was recorded on the north western corner of the western gable behind the guttering. Lead flashing throughout B2 was in good condition with minimal lifted edges, but one crevice was recorded on the small extension on the northern aspect near the entrance to the swimming pool room. The walls on B2 were in good condition with stonework and mortar having no suitable cracks or gaps.

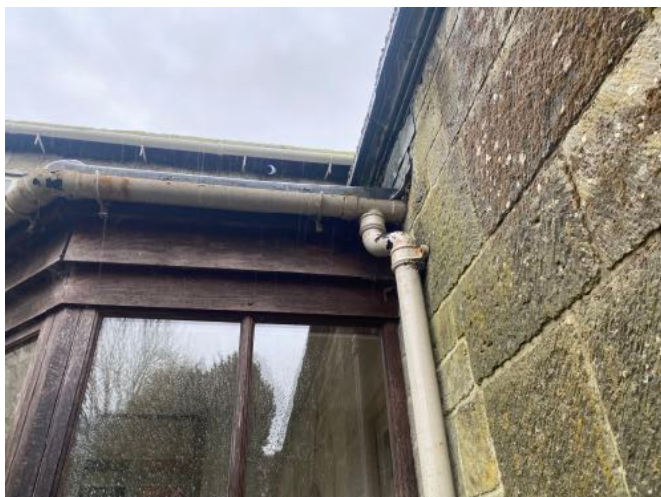
**Image 17:** Crevice under lead flashing of small extension connection B2 to the underground pool.

- 5.20. The walls around the pool entrance were in good condition with no entry points for bats. A small crevice was noted on the small extension connecting B2 to the underground pool. This was assessed as being too exposed for a bat.
- 5.21. A garage was adjoined to the western side of B2 and had a large section of ivy which may provide shelter or resting opportunities for bats and birds.

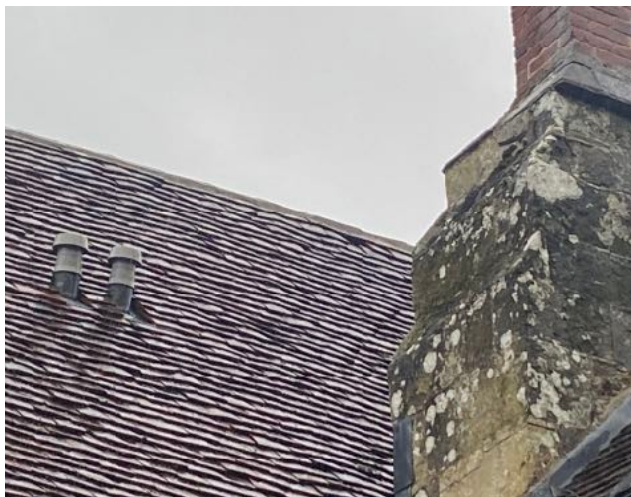
**Image 18:** Missing tile on western aspect of B1.

- 5.18. B1 had clay roof tiles and parapet walls on the gable ends made of stone. The roof was mostly in good condition, with minimal slipped or damaged tiles apart from on the south-western elevation where a missing tile was recorded by the ride, and near the dormer where another lifted tile was present. The lead flashing was in good condition with no potential roosting crevices recorded. The eaves had a wooden soffit board throughout and no suitable roost features were recorded behind the board. The walls and gable ends were made of stone, which was in good condition with no gaps or cracks suitable for bats to roost in the stonework or mortar.

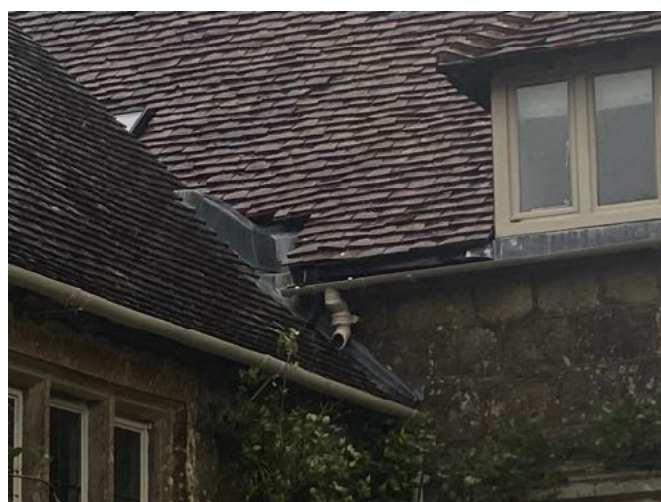
**Image 19:** Raised roof tiles on lower southwest aspect of B1.

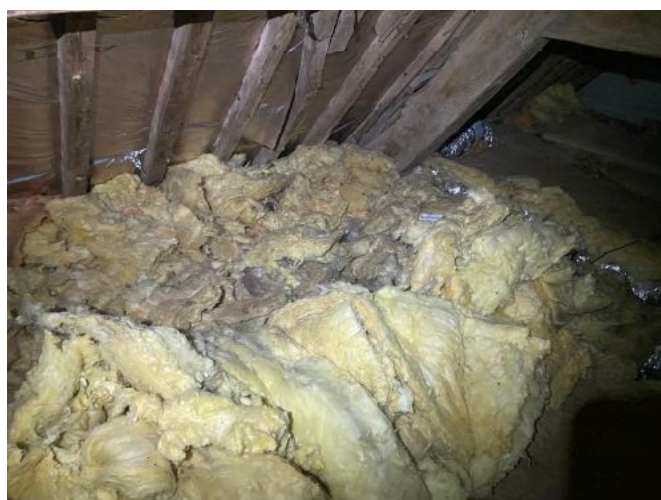
**Image 21:** Pile of old insulation towards the southern aspect of L1 where droppings were found.

- 5.22. The loft void in B1 on the eastern aspect (L1) had a traditional pitched wooden frame with large ties and hangars. The space was large and uncluttered (6m long x 4m wide x 2.5m apex). The roof insulation was fibreglass felt with aluminium foil and was in good condition with no light ingress recorded. Cobwebs and rodent droppings were recorded throughout the void particularly at the apex and on the south aspect. Two additional voids were recorded to the south and north aspects but these were not accessible. The floor was made

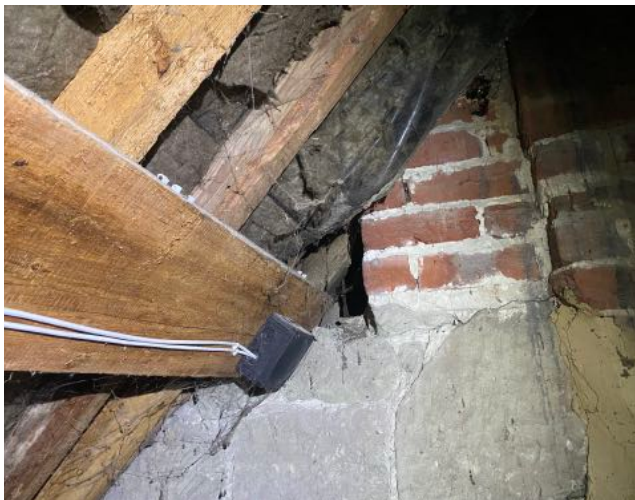
**Image 22:** Gap between eastern chimney and roof of L2.

- 5.23. Two loft voids were accessed in B2, with one being further east (L2) and the other towards the western gable end (L3). L2 had a wooden frame in a single pitch with fibreglass felt insulation (2m long x 3m wide x 2.5m apex). The insulation was in good condition with no crevices recorded. Cobwebs were present throughout the void, as well as rodent droppings and bat droppings. No light ingress or possible entrance points were recorded throughout the loft. There was a brick chimney with a lower stone wall on the eastern side in poor condition with areas of missing bricks or stones as well as gaps in the mortar with suitability as crevices. Gaps were also recorded behind the chimney stack and around the walls, potentially leading to crevices towards the eastern aspect.

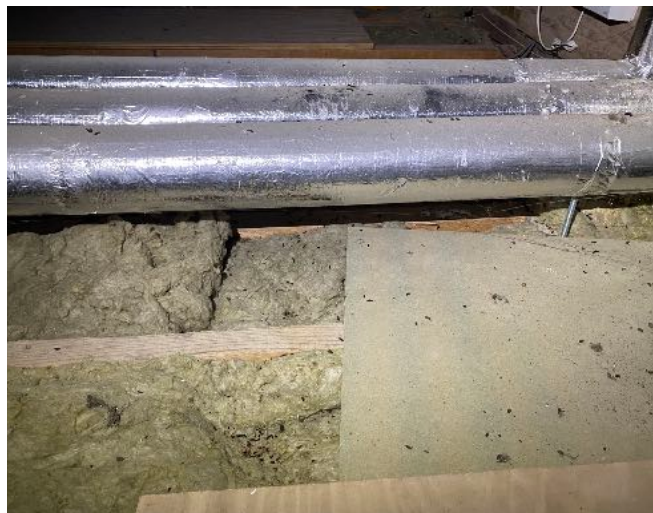
**Image 24:** Area of droppings within L2.

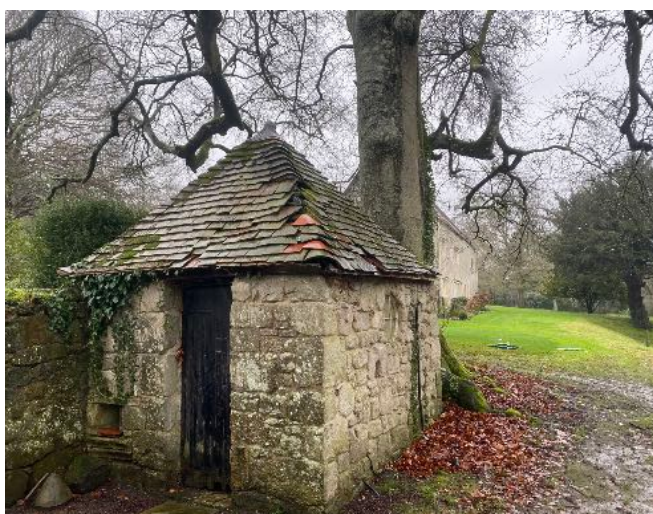
**Image 27:** South aspect of B4 with multiple missing / slipped roof tiles.

- 5.26. Two additional stone outhouses with slate roof tiles on the southern side of the site were inspected for evidence and suitability for bats. The first (B3) can be seen in **Image 25** and was inaccessible. The roof tiles were in good condition and no suitable crevice features or potential entry points were identified on the exterior of the building. **Image 27** shows the other outhouse (B4) with multiple missing / slipped tiles. After internal inspection no suitable entry points into the room through the plastic lined roof were identified. The internal space was cluttered and cobwebs were present. No evidence of bats was recorded within B3 or B4. B3 was assessed as having **negligible potential** to support roosting bats, while B4 had **low potential** due to the crevices under slipped and missing roof tiles.

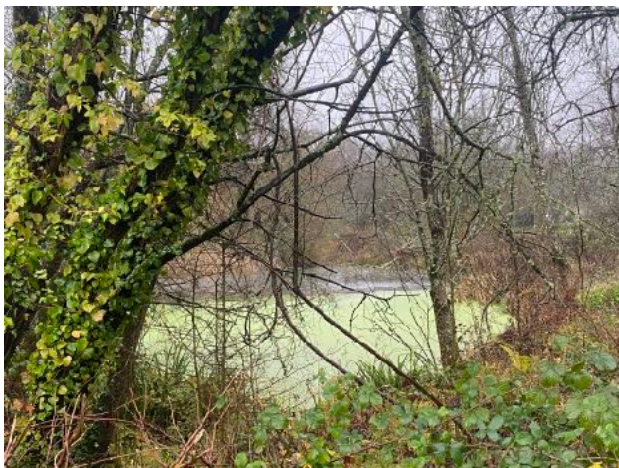
**Image 29:** View of P2 250m north from site with algae and surrounding scrub.

- 5.33. As such, P2 was assessed as HSI score 0.75, good. However P2 is located downstream from P1 and the barrier of a road between the ponds means migration of GCN from P2 to P1 is considered unlikely.

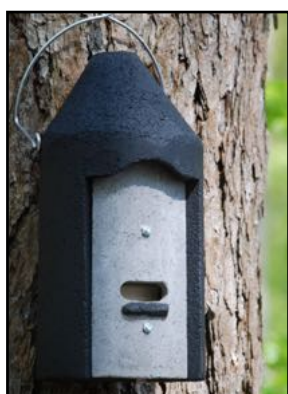
### Schwegler 2F Double Front Panel

- Manufactured from long-lasting woodcrete
- Lifetime - 20-25 years
- Suitable for pipistrelle and Myotis species
- A second inner wooden panel is fitted adjacent to the front panel imitating a cavity wall

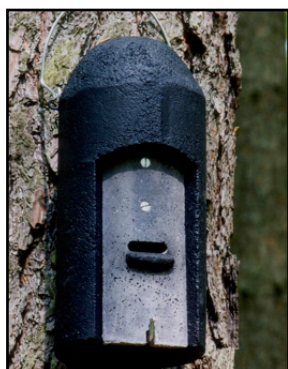
### Schwegler 1FD Double Front Panel

- Manufactured from long-lasting woodcrete
- Lifetime - 20-25 years
- Suitable for pipistrelle and Myotis species
- A second inner wooden panel is fitted adjacent to the front panel imitating a cavity wall
- Small entrance hole discourages birds from using the box

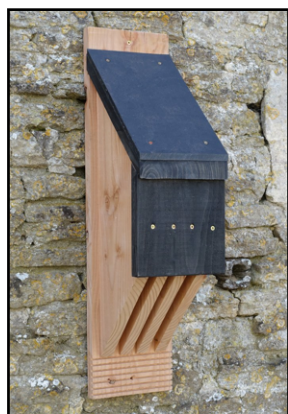
### Vincent Pro Bat Box

- Manufactured from timber and recycled plastic
- The front and the top of the box is black, which helps heat absorption
- Suitable for a range of species including pipistrelle species, Myotis species, and brown long-eared bats.
- No maintenance required

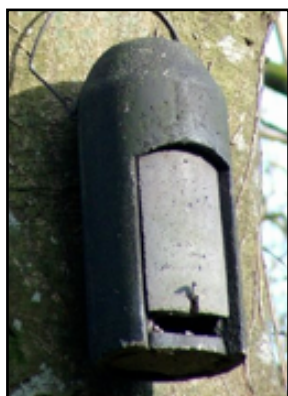
### Schwegler 2FN

- Manufactured from long-lasting woodcrete
- Lifetime - 20-25 years
- Suitable for pipistrelle species, Myotis species, serotine, brown long-eared, noctule and Leisler's bats
- Dual entrance
- Birds and dormice have also been found using this box
- A newer model is now available, Schwegler 3FN, designed with smaller entrance holes which discourage birds and dormice

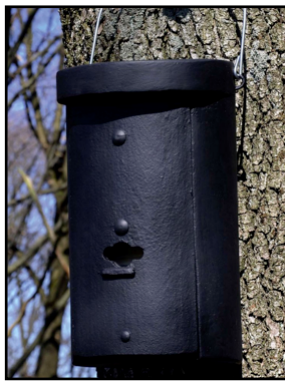
## Schwegler 1FS Large Colony Box

- Manufactured from long-lasting woodcrete
- Lifetime - 20-25 years
- Suitable for a range of bats including pipistrelle species, Myotis species, Noctule, and brown long-eared bats
- Three grooved inner wooden panels are connected to the front panel, which are ideal for bats to cling to.
- Accommodates large summer colonies

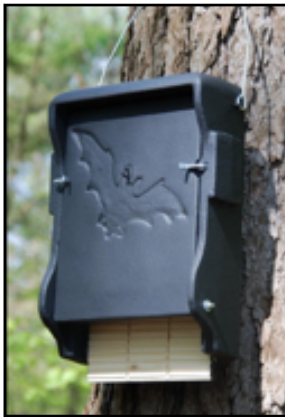
## Schwegler 1FF Colony Box

- Manufactured from long-lasting woodcrete
- Lifetime - 20-25 years
- Suitable for a range of crevice dwelling bats including pipistrelle species, barbastelle, noctule, and brown long-eared bats
- Rough wooden surface for bats to cling onto and climb
