**Nos 20-24 Market Place  
WARMINSTER  
Wiltshire**

**Emergency Repairs**

***Heritage Statement***

**Report reference: MH3921-3v1**

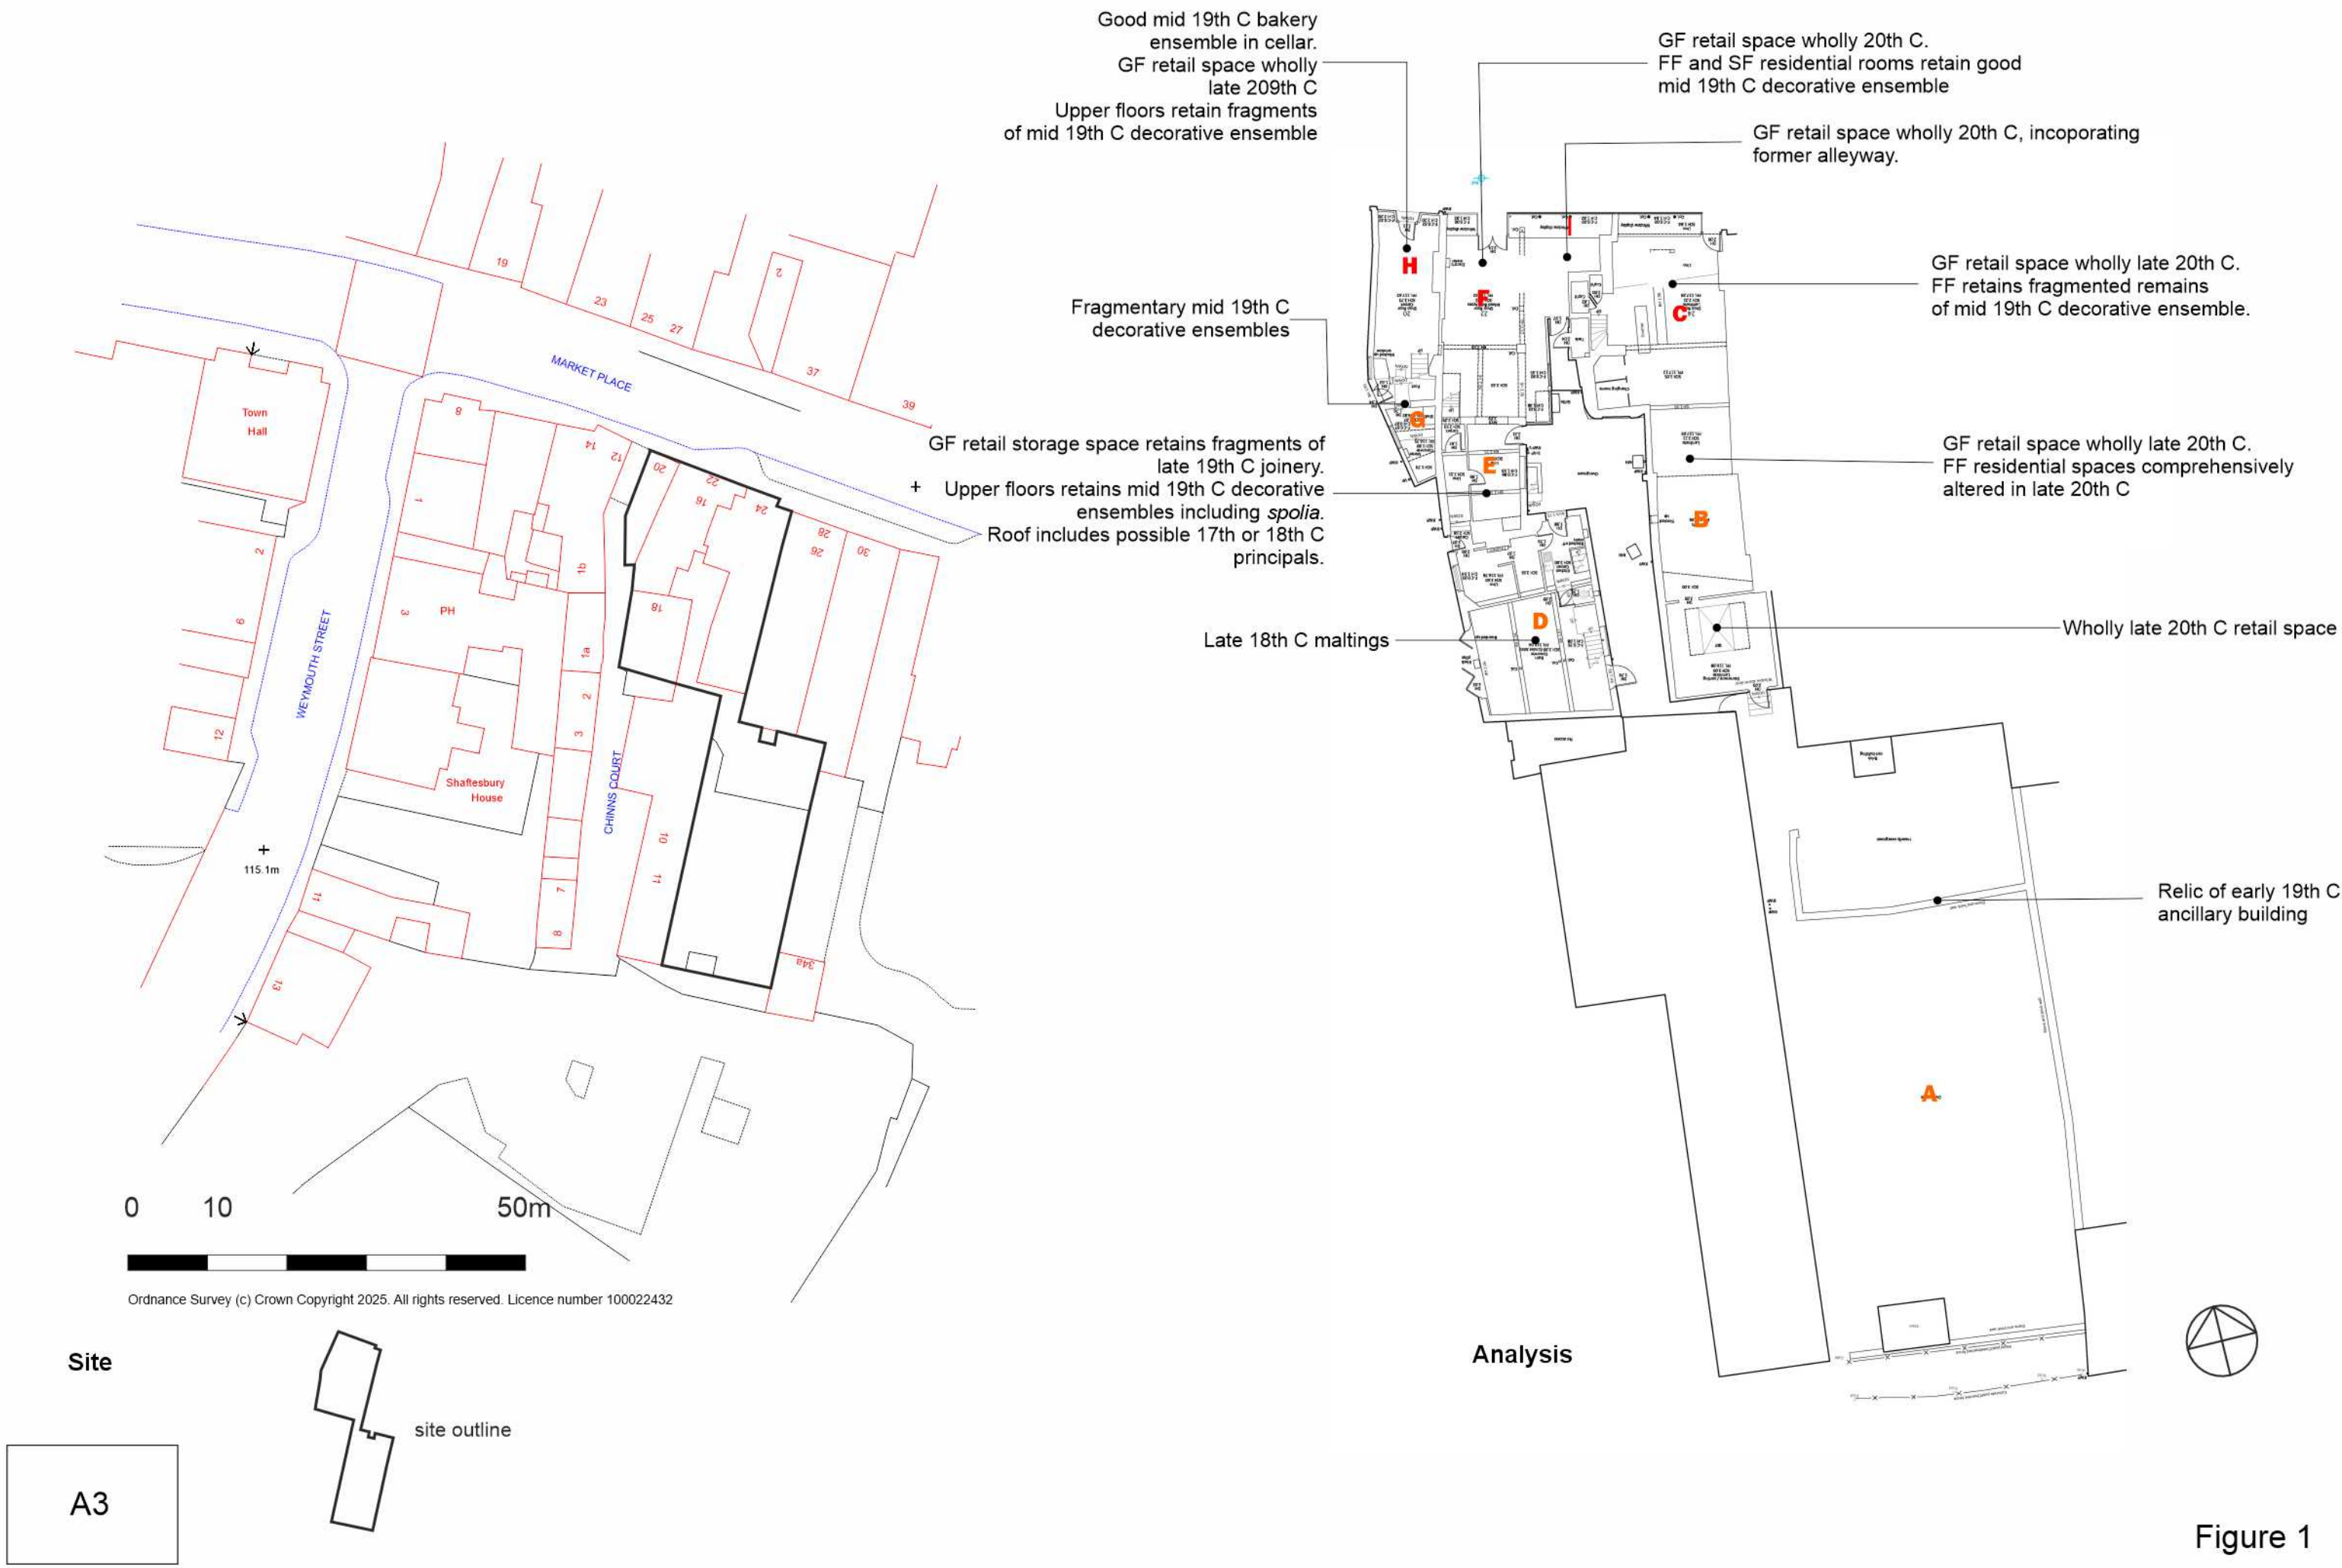
Figure 1

- 2.1.1 Nos 20-24 are three partially conjoined buildings on the south side of the Market Place in Warminster, close to its junction with Weymouth Street, centred on NGR 387478 / 145052. They are linear, multi-cell buildings of slightly irregular alignment that extend from The Market Place southwards to the Chinns Court public car park. For the purposes of this study only, the constituent structural cells of the three buildings are referred to here as Cells A-H, the dispositions of which are indicated on Figure 1, and their respective floor levels as -1, 0, 1 and 2 where '0' denotes the ground floor.

Figures 1 and 3.1-3.2

Figures 1 and 2

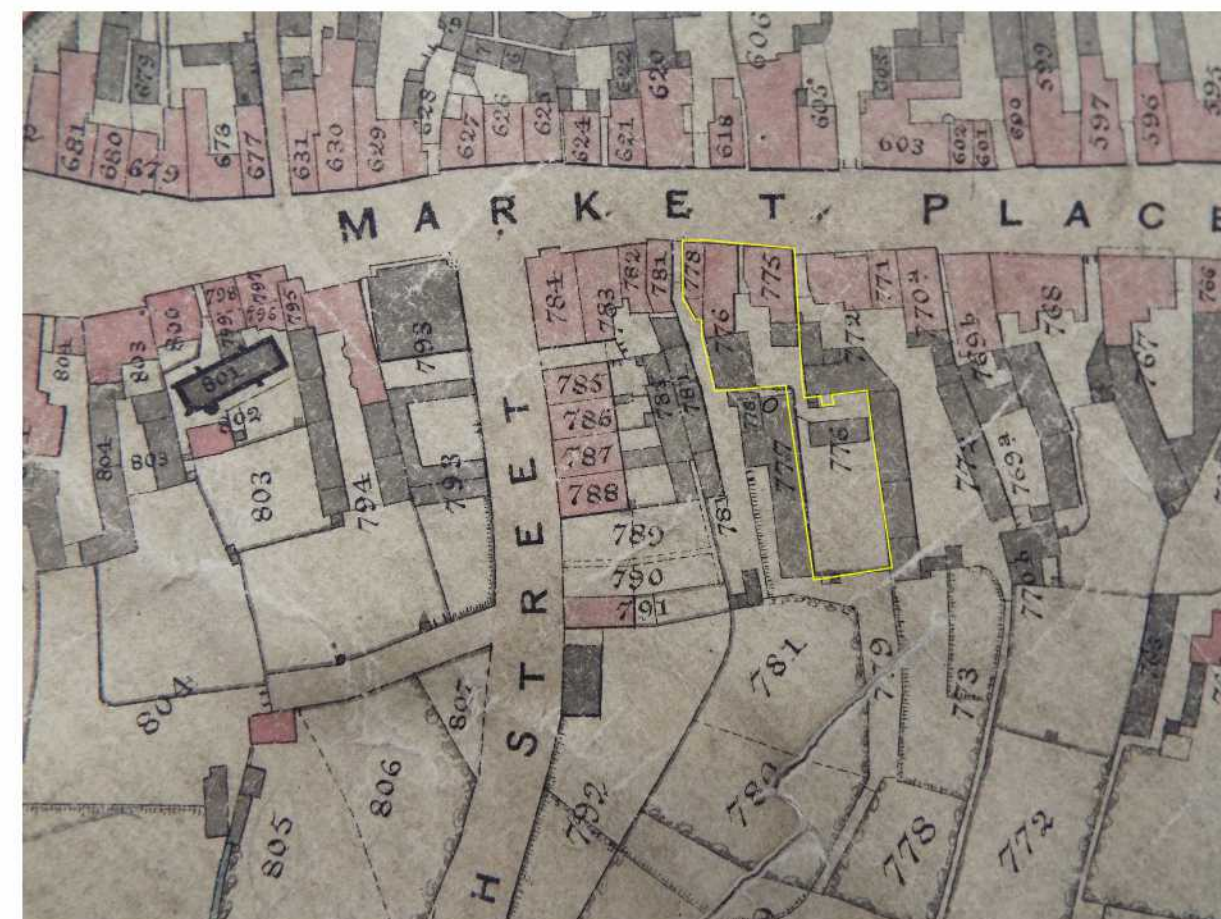
Figure 2

1783 Encklosure Survey (1850 copy)

1838 Poor Law Commissioners' Survey

1886 Ordnance Survey

1901 Ordnance Survey

1924 Ordnance Survey

- 3.1.1 Comparison of cadastral surveys reveals that the outlines, spatial density and use of the three buildings has changed since 1783.
- 3.1.2 On the 1783 survey, Cells H, F and C-B – the Market Place frontages – are toned yellow to indicate residences. The detail of Cells G and H is ambiguous, possibly indicating that Cell G did not exist at that time, or has been modified since then to create a tapered outline at its south end. There was an open passage between Cells F and C leading to a yard enclosed on its south, west and east sides. Cells D and E had slightly different outlines than today and were toned grey to indicate ancillary-trade use. Cell A was open ground – probably a garden.

- 3.1.3 By 1840, the Market Place frontages had been unified with a single building line slightly forward of the 1783 boundary. The tapered outline of Cell G had been created; Cell E had been incorporated within the residential space of Cell F – i.e. adapted for residential use – and the present broad outline of Cell D created; Cell B had been shortened and a detached structure had been constructed at the north end of what is now Cell A. The passage between Cells F and C remained and extended to what is now Cell A. The Market Place frontages – Cells G, H, F and C – were residential; the other structural cells were in ancillary-trade use and Cell A was probably a garden with an ancillary building – privies ?.

- 3.1.4 From c. 1886 onwards, the Ordnance Survey maps do not indicate building use, except in a few random instances, or structural divisions within demises. Nos 20, 22 and 24 are each shown with a simple outline. Nonetheless, the outline of Nos 20 and 22 (Cells G/H and D/E/F) appear to have been essentially as in 1840; the rear of No 24 (Cell B) had been extended slightly southwards; and the detached structure in Cell A had been added to on its south side and the basics of a garden layout created.

- 3.1.5 That layout remained essentially unchanged til at least 1924. After that date, the present southern end of Cell B was created and the detached structure within Cell A demolished, leaving only its south wall as a relic garden feature.

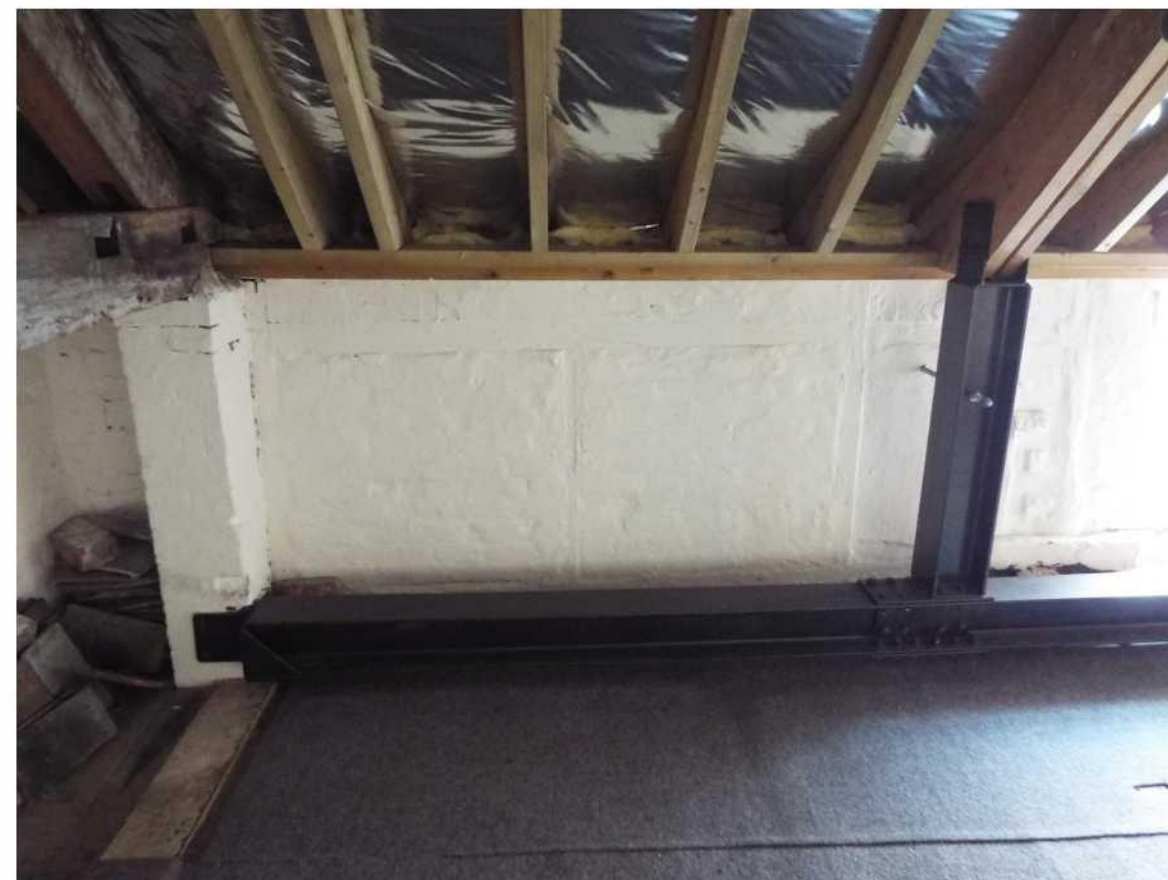
Cell 'B'. Roof structure.

- a. Retail space of No. 24. Northern third present in 1838 but rest built after 1838 on footprint of buildings shown in 1783 but demolished by 1838. Southern half built after 1924.
- b. Essentially a 20<sup>th</sup> C structure of no archaeological, historical or aesthetic significance, but retains isolated fragments of earlier – possibly 18<sup>th</sup> century - roof structure at northeast corner of B1.

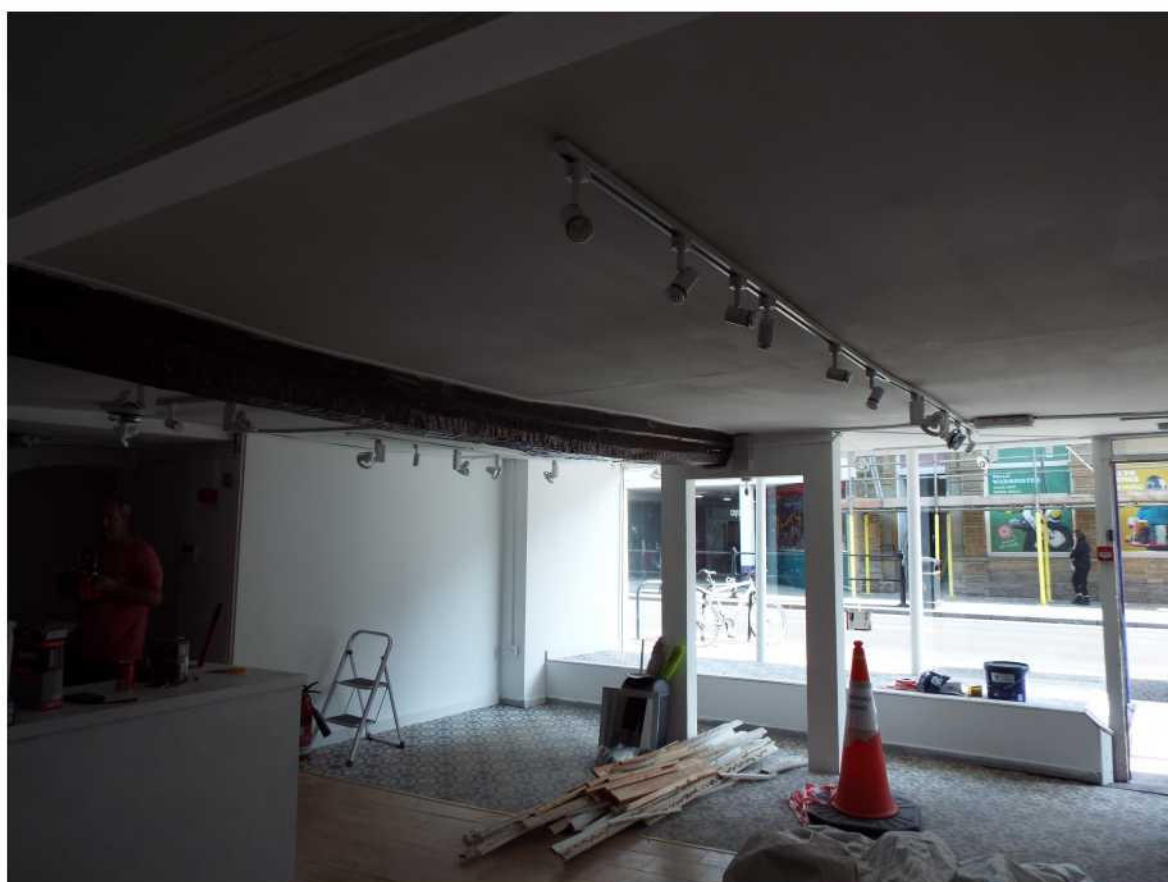
Cell 'C' retail space.

- a. Retail space of No. 24 with former domestic spaces above in C1. Present in 1783 and probably re-fronted and refurbished in 1836.
- b. Retail space and shop front are of wholly 20<sup>th</sup> C character and fabric of no archaeological, historical or aesthetic significance. Former domestic spaces above in C1 retain fragmented and butchered decorative scheme of mid 19<sup>th</sup> C date with 20<sup>th</sup> C insertions and steep roof structures above the stairwell that are probably of 18<sup>th</sup> century or earlier date.

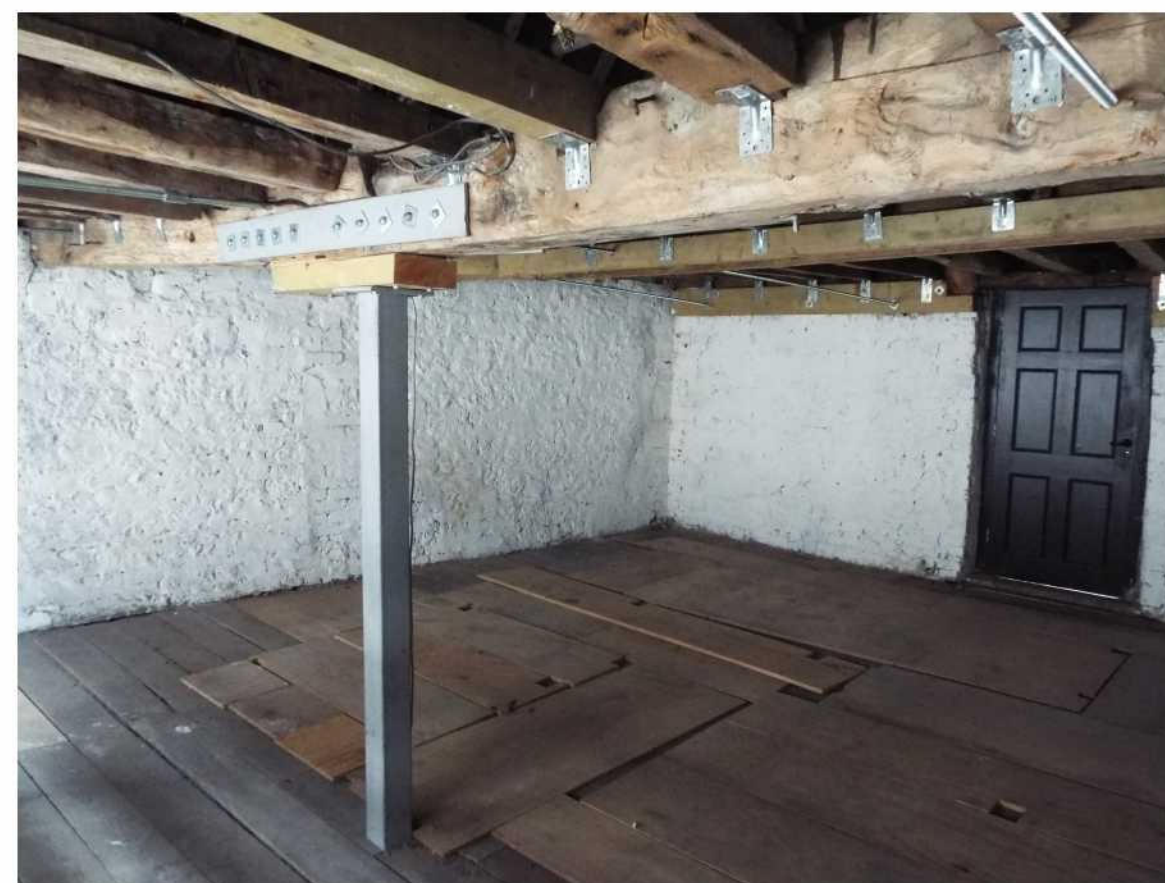
Cell 'D' first floor

- a. Redundant storage space that opens onto Chinns Court. Possibly present in 1783 but extended or rebuilt by 1838.

- b. Probably built as a maltings, as indicated by low ceiling height and window openings in east wall and possibly retaining the kiln enclosure in its northwest corner, but malting floors have been lost. Inserted door and window openings in west wall onto Chinns Court are of 20<sup>th</sup> C date, but it retains primary window openings in the east wall. This is of moderate archaeological and historical significance and the west elevation, though not aesthetic in the strict sense of the word, contributes to the vernacular charm of Chinns Court.

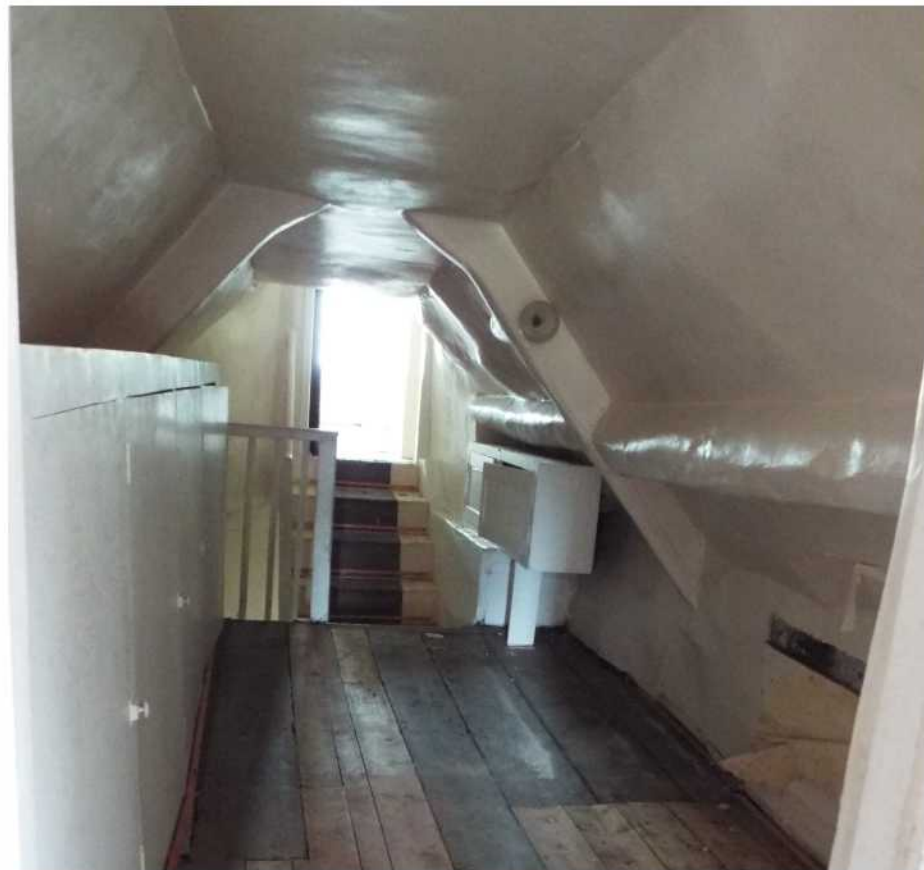
Cell 'E' 17th - 18th C roof structure

- a. Retail space with residential accommodation on two floors above and cellar below (not entered). Structural envelope created between 1783 and 1838 as an ancillary building, but present fabric incorporates late 17<sup>th</sup> – early 18<sup>th</sup> details as primary components used to lend the building an air of antiquity – i.e. *spolia* -, as well as a suite of early 19<sup>th</sup> C joinery.
- b. This is an archaeologically and historically complex structure of modest aesthetic significance as an exercise in early 19<sup>th</sup> C antiquarianism. Of particular interest are the mullioned stone window frames and their iron casements in the east wall, the salvaged 17<sup>th</sup> C cupboard door in E2, the early 19<sup>th</sup> C panelling and salvaged 17<sup>th</sup> C bolection fire surround in E1. The ground floor has been stripped of most historical details already.

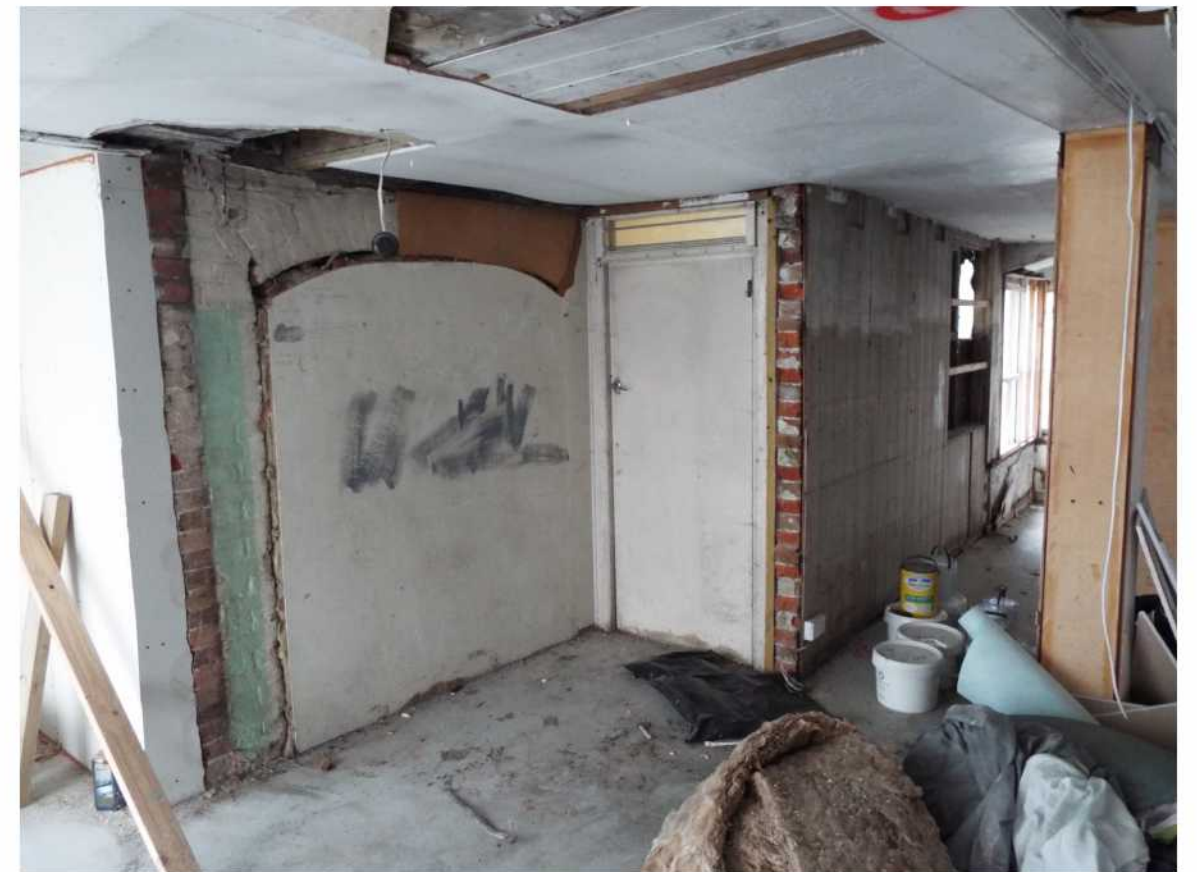
Cell 'F' retail space

- a. Retail space with residential accommodation on two floors above, including kitchen/bathroom cell oversailing former passage at the back, accessed via stairwell that forms a 'link block' between this and Cell E. Structural envelope present in 1783 and re-fronted in c. 1836, with steep-pitched roof structure of 17<sup>th</sup> – early 18<sup>th</sup> C form surviving in the 'link block' stairwell.

- b. Ground floor is a 20<sup>th</sup> C retail space stripped of all historical details, which has been extended eastwards into the shop front of No. 24 and incorporates an alley way that formerly ran between Nos 22 and 24 from Market Place to the rear of the plot and the residential entrance door of Cell E. The shop front is of wholly 20<sup>th</sup> century construction resting on a plinth of fletton bricks in OPC mortar. The first floor contains a complete suite of late 18<sup>th</sup> – early 19<sup>th</sup> C joinery and plasterwork in the main front room F1 together with pit-sawn elm floor joists, but the kitchen/bathroom cell and the floor coverings generally retain no historical fabric. The second floor is less decorative and incorporates salvaged window frames, as well as highly unusual forelock bolts through the front wall plate that the author has not seen before in this context, a steep-pitched roof structure of 17<sup>th</sup> or early 18<sup>th</sup> C form over the stairwell and elm floor boards. This is an archaeologically and historically complex structure of modest aesthetic significance.

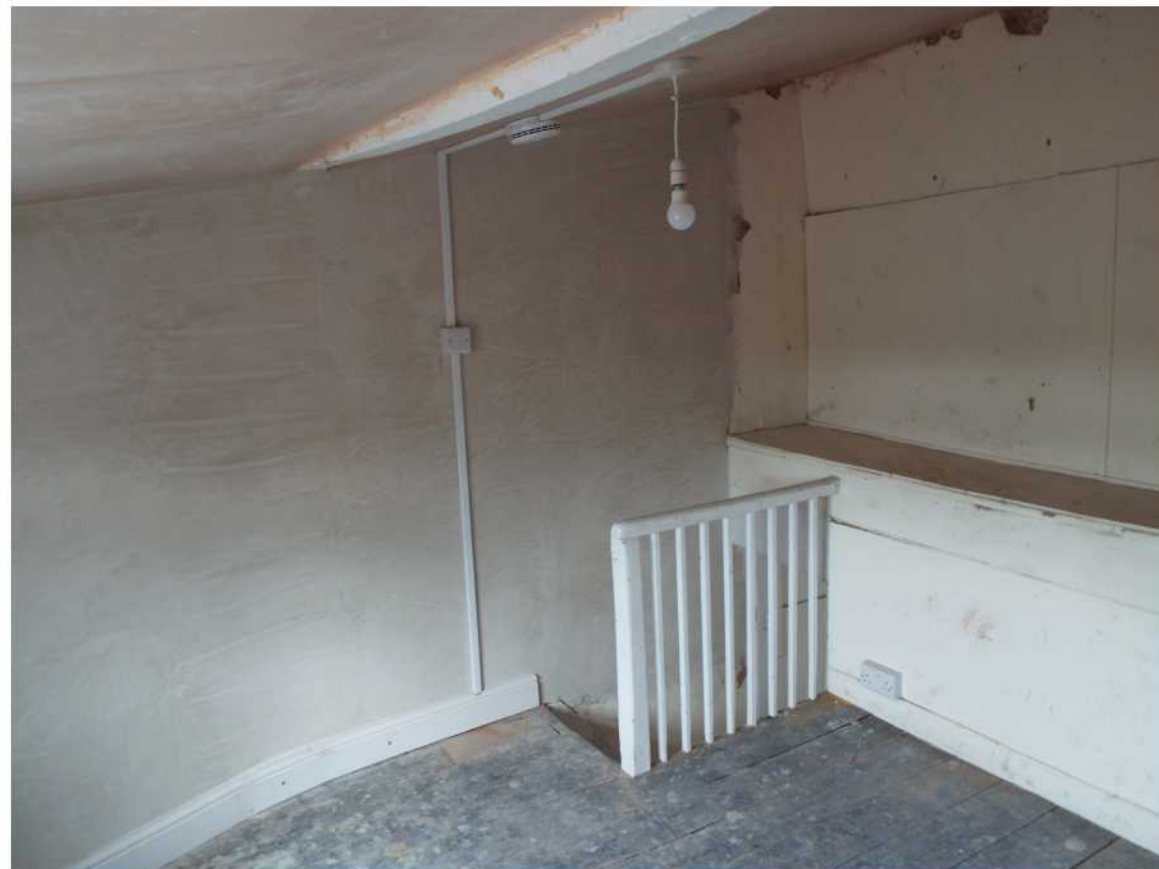
Cell 'G' 2nd floor

- a. Ancillary/stairwell space at the rear of No 20. Structural envelope created between 1783 and 1836.
- b. Contains small amount of 19<sup>th</sup> joinery and one re-used 18<sup>th</sup> C window frame, but the fabric is generally of 20<sup>th</sup> C date and of no archaeological, historical or aesthetic merit.

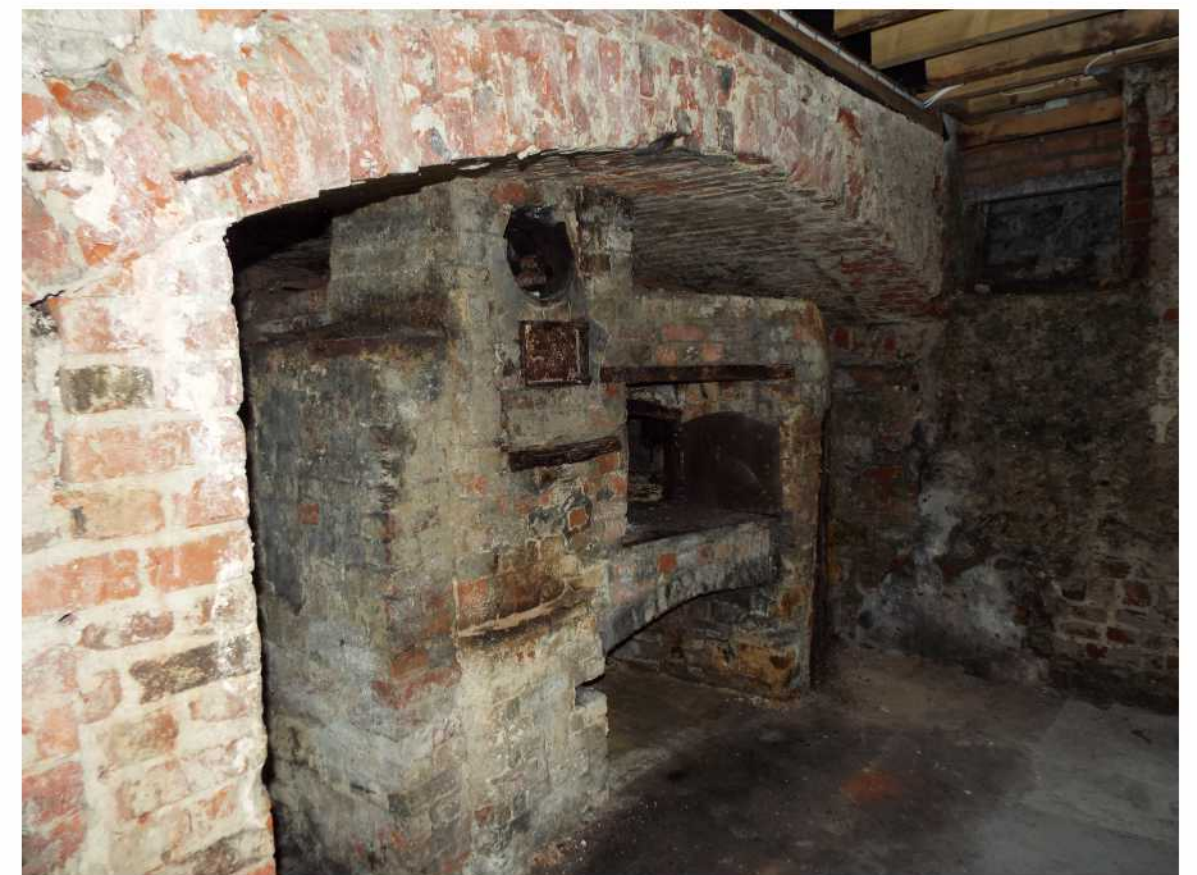
Cell 'H' oven ensemble in cellar

- b. Cellar contains an outstanding suite of domestic and commercial cooking facilities, together with mid 19<sup>th</sup> C joinery and is likely to have served as a commercial bakery in the later 19<sup>th</sup> century, but the floor above and supporting masonry have been comprehensively rebuilt in late 20<sup>th</sup> C which robs the ensemble of some of its historical character. Ground floor is a 20<sup>th</sup> C retail space lacking historical details except the **form** of the shop front; first floor is a 20<sup>th</sup> C retail space retaining elements of an incomplete suite of mid 19<sup>th</sup> C joinery; second floor is residential accommodation containing a more or less complete suite of mid 19<sup>th</sup> C joinery including staircases and salvaged door leaves but the spatial integrity has been compromised by a 20<sup>th</sup> C kitchen/bathroom enclosure; third floor lacks all historical fabric except the structural envelope.
