# **Stage 1: Tier 2 Site Investigation GQRA**

Project Reference: P23.207.GQRA.03  
**Former Honda Garage, Chippenham**

**Padlock Chippenham South Limited**

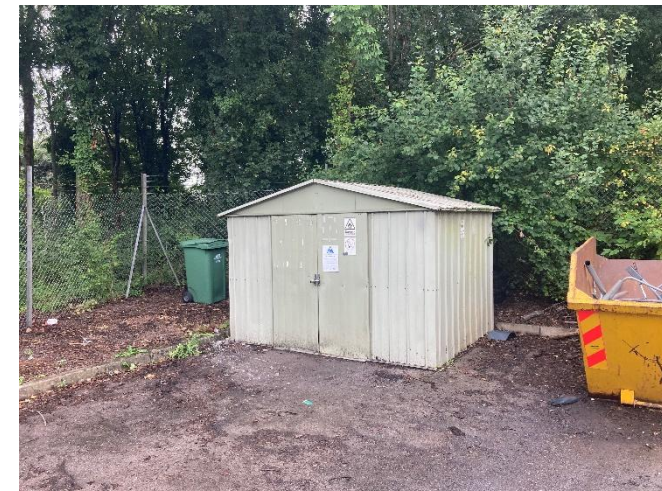
4.

| <b>Job Number:</b> | P23.207 | 1. Existing site<br>2. Existing site<br>3. Existing site<br>4. Fuel storage shed | | <b>IMPACT</b><br><b>GEO</b> TECHNICAL<br>Impact Geotechnical Limited<br><a href="http://www.impactgeo.co.uk">www.impactgeo.co.uk</a> |

An oil/fuel tank (Above-ground Storage Tank – AST) was located at the north-eastern elevation of the commercial building, just within the staff parking/garage area. This was approximately 1m<sup>3</sup> in volume, and supported/raised on concrete blocks; during the investigation it was mostly empty with some staining around the inlets/outlets. There was no other evidence of either underground or above-ground storage tanks during the investigation.

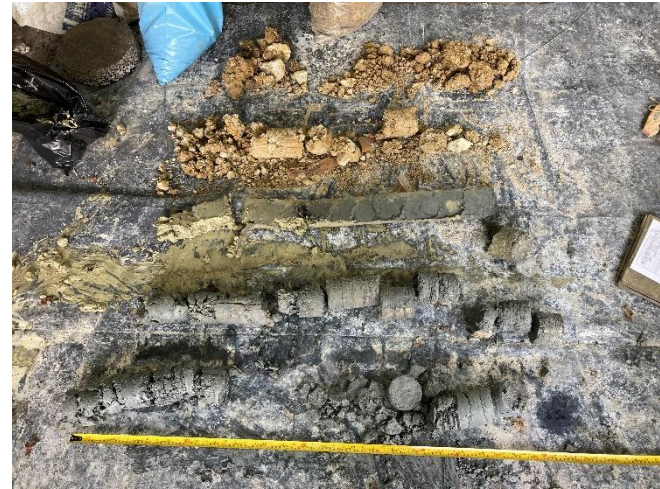
6.

| <b>Job Number:</b> | P23.207 | 5. BH1<br>6. BH1 1.00m to 6.50mbgl<br>7. BH1 11.00m to 15.00mbgl<br>8. BH1 monitoring well installation | |

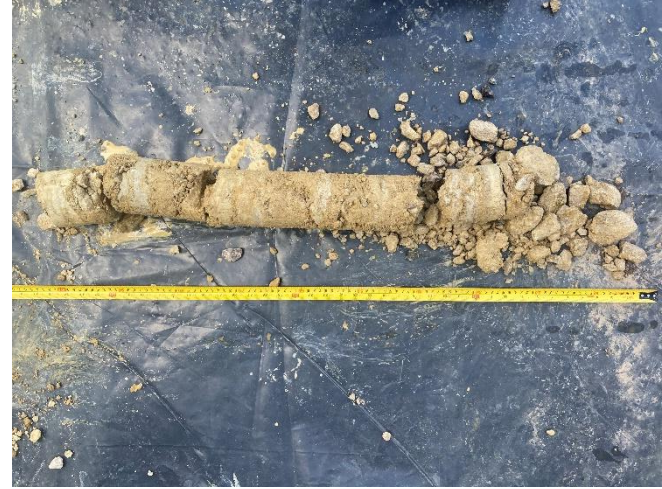
10.

| <b>Job Number:</b> | P23.207 | 9. BH2<br>10. BH2 1.00m to 2.00mbgl<br>11. BH2 2.00m to 4.00mbgl<br>12. BH2 monitoring well installation | | <b>IMPACT</b><br><b>GEO</b> TECHNICAL<br>Impact Geotechnical Limited<br><a href="http://www.impactgeo.co.uk">www.impactgeo.co.uk</a> |

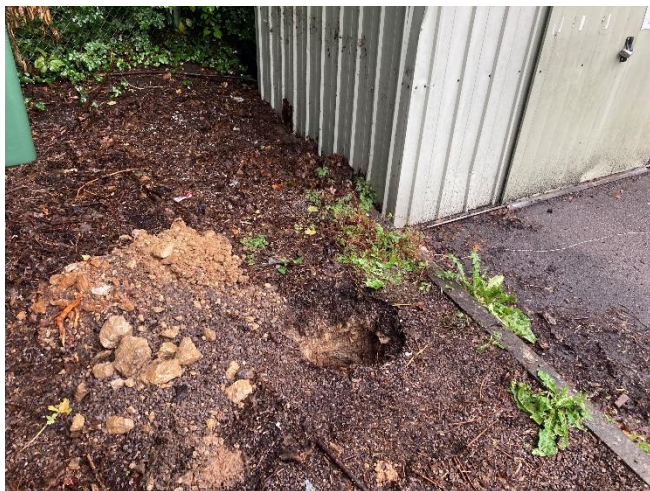
| Job Number: | P23.207 | 21. TP4 in relation to fuel storage shed<br>22. Inspection pits<br>23. Garage<br>24. Staining on ground | | <b>IMPACT</b><br>GEOTECHNICAL<br>Impact Geotechnical Limited<br><a href="http://www.impactgeo.co.uk">www.impactgeo.co.uk</a> |

| Hole ID | Type | Location | Rationale |
|---|---|---|---|
| TP4 | | Adjacent to fuel storage area. | To determine if any leaks/spills have occurred at the fuel storage. Feature not included with Preliminary |

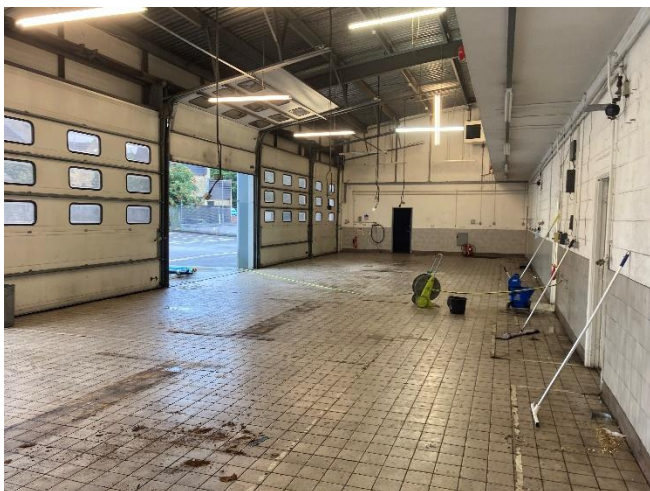
23.

At the time of the investigation, the internal areas of both the car dealership and garage had been recently cleared and the building left mostly empty. However, evidence of garage use was present: staining around suspected vehicle lifters, some hydrocarbon sheening on the ground, inspection pit at one side of the building, the occasional abandoned fuel can (empty). The garage has a mezzanine floor, which was believed to have been used to store office equipment for the car dealership. The surface of both the internal areas to the car dealership and garage was hardstanding.
