# PRELIMINARY ROOST APPRAISAL REPORT

COPPICE DELL, 2 CHURCH LANE,  
LIMPLEY STOKE, WILTSHIRE

stark ecology<sup>ltd</sup>

FEBRUARY 2026

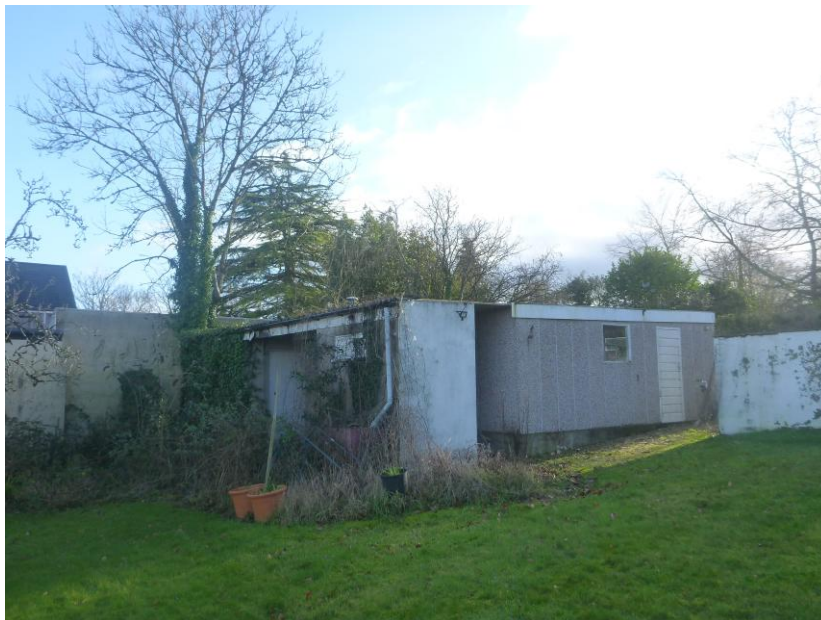
**Fig 2:** The garage at Coppice Dell.

The garage at Coppice Dell is a single storey building which has prefabricated cement panel walls and an unlined corrugated cement fibre roof which has a shallow mono-pitch. The roof panels are sealed to the walls with a metal fascia board.

This photo taken facing southeast on 27<sup>th</sup> January 2026.

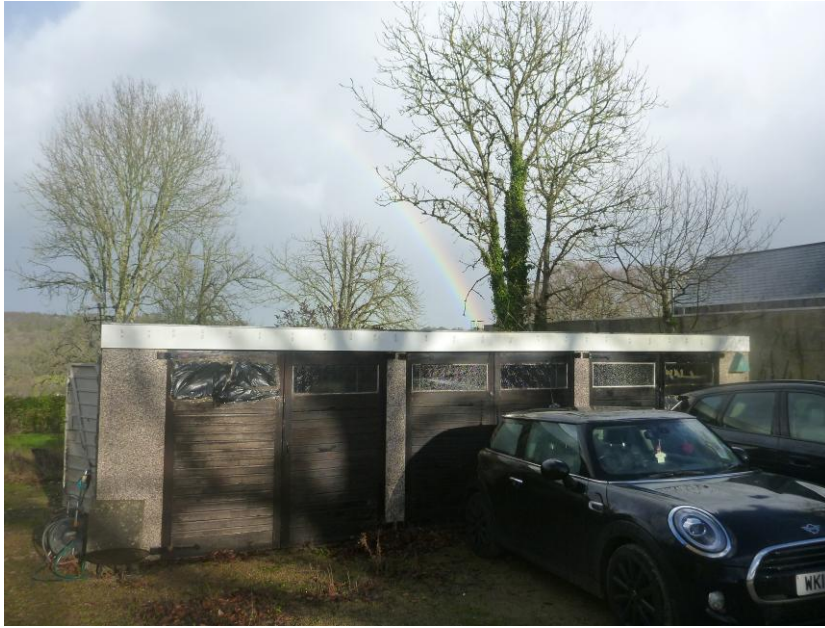
**Fig 3:** Doors on the southern face of the garage are kept closed and secured.

Vehicular access to the garage is through timber doors which include glass panels. These doors are not in regular use and are kept closed and secured.

This photo taken facing north on 27<sup>th</sup> January 2026.

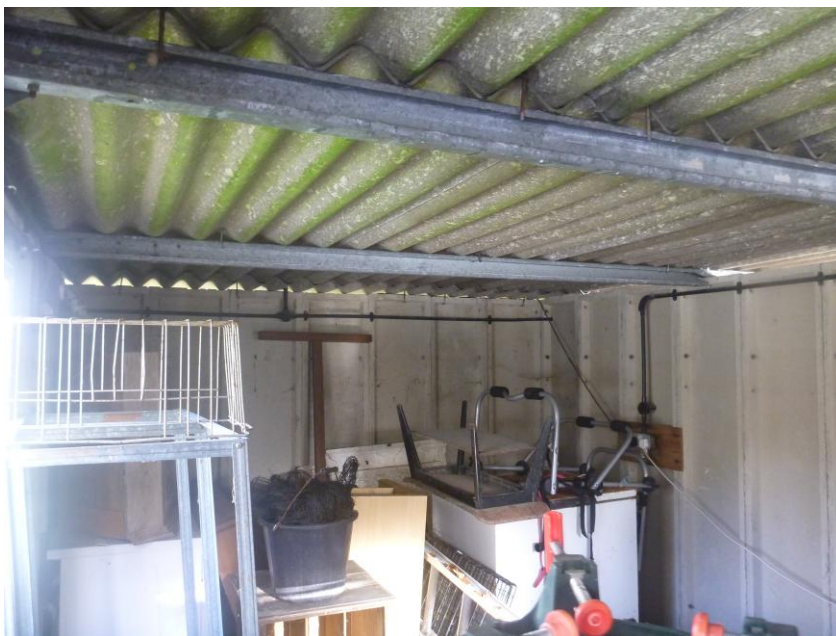
**Fig 4:** All internal areas of the garage are disturbed by daylight.

Internally the garage is disturbed by daylight between sunrise and sunset and there are no crevices or other areas inside the building that are not disturbed by the ingress of light.

There is no direct access to internal areas of the garage as doors are kept closed and secured. Windows allow daylight to penetrate all areas of the building. All areas of the garage were accessible to the surveyor at the time of this survey and no evidence of bats was found in any area.

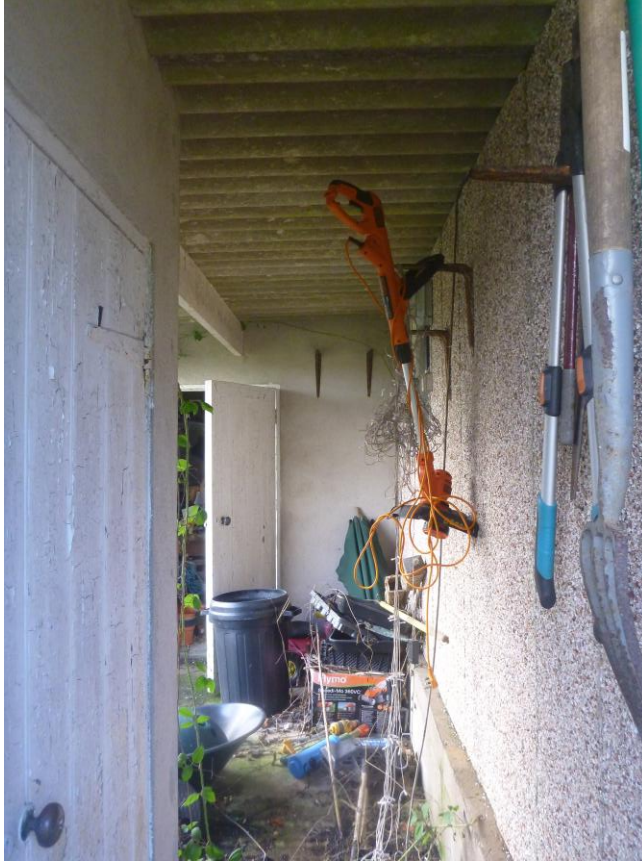
**Fig 5:** There is an open alcove on the northern face of the garage.

At the rear of the building is an open alcove area with a concrete pad base and with an overhang of the unlined corrugated cement fibre roof. This area of the building is open to the elements and provides no shelter from daylight, wind or the ingress of rain.

Externally the garage at Coppice Dell is well sealed with no gaps identified in the walls and no crevices identified in the roof or where the roof and walls join which could be used by roosting bats. The alcove to the rear of the garage was carefully considered as it is open, allowing fly-in access, but there is no shelter in this area from daylight, wind or rain and so having been fully inspected, it was concluded that this area of the building would not provide suitable shelter for bats (including as a night roost or feeding perch).

Most of the garage building does not provide opportunities for nesting birds as there is no fly-in access. The alcove to the rear is accessible for nesting but no evidence of use by nesting birds was found here.

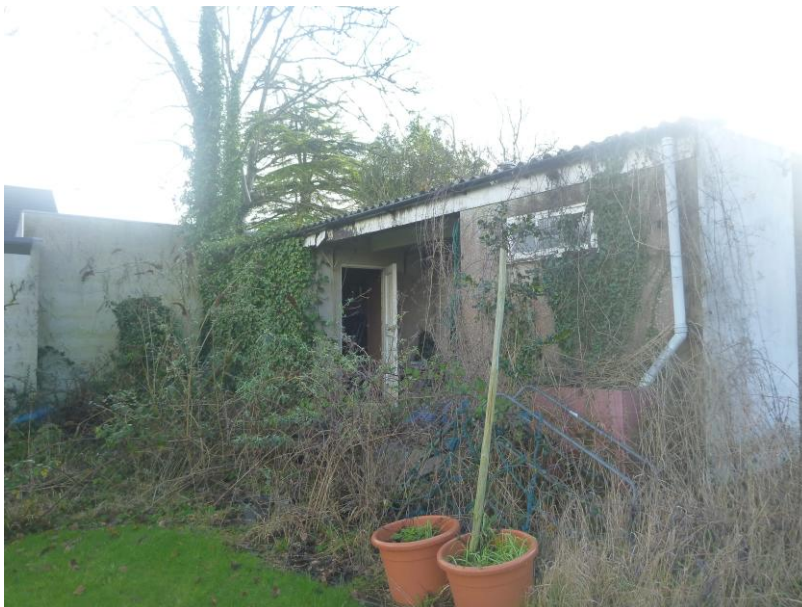
**Fig 6:** The rear of the garage is covered in ivy.

To the rear of the garage the building is covered in ivy *Hedera helix* and there is bramble *Rubus fruticosus* agg. and buddleia *Buddleia davidii* to the north and east of the building. There is a triple stemmed ash *Fraxinus excelsior* tree at the northeastern corner of the building.

The ivy which covers the northern part of the building is potentially suitable for nesting birds to use, as is the bramble and buddleia scrub.

The bramble, buddleia and ivy adjacent to the garage are suitable for nesting birds and removal of this vegetation should avoid the active nesting season (March to August, inclusive).

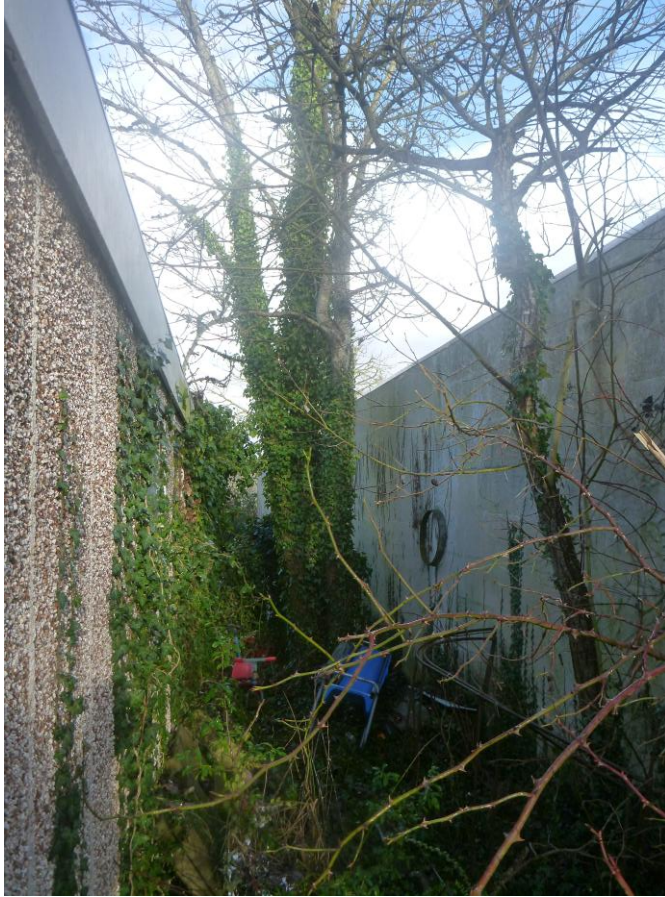
**Fig 7:** There is scrub to the east of the garage and a triple-stemmed ash tree.

An ivy-covered ash tree at the north east corner of the garage does not support any features which could be used by roosting bats and the ivy is not dense enough to be used for this purpose.
