| Site | Albert Cottages,<br>43-45 London Road,<br>Chippenham SN15 3AJ | Date | 13.01.2026 |
| | | Sheet | 25-3076-B D03 REV 01 |
| | | Job | Repaired of front garden wall |

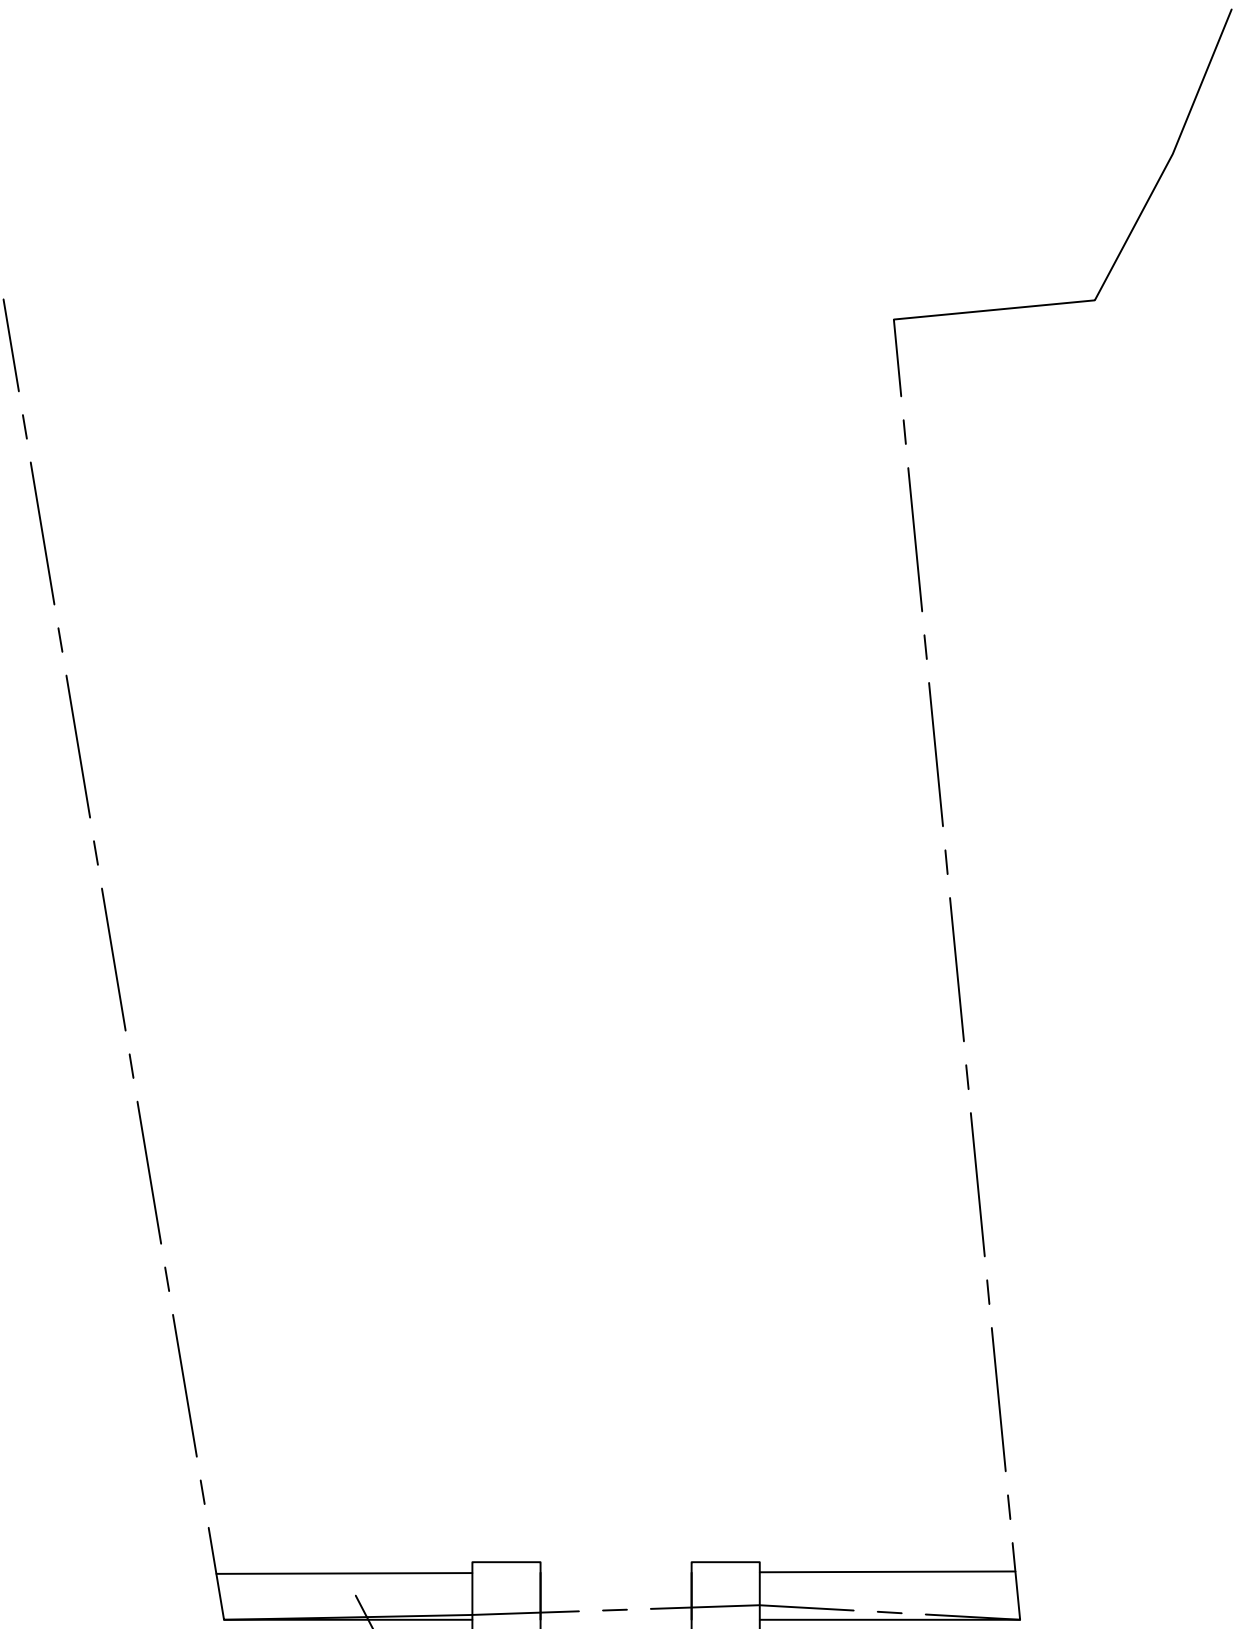
Proposed Plan

Due to gaps in the top coping stones & bulging of the existing wall structure, it has lead to leaks and structural damage.  
The wall leaf will need to be repaired/rebuilt using the existing stone but making it vertical (straight again).  
The use of mortar will be incorporated, in replace of the cement base pointing that has been done over the years.

The works will be carried out with minimal disruption to the existing fabric of the dwelling and with no alterations to the external appearance of the Listed Building.

Any repairs to the existing fabric of the wall will be carried out using lime mortars and where the existing fabric is damaged, this will be carefully renovated using traditional methods.

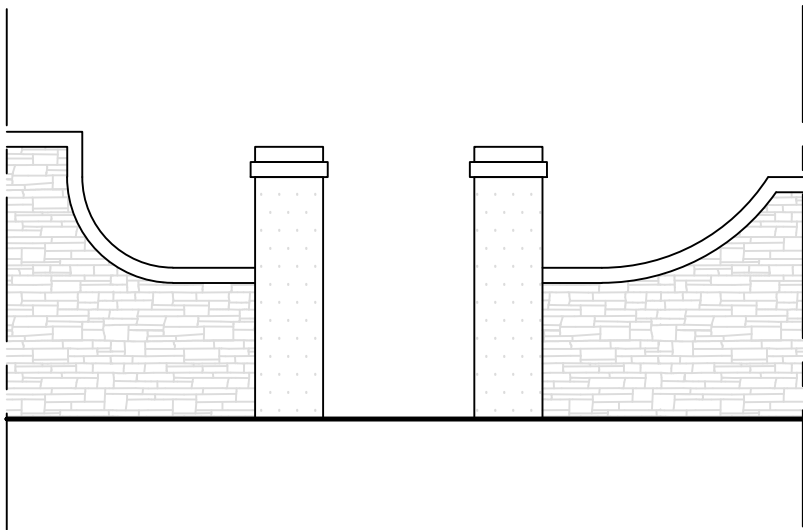
Existing Southwest Elevation

Due to gaps in the top coping stones & bulging of the existing wall structure, it has lead to leaks and structural damage.  
The wall leaf will need to be repaired/rebuilt using the existing stone but making it vertical (straight again).  
The use of mortar will be incorporated, in replace of the cement base pointing that has been done over the years.

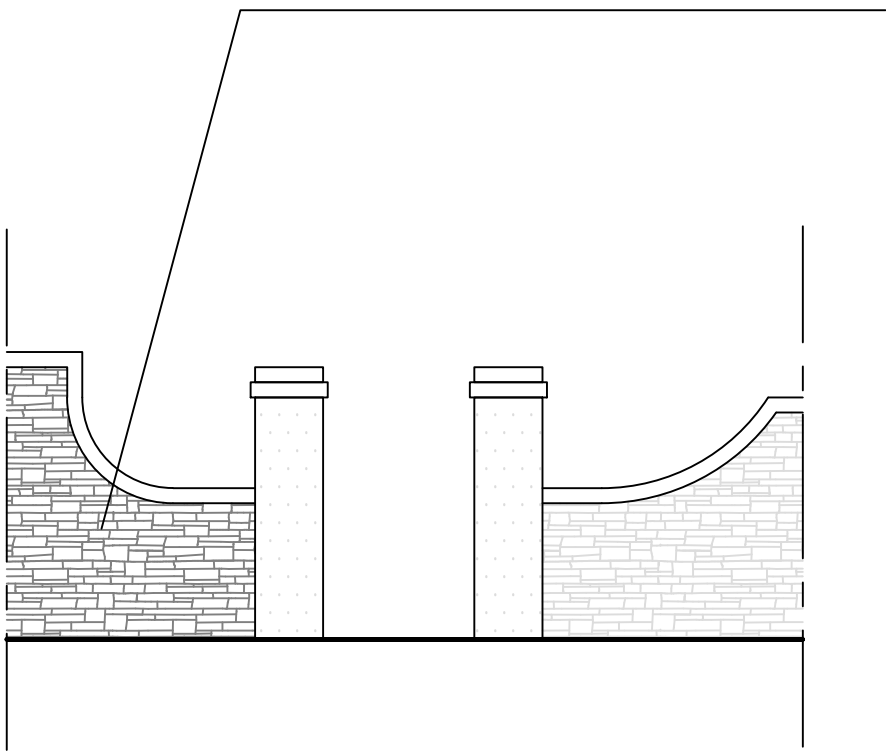
Proposed Southwest Elevation

The works will be carried out with minimal disruption to the existing fabric of the dwelling and with no alterations to the external appearance of the Listed Building.

Any repairs to the existing fabric of the wall will be carried out using lime mortars and where the existing fabric is damaged, this will be carefully renovated using traditional methods.
