**CHARLIE'S PLACE, LAND OFF SODOM LANE,  
GRITTENHAM, ROYAL WOOTTON BASSETT,  
WILTSHIRE, SN15 4JY.**

**ARBORICULTURAL METHOD STATEMENT  
FOR  
GYPSY SITE DEVELOPMENT**

**Project Reference: 25.2001**

**SEPTEMBER 2025**

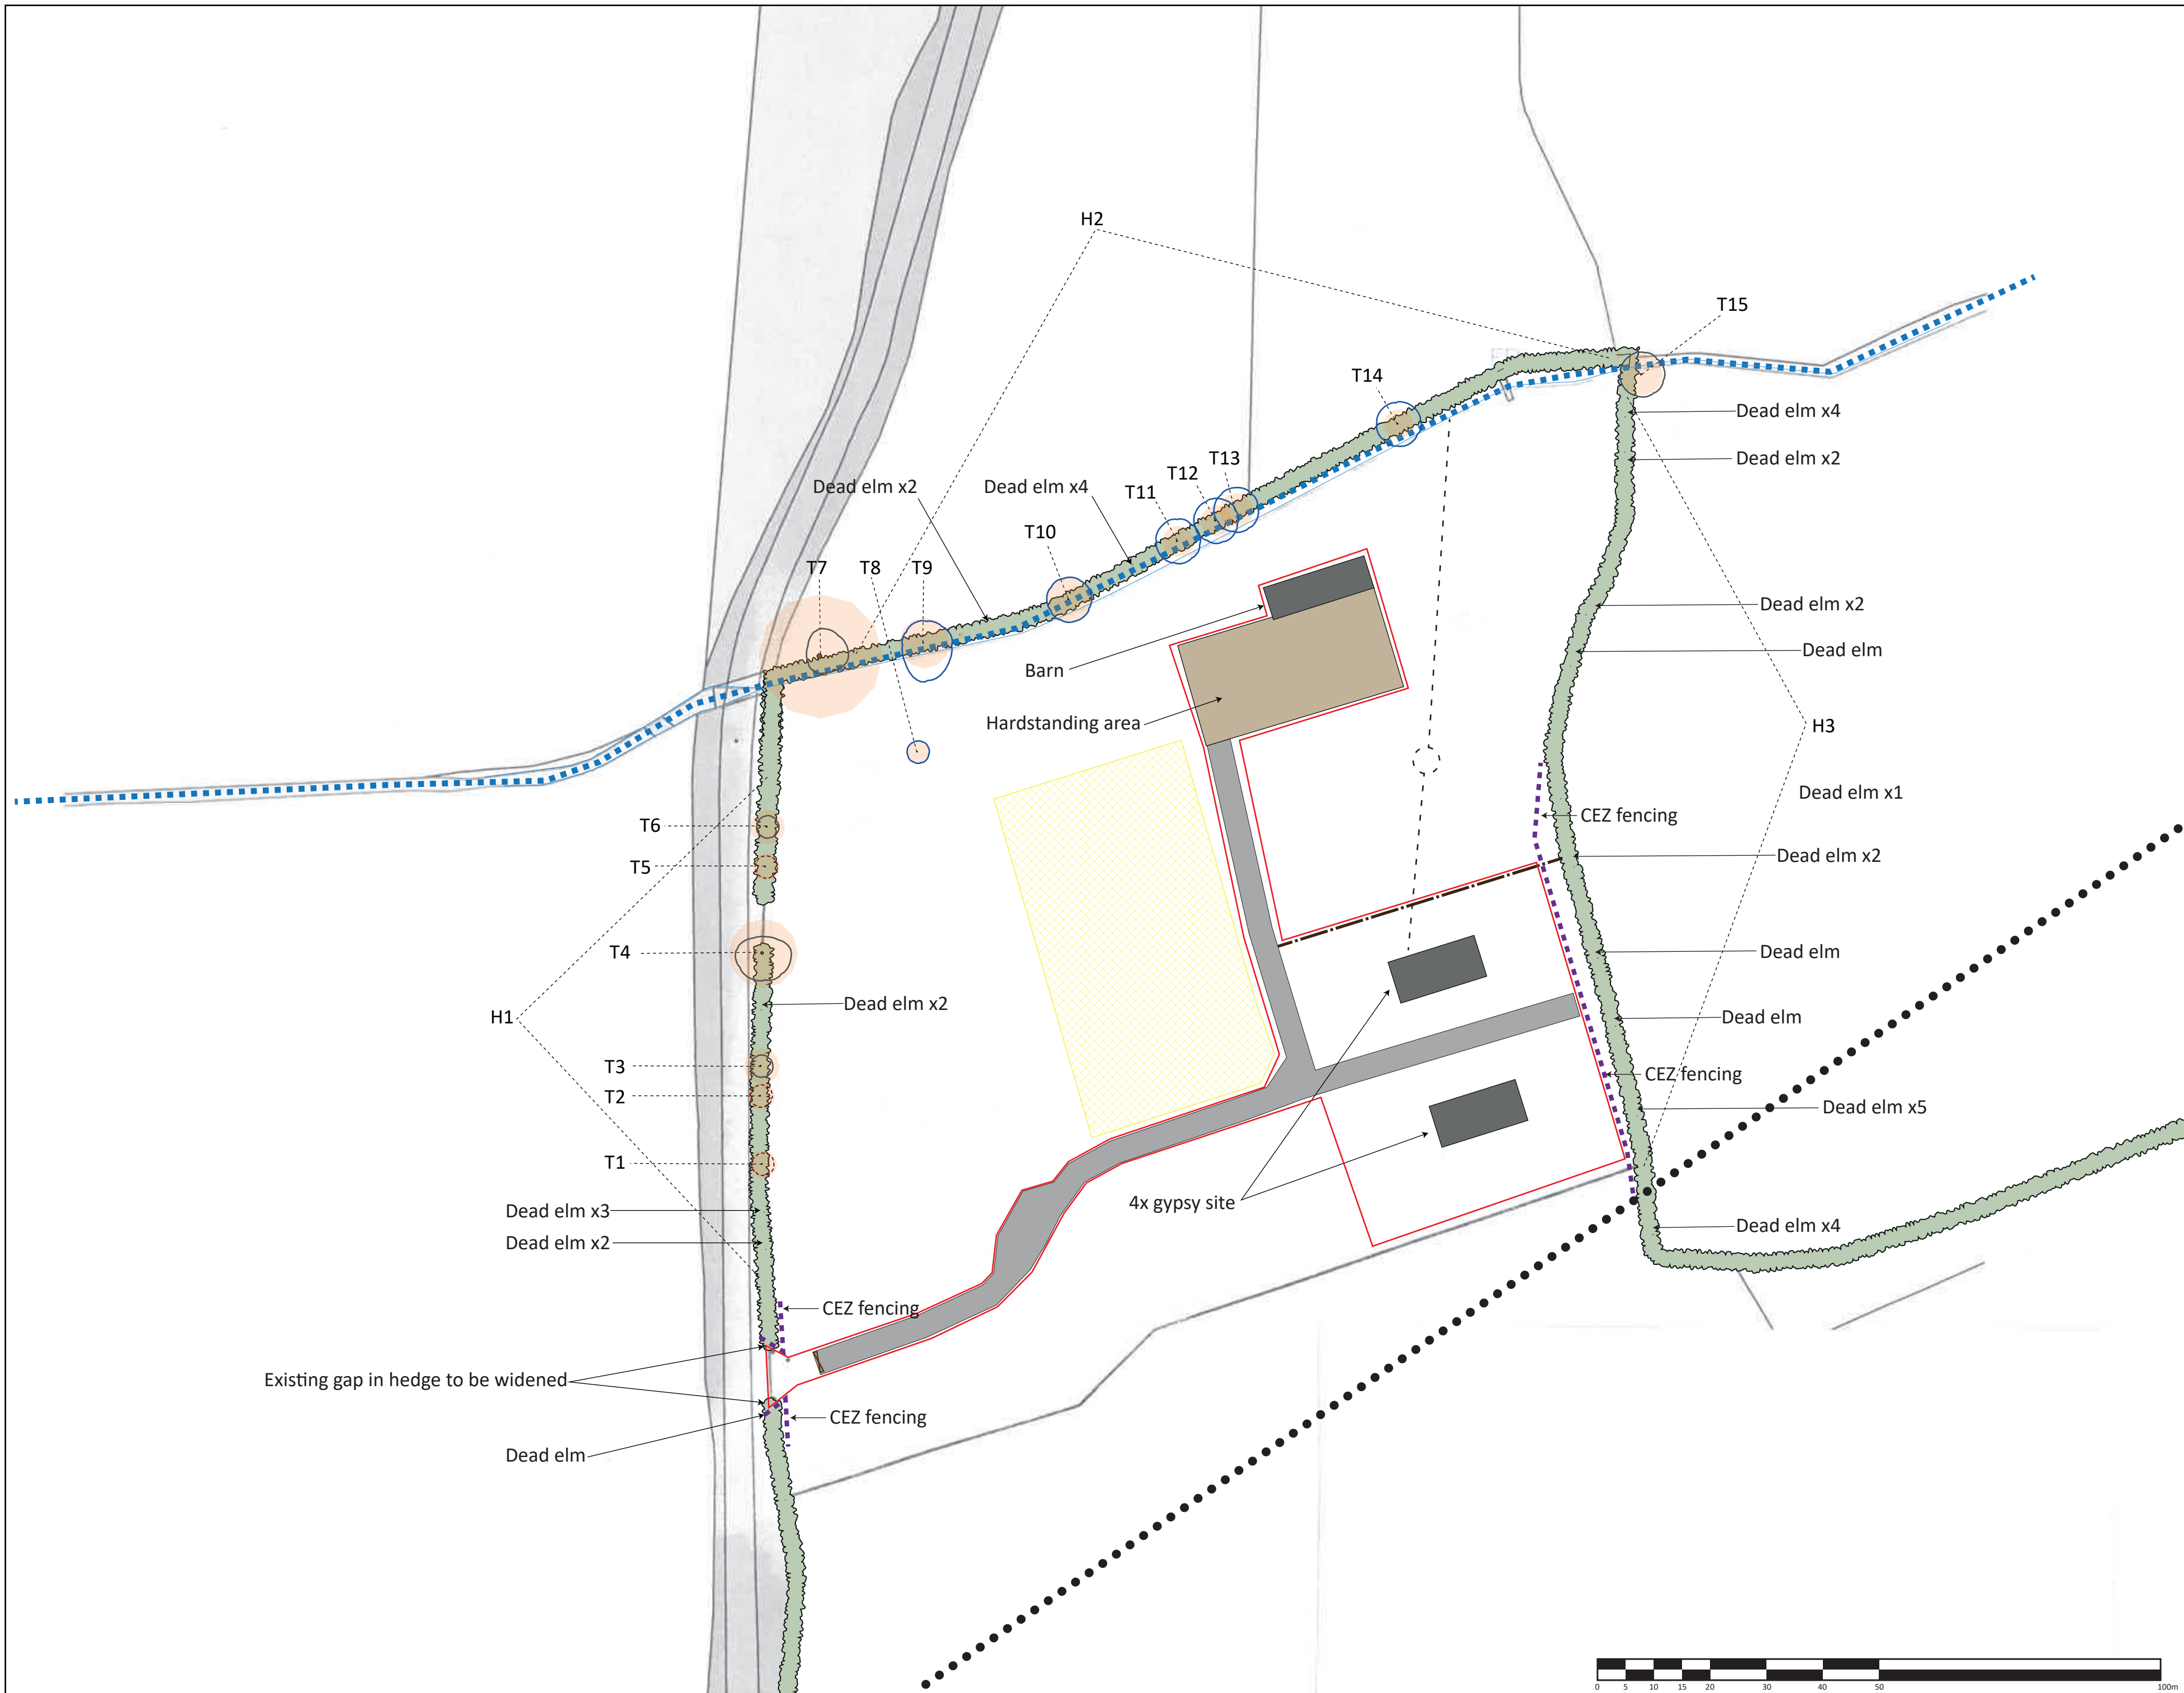
Drawing title: Tree Protection Plan

**1.7** A TPP illustrating the key features of those trees at the site and the requirements for their protection through the development process can be found in Illustrative Material at plan ARB-2001-01 based on the drawing of the scheme submitted for planning approval, drawing no. JL-JH-02 Rev D.

**2.11** CEZ fencing must be installed prior to any other construction activity commencing (excluding tree work), including moving any plant, site cabins/toilets or materials onto site. This will ensure no construction activity can impact on the sensitive areas of the adjacent trees. The required position of CEZ fencing is shown as purple dashed lines on the TPP provided.

- CEZ fencing is to be installed around trees to be retained. The position of the fencing is guided by the radius distance of adjacent tree RPAs as shown in Table 2, as marked out in Phase 1 and as shown in the TPP (purple dashed lines). It must be strictly followed.

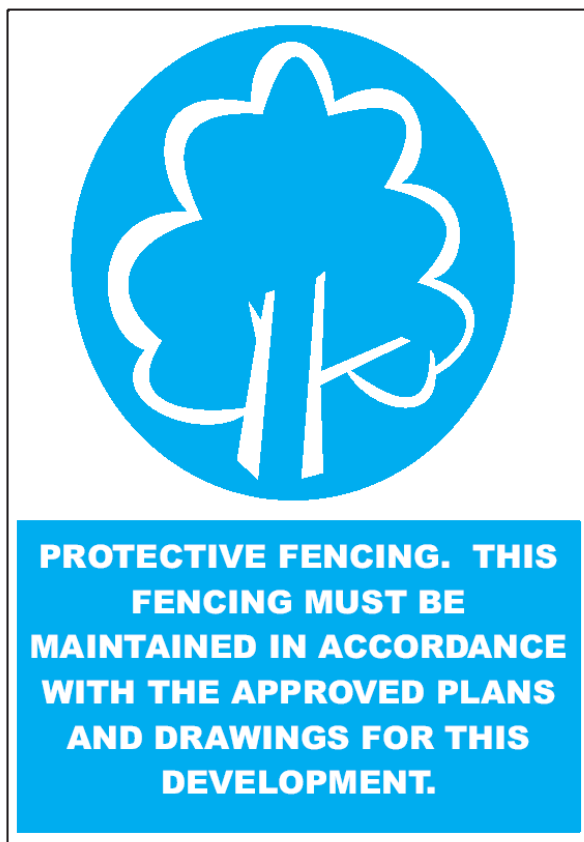
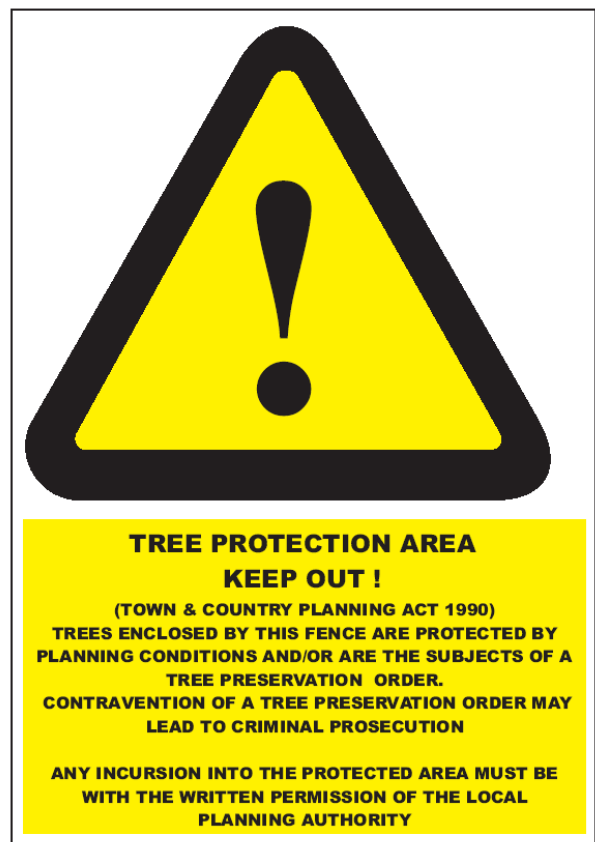
### APPENDIX 3: EXAMPLES OF TREE PROTECTION NOTICES

- Any changes to the position of the CEZ fencing can only be made with the consent of the arboricultural supervisor and the LPA.
- All-weather notices are to be fixed to the barriers with the words: 'Construction Exclusion Zone - Keep Out' or similar (see example in Appendix 3).
