## Preliminary Ecological Appraisal and Roost Assessment

17 Happy Land, Ashton Keynes, Wiltshire, SN6 6PN

This report is prepared to inform a planning application with the Wiltshire Council. The proposal is described as:

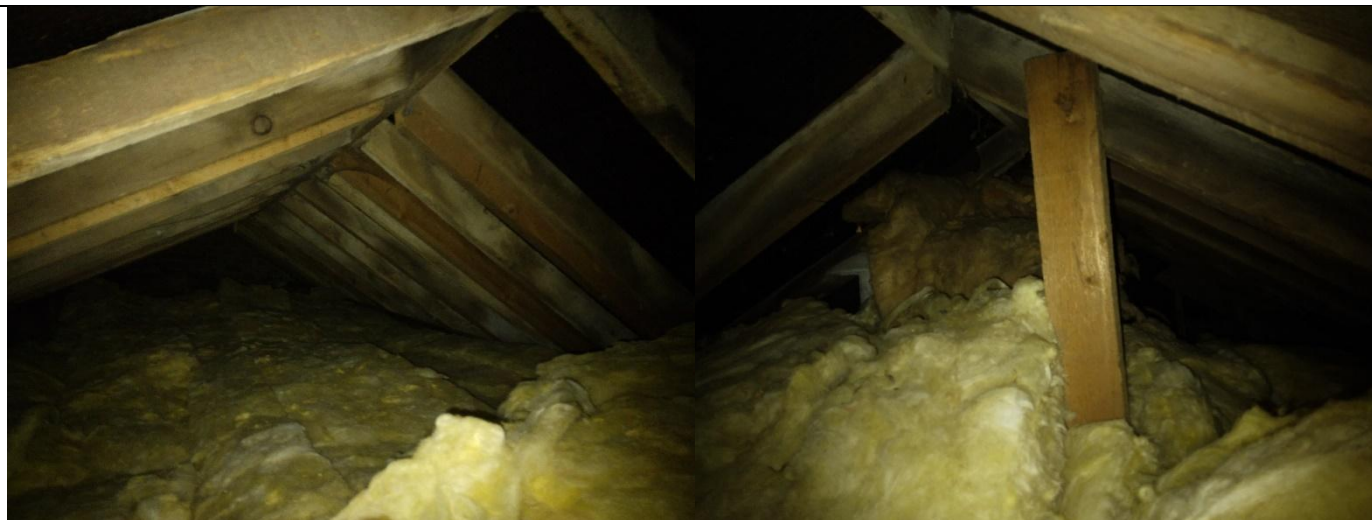
Northern elevation

No exterior crevices were noted, and the verge of the building was covered with bird mesh to stop nesting birds. The building was considered negligible as it lacked suitability for crevice and loft-dwelling bats (well-sealed).

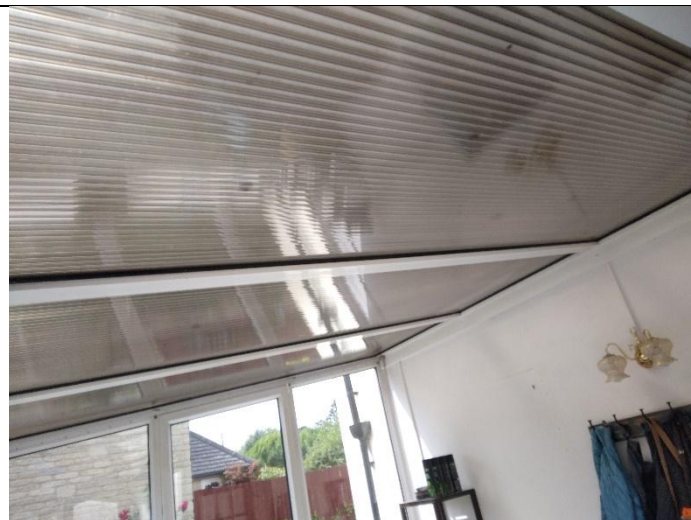
Eastern and southern elevation

B1b is a single-storey (PVC) conservatory with a lean-to roof attached to the southern elevation of B1a. The conservatory was vaulted (no void). No exterior crevices were noted, and the building was considered negligible as it lacked suitability for crevice and loft-dwelling bats (well-sealed, light spill, and temperature fluctuation).

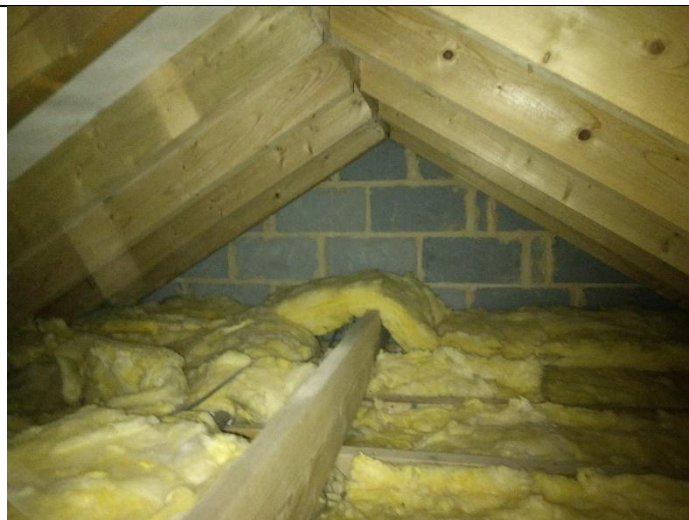
Northern elevation

B1c is a single-storey (rendered) extension with a pitched (concrete double roman tile) roof attached to the eastern elevation of B1a. There was no evidence of bats internally or externally. The loft void was lined with Breathable Roof Membrane (BRM) (good condition) and was approximately 1m high x 1.5m wide x 3m long. The void had an internal temperature of 27°C and a humidity of 57%.

No exterior crevices were noted, and the verge of the building was filled with bird mesh to stop nesting birds. The building was considered negligible as it lacked suitability for crevice- and loft-dwelling bats (due to being well-sealed).

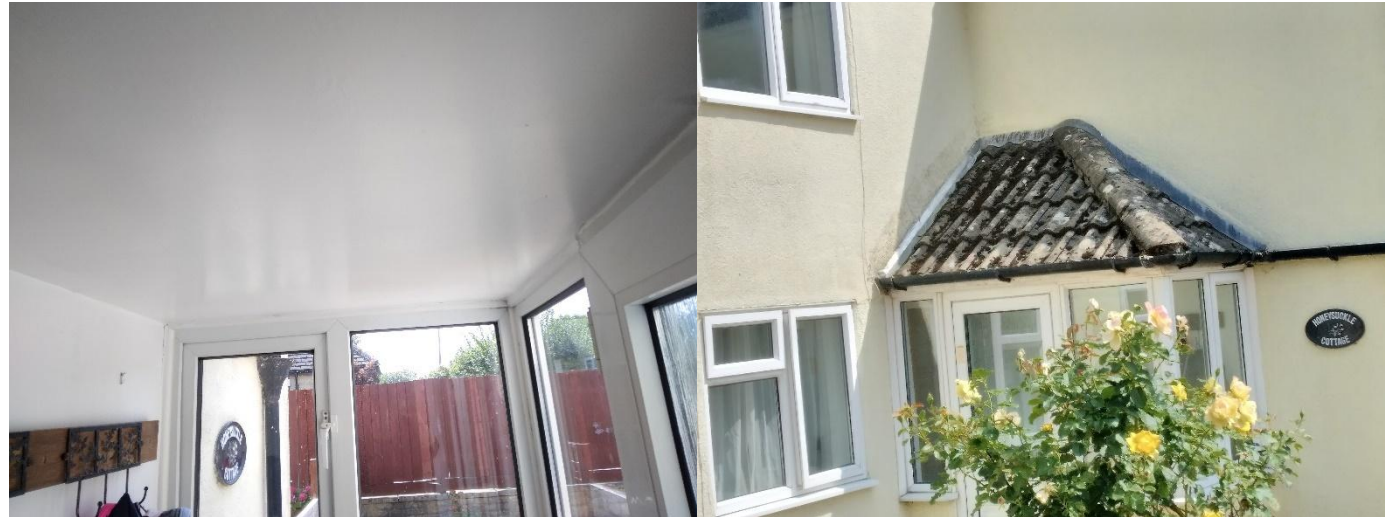
B1d is a small porch with a pitched (concrete double roman tile) roof attached to the north-western elevation of B1d. There was no access to the void space within the roof of B1d. No exterior crevices were noted, and the building was considered negligible as it lacked suitability for crevice and loft-dwelling bats (well-sealed).

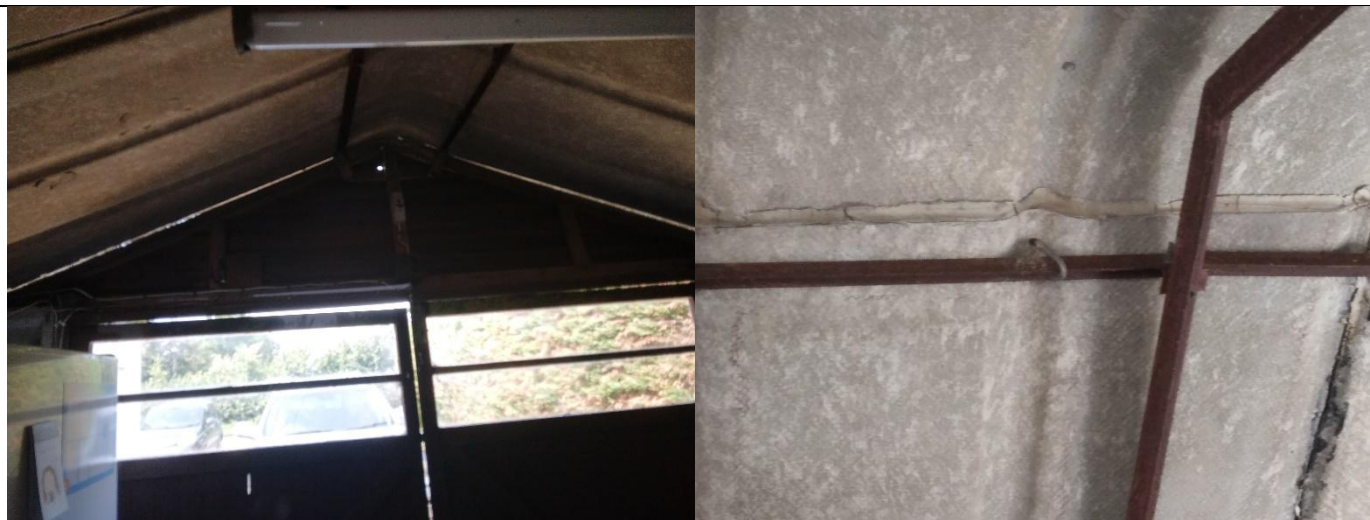
B2 is an asbestos-type garage with a pitched roof. The building has wooden cladding on the southern elevation and a flat roof canopy extension on the western elevation. The internal space is well-lit, with no roosting features suitable

for crevice or void-dwelling bats. There were multiple access points into the building (gaps between door and frame). However, there are no suitable interior features for void-dwelling or crevice-dwelling bats. The building was considered negligible as it lacked suitability for crevice- and loft-dwelling bats (due to the absence of roosting points and significant light spill).

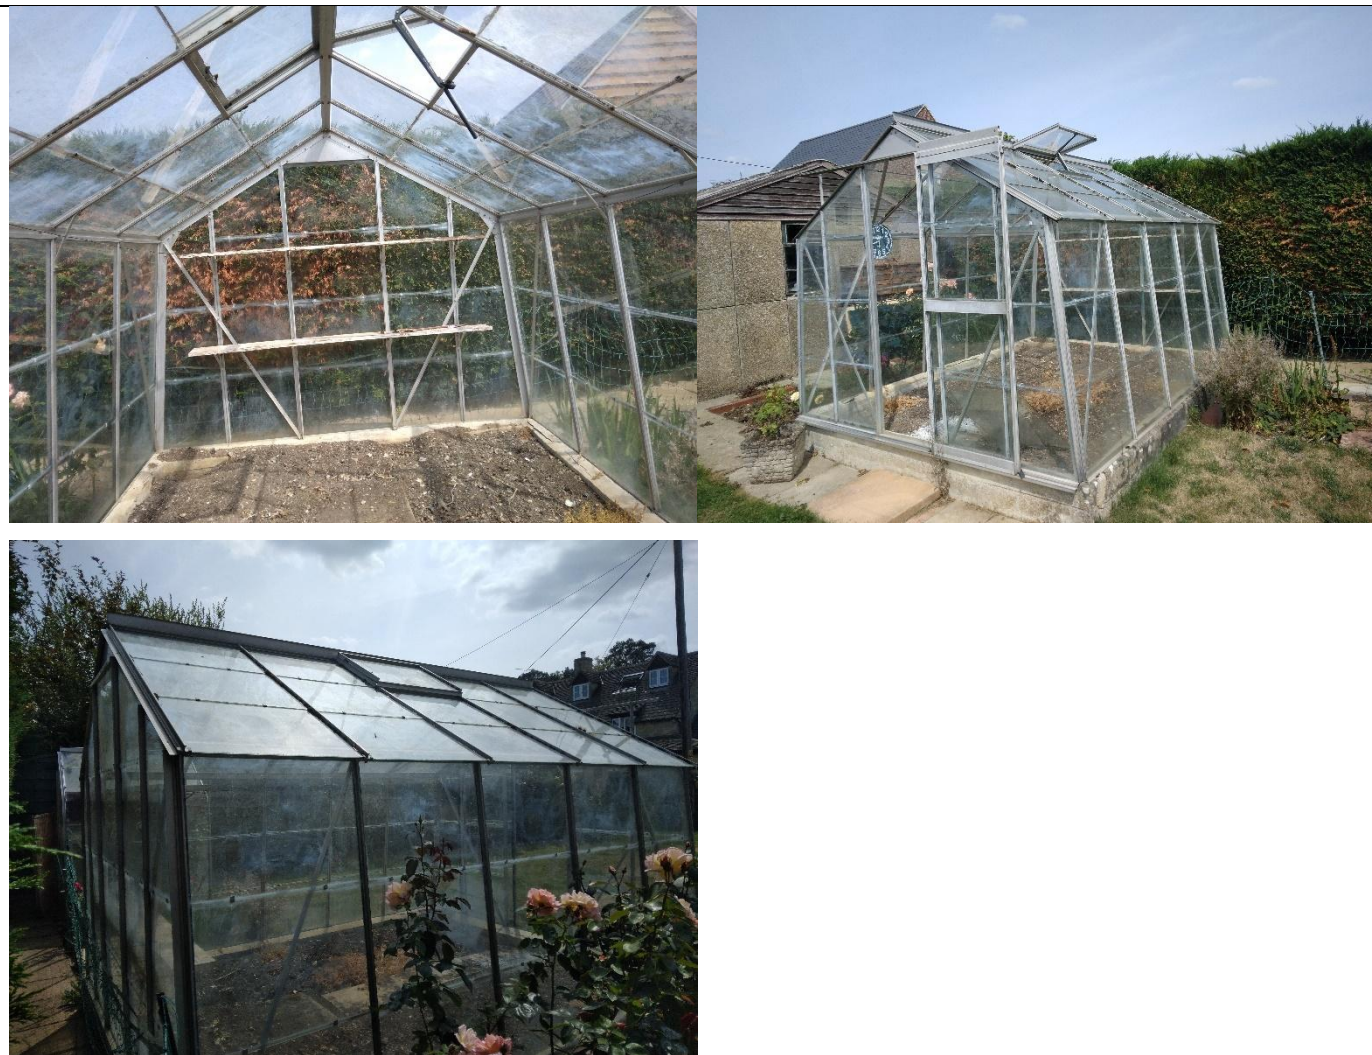
B3 is a metal-framed greenhouse with glass panels on all elevations. No exterior crevices were noted, and the building was considered negligible as it lacked suitability for crevice and loft-dwelling bats (well-sealed, light spill, and temperature fluctuation). Building B3 is currently not included in the proposed plans.

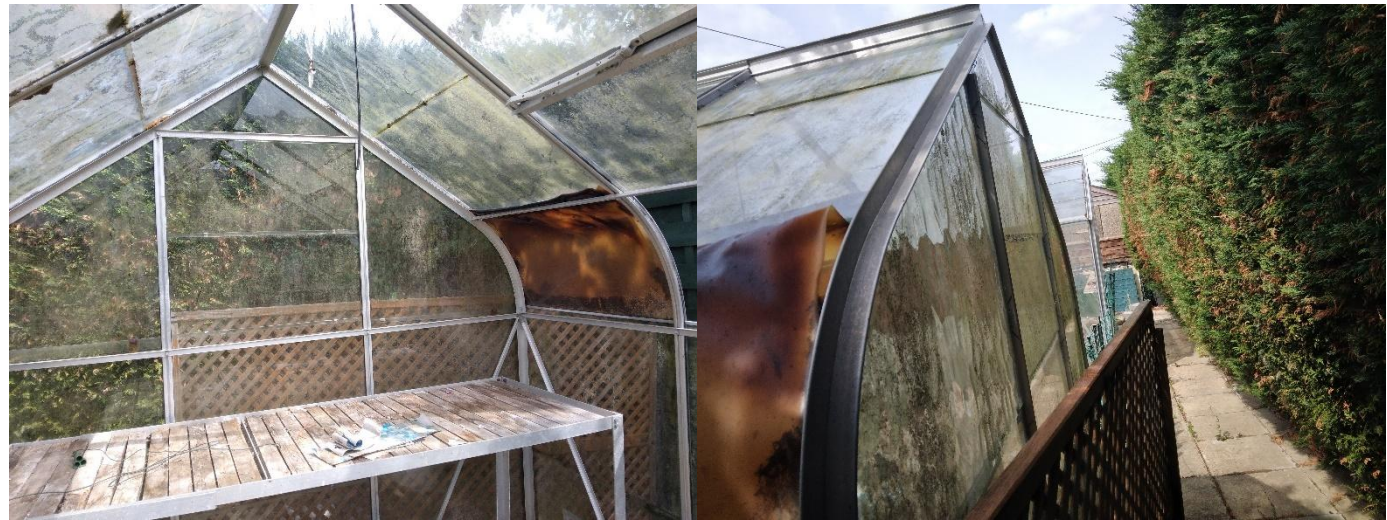
B4 is a small metal-framed greenhouse with glass panels on all elevations. A panel of glass was missing from the exterior of the building. However, there are no suitable exterior or interior features for void or crevice-dwelling bats. The building was considered negligible as it lacked suitability for crevice and loft-dwelling bats (light spill, and temperature fluctuation). Building B4 is currently not included in the proposed plans.

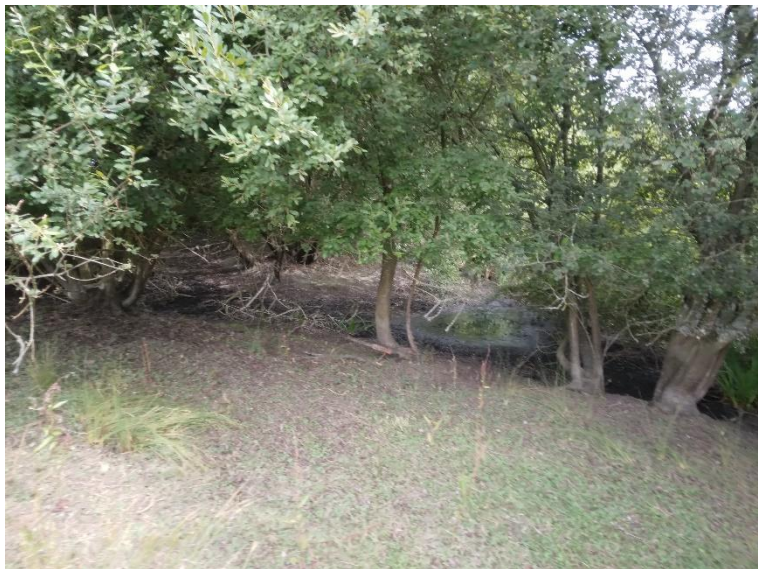
Photo 8: Looking at pond P1.
