Proposed Residential Development  
Land South East of 18 Midford Lane  
Limpley Stoke  
Nr Bath  
BA2 7GP

## GEOTECHNICAL AND PHASE II CONTAMINATION REPORT

REPORT NO. 18022, January 2019

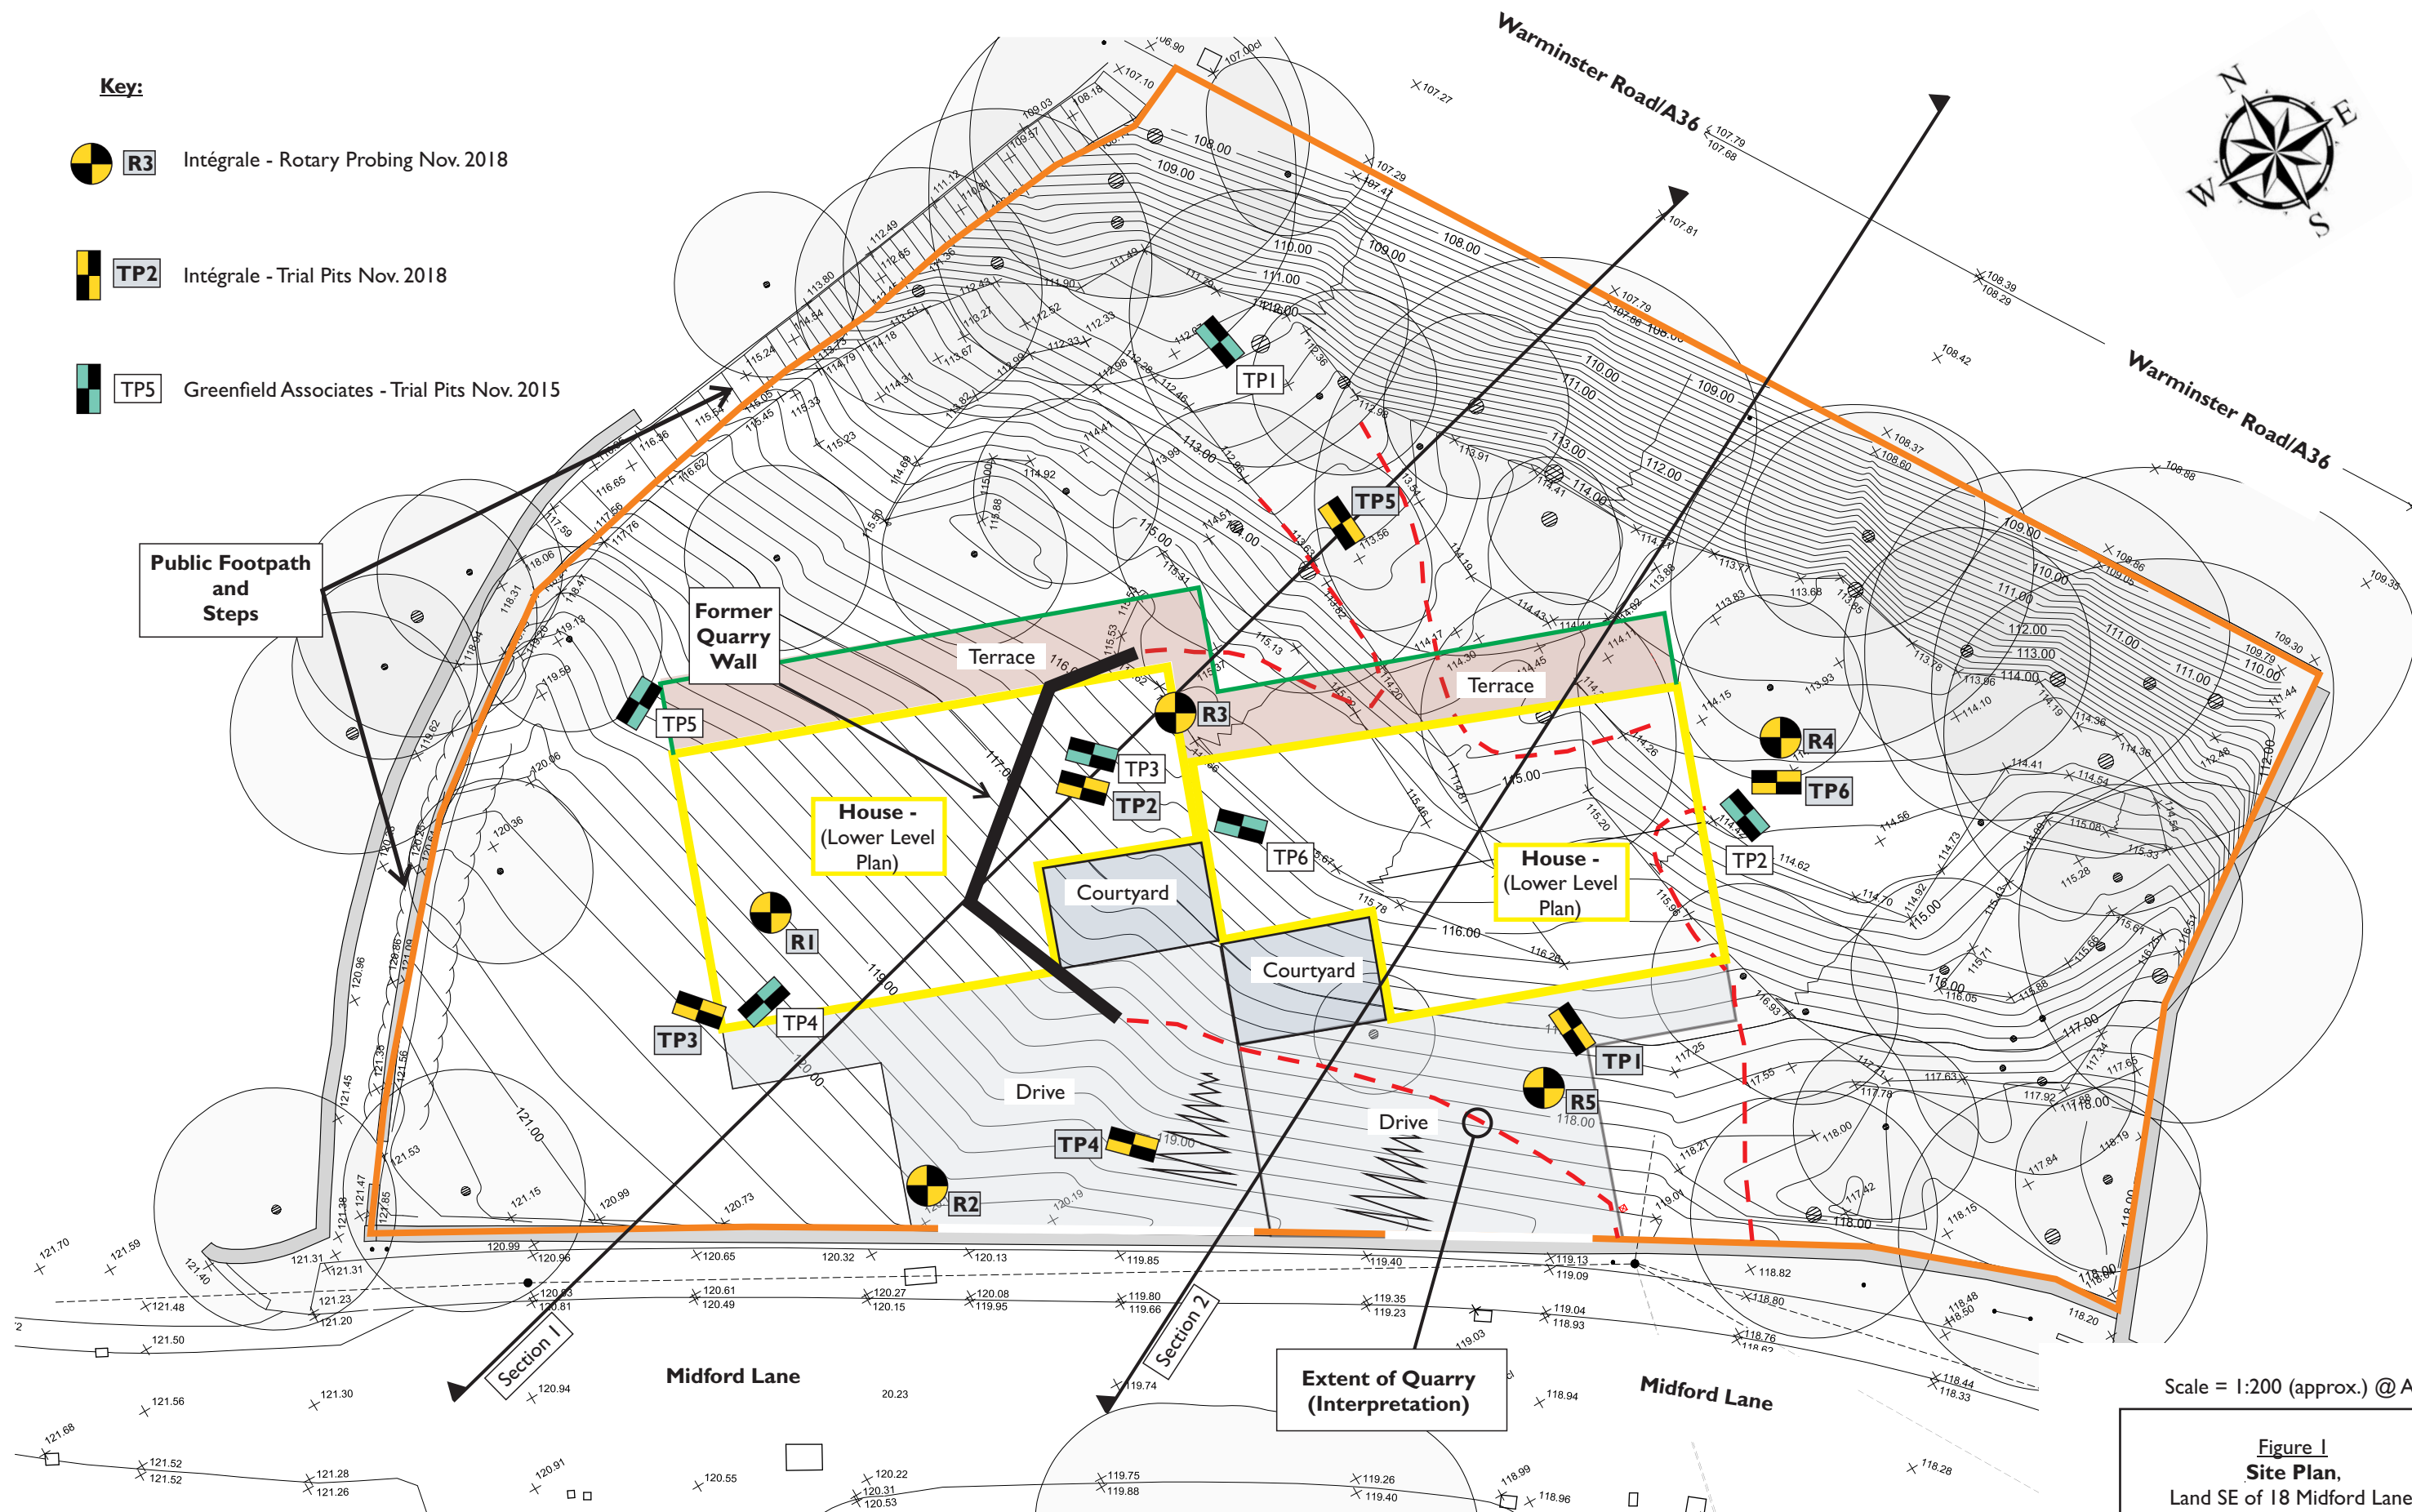
**Figure 1**  
**Site Plan,**  
 Land SE of 18 Midford Lane,  
 Limpley Stoke,  
 Bath,  
 BA2 7GP

**TP5** Greenfield Associates - Trial Pits Nov. 2015

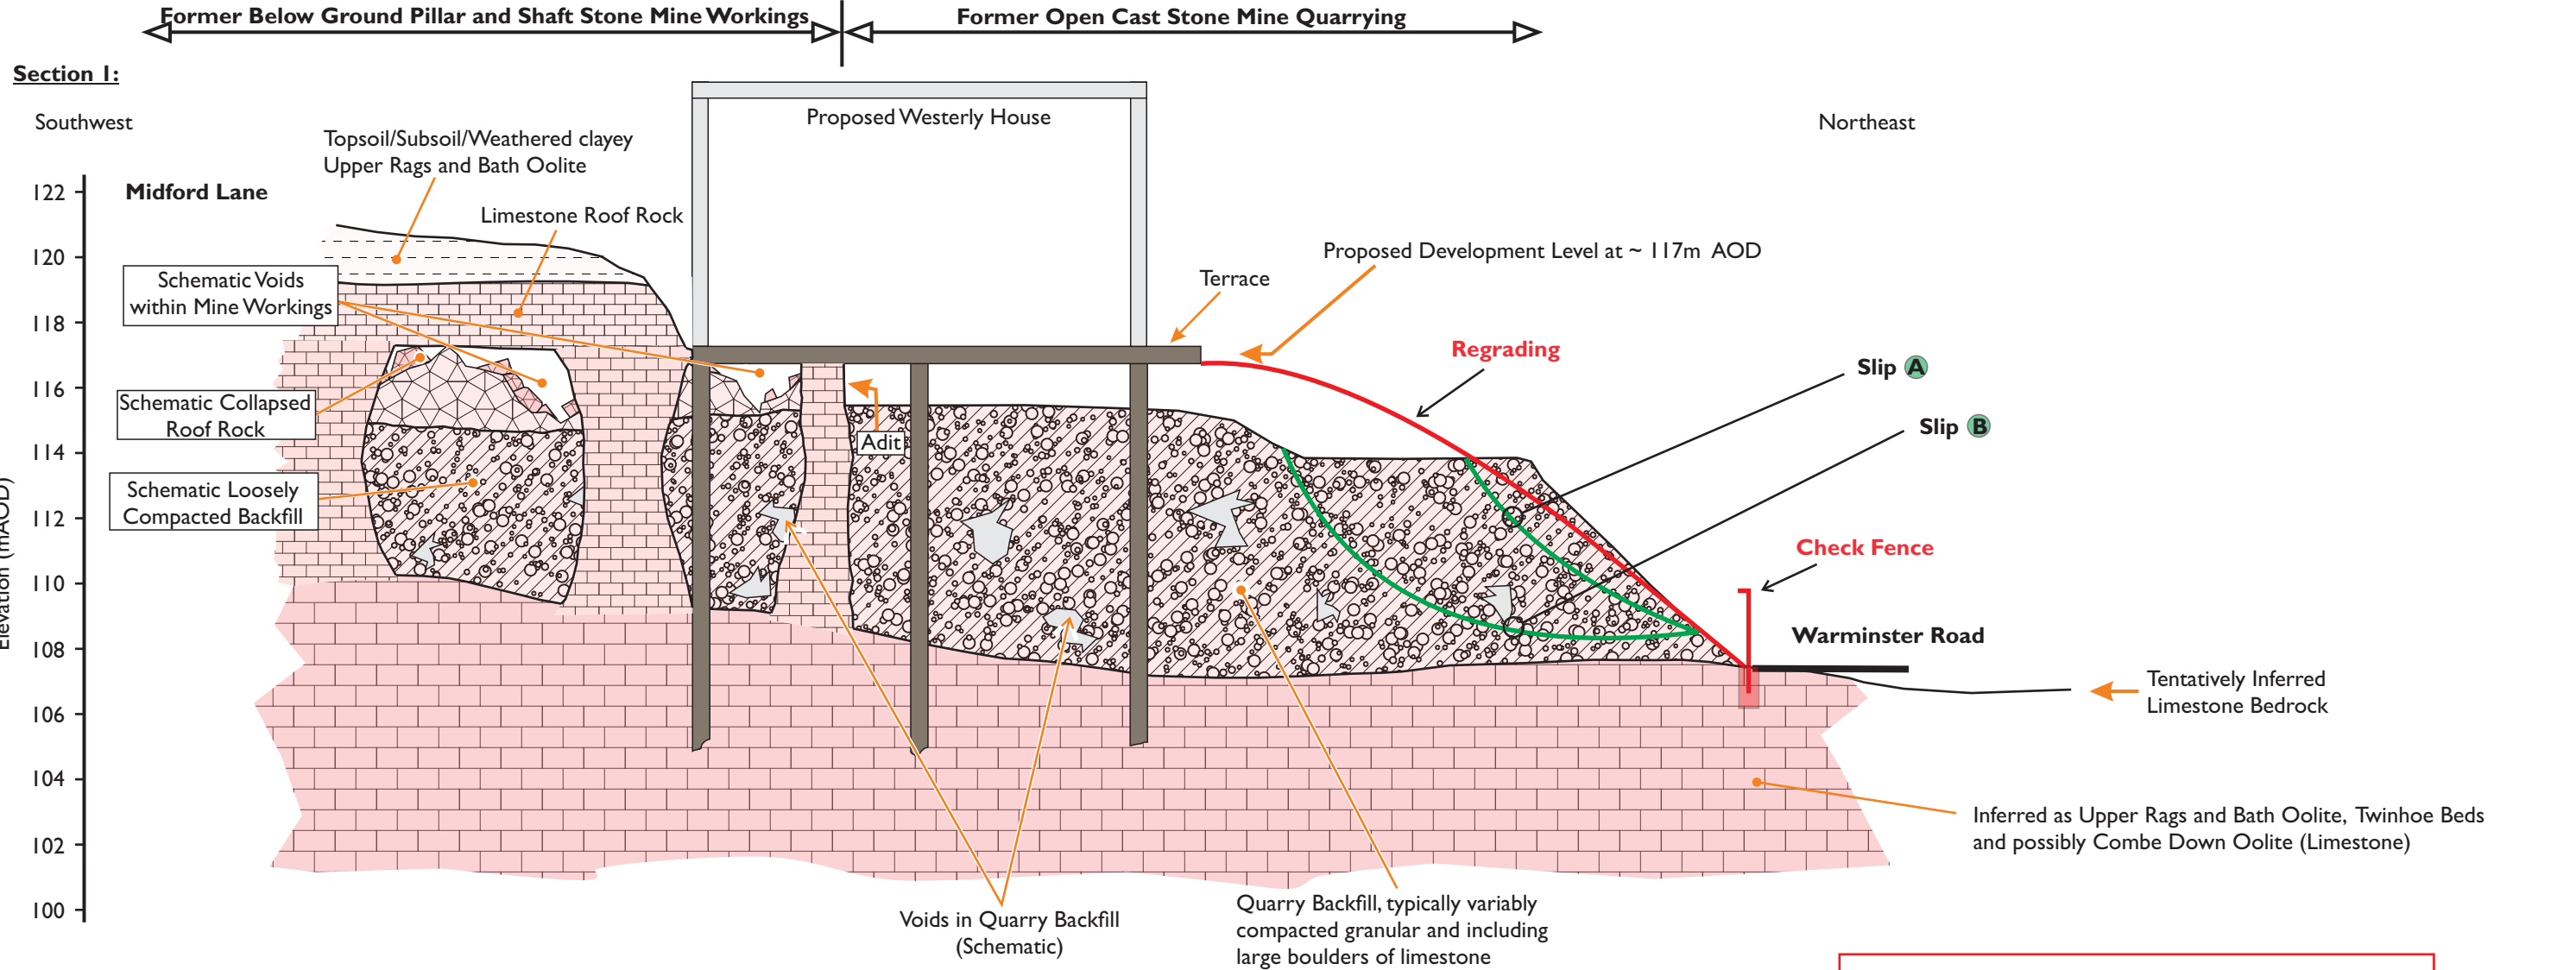
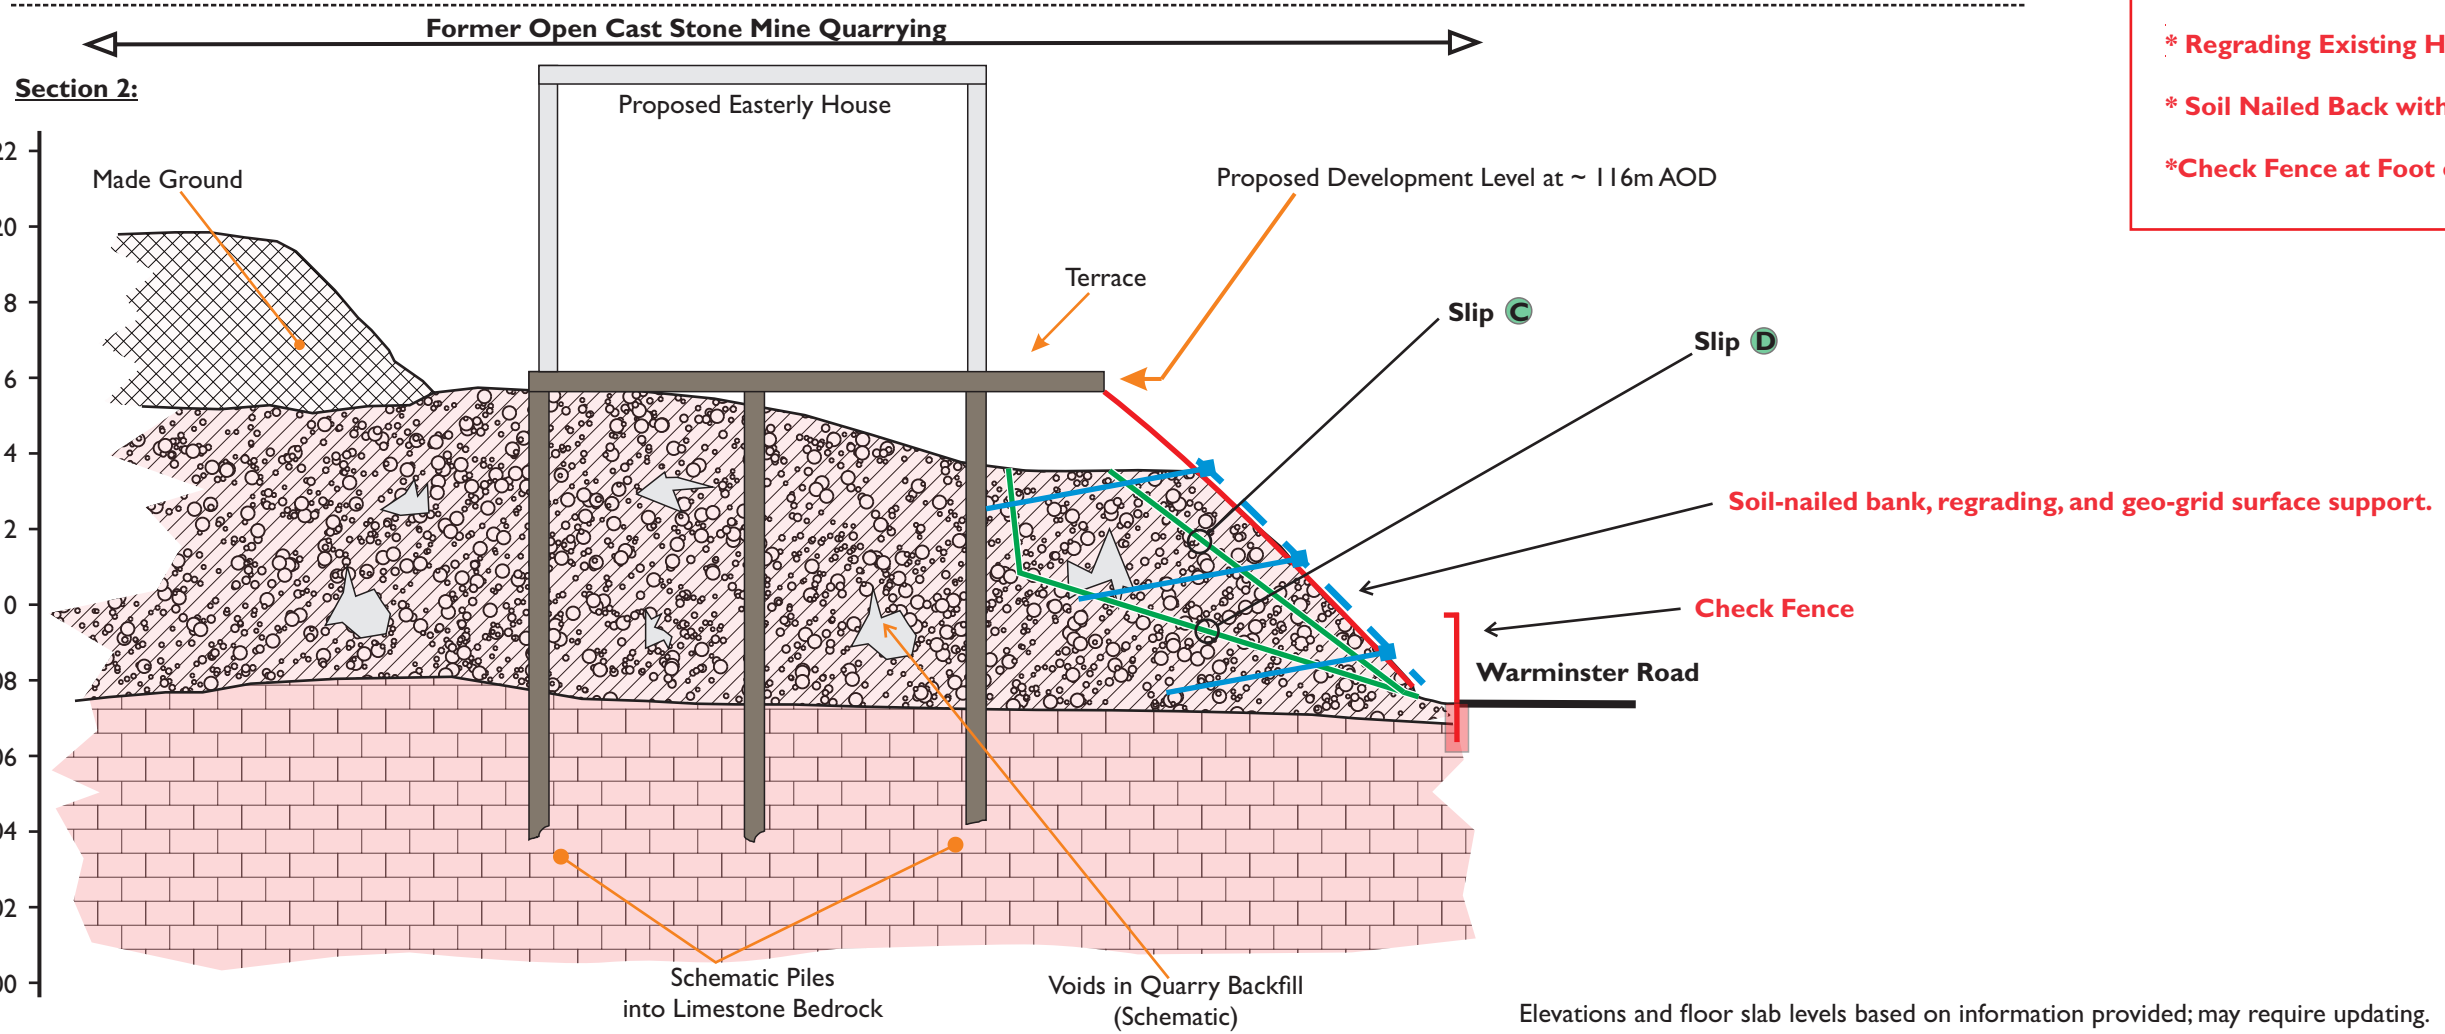
**Figure 2**

Four typical modes of slope failure have been modelled. Circular slips A & B are shown on Section 1, and non-circular Slips C & D on section 2 of Figure 2, encompassing the Lowest Slope Facet at a gradient of between 40-45 degrees. Slips A and C are shallower (1-2m) than Slips B and D (3-5m).

- Possible Methods to Improve Slope Stability:**
- \* Regrading Existing Highway Bank
  - \* Soil Nailed Back with Geo-Grid Surface Support
  - \* Check Fence at Foot of Slope

A preliminary slope stability assessment has tentatively concluded that shallow (1-2m deep) failure modes are the most critical. Measures to ensure adequate stability close to Warminster Road could include a combination of regrading, soil nailing and/or stability counterfort trenches. More rigorous analyses are required when the design has been finalised.

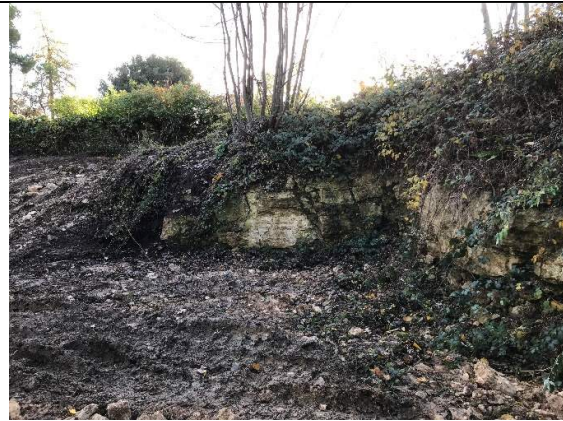
| REFERENCES | |
|---|---|
| Rock/ soil exposures | Former quarry face c.2.5-3m tall exposing fractured limestone. |

Plate 7 – Quarry face

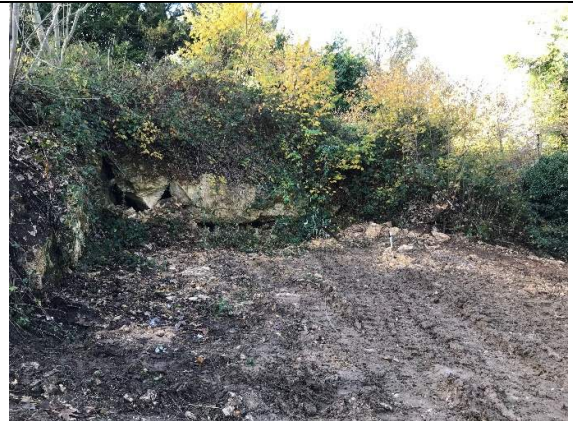
Plate 8 - Quarry face

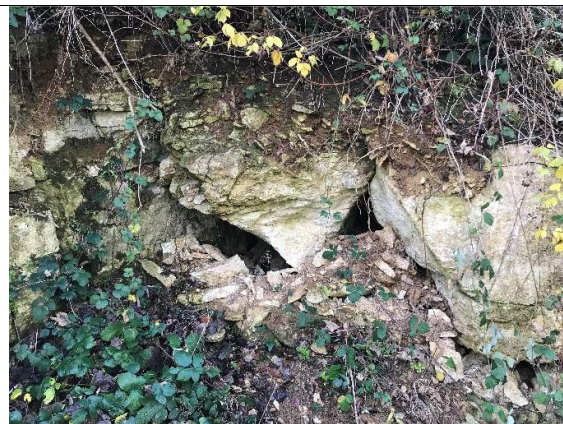
Plate 9 – Adit in quarry face

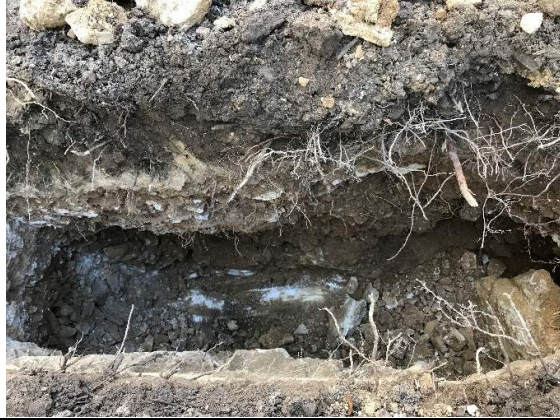
Plate 13 – TP1

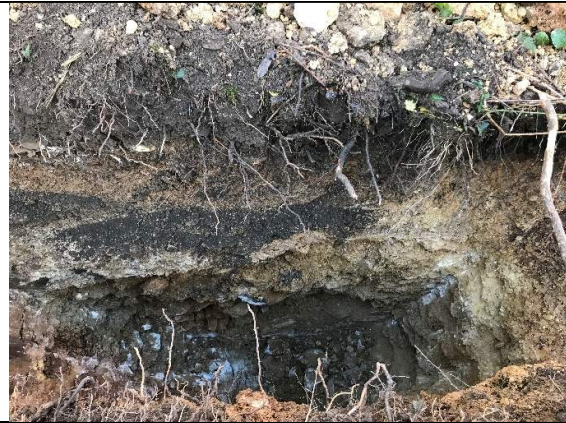
Plate 19 – TP4

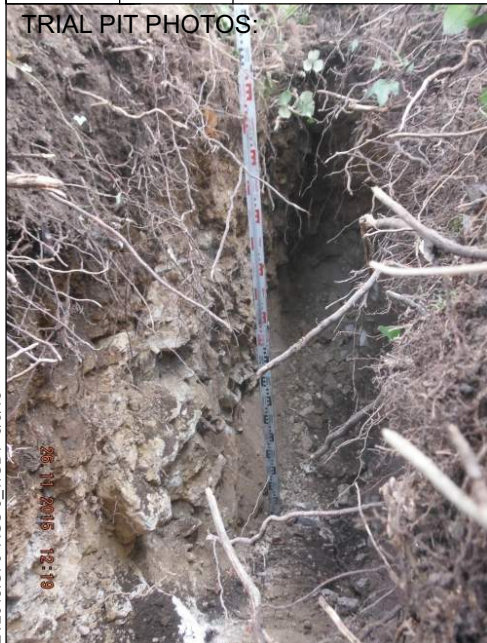
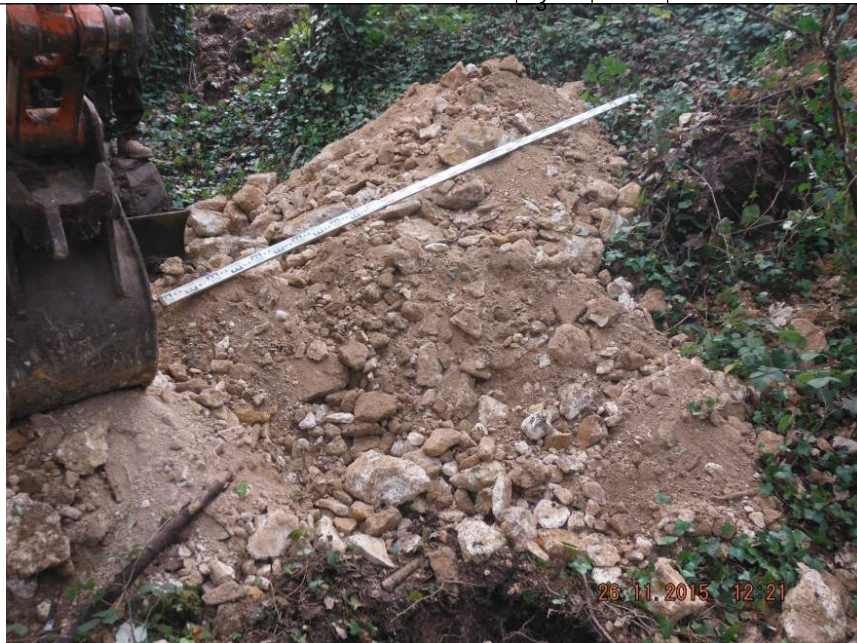
Some spalling at 1m on west side of trial pit  
No groundwater encountered

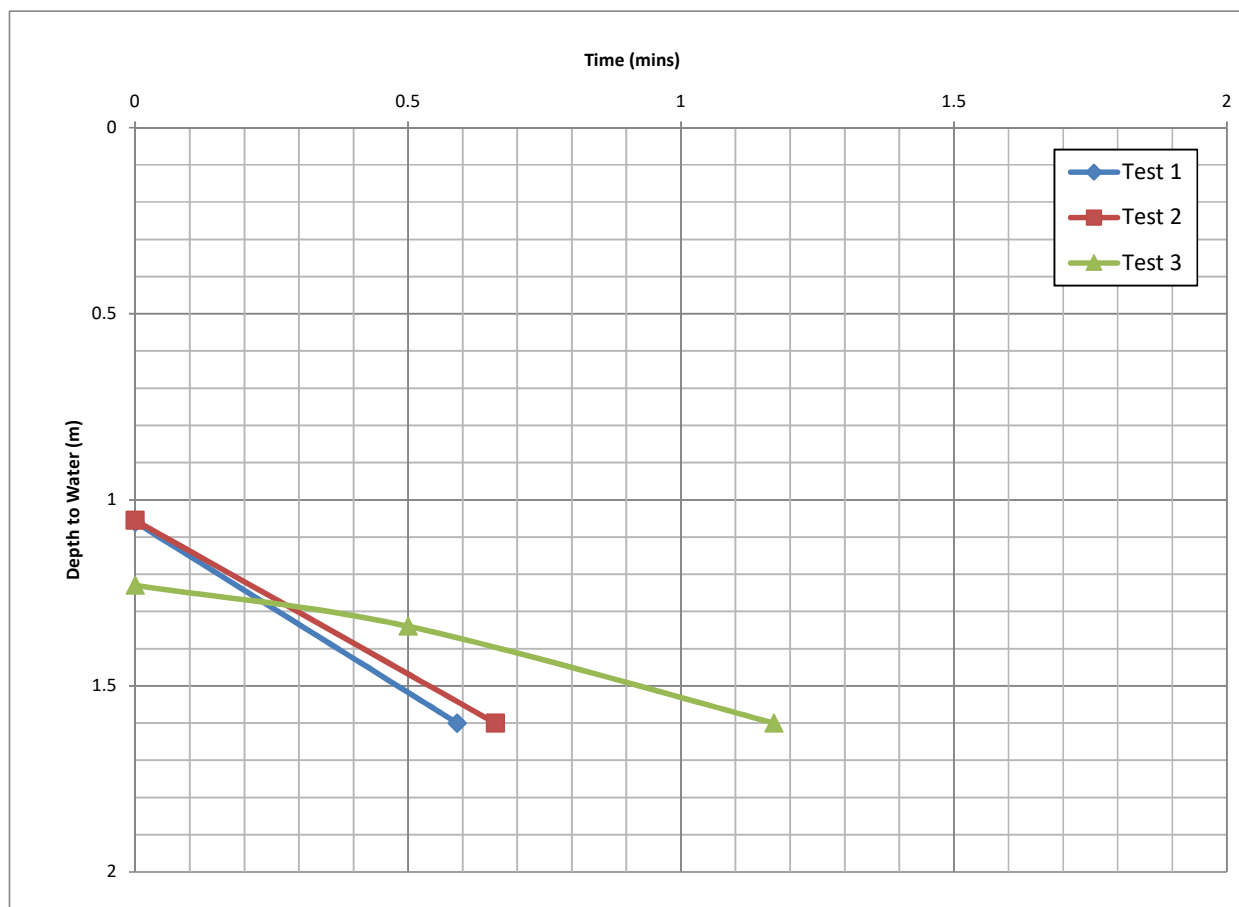
At TP1, within 2 minutes, the water had fully drained away in all three tests, resulting in a calculated Design Infiltration Rate of  $\sim 3 \times 10^{-3}$  m/s. Testing was completed in the variably compact and granular Made Ground.

Design Soil Infiltration Rate (m/s)

3.31E-03

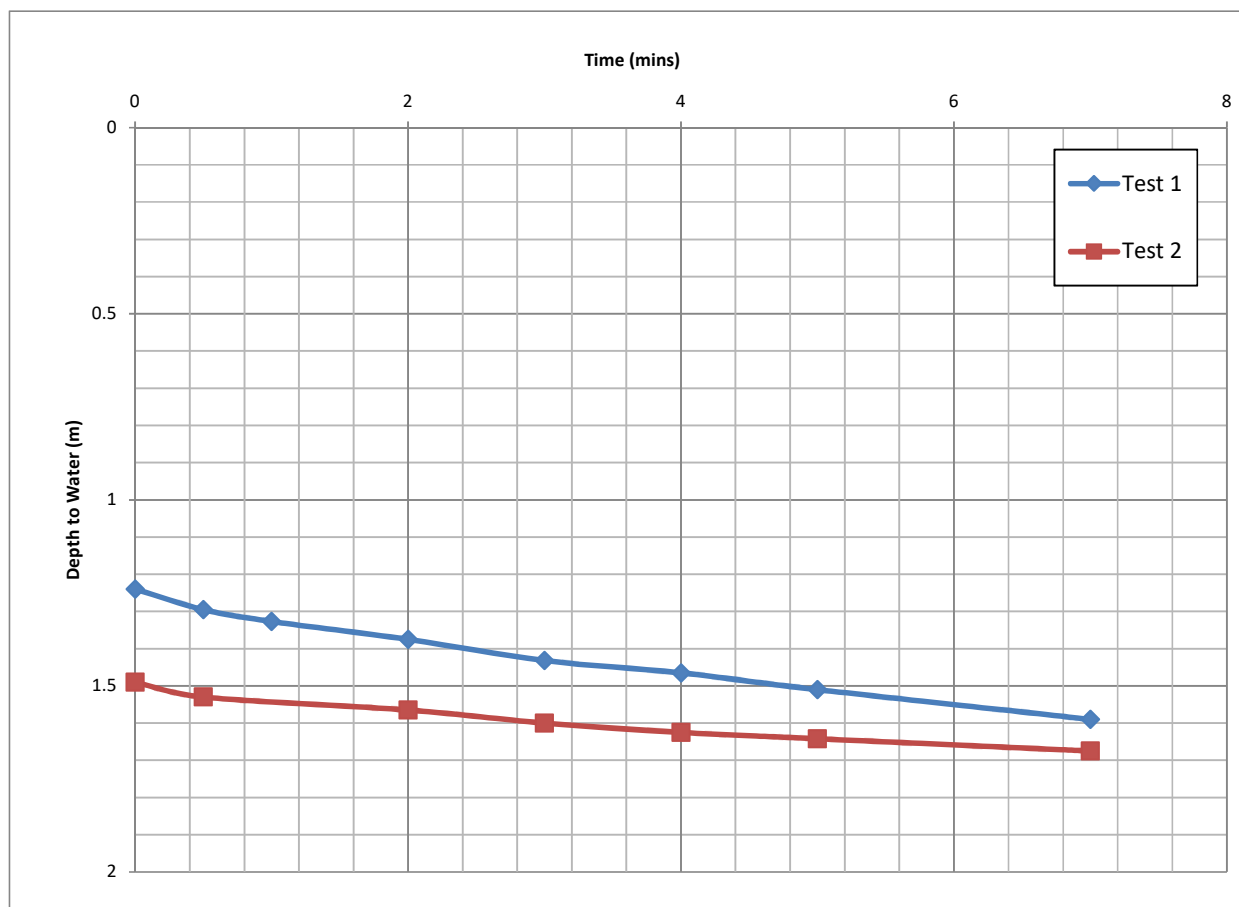
In TP4, two tests were completed within the variably weathered natural strata, with water draining away within 10 minutes, resulting in an infiltration rate of  $\sim 3 \times 10^{-4}$  m/s.

Soil Infiltration Rate (m/s)

2.95E-04
