## HERITAGE STATEMENT

### REPLACEMENT ROOF COVERING AND STRUCTURAL REMEDIAL WORKS TO THE ORANGERY AT GRITTLETON HOUSE

**Site Address:** The Street, Grittleton, Chippenham, Wiltshire, SN14 6AP

**Proposals:** Listed Building Consent for replacement roof covering and structural remedial works

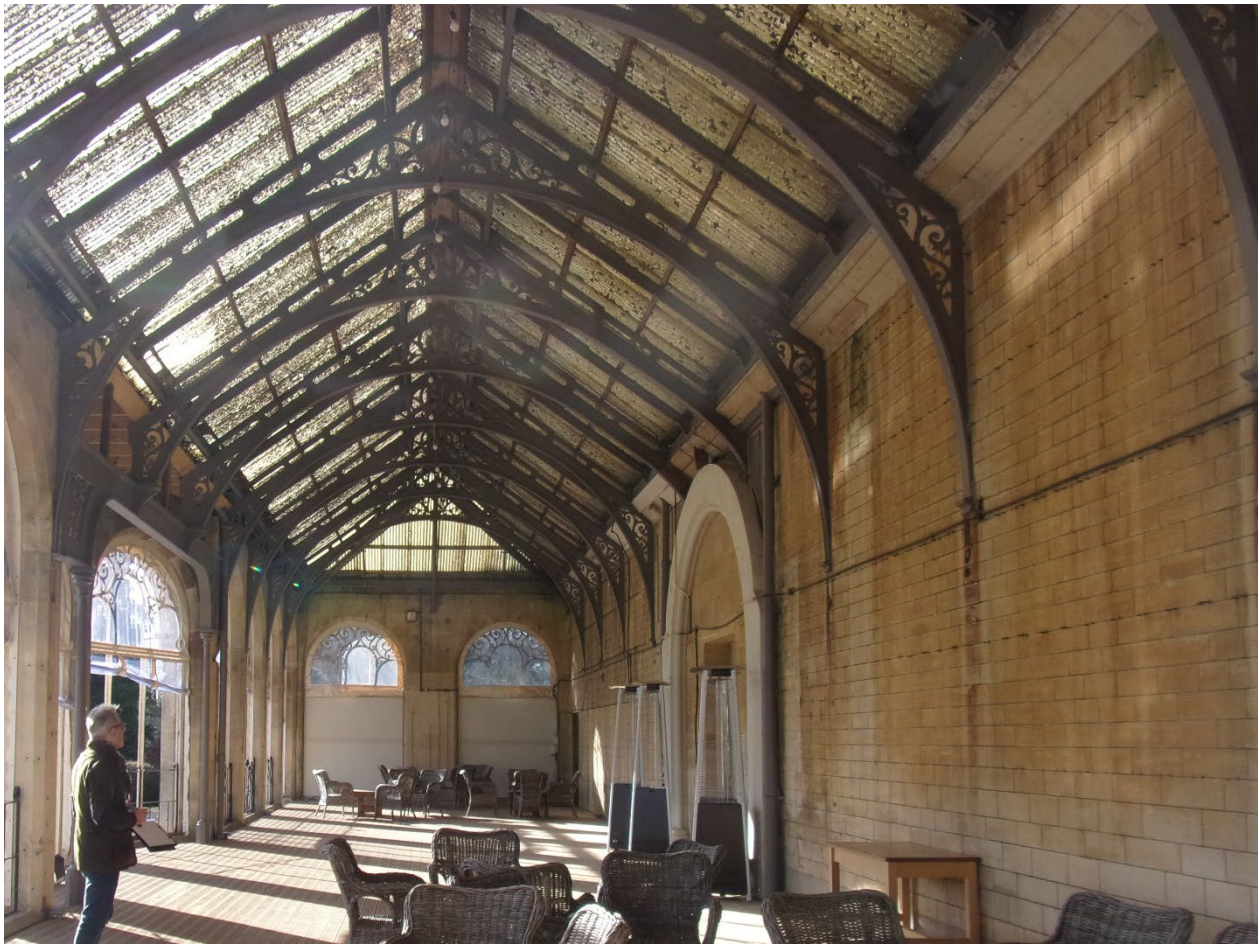
*Internal view of The Orangery indicating the roof structure and corrugated roof covering*

- **Material:** Corrugated fibreglass sheeting
- **Installation method:** Secured via bolts and fasteners to underlying steel purlins
- **Age and condition:** Estimated 30+ years old; brittle, deteriorated, covered in lichen; no longer weathertight or fit for purpose
- **Structural implication:** Weight remains relatively modest, but material brittleness poses safety and weatherproofing risks

- **Primary structure:** Ten (10) decorative steel A-frame trusses positioned at regular intervals along the length of the orangery
- **A-frame attachment:** Built into or connected to masonry columns (south elevation) and masonry walls (north elevation abutment to main house)
- **Purlins:** Steel angle sections or channels spanning between A-frame points; original sizing not precisely documented (obscured by internal linings)
- **Roof profile:** Hipped (sloped on all sides)
