# DAVID PARTRIDGE LTD

**REPORT ON            ‘THE ORANGERY’ at  
GRITTLETON HOUSE,  
HULLAVINGTON,  
WILTSHIRE  
SN14 6AP**

| <b>JOB NUMBER</b> | <b>25 / 195</b> |

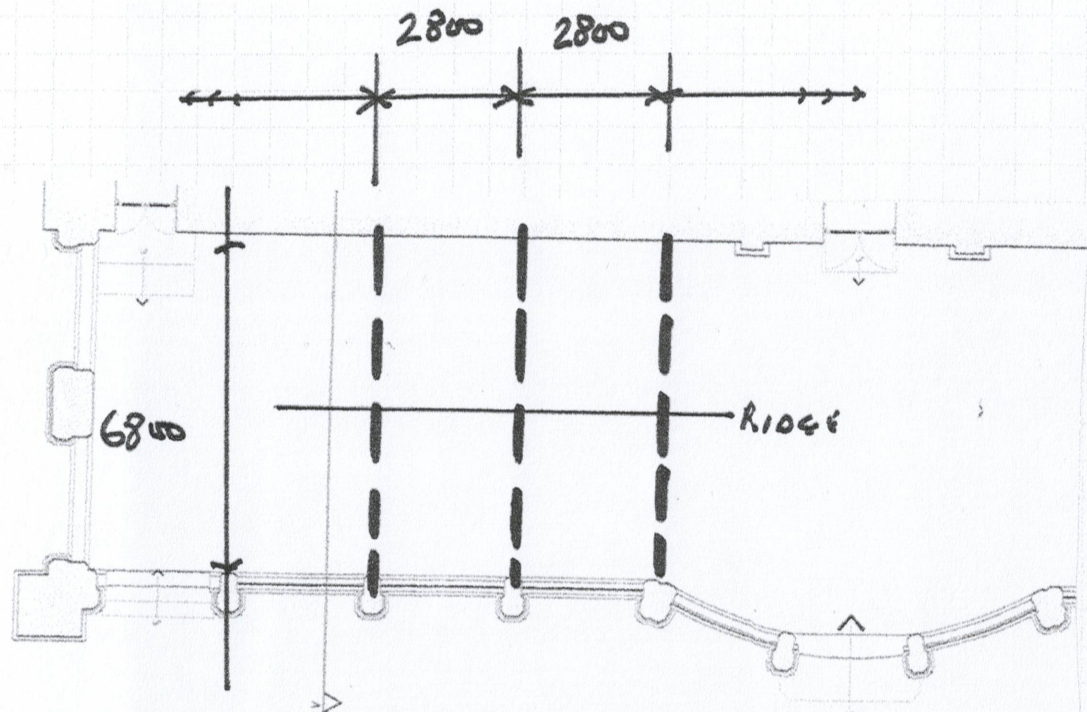
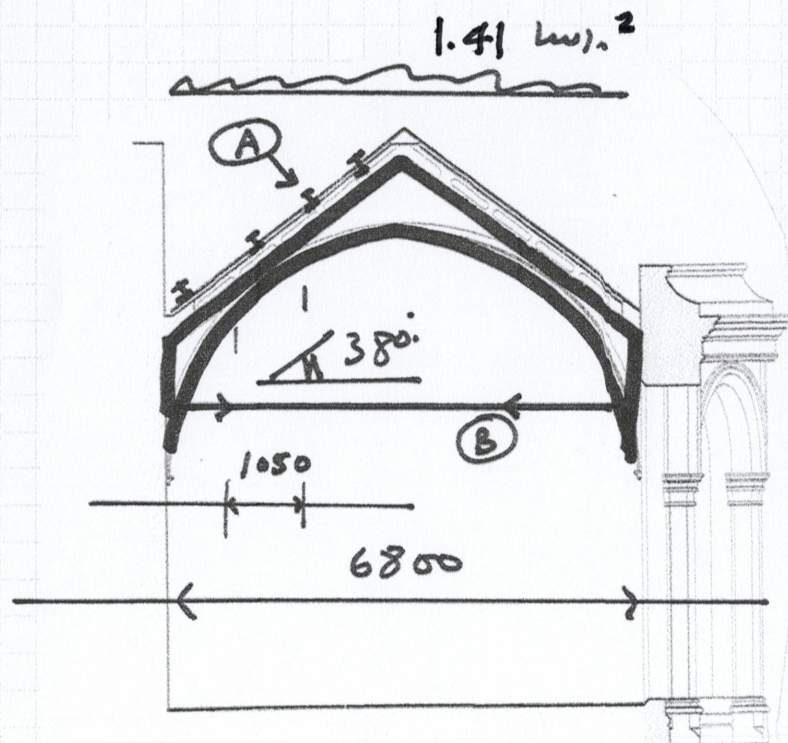
FLOOR PLAN

LAYOUT

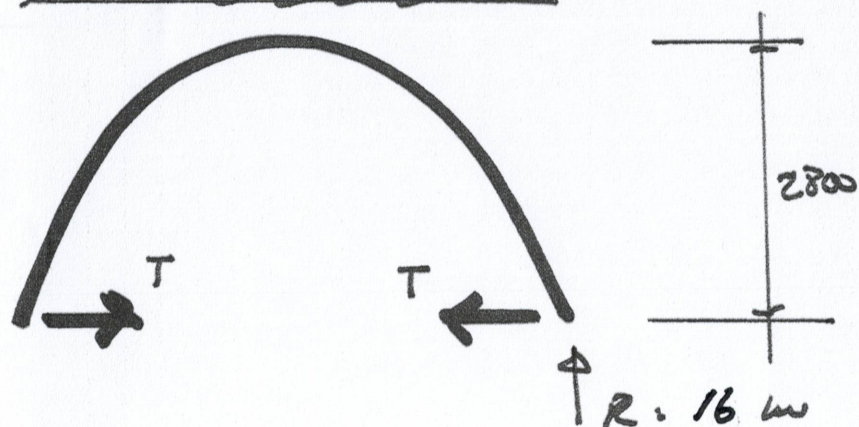
② TRUSS / TIE BAR

$$(1.41 \times 2.80) + 0.60 = 4.58 \text{ kN/m}$$

$$(16 \times 3.4) = (4.55 \times 3.2 \frac{1}{2}) + (T \times 2.80)$$

$$\therefore T = 11 \text{ mm}$$

$$\text{AREA TIG} = \frac{11500}{160} = 69.4 \text{ mm}^2$$

18 - BAR

$$A = 179 > 69.4 \checkmark$$

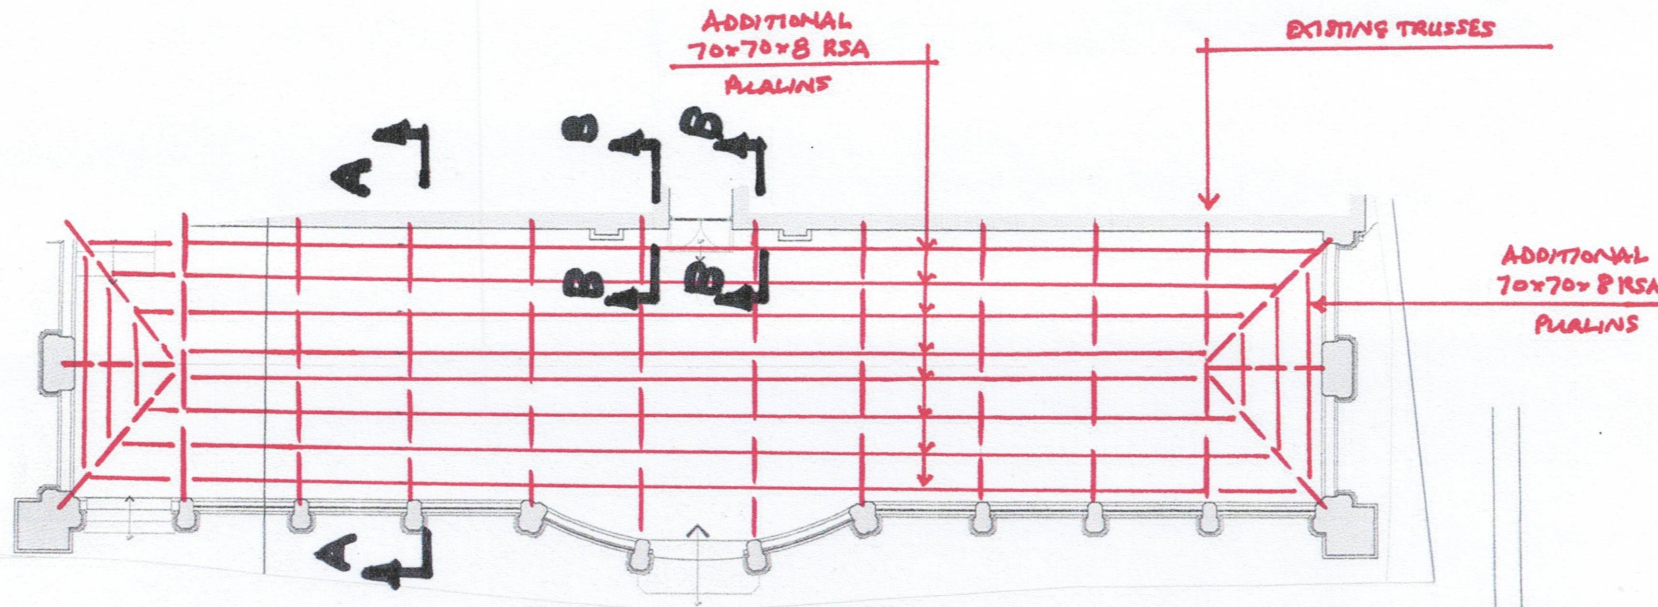
| 25/195 : 01 | |

PLAN

The most simple and structurally efficient remedy is to install a tie across the building width between the feet of each truss. I have prepared calculations to prove what is required and drawings to demonstrate the details, all included as Appendix 'B'. The vertical position of the tie is determined by the height of the arched 'feature' against the southern wall of the house; the ties cannot be below this height and so will be installed immediately above it.

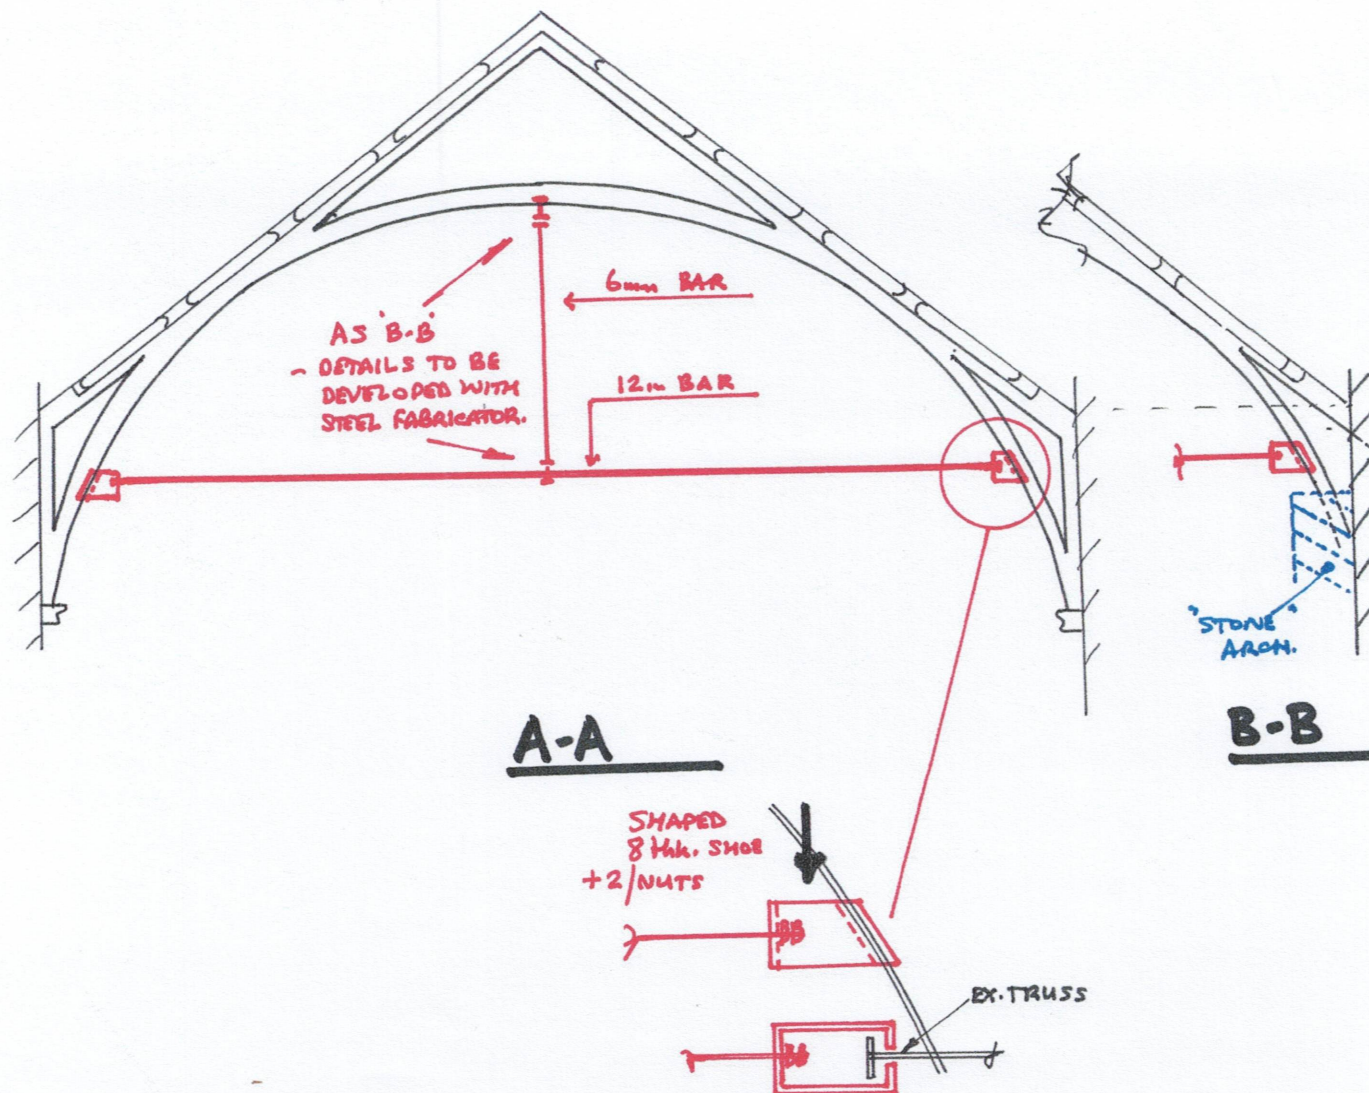
| 25/195 :02 | |

SECTIONS

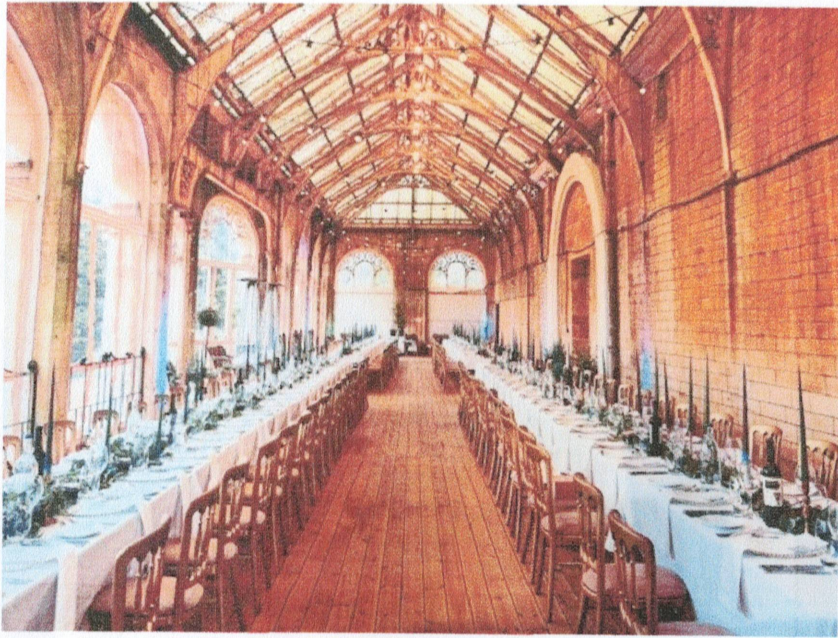
**PLATE 01 -- INTERNAL VIEW**

Unfortunately, the purlins and trusses could not be seen due to the presence of a temporary fabric ceiling supported from the roof structure, presumably to 'manage' the internal air temperatures. However, my Clients have found a photograph of the building interior; this shows the roof soffit and walls, and is included as Plate 01 in Appendix 'A' as reference.

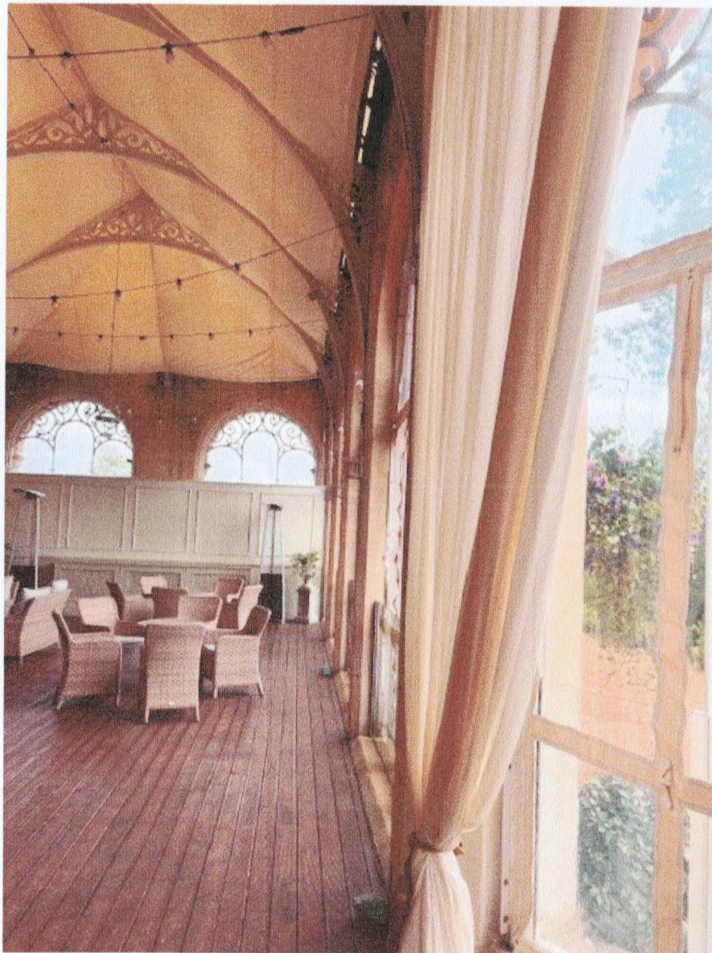
**PLATE 02 -- LEANING SOUTHERN ELEVATION WALL**

The external and internal inspection of the masonry showed a very slight outwards lean at the head of the columns in the two gable ends, and slightly more in the long, southern wall. [ Plate 02 ]. In addition, some cracking can be seen in the turned masonry arches in the southern wall. [ Plate 03 ]. This damage clearly indicates outwards movement of the upper part of the southern wall caused by an unrestrained outwards thrust at the feet of the roof trusses.

This type of cause of damage is very typical in large roofs where there is no effective lateral tie to the truss feet where they are built into their supporting walls. The material properties of the trusses are unknown because the date of manufacture pre-dates the time when adequate records were retained. Accordingly, it is impossible to precisely calculate the magnitude of theoretical outwards spread at eaves level – nevertheless, by comparing those likely material properties with current parameters I have assessed that the likely eaves spread will be approximately 25-35mm at the southern elevation; there can be no spread at the northern side due to the buttressing provided by the house.

The existing spread at eaves level clearly indicates that the existing roof structure and its supporting masonry cannot satisfactorily sustain the weight imposed by the roof structure with the consequence being outwards spread at eaves level and cracking of some masonry units.
