As an update to my concerns about flooding from the proposed development site application PL/2026/00195, the photographs below show how flooding and surface water runoff extends to other areas putting them at risk of flooding.

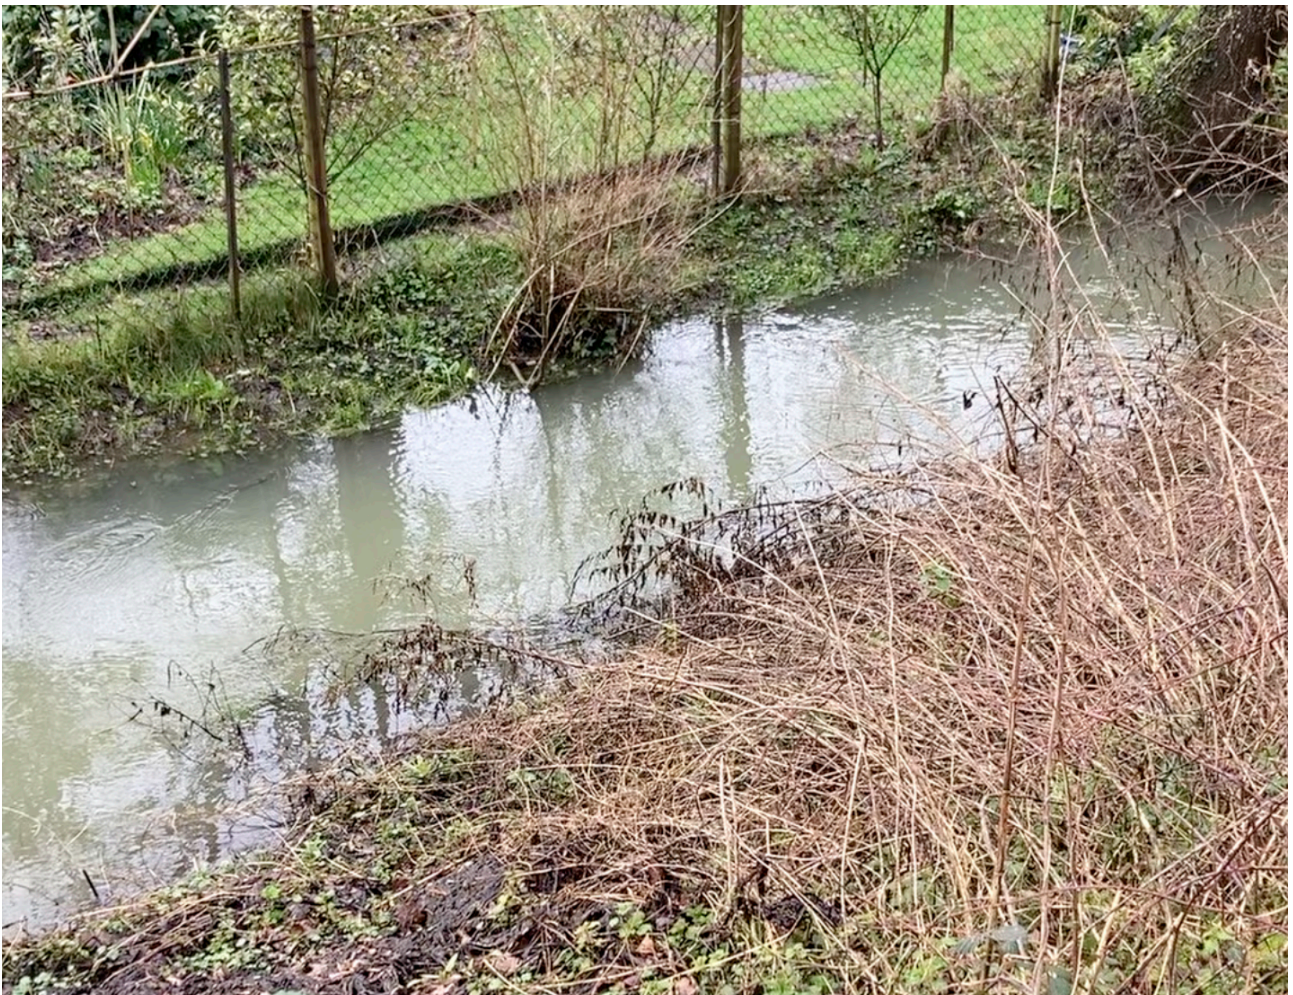
Today my wife noted that the River Were at this point was encroaching onto the back gardens of houses along Manor Gardens.

**Above:** River Were is close to flooding the back garden

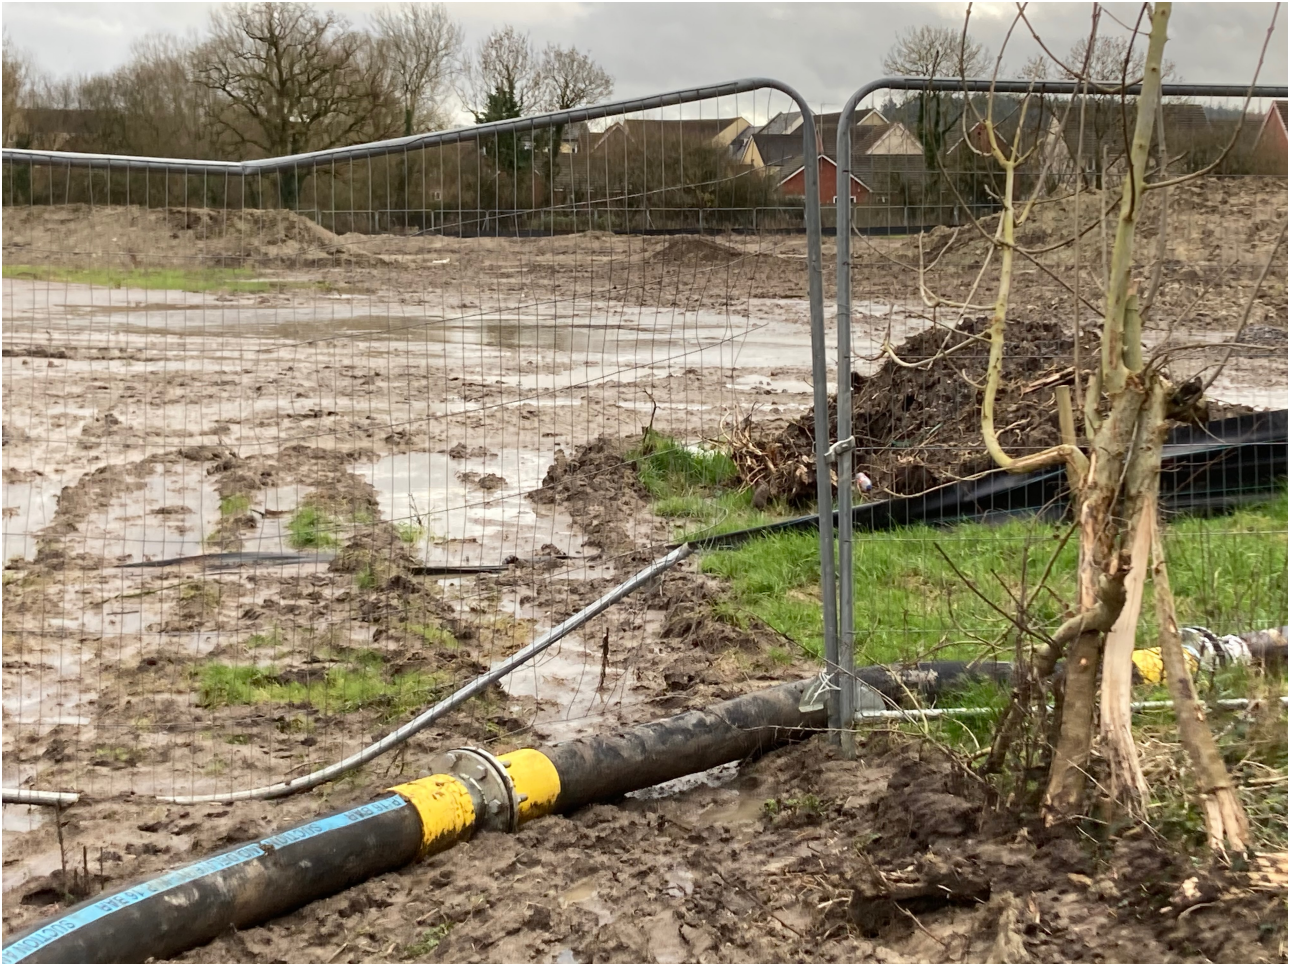
The source of the muddy water is the Jubilee housing development which has flooded over much of its land to such an extent that the water exceeds the height of the retention pond which has been barricaded to prevent further overflow, with straw bales laid to minimise the effects of flooding. The pumping has used long pipes to take the water to the river where at which point the flood water is taken down hill causing the problems at Manor Gardens and Newport.

**Above:** Part of the piping to remove flood water from Jubilee Gardens.

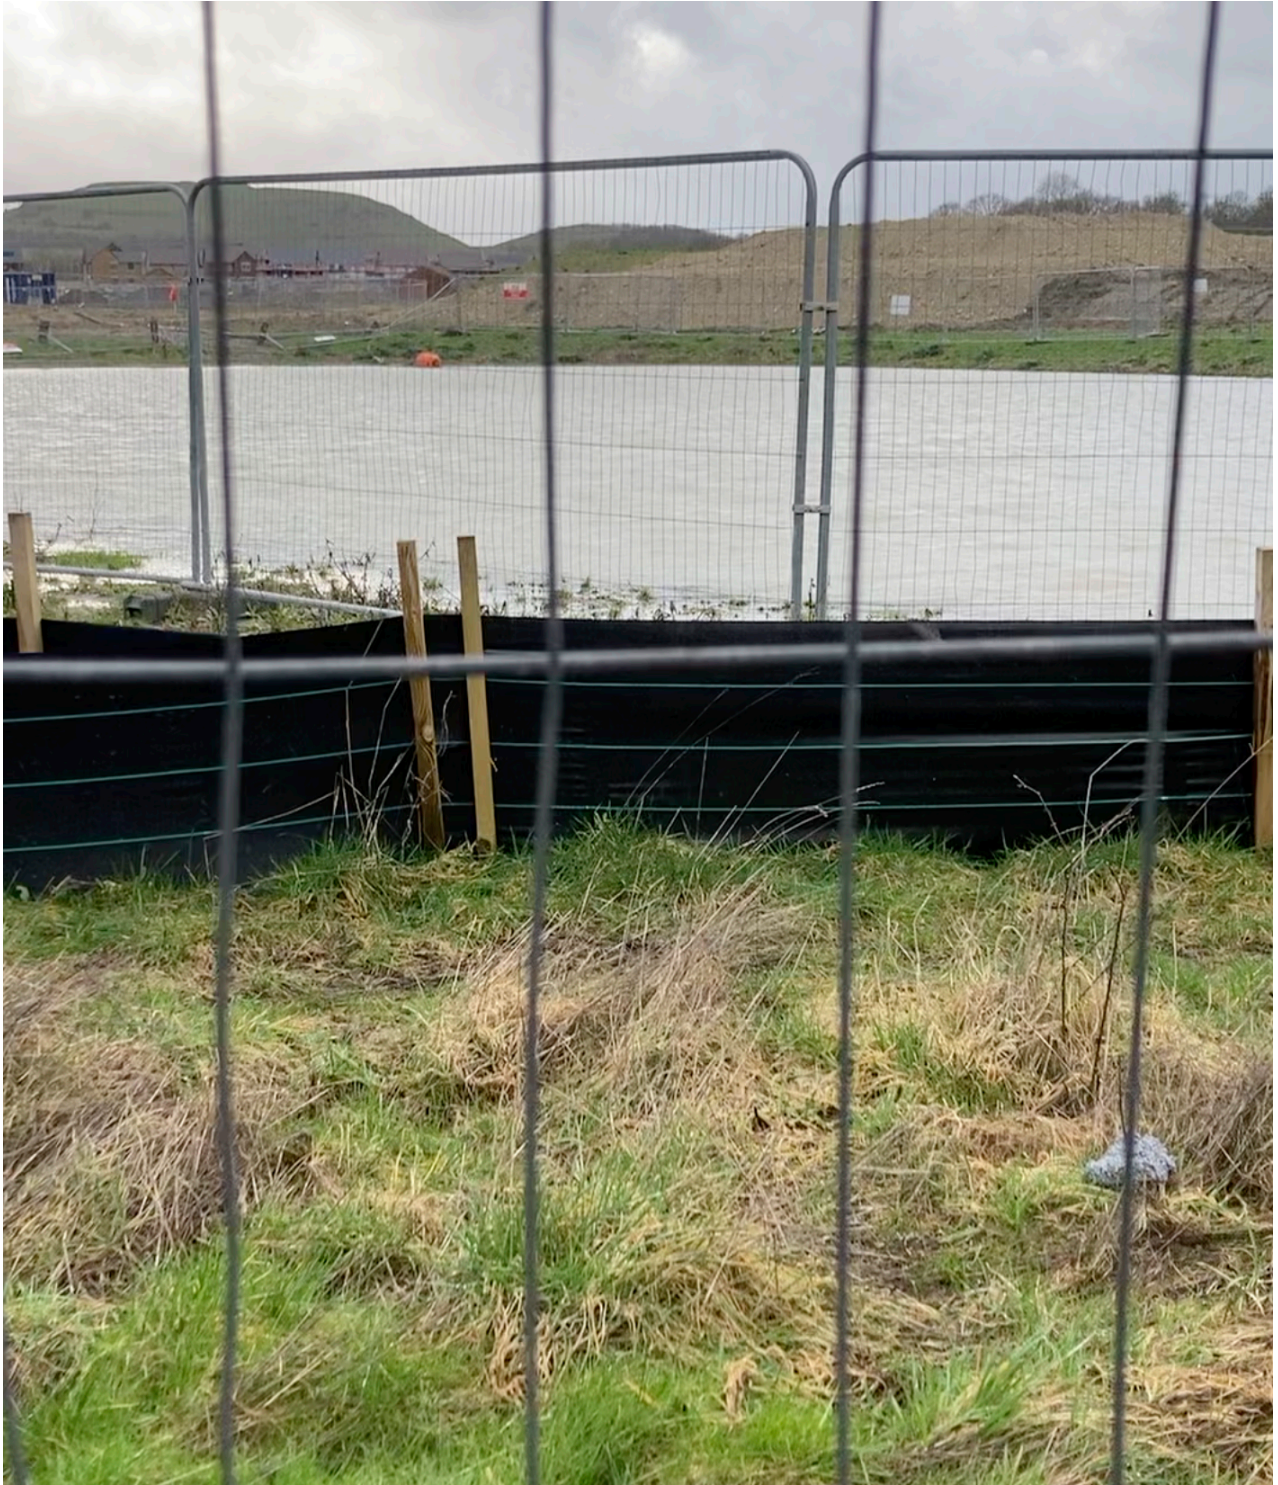
**Above:** Water in the attenuation pond is flooding, requiring extra barricading.

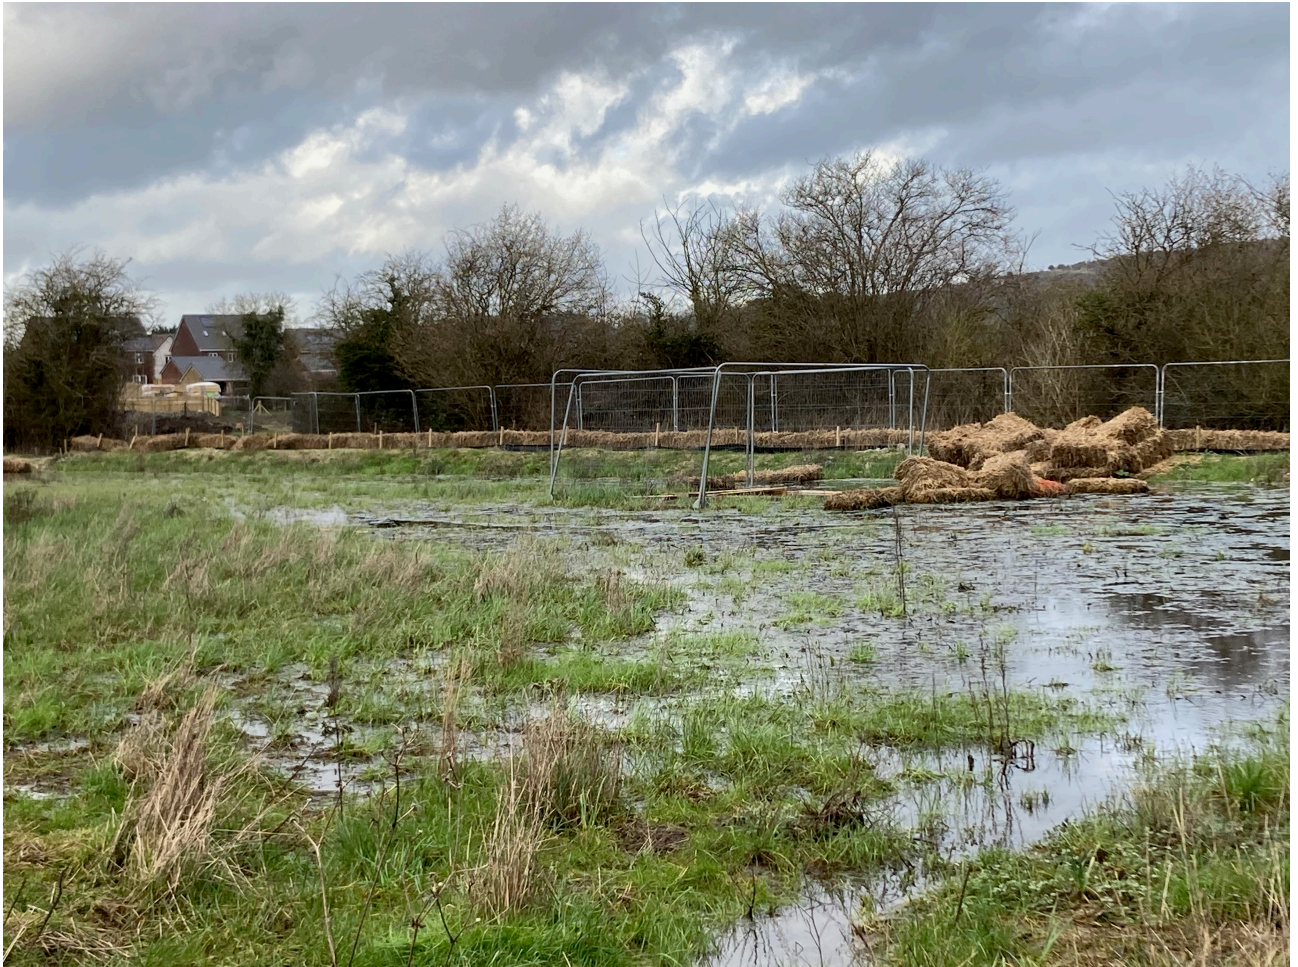
**Above:** Hay bails have been placed to reduce flooding spreading further into the Jubilee Gardens development.

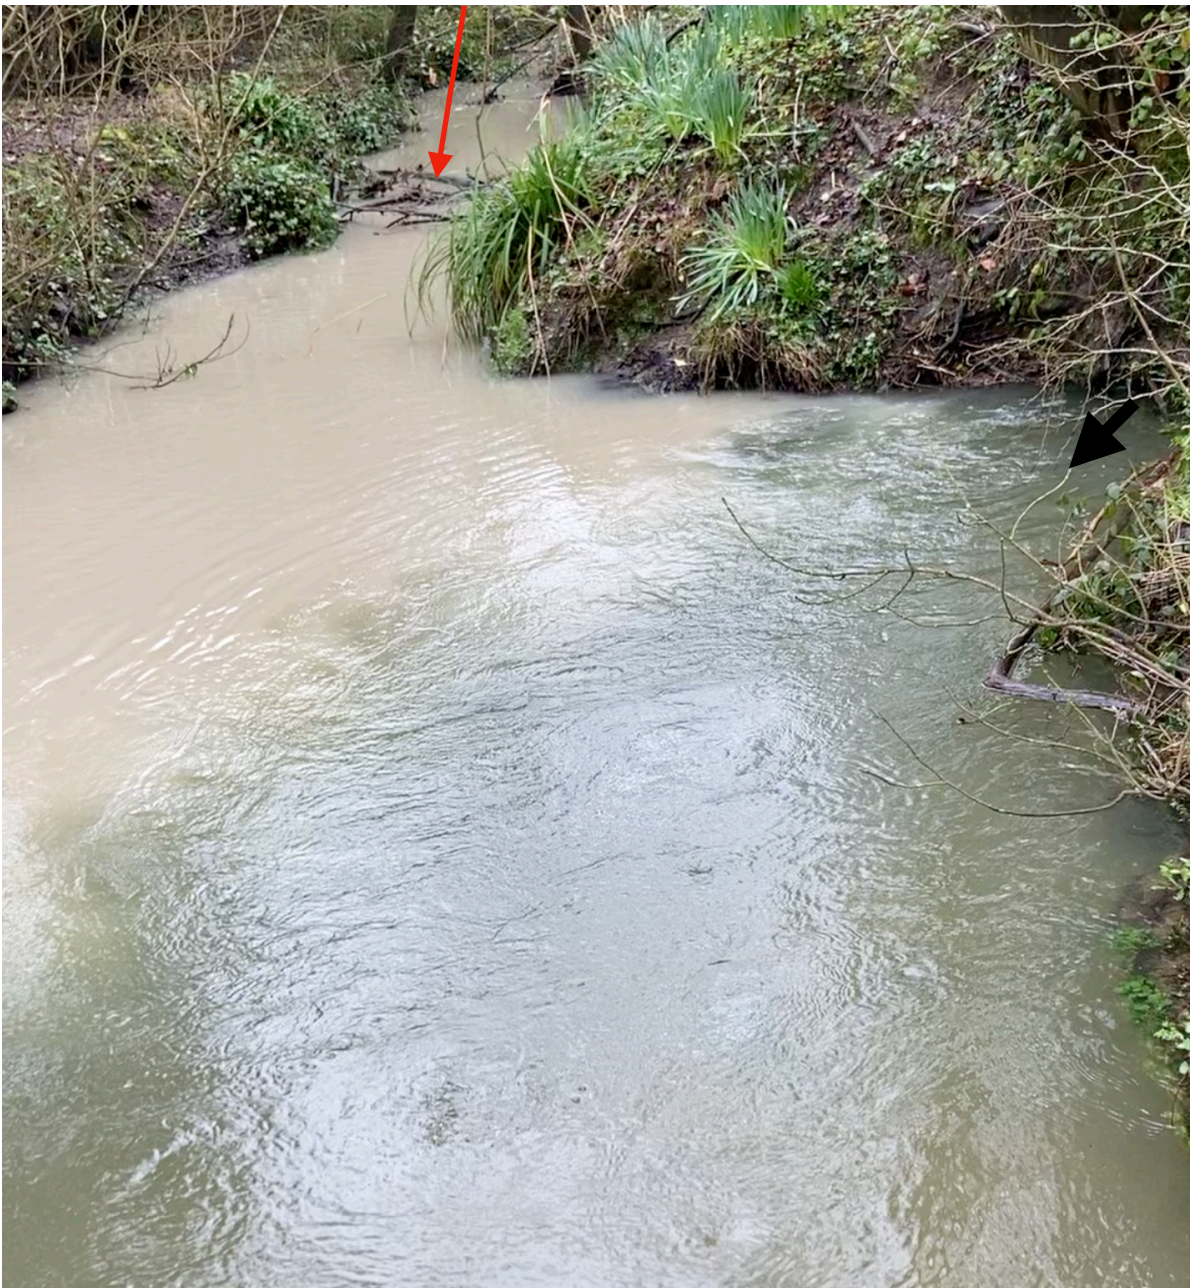
The photograph below highlights that floodwater from the Jubilee Gardens development, marked by the red arrow is muddy, whereas water from the un-named stream runoff, marked with the black arrow, is clear.

Both sets of water contribute to the effects seen in the first photograph, where if flood water run off gets worse, the back gardens along Manor Gardens will be flooded.

**Above:** Muddy water from Jubilee Gardens is seen mixing with clear water from the un-named stream at the point of the bridge.
