| Project:<br><b>Project Autumn Phase 8</b> | | | | |
| Drawing Title:<br><b>Existing Cluster Plan, Phase E<br/>Lodges 832 - 841</b> | | | | |
| Project Address:<br><b>Longleat Forest, Warminster BA12 7PU</b> | | | | |
| Drawing No:<br><b>2479-LF-P8-(E)001</b> | | | | |

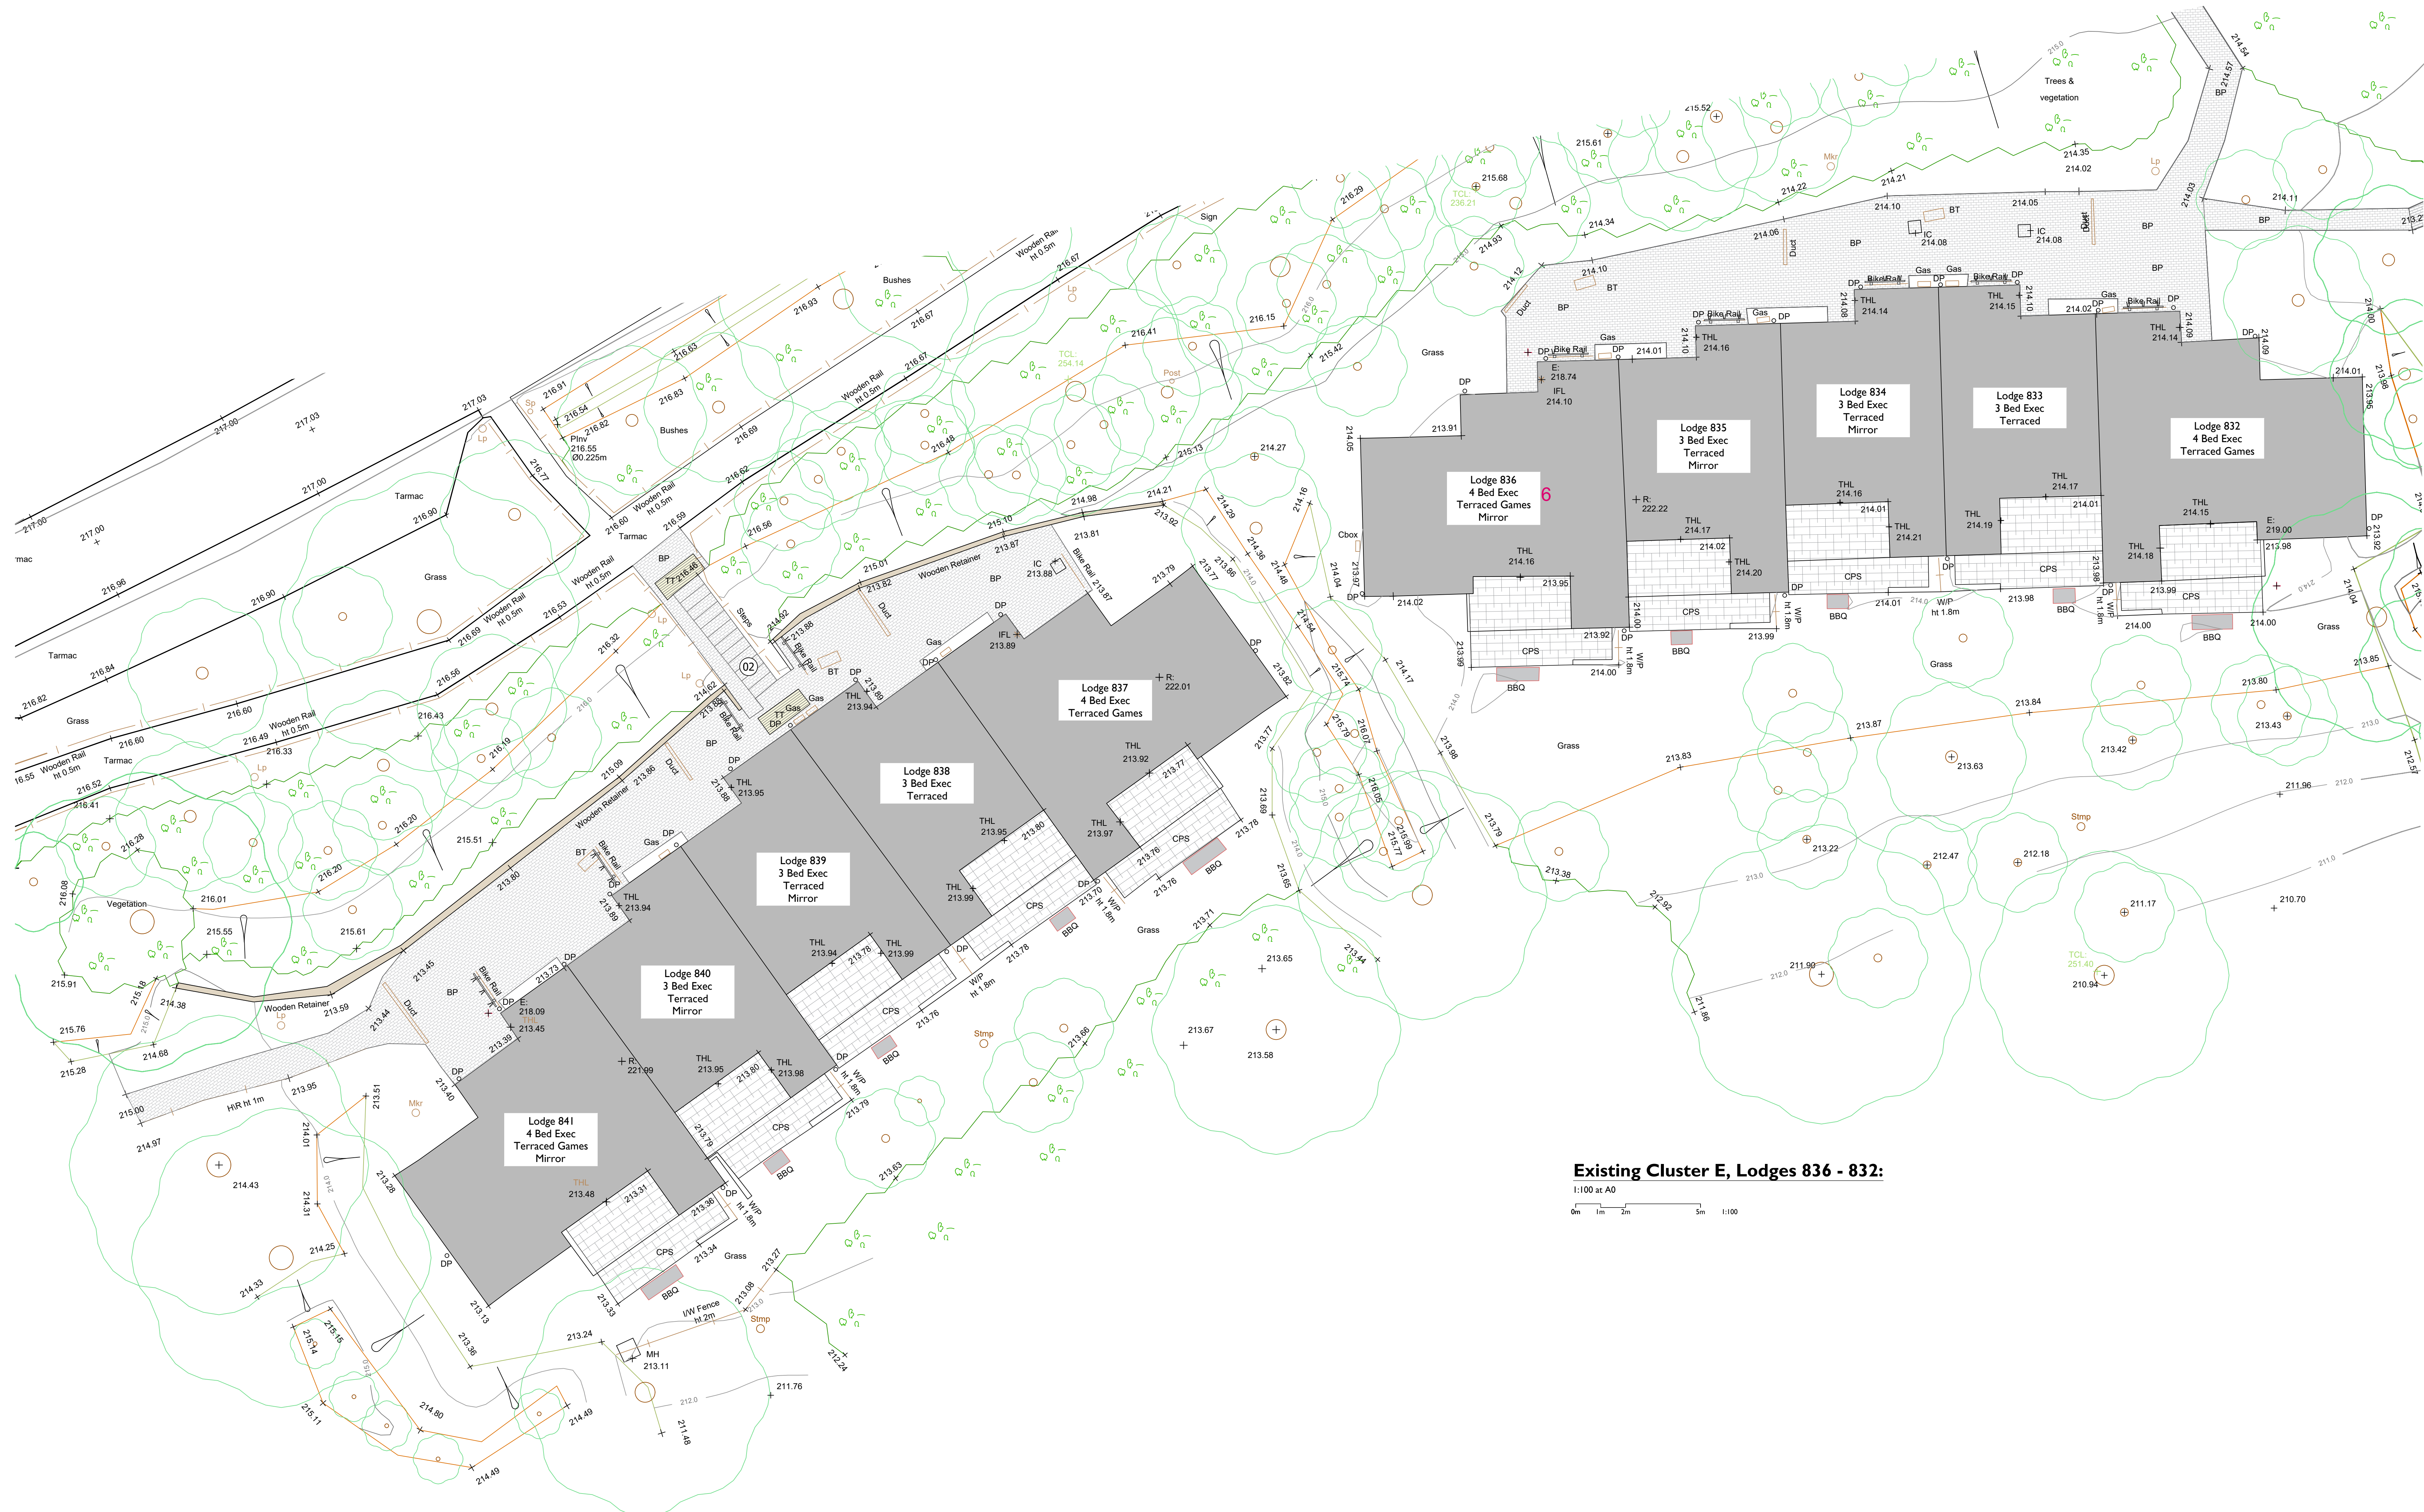
- Key Site:**
- Existing Patio
  - Existing Lodge Block Paving to be jet washed using a rotary paving washer head
  - Existing Block Paving
  - Existing Lodge Block Paving to be jet washed using a rotary paving washer head
  - Retaining Wall
  - Existing retaining wall in poor condition. Village to survey extent of retaining wall and work to fall under village dilapidation budget.
  - Existing Steps
  - Existing steps / handrails in poor condition. Village to survey and works to fall under village dilapidation budget.
  - Bike Rack
  - Retaining Wall
  - Steps
  - Tactile Paving
  - Acro Drains
  - BBQs

**Existing Cluster E, Lodges 836 - 832:**

**Existing Cluster E, Lodges 841- 837:**
