Project:  
Project Autumn Phase 8

Drawing Title:  
Existing Cluster Plan, Phase D  
Lodges 820 - 829

Project Address:  
Longleat Forest, Warminster BA12 7PU

Drawing No:  
2479-LF-P8-(D)001  
TENDER ISSUE

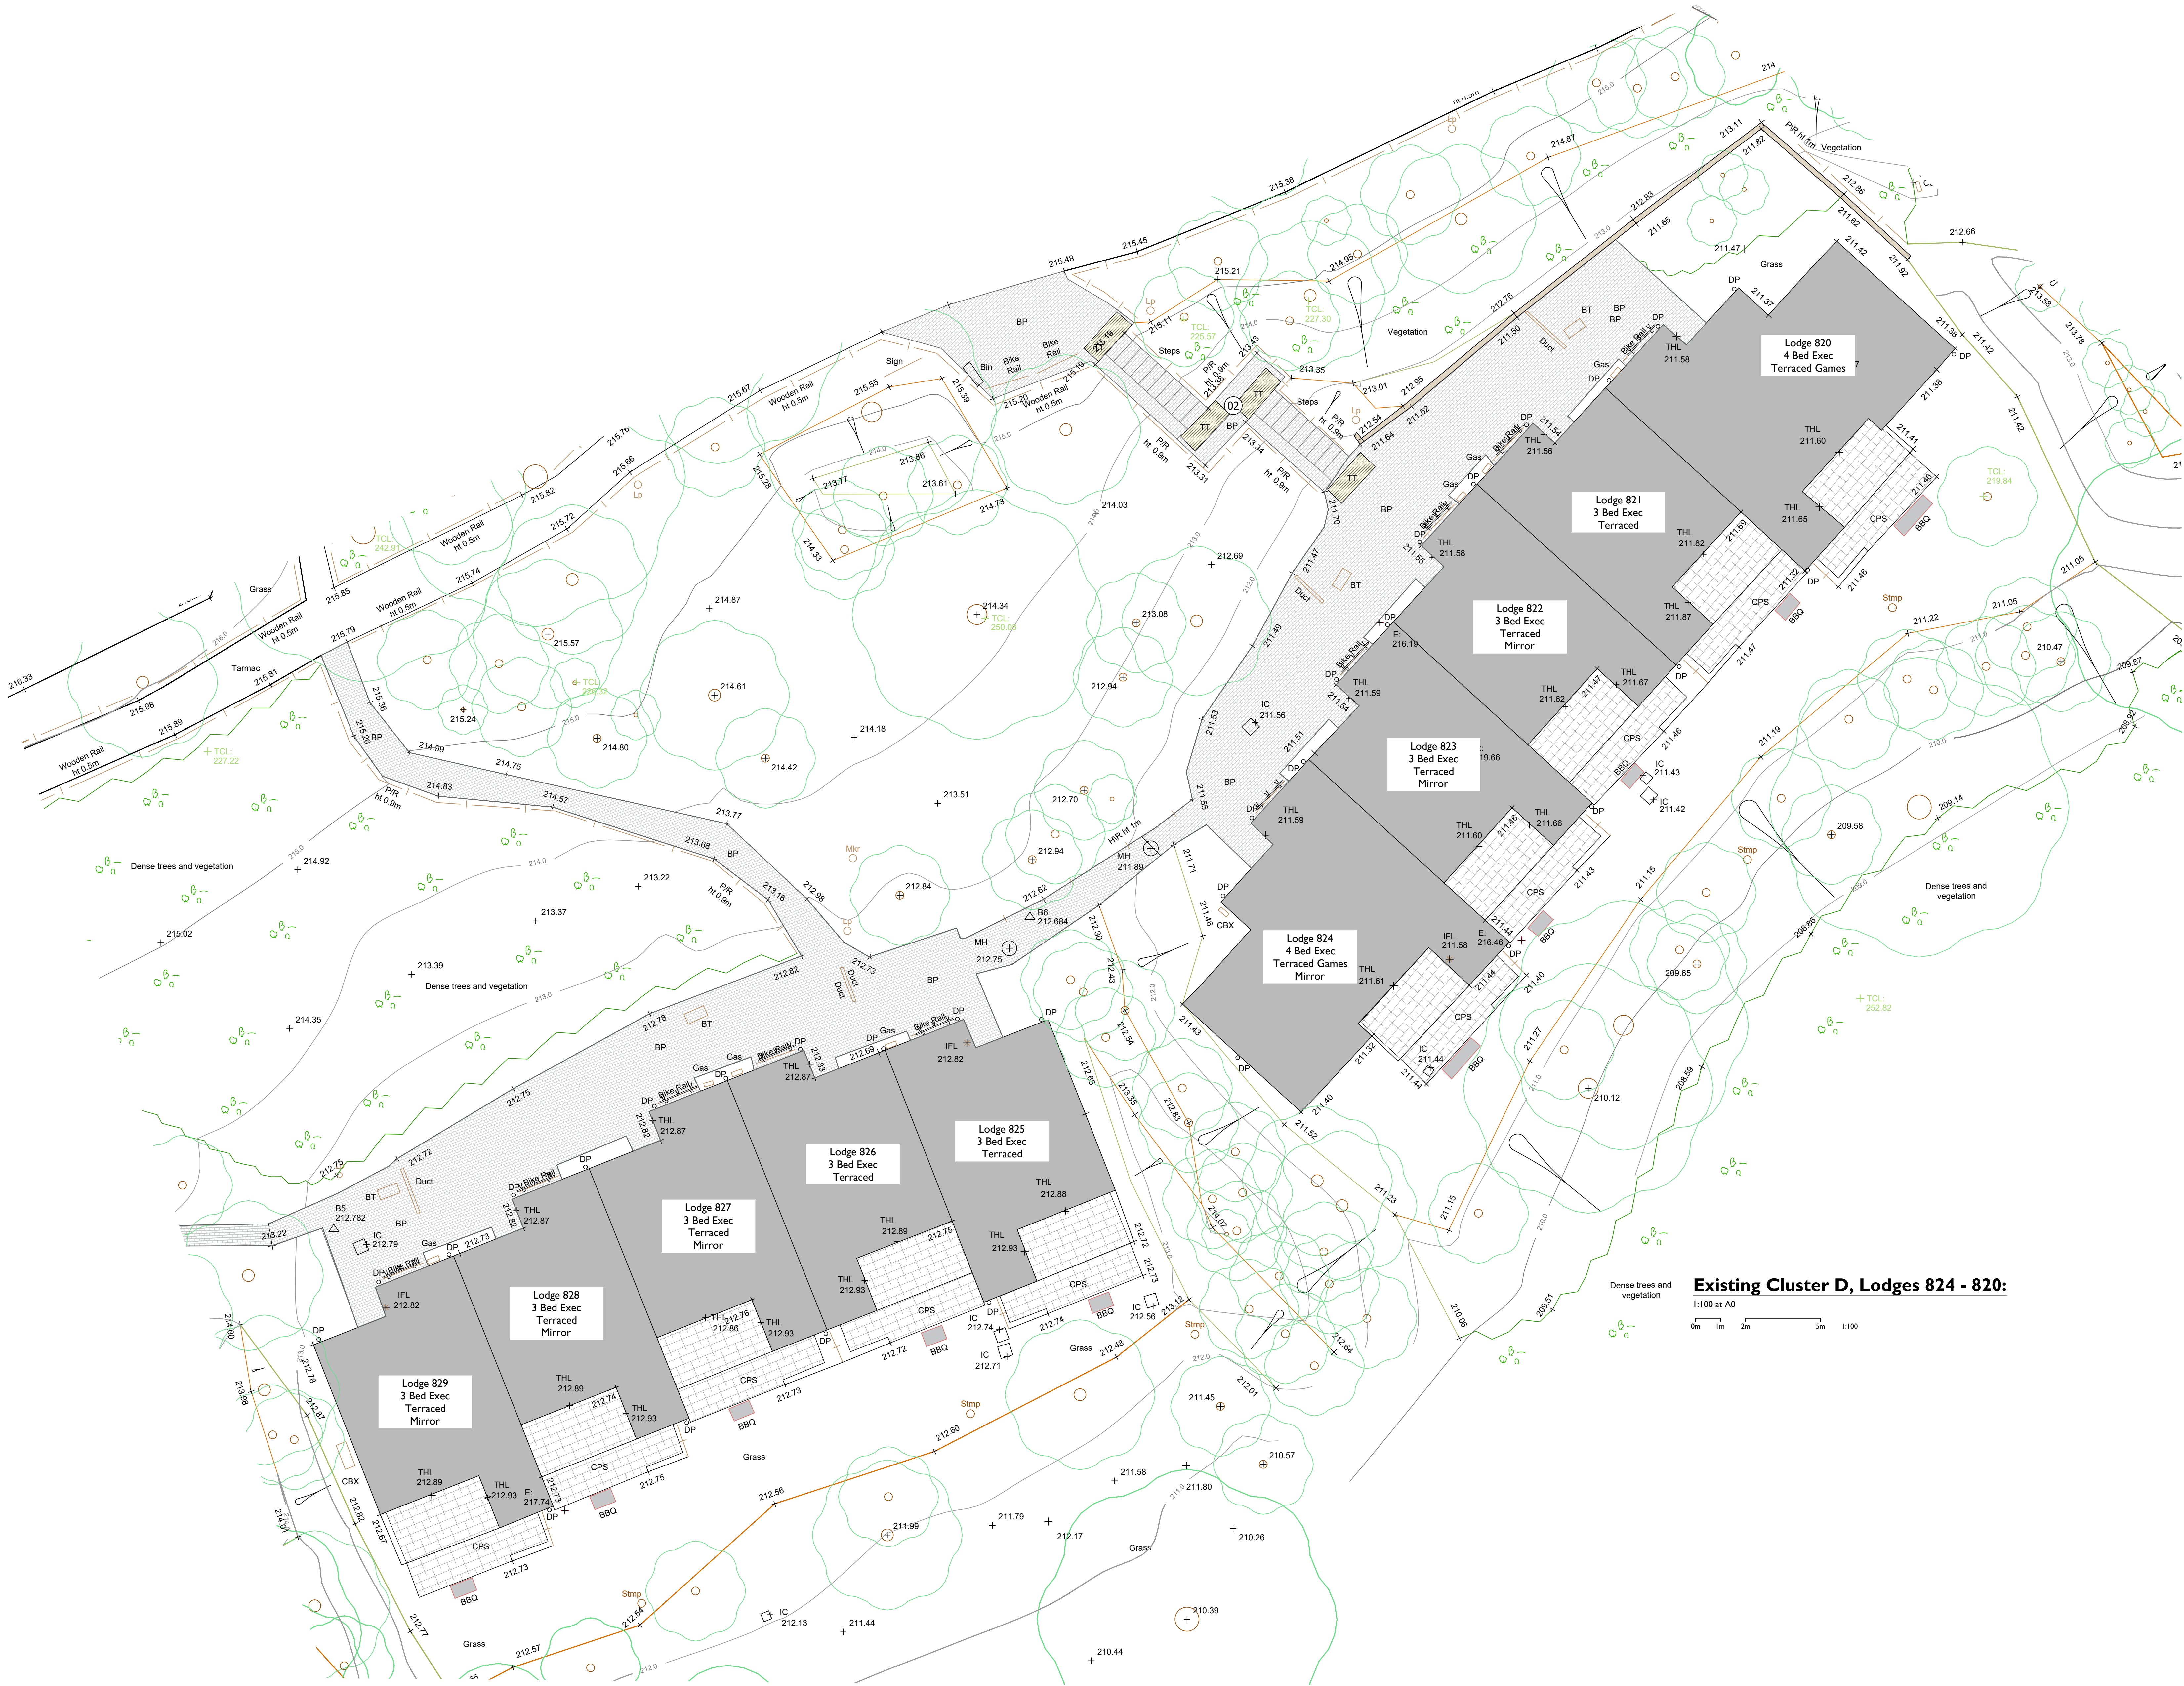
Existing Cluster D, Lodges 829- 825:

Existing Cluster D, Lodges 824 - 820:

- Key Site:**
- Existing Patio  
Existing Lodge Block Paving to be jet washed using a rotary paving washer head.
  - Existing Block Paving  
Existing Lodge Block Paving to be jet washed using a rotary paving washer head.
  - Retaining Wall  
Existing retaining wall in poor condition. Village to survey extent of retaining wall and work to fall under village dilapidation budget.
  - Existing Steps  
Existing steps / handrails in poor condition. Village to survey and works to fall under village dilapidation budget.
  - Bike Rack
  - Retaining Wall
  - Steps
  - Tactile Paving
  - Acro Drains
  - BBQs
