2 – 3 BENCES LANE CORSHAM WILTS SN13 0DD

## HISTORICAL ASSESSMENT

Creating first floor link, further minor alterations  
and linking together outbuildings

February 2026

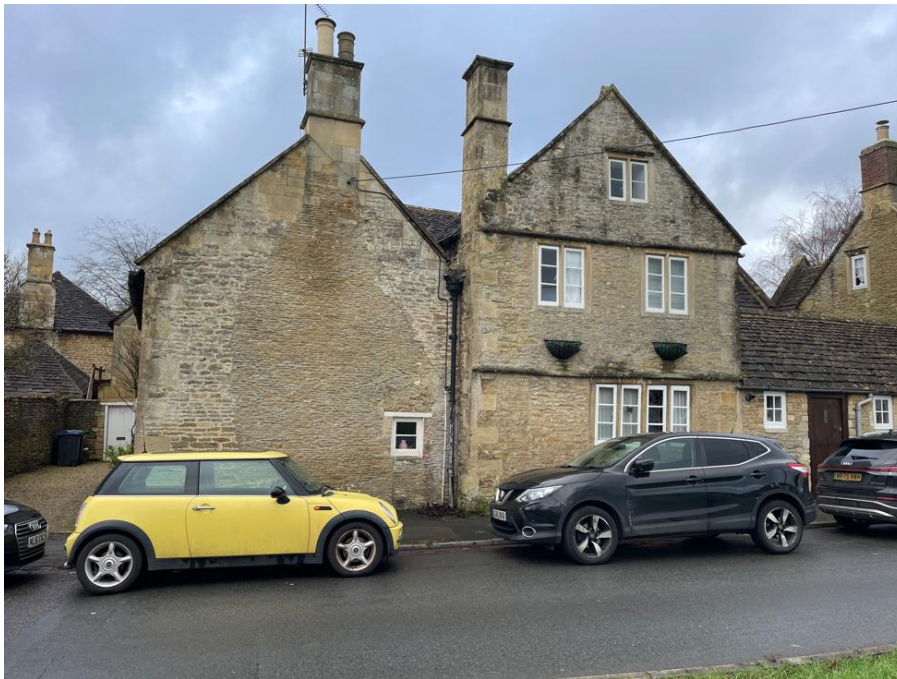
**2 – 3 Bences Lane seen from the common, with no. 6 Bences Lane to the right**

From an external appraisal of the buildings and adjoining cottage, we believe no.6 Bences Lane is the original 'house' and no's 2&3 were originally outbuildings. The junction between no's 2 & 3 has

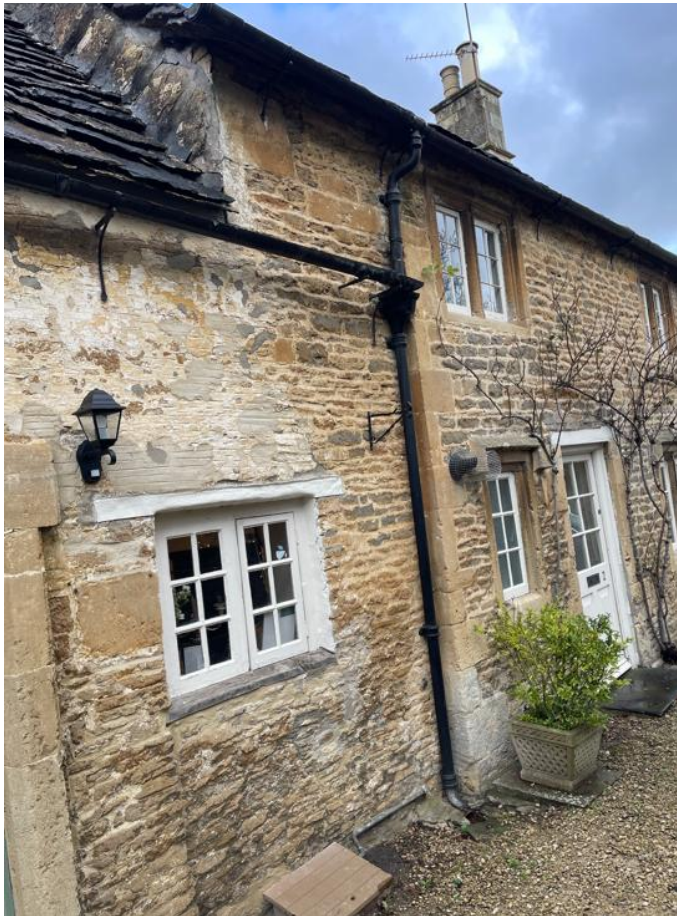
## **The junction between the two cottages appears to land over the Kitchen window**

The end of the cottage finishes approximately 1m from the neighbouring property to the rear, and a flying freehold belongs to the neighbours.

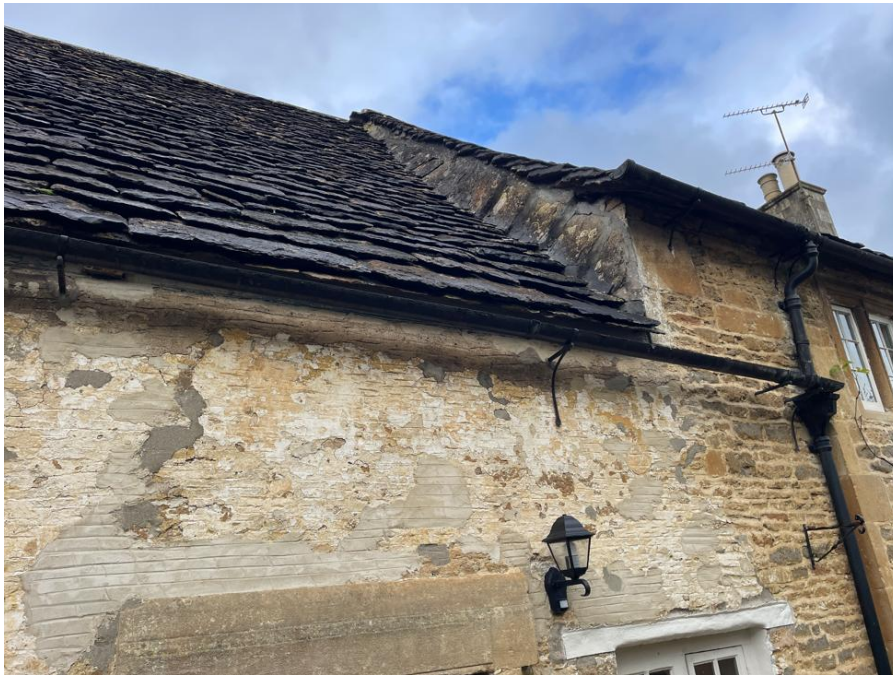
Further, the roof to no.6 has been extended over no's 2 & 3 as can be seen on the roof plan. The extension has 'lightweight' rendered walls to close off the spandrel rather than applying weight to the roof. It is however not entirely clear why or when this junction occurred, but we believe it was after the 'house' (6) and outbuildings, and was perhaps added to reduce the length of what is probably a problematic gutter between the two properties.

## **Junction between no's 2 & 3**

All in all, this is a very unusual 'joining together' of two cottages and it is unlikely that the true explanation will be uncovered. However the joining together has resulted in a disjointed first floor plan.

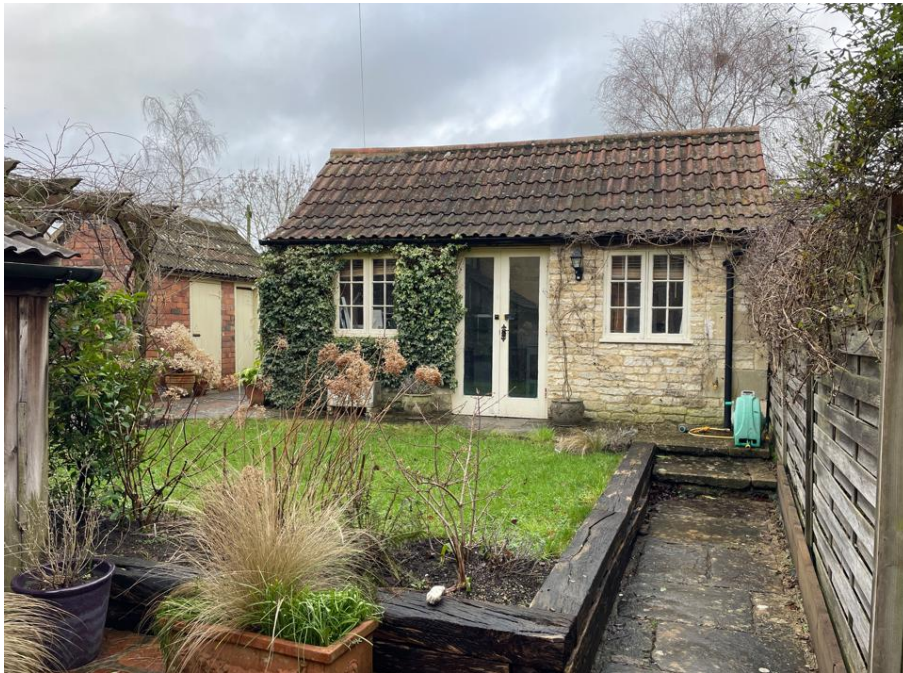
In the rear garden, accessed by going under the flying freehold, there are two outbuildings, with the northern most (larger) constructed over 10 years ago. The southern one is of greater age.

## Outbuildings
