## **Bugley Farm, Warminster Proposed Residential Development Controlled Waters Risk Assessment (CWRA)**

Report Reference: ESP.8917.4155

Prepared for:  
Keepmoat Homes Ltd  
The Waterfront  
Lakeside Boulevard  
Doncaster  
Yorkshire  
DN4 5PL

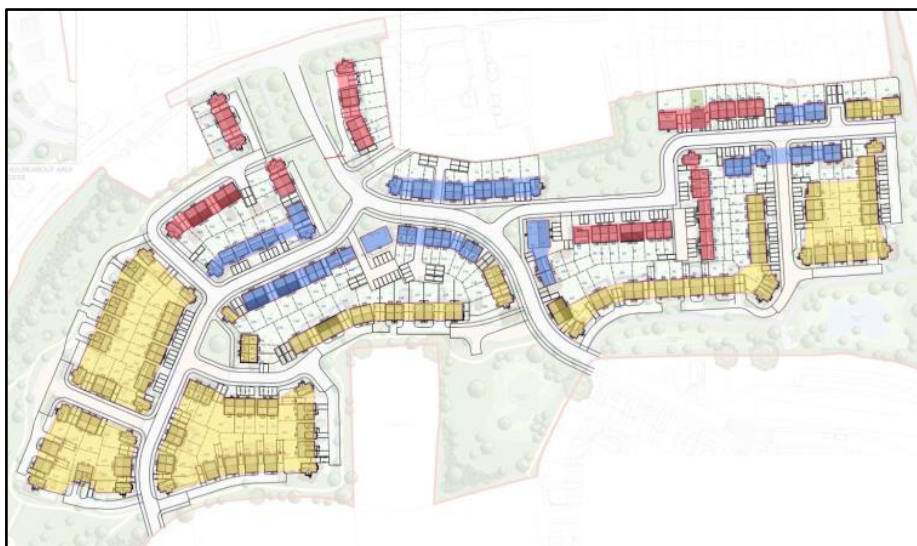
Insert 2 – Proposed Development Layout (after PPDS, document ref: STD001-PRO-X-XX-SP-DT-0122)

The proposed development comprises 227no. private and affordable residential units of varying size, with associated areas of private gardens, landscaping and hardstanding. A proposed site layout is shown as Insert 2 below.
