## Bat Emergence and Re-Entry Surveys (BERS)

Methuen Arms, 2 High Street, Corsham, SN13 0HB

Concorde BGW Ltd

“Internal alterations to the existing structures comprising (but not limited to) refurbishment of barn and attached outbuilding, installation of toilets at first floor level, creation of new food preparation area, installation of new floor, new wall finishes and repairs throughout. External alterations comprising new single storey rear extension, new doors, repairs and maintenance to rainwater goods”.

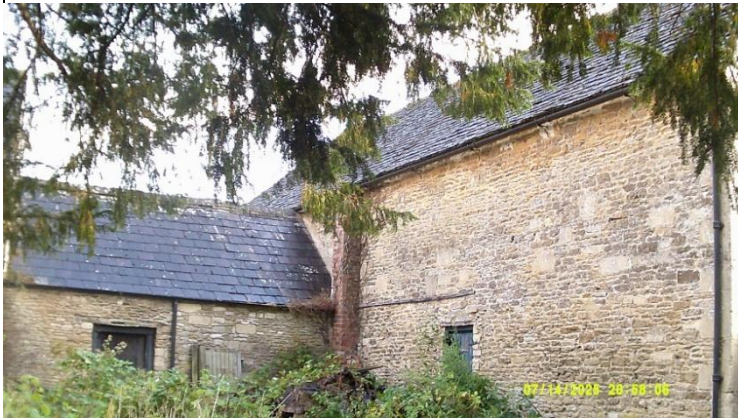
| Date of survey | | Sunset; Start - End |
|---|---|---|
| Surveyor 1 | <p><b>No emergences observed</b></p> <p>Key flight paths: N/A</p> <p>Key foraging activity: Above surveyor positions one and five, throughout the tree foliage.</p> <p>Species observed: Common pipistrelle and serotine.</p> <p>Summary of general activity:</p> <p>The first activity recorded during the survey was a common pipistrelle seen foraging above surveyor position throughout the tree foliage and east towards surveyor position five at 21:41. This continued intermittently until 22:10 with one recording of a serotine at 22:01. Between 22:15 and 22:25 there were four occurrences of common pipistrelles heard and not seen. From 22:31 till 22:49 there was continuous foraging throughout the same area as before. The final bat activity was a common pipistrelle heard and not seen at 22:56.</p> | <p>Full elevation photo showing surveyor's view.</p> |

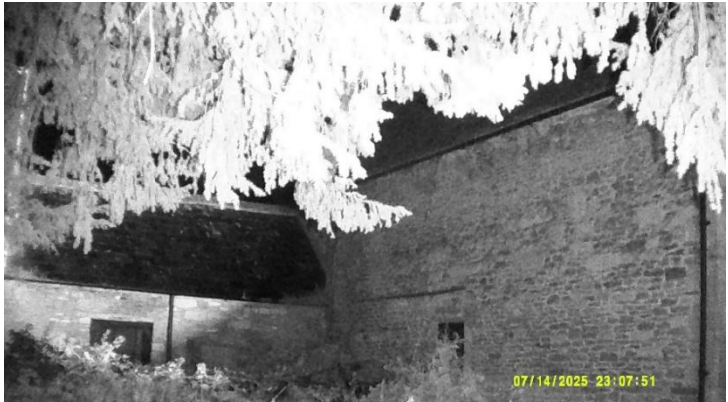
| <p><i>IR position 1</i><br/><i>Nightfox Whisker and</i><br/><i>Nightfox XB5 PRO</i></p> | <p>Camera position: observing east elevation of B1 and the north elevation of B2.</p> <p><b>No emergences or entries into the building seen upon review.</b></p> <p>No additional observations or bat activity recorded upon review.</p> | <p>Darkest point full elevation photo showing surveyor's view</p> |

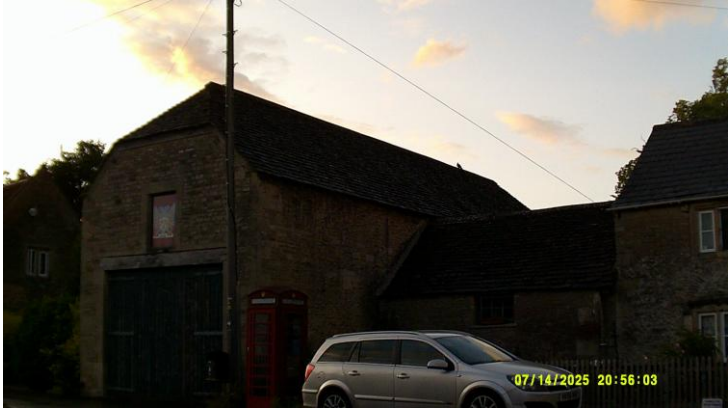
| <p><i>Surveyor 2</i></p> | <p><b>No emergences observed.</b></p> <p>Key flight paths: North to south above B2.<br/>Key foraging activity: N/A<br/>Species observed: Common pipistrelle, noctule and serotine.</p> <p>Summary of general activity:<br/>The first bat recorded was a Common Pipistrelle heard and not seen at 21:42. Common Pipistrelles were heard frequently throughout the survey, often seen commuting north to south over B2 as confirmed by other surveyors. At 22:12 a noctule was heard and not seen. There were two occurrences of serotines heard and not seen: 22:45 and 22:50.</p> | <p>Full elevation photo showing surveyor's view.</p> |

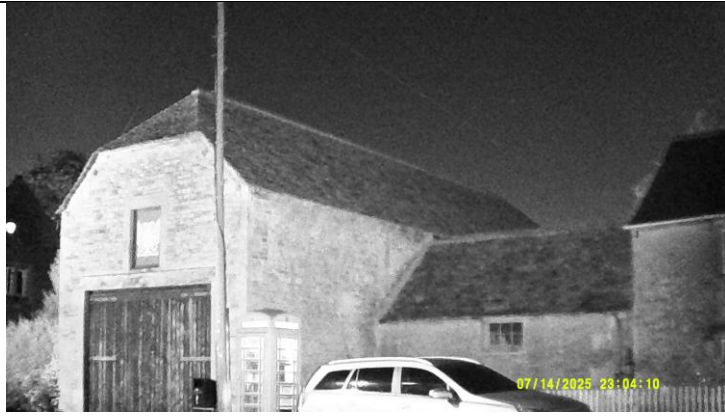
| <p><i>IR position 2</i></p> | <p>Camera position: observing the east elevation of B1 and the south elevation of B2.</p> | <p>Darkest point full elevation photo showing surveyor's view.</p> |

| <p><i>Nightfox Whisker and Nightfox XB5 PRO</i></p> | <p><b>No emergencies or entries into the building seen upon review.</b></p> <p>No additional observations or bat activity recorded upon review.</p> | |

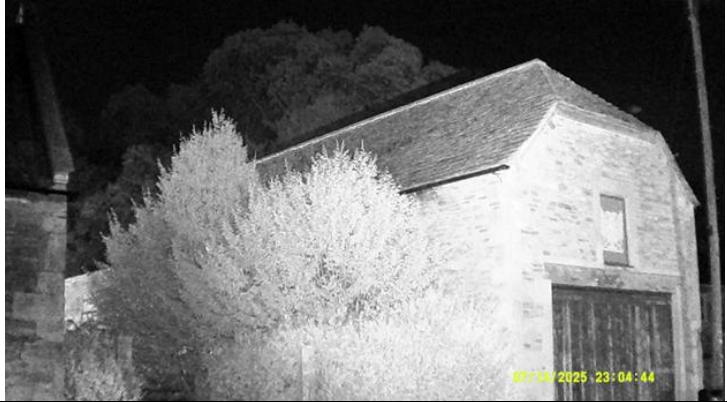
| <p><i>IR position 3</i><br/><i>Nightfox Whisker and</i><br/><i>Nightfox XB5 PRO</i></p> | <p>Camera position: observing the south and west elevation of B1.</p> <p><b>No emergences or entries into the building seen upon review.</b></p> <p>Summary of additional observations:<br/>At 22:07 a bat was seen not heard commuting northeast past the buildings West elevation.</p> | <p>Darkest point full elevation photo showing surveyor's view.</p> |

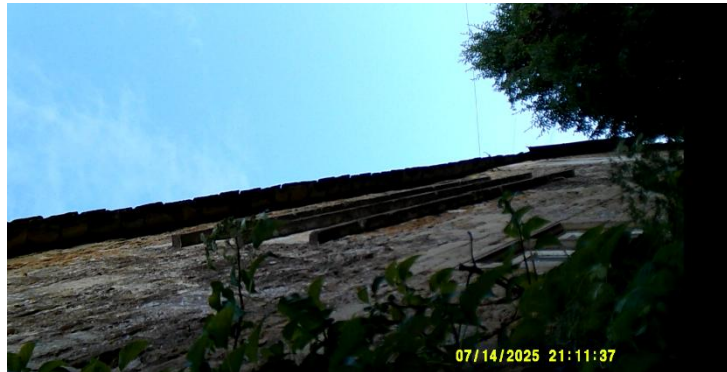
| <p><i>IR position 4</i><br/><i>Unmanned IR</i><br/><i>Nightfox Whisker and</i><br/><i>Nightfox XB5 PRO</i></p> | <p>Camera position: observing the west elevation of B1.</p> <p><b>No emergences or entries into the building seen upon review.</b></p> <p>Summary of additional observations:<br/>Common pipistrelles can be seen commuting south to north over B1 and in front of the western elevation.</p> | <p>Full elevation photo showing unmanned IR's view.</p> |

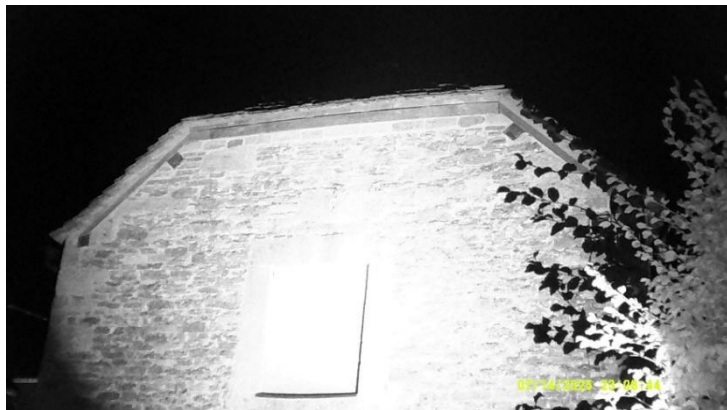
| <p><i>IR position 5</i><br/><i>Nightfox Whisker and</i><br/><i>Nightfox XB5 PRO</i></p> | <p>Camera position: observing the north elevation of B1.</p> <p><b>No emergences or entries into the building seen upon review.</b></p> <p>No additional observations or bat activity recorded upon review.</p> | <p>Darkest point full elevation photo showing surveyor's view.</p> |

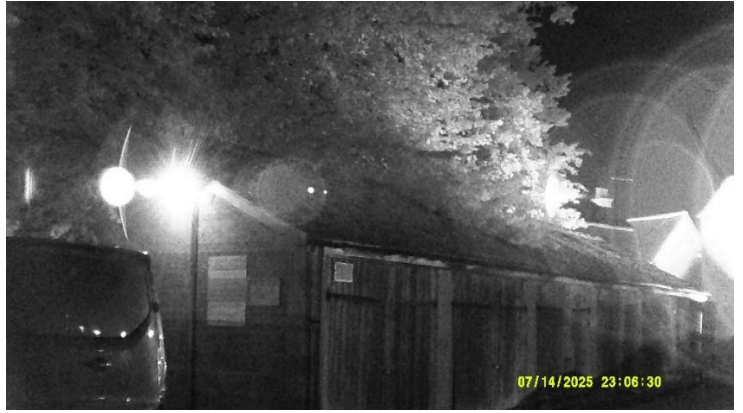
| <p><i>IR position 7</i></p> <p><i>Nightfox Whisker and</i></p> <p><i>Nightfox XB5 PRO</i></p> | <p>Camera position: observing the north and west elevations of B3.</p> <p><b>No emergencies or entries into the building seen upon review.</b></p> <p>No additional observations or bat activity recorded upon review.</p> | <p>Darkest point full elevation photo showing surveyor's view.</p> |

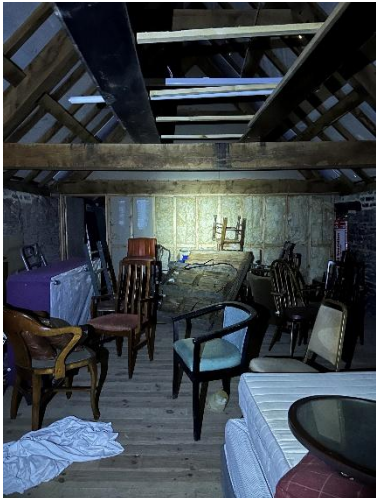
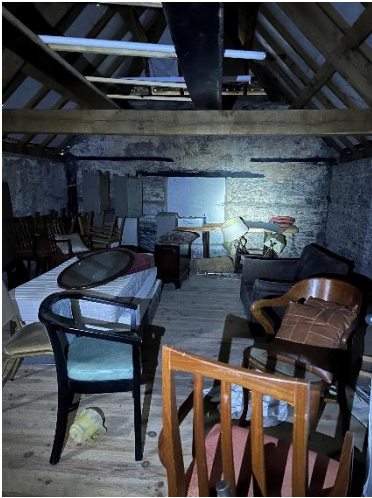
| | B1 northern half of loft void: loft void from north elevation | B1 northern half of loft void: loft void from central wall. |

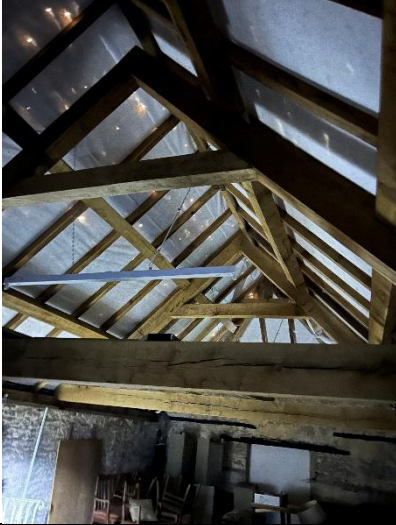
| | B1 northern half of loft void: Roof structure with gaps and wooden beams. | | B1 northern half of loft void: Bat dropping observed x1 observed | |

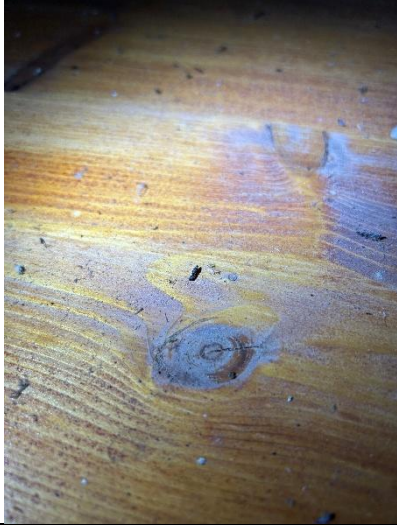
Even though three individual common pipistrelle droppings were found within the loft void of B1, the fact no emergence or re-entry activity was observed during the surveys indicates that these droppings would be as a result of an exploratory visit. However, this demonstrates that there is still risk to bats as a result of the proposed works, therefore precautionary working measures are needed to reduce risk to an acceptable level.

If works are started before May 2026 - Prior to removal of the roof tiles, another visual inspection using a torch will be carried out by a suitably qualified ecologist to inspect the roof tiles and loft void of B1.

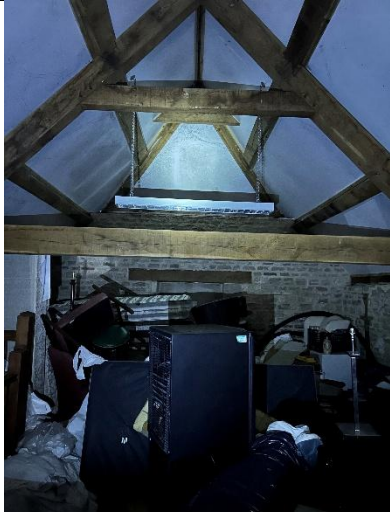
| | | B1 southern half of loft void: loft void from central wall. | | B1 southern half of loft void: Bat dropping observed x1 observed | |

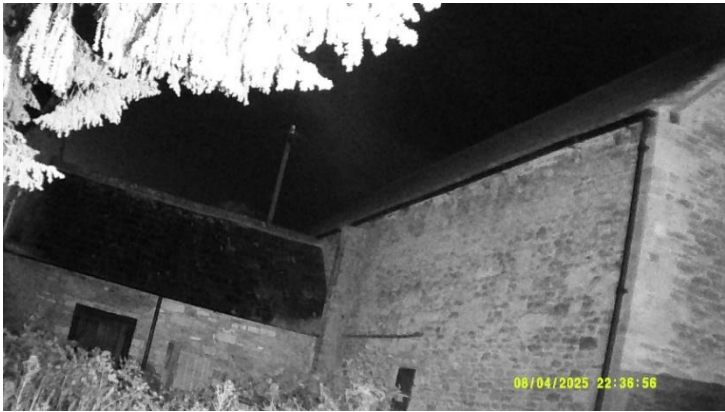
| <p><i>IR position 1</i><br/><i>Nightfox Whisker and</i><br/><i>Nightfox XB5 PRO</i></p> | <p>Camera position: observing east elevation of B1 and the north elevation of B2.</p> <p><b>No emergences or entries into the building seen upon review.</b></p> <p>No additional observations or bat activity recorded upon review.</p> | <p>Darkest point full elevation photo showing surveyor's view.</p> |

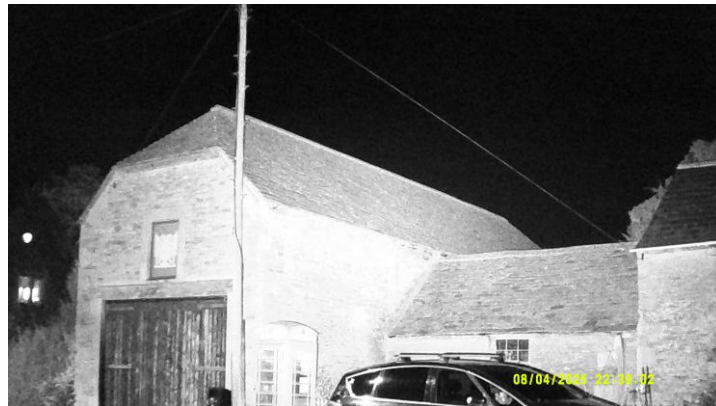
| <i>IR position 2</i><br><i>Nightfox Whisker and</i><br><i>Nightfox XB5 PRO</i> | <p>Camera position: observing the east elevation of B1 and the south elevation of B2.</p> <p><b>No emergences or entries into the building seen upon review.</b></p> <p>Summary of additional observations:<br/>Frequent common pipistrelle foraging activity across the southern elevation of B2 from 21:31 – 22:10.</p> | <p>Darkest point full elevation photo showing surveyor's view.</p> |

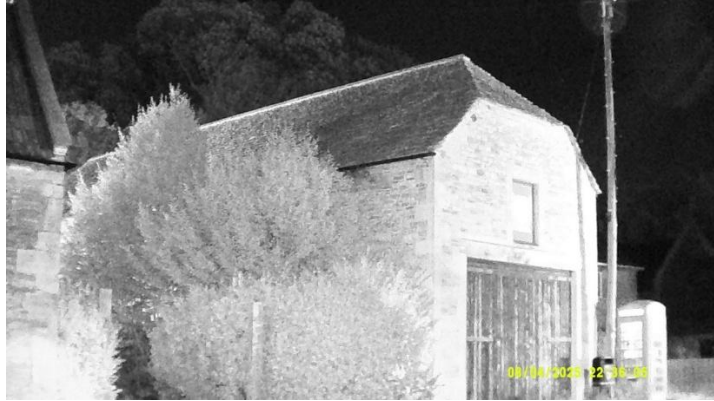
| <p><i>IR position 3</i><br/><i>Nightfox Whisker and</i><br/><i>Nightfox XB5 PRO</i></p> | <p>Camera position: observing the south and west elevation of B1.</p> <p><b>No emergences or entries into the building seen upon review.</b></p> <p>Summary of additional observations:<br/>At 21:38 a bat can be seen foraging high above B2 which coincides with a noctule heard at the time. Another bat can be seen foraging in front of the eastern elevation of B1 at 22:10. This coincides with serotine calls detected during the survey.</p> | <p>Darkest point full elevation photo showing surveyor's view.</p> |

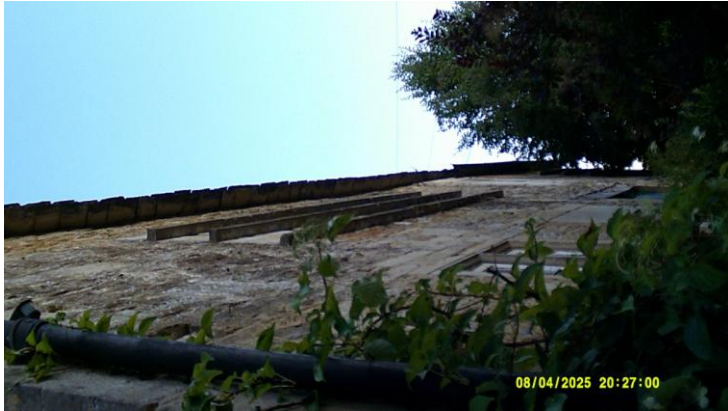
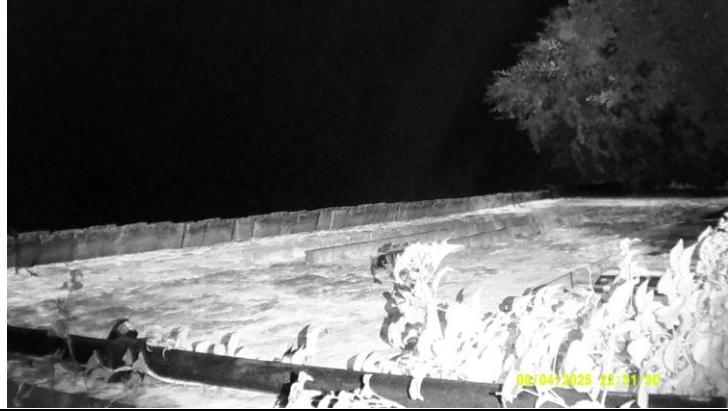
| <p><i>IR position 4</i><br/> <i>Unmanned IR</i><br/> <i>Nightfox Whisker and</i><br/> <i>Nightfox XB5 PRO</i></p> | <p>Camera position: observing the west elevation of B1.</p> <p><b>No emergences or entries into the building seen upon review.</b></p> <p>Summary of additional observations:<br/> Common pipistrelles can be seen commuting south to north over B1 and in front of the western elevation from 21:06 – 21:27.</p> | <p>Full elevation photo showing unmanned IR's view.</p> <p>Darkest point full elevation photo showing surveyor's view.</p> |

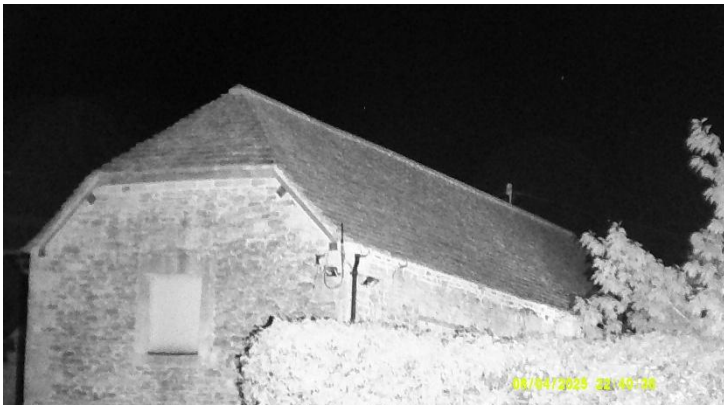
| <i>IR position 5</i><br><i>Nightfox Whisker and</i><br><i>Nightfox XB5 PRO</i> | <p>Camera position: observing the north and west elevations of B1.</p> <p><b>No emergences or entries into the building seen upon review.</b></p> <p>Summary of additional observations:<br/> Two common pipistrelles can be seen commuting from southeast to northwest over B1 at 21:01.</p> | <p>Darkest point full elevation photo showing surveyor's view.</p> |

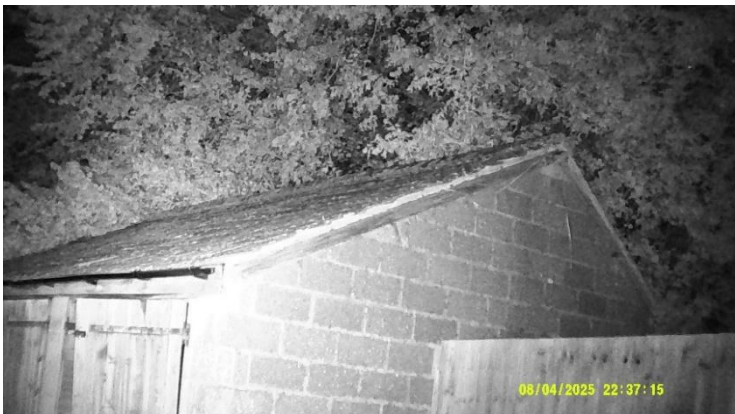
| <i>IR position 6</i><br><i>Unmanned IR</i><br><i>Nightfox Whisker and</i><br><i>Nightfox XB5 PRO</i> | <p>Camera position: observing the south elevation of B3.</p> <p><b>No emergences or entries into the building seen upon review.</b></p> <p>No additional observations or bat activity recorded upon review.</p> | <p>Full elevation photo showing unmanned IR's view.</p> <p>Darkest point full elevation photo showing unmanned IR's view.</p> |

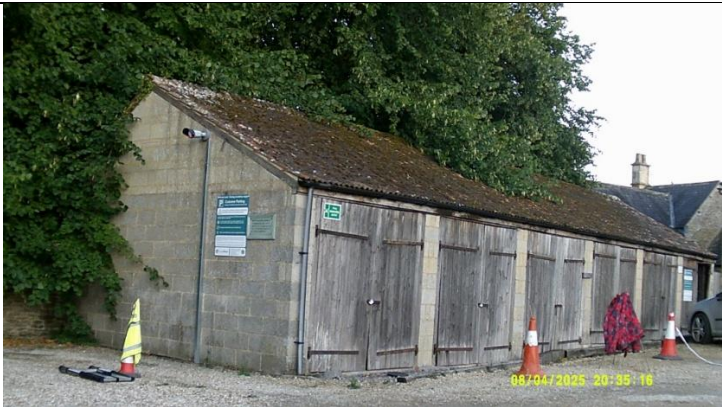
| | <p>Key flight paths: N/A</p> <p>Key foraging activity: In between the southern elevation of B3 and northern elevation of B1.</p> <p>Species observed: Common pipistrelle, noctule and serotine.</p> <p>Summary of general activity:</p> <p>The first bat activity recorded during the survey was a common pipistrelle heard and not seen at 21:07. This was followed by a noctule heard and not seen at 21:08. Common pipistrelles were seen intermittently foraging between the southern elevation of B3 and the northern elevation of B1 from 21:39 to 22:29. Between 21:47 and 22:17 there were seven occurrences of bats heard and not seen: three noctules and four serotines.</p> | |

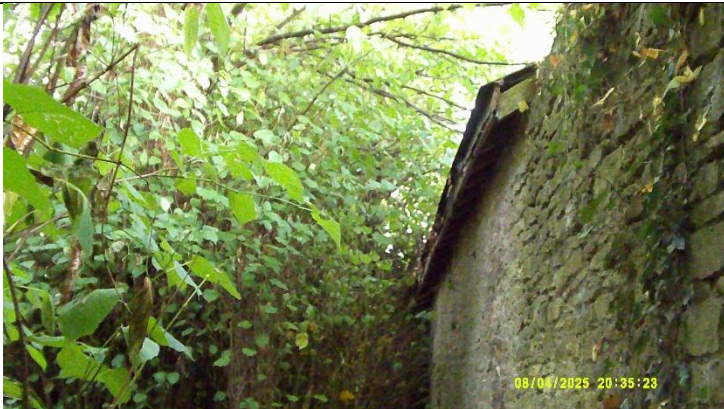
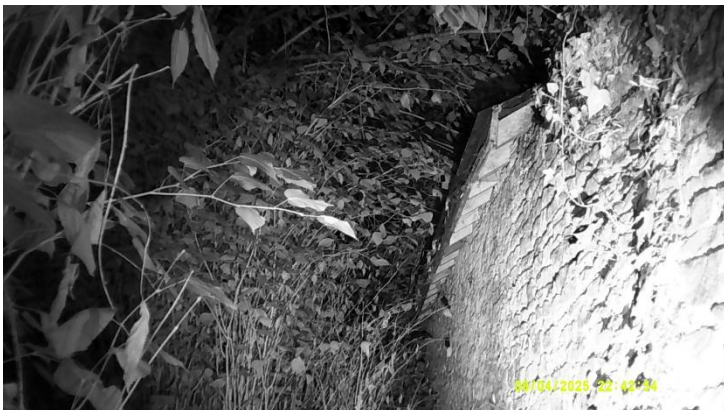
| <p><i>IR position 8</i></p> <p><i>Unmanned IR</i></p> | <p>Camera position: observing the east elevation of B3.</p> | <p>Full elevation photo showing unmanned IR's view.</p> |

| <i>Nightfox Whisker and Nightfox XB5 PRO</i> | <p><b>No emergences or entries into the building seen upon review.</b></p> <p>No additional observations or bat activity recorded upon review.</p> | <p>Darkest point full elevation photo showing unmanned IR's view.</p> |

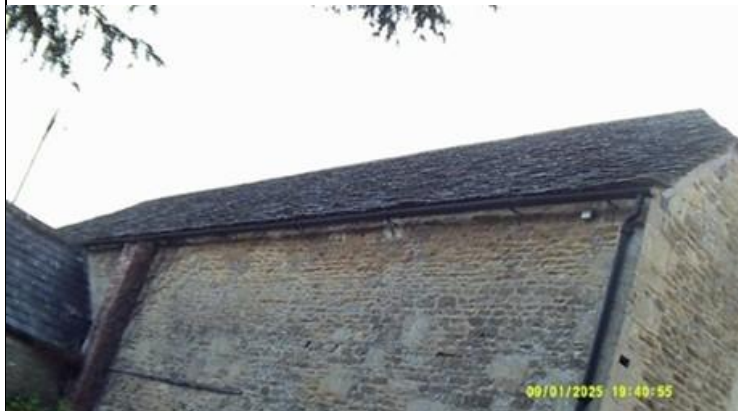
| Surveyor 1 | No emergencies observed<br><br>Key flight paths: N/A<br>Key foraging activity: N/A<br>Species observed: Noctule and Common pipistrelle<br><br>Summary of general activity:<br>The first activity recorded during the survey was a noctule heard but not seen at 20:06. There was a constant period of common pipistrelle heard and not seen activity from 20:06 till 20:29. The final two bats | | | Full elevation photo showing surveyor's view.<br> | |

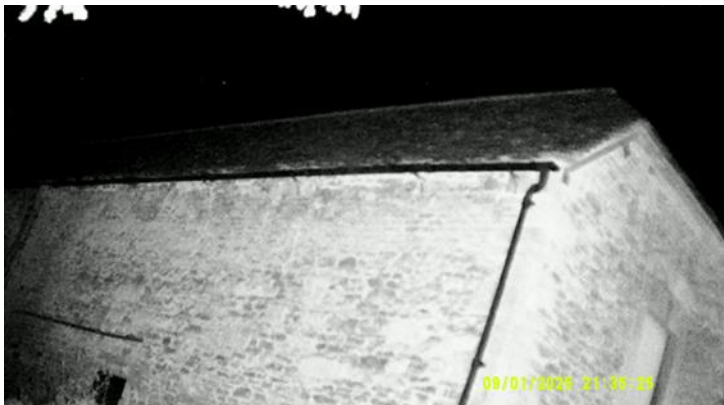
| <i>IR position 1</i><br><i>Nightfox Whisker and</i><br><i>Nightfox XB5 PRO</i> | <p>Camera position: observing east elevation of B1</p> <p><b>No emergences or entries into the building seen upon review.</b></p> <p>No additional observations or bat activity recorded upon review.</p> | <p>Darkest point full elevation photo showing surveyor's view</p> |

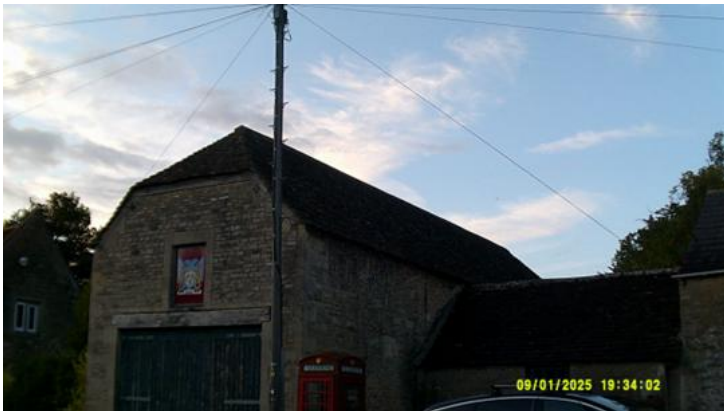
| <i>Surveyor 2</i> | <p><b>No emergences observed.</b></p> <p>Key flight paths: North in front of the eastern elevation.<br/>Key foraging activity: Above the trees northeast of the site and in front of the eastern elevation.<br/>Species observed: Common pipistrelle, soprano pipistrelle, noctule and serotine.</p> <p>Summary of general activity:<br/>The first bat activity recorded was a noctule heard but not seen at 19:56. This was followed by another noctule at 20:01 which was seen foraging above the trees northeast of the site. Two common pipistrelles were seen commuting north in front of the eastern elevation of B1 at 20:06 and 20:10. Common pipistrelle foraging activity in front of the eastern elevation was then frequently seen and heard throughout the remainder of the survey.</p> | <p>Full elevation photo showing surveyor's view.</p> |

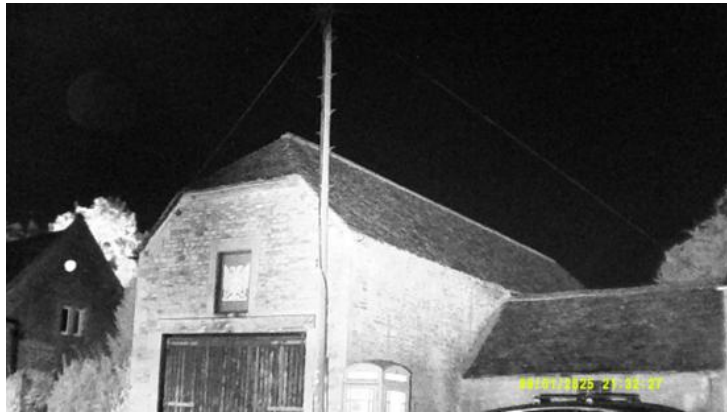
| <p><i>IR position 2</i><br/><i>Nightfox Whisker and</i><br/><i>Nightfox XB5 PRO</i></p> | <p>Camera position: observing the east and south elevations of B1</p> <p><b>No emergences or entries into the building seen upon review.</b></p> <p>No additional observations or bat activity recorded upon review.</p> | <p>Darkest point full elevation photo showing surveyor's view.</p> |

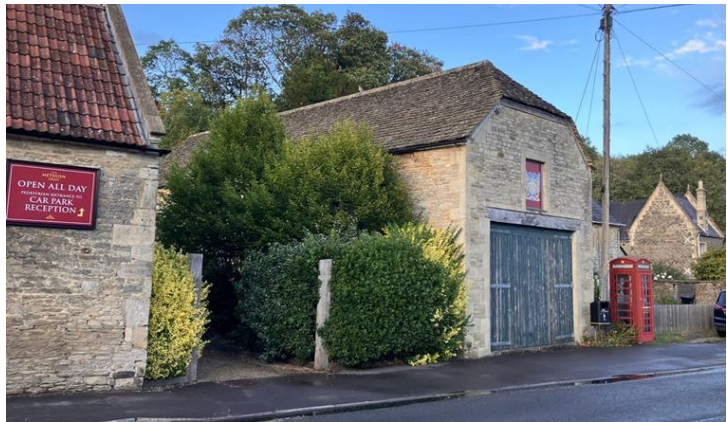
| <p><i>Surveyor 3</i></p> | <p><b>No emergences observed</b></p> <p>Key flight paths: south to north in front of the eastern elevation and north in front of the buildings west elevation.</p> <p>Key foraging activity: Above the road southeast of the building.</p> <p>Species observed: Common pipistrelle, soprano pipistrelle and serotine.</p> <p>Summary of general activity:<br/>The first bat activity recorded during the survey was a common pipistrelle commuting south to north in front of</p> | <p>Full elevation photo showing surveyor's view.</p> |

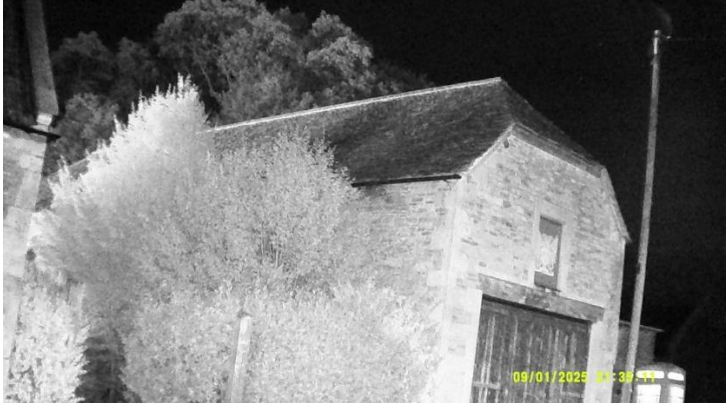
| <p><i>IR position 3</i><br/><i>Nightfox Whisker and</i><br/><i>Nightfox XB5 PRO</i></p> | <p>Camera position: observing the south and west elevation of B1.</p> <p><b>No emergences or entries into the building seen upon review.</b></p> <p>Summary of additional observations:<br/>At 20:41 and 20:43 two bats were seen commuting north past the east elevation.</p> | <p>Darkest point full elevation photo showing surveyor's view.</p> |

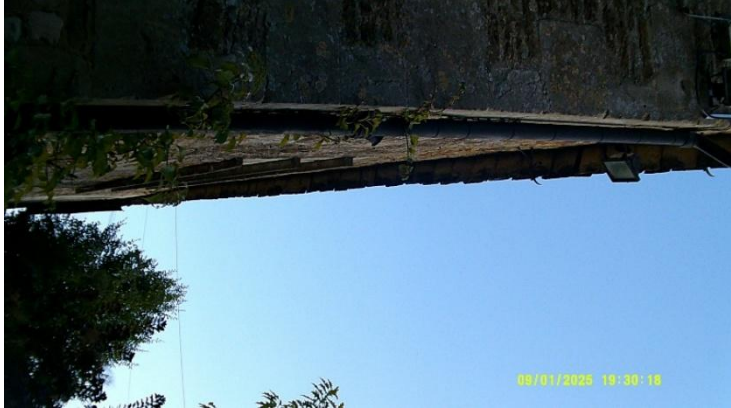
| <p><i>IR position 4</i><br/><i>Unmanned IR</i><br/><i>Nightfox Whisker and</i><br/><i>Nightfox XB5 PRO</i></p> | <p>Camera position: observing the west elevation of B1.</p> <p><b>No emergences or entries into the building seen upon review.</b></p> <p>Summary of additional observations:<br/>There were three occurrences of common pipistrelle activity recorded on the IR camera. At 20:27 a bat can be seen commuting south to north in front of the western elevation. Two further common pipistrelles were recorded foraging in front of the western elevation at 20:29. The final bat activity recorded was a bat commuting south to north at 21:13. Species identification was completed post survey through call detected via an EMT2.</p> | <p>Full elevation photo showing unmanned IR's view.</p> <p>Darkest point full elevation photo showing surveyor's view.</p> |

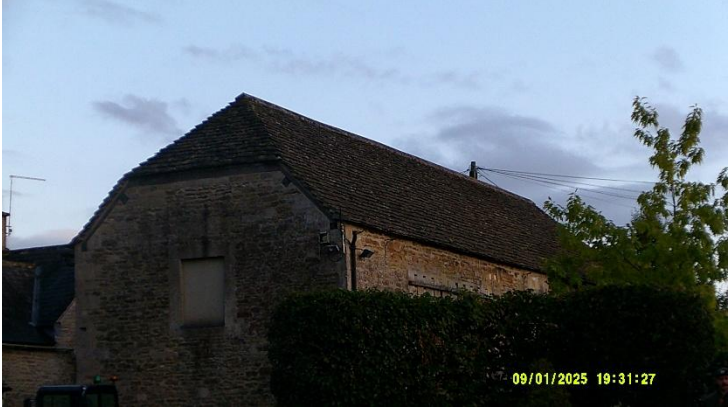
| Surveyor 5 | <p><b>No emergencies observed</b></p> <p>Key flight paths: West to east above surveyor 5.<br/>Key foraging activity: Above the trees northeast of the site.<br/>Species observed: Noctule, common pipistrelle, soprano pipistrelle and serotine.</p> <p>Summary of general activity:<br/>The first bat activity recorded was a noctule heard and not seen at 20:01. This was followed by a common pipistrelle heard and not seen at 20:11. At 20:14 a common pipistrelle was seen commuting from west to east above surveyor position five. The final bat observed was a common pipistrelle foraging above the trees northeast of the site. From 20:27 till 20:38 there were six occurrences of bats heard but not seen: three common pipistrelles, one soprano pipistrelle, one serotine and one noctule. There was a period of continuous rain from 20:36 till 20:56. Between 20:59 and 21:27 there were seven occurrences of common pipistrelles heard and not seen.</p> | <p>Full elevation photo showing surveyor's view.</p> |

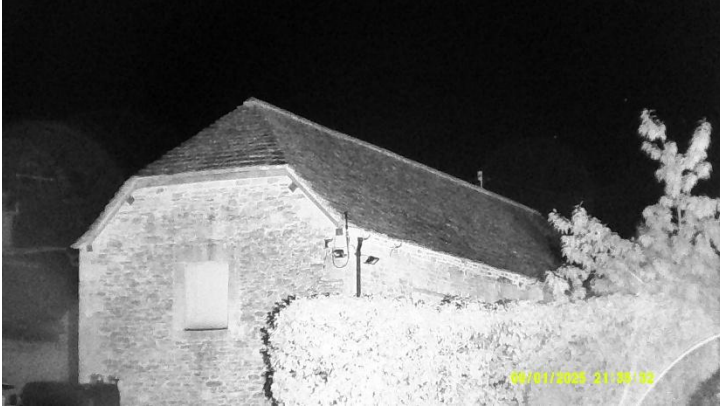
| <i>IR position 5</i><br><i>Nightfox Whisker and</i><br><i>Nightfox XB5 PRO</i> | <p>Camera position: observing the north and west elevations of B1.</p> <p><b>No emergencies or entries into the building seen upon review.</b></p> <p>Summary of additional observations:<br/> At 20:21 a bat can be seen commuting west before heading south in front of the western elevation. Additionally, another bat can be seen commuting north in front of the western elevation before heading east in front of the northern elevation. This activity corresponds with a serotine call detected during the survey.</p> | <p>Darkest point full elevation photo showing surveyor's view.</p> |
