**CHERRY BANK  
SOUTH STREET  
BROADCHALKE  
WILTSHIRE  
SP5 5DN**

**ECOLOGICAL SURVEY REPORT (BATS)**  
**(Preliminary Roost Assessment/DBW)**

**Prepared for:**  
**Mrs K. ESDON.**  
**Date: 15/8/25.**  
**Ref: NWP/ESR-15/8/25-version 1.**

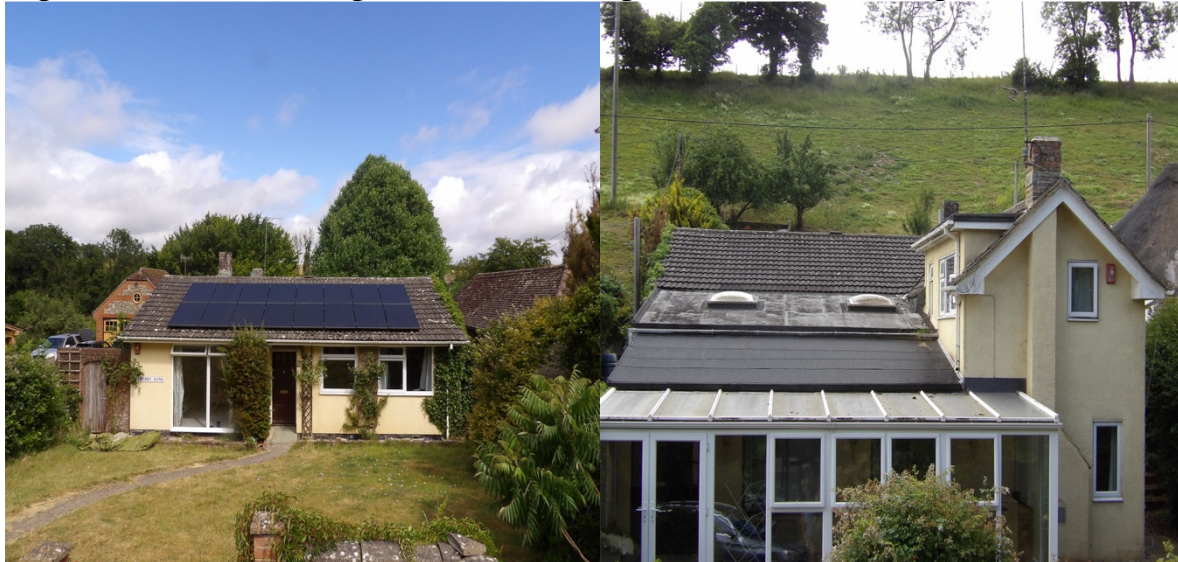
The application site comprises of a detached brick-built dwelling with single and double storey aspects. Figure 1/2.

Figure 1. Main dwelling, front view.    Figure 2. Main dwelling, rear view.

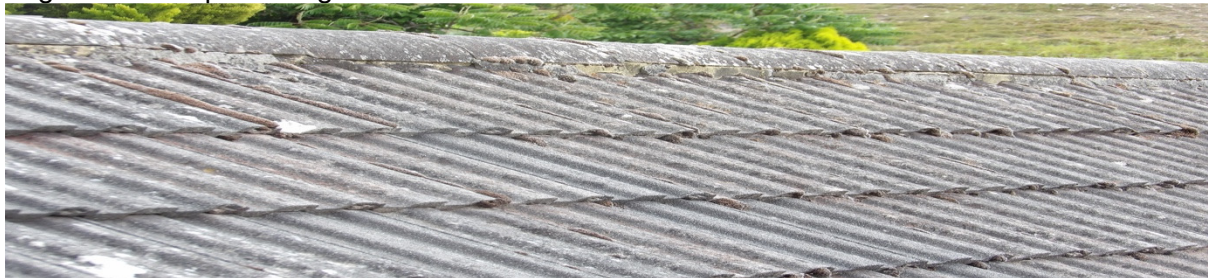
Figure 1. Example of ridge tiles.

The ridge tiles were in good condition with no significant mortar missing. Figure 1.

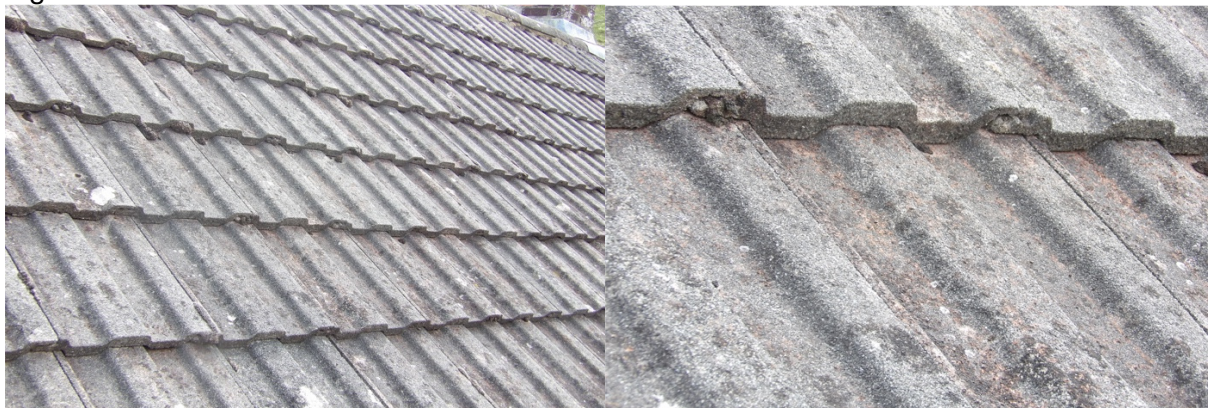
Figure 2/3. General tiles

The tiles covering the roof were in good condition, no visible slipped/missing/broken. Figure 2/3.

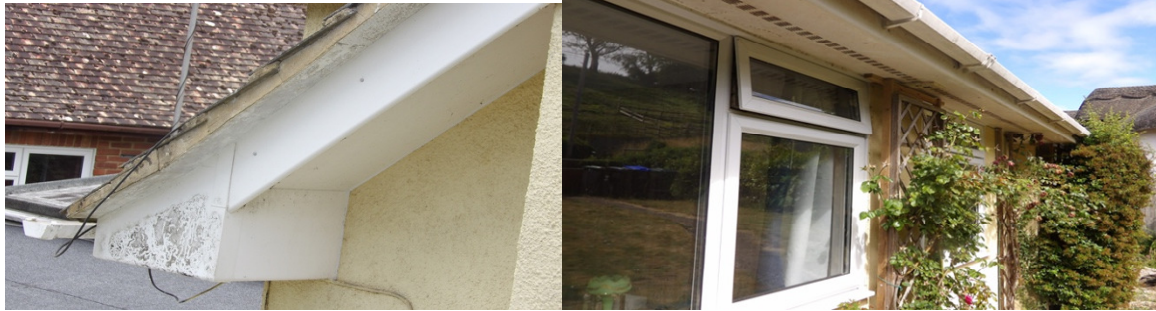
Figure 4/5. U.P.V.C soffits and fascia.

The U.P.V.C soffits and fascia were all in good condition with no significant splits or openings that bats could exploit. Figure 4/5.

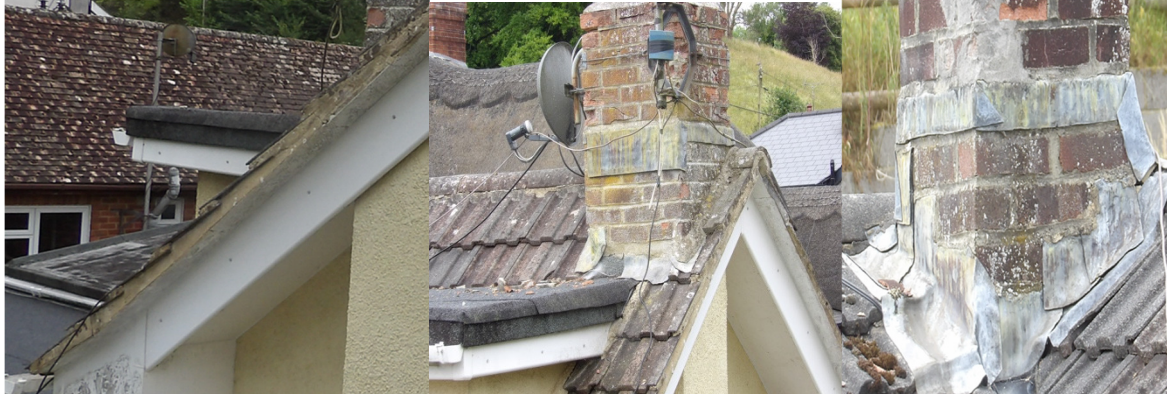
Figure 6. Example of eaves tiles. Figure 7/8. Leadwork around chimney.

The eaves tiles were complete with no significant missing mortar. Figure 6.

There were 2 chimney stacks. The leadwork was complete and close fitting. Figure 7/8.

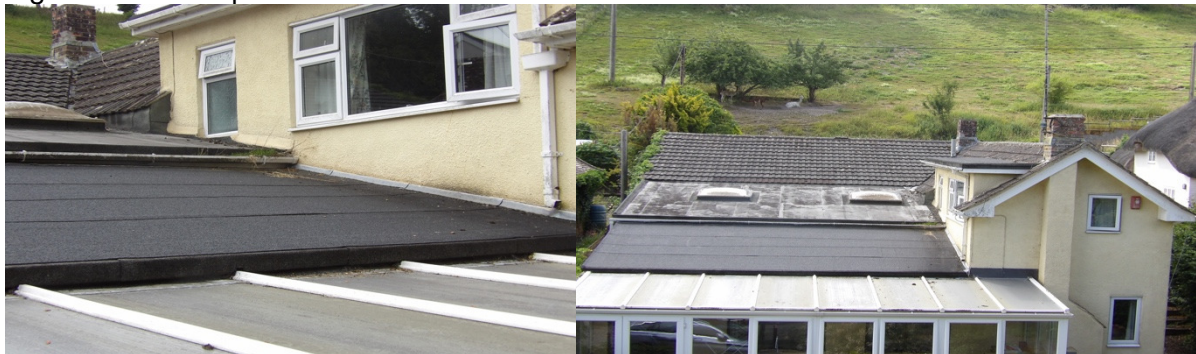
Figure 9/10. Composite covered roofs.

The composite covering on the flat roofs was in good condition, close fitting with no significant rips or tears. Figure 9/10.

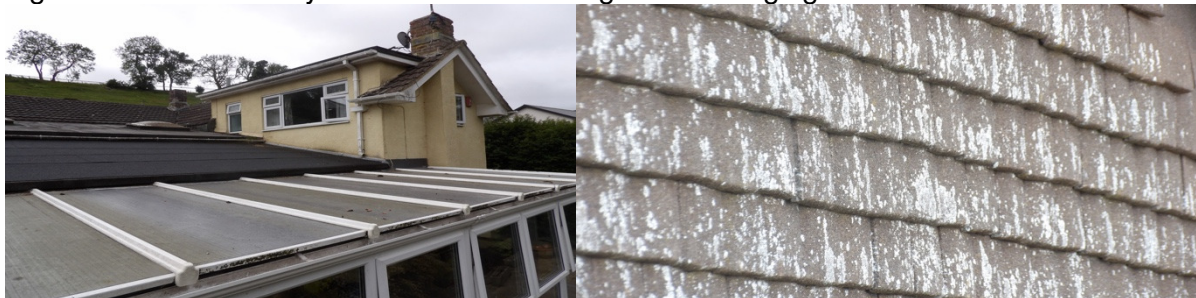
The conservatory had a U.P.V.C roof. Figure 11.

There was an area of hanging tiles, these were close fitting with none slipped/broken/missing. Figure 12.

Figure 11. Conservatory roof.

Figure 12. hanging tiles.

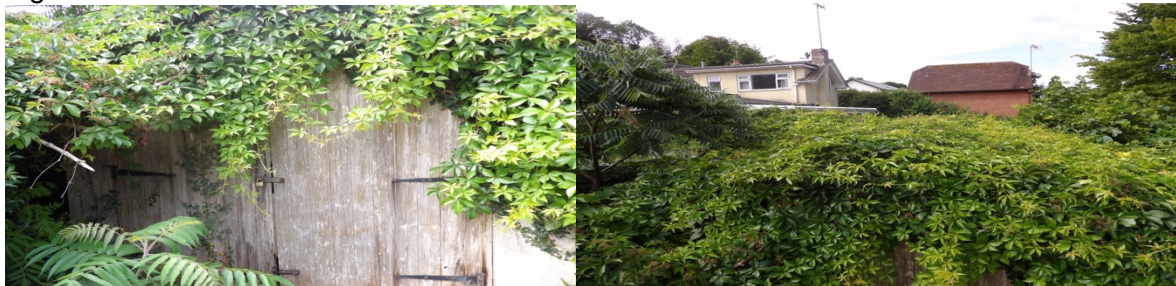
The garage was of prefabricated concrete construction, single skin with a sheet material covering the pitched roof, it was covered by a creeping vine. Figure 13/14.

No bats or evidence of bats was recorded during the external inspection of the main dwelling/garage, there were no visible roosting opportunities or ingress points that bats could exploit.

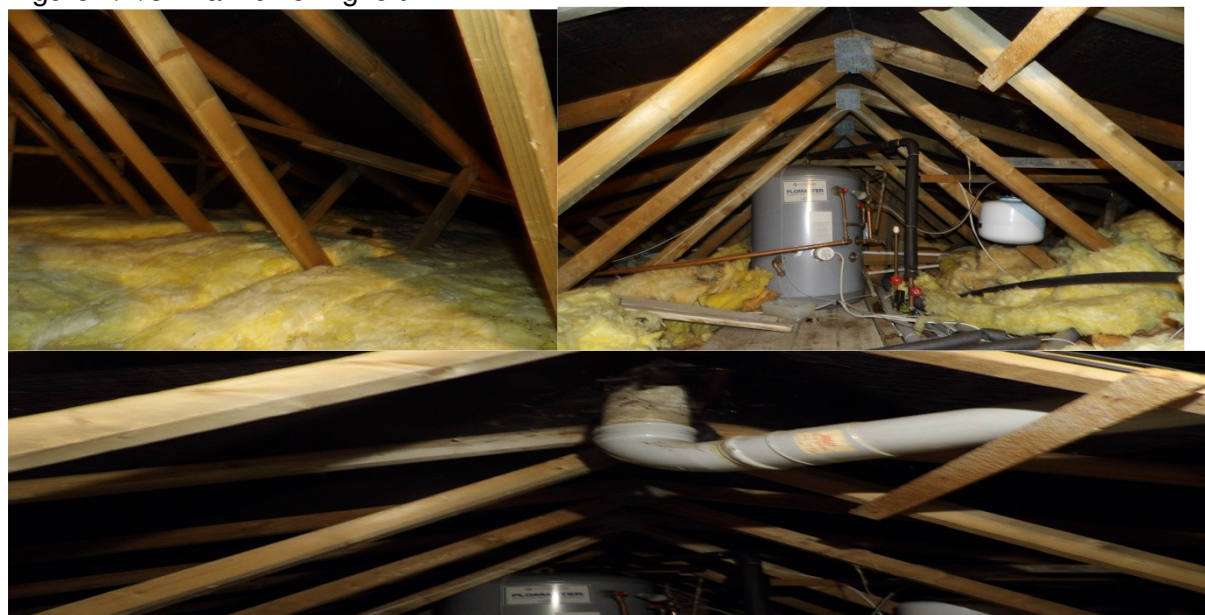
Figure 1/2/3. Main dwelling loft.

The loft space in the main dwelling was accessed using a ladder and was in good condition. The loft area was partially lit, it was partially boarded and insulated. The tiles were lined with bitumen felt, this was in good condition with no visible rips/tears. The roof void was not being used. There was no light ingress.

Figure 1/2/3. Show general structure and condition of loft in main dwelling.

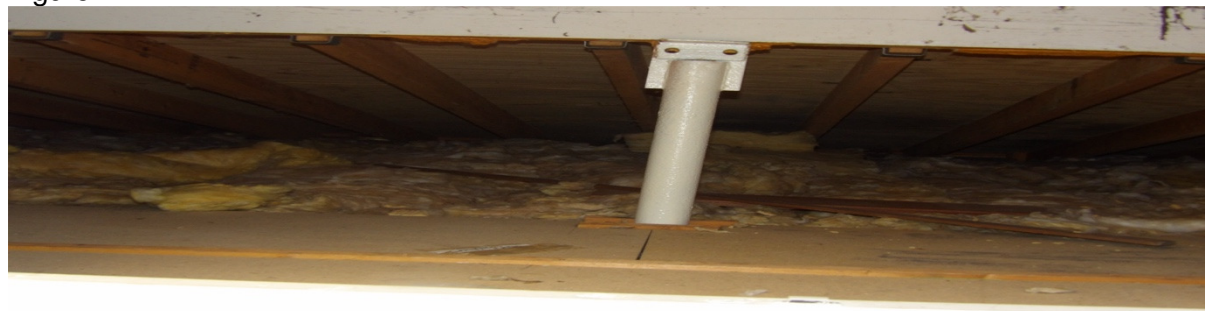
There was an access point into a void above a flat roof section, it was not boarded or lit but it was insulated. Figure 4.

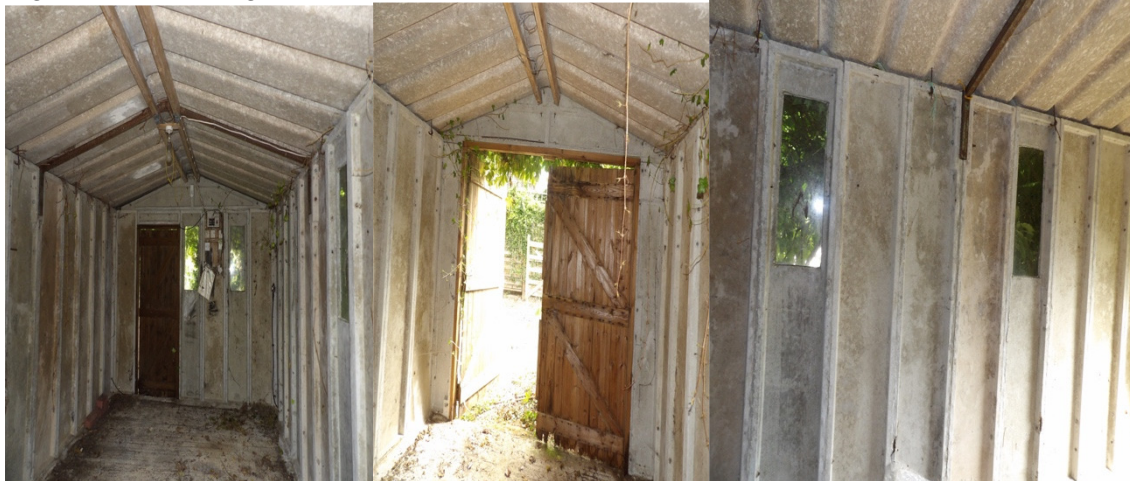
Figure 5/6/7. Garage.

The garage had no roof void.

The door when closed was close fitting.

The floor was concrete.

It was not currently in use.

Figure 5/6/7. Show general structure and condition of the garage.

No evidence of bats was recorded during the internal inspection of the main dwelling and garage.
