## Down Farm Stable

**Kington St Michael, Wiltshire**

## Protected Species Report

February 2026

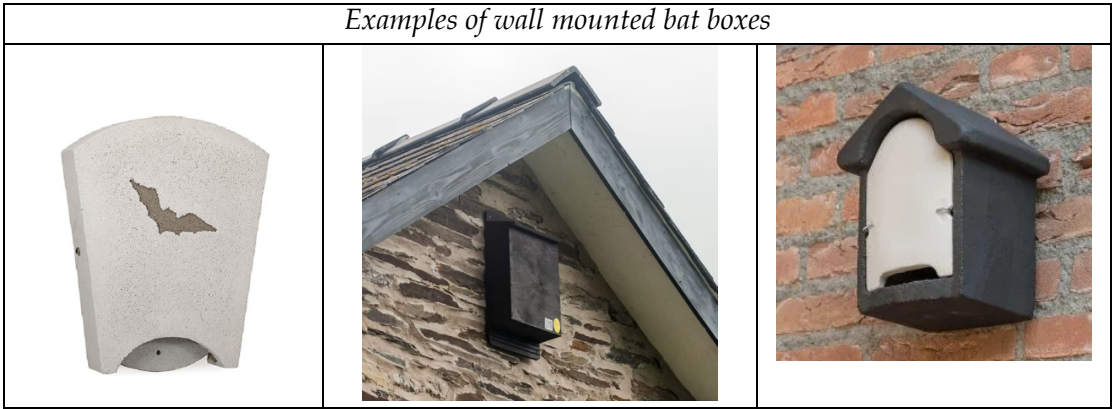
To provide external bat roosting features as an enhancement for roosting bats, one bat wall mounted bat box will be attached to the exterior north-east gable of the adjoining barn, as shown on drawing LPC 5618-PR-203A in Appendix A. A range of suitable, durable [Woodstone] boxes can be view on-line ([www.nhbs.com](http://www.nhbs.com) or [www.wildcare.co.uk](http://www.wildcare.co.uk)).

The bat box will be installed close to the roof apex (so that it is as high as possible) and no external lighting will be used adjacent to or shine directly at the bat box entrance slot (see Section 6.4). Clear lines of flight to the bat roost box entrance will always be maintained.

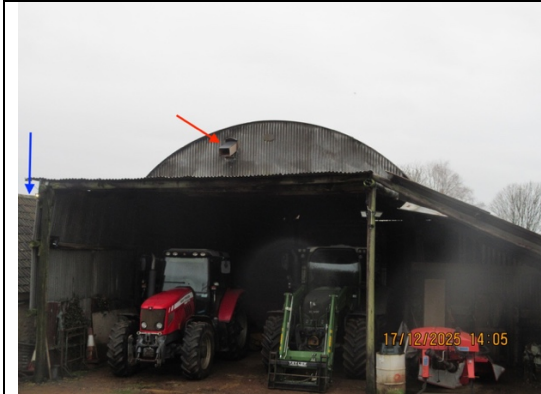
| <p>Photo C1. Exterior of Dutch barn with red arrow showing the bat loft tunnel entrance and blue arrow indicating the proximity of the stables building</p> | <p>Photo C2. Interior of Dutch barn showing the underside of the bat loft and internal roost entrance</p> |

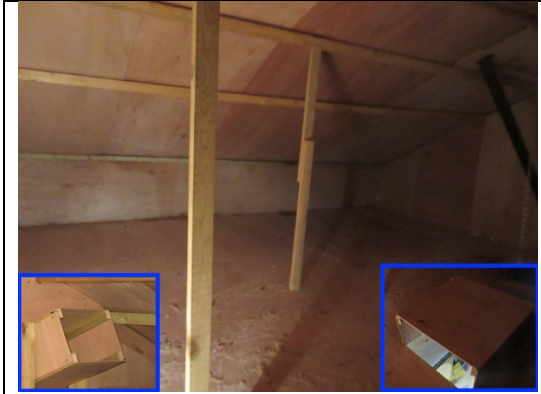
| <p>Photo C3. Interior of the bat loft with inset images showing the roost entrances</p> | <p>Photo C4. Internal baffles in the bat loft to partition the void.</p> |

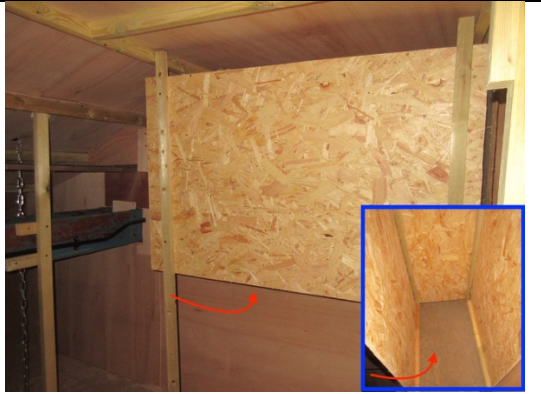
squeeze board is a panel that attaches to the baffle with small battens leaving a 25mm gap between the two boards.
