**Melksham Community Hospital  
St. Damian's Block  
Precautionary Working Method Statement**

**For NHS Property Services Ltd.  
24 February 2026**

| | Project information |
|---|---|
| <b>Document title</b> | Melksham St. Damian's Block PWMS |

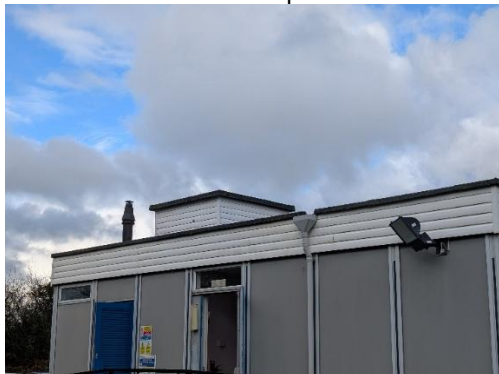
- 2.3.4 The only area of the site that contained PRFs was the roof extension/tank room (Plate 1). The PRFs included:

Plate 1: Southwestern aspect of the Site showing the roof extension/tank room.

- 4.4.1 A bat-licensed ecologist will directly supervise the soft demolition of the roof extension/tank room. A contractor should carefully remove the roof material under direct supervision of the licensed bat ecologist. All roofing materials should be removed until the structure is declared destroyed/unsuitable for roosting bats by the ecologist.

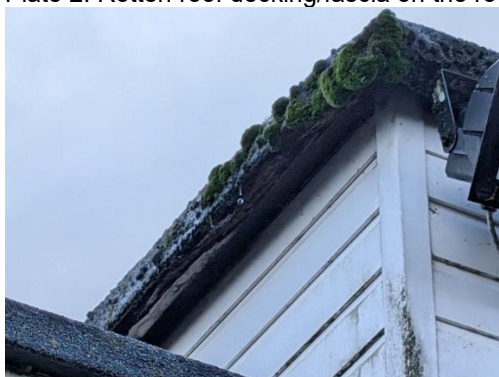
- Rotten timber roof decking/fascia on the exterior of the roof extension/tank room (Plate 2)
- Light ingress within the roof extension/tank room (Plate 3).

Plate 2: Rotten roof decking/fascia on the roof extension/tank room.

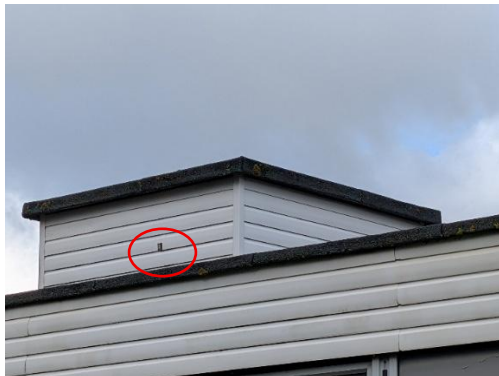
Plate 3: Cut out hole into roof void/tank room potentially creating area of light ingress.

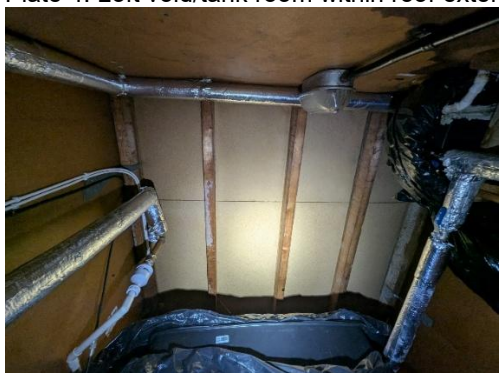
- 2.3.5 The PBRA results and locations of PRFs can be found in Figure 3. An internal view of the tank room/roof extension can be seen in Plate 4.

Plate 4: Loft void/tank room within roof extension.
