# Stourhead Garden Lake Seepage Remediation

## Heritage Impact Assessment

January 2026

Prepared for:  
The National Trust

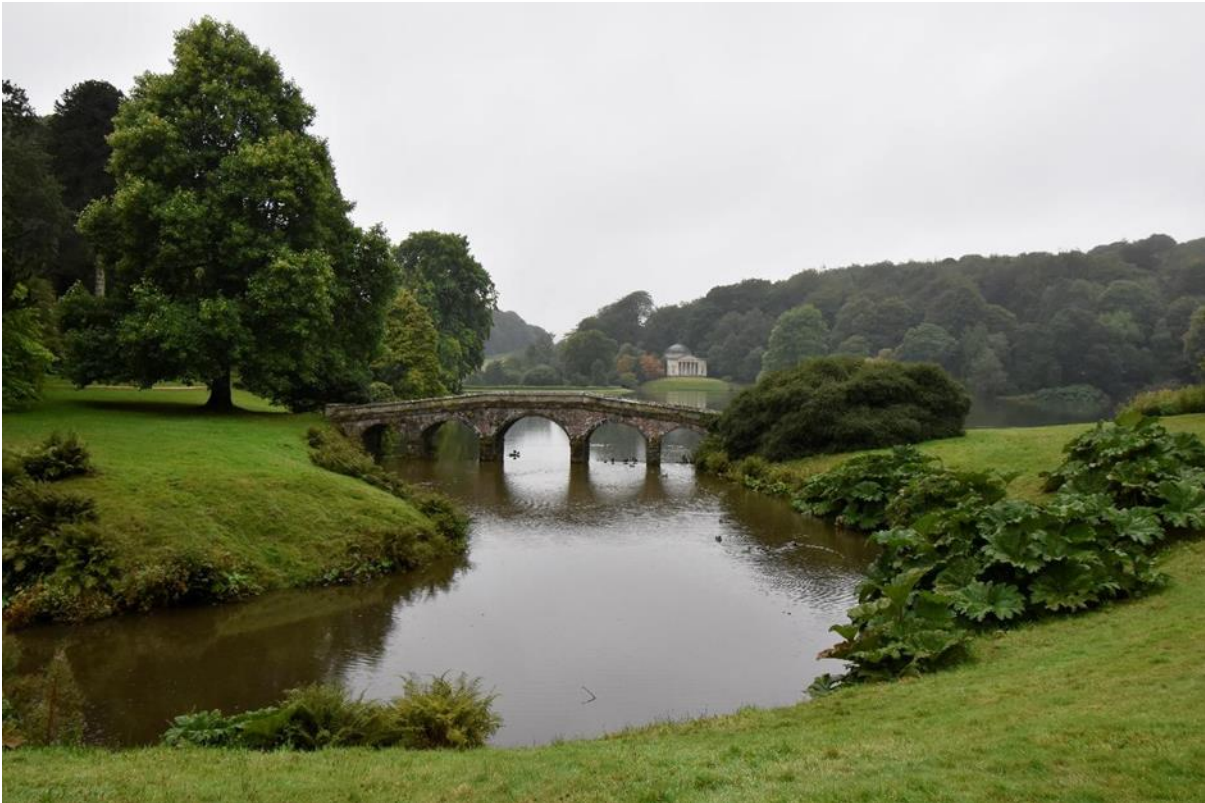
Plate 1: View from the eastern extent of the Garden Lake; the Palladian Bridge is visible in the foreground with the Pantheon to visible across the lake.

Other assets found throughout the study area appear mainly as bridges on the avenues and paths around the grounds between 10m and 375m from the Site. Exceptions to this are the Grade II Listed grotto underpass (1283534, photograph 11) which, while not a bridge, does relate to moving through the park; and the Grade II Listed Horse Trough in Lake (1199247) which is situated on a well-used carriage and bridleway leading from the house to the nearby Alfred's Tower. The Grade II Listed Iron Bridge (1131103, photograph 10) is located directly west of the Site boundary and is within 10m of the Site. It dates to 1840 where it was developed by the foundry Maggs & Hindley, owned by early industrialists Daniel Maggs and Edmund Samuel Hindley, and was installed to replace an oak bridge carrying the footpath over the western arm of the lake. The Rockwork Bridge (1199172, photograph 7) is a Grade I Listed Building which crosses Zeal's Road to the south-west of the village, carrying a footpath from the Garden Lake to the Temple of Apollo. The Palladian Bridge (1131099, photograph 3) is a Grade I Listed Building located over the eastern arm of the Garden Lake which was constructed in 1762 for Henry Hoare II, and now forms part of the 'postcard view' of the lake and gardens from Stourton High Street (Woodbridge 1982) (Plate 1).

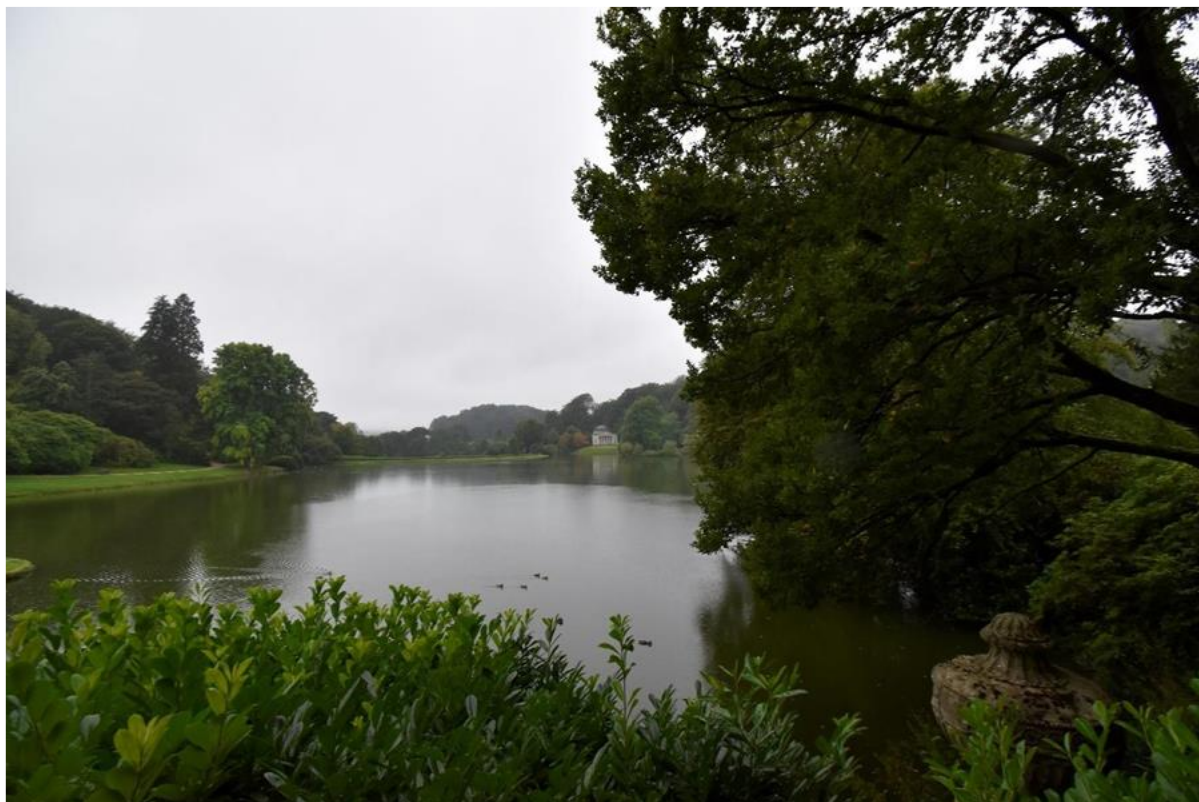
Plate 2: View across the Garden Lake from the Temple of Flora.

During the 1740s-60s, Henry Hoare II commissioned the architect Henry Flintcroft to design and construct three Classical Greek style 'temples' throughout the Stourhead grounds. The Pantheon (1131102, photograph 2) is a Grade I Listed Building constructed in 1753-54 and located approximately 40m to the north of the Site. It is considered to be the most important element of the gardens, providing a focus for vistas across the lake from various locations (Woodbridge 1982; Gunnis 1951) (Plate 1). This asset has unobstructed views towards the Site across the western arm of the Garden Lake. The Temple of Flora (1318472, photograph 9) is a Grade I Listed building constructed in 1744-46 and is located on the eastern edge of the Garden Lake, approximately 350m from the Site, with unobstructed views across the water to The Pantheon (Plate 2) but not to the location of the Site due to the form of the Garden Lake.

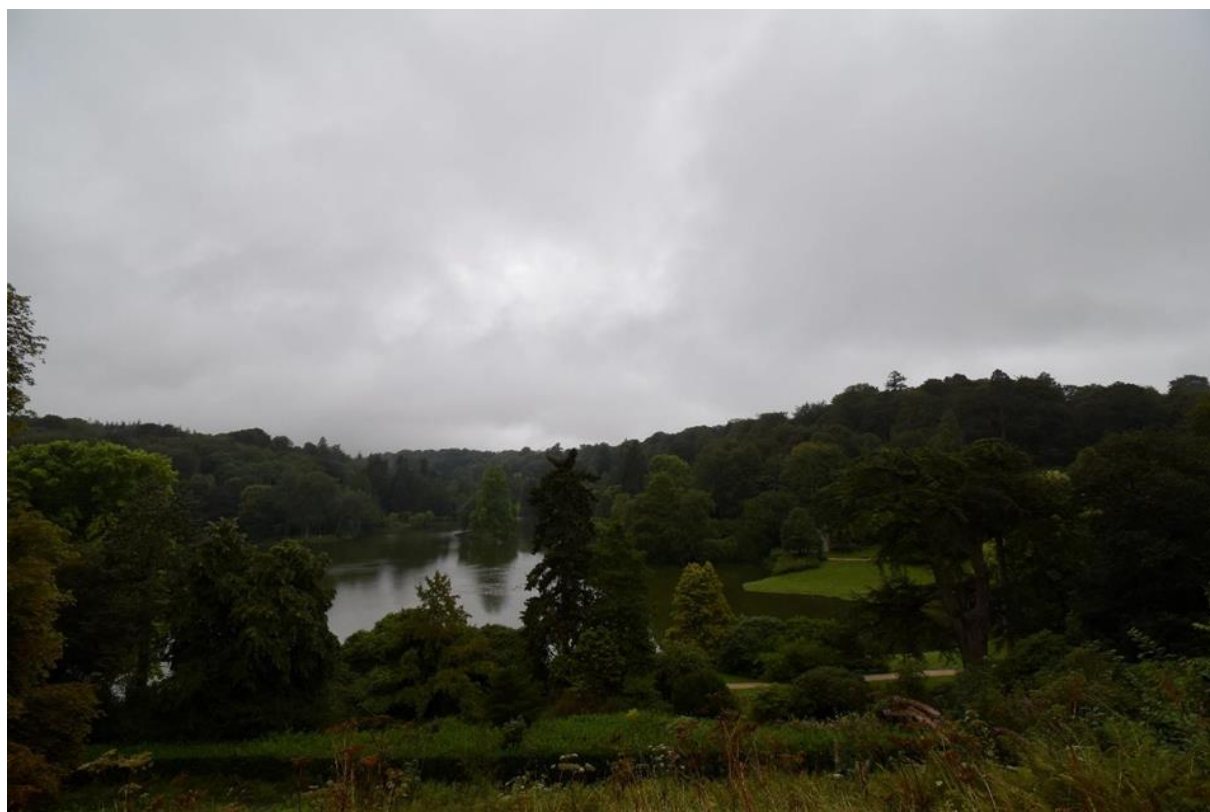
Plate 3: View from the principal elevation of the Temple of Apollo, overlooking the Garden Lake and Stourhead Estate.

The Temple of Apollo (1131100, photograph 8) is a Grade I Listed Building constructed in 1765 which is located on the top of a hill to the south-east of Garden Lake commanding views across the lake (Plate 3). It is located approximately 285m to the south-east of the Site.

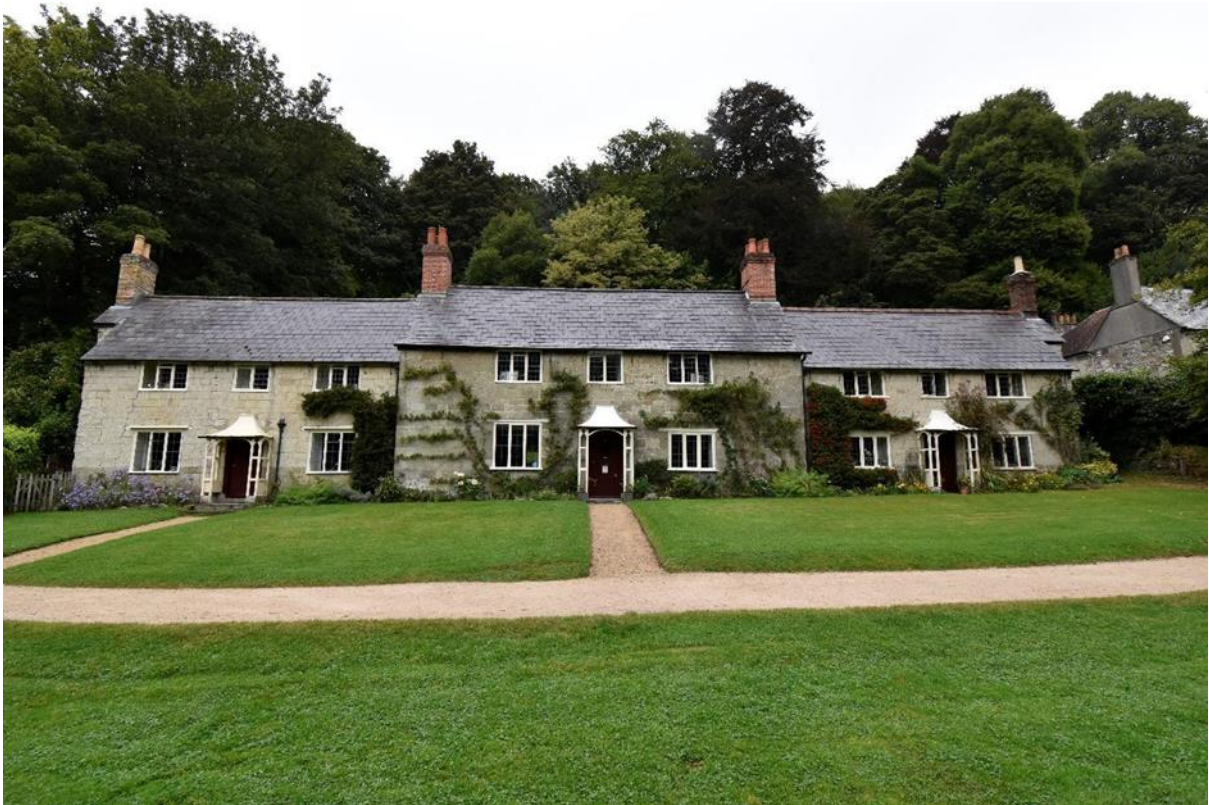
Plate 4: No's 87, 88, and 89, High Street

Three dwellings are located within the study area at between 390m and 490m from the Site. 87 and 88, High Street (1198927) comprise a pair of cottages in a row which are now used as an office. They form a picturesque group (Plate 4) with the Post Office (outside the study area) and 89 High Street (1131134). These assets have been scoped out of further assessment due to their distance from the Site and their location outside the Stourhead Estate boundary. The Kennels (1131110) are a Grade II Listed Building which comprise a gamekeeper's house and kennels, dated to 1794 and attributed to Richard Colt Hoare II of Stourhead.

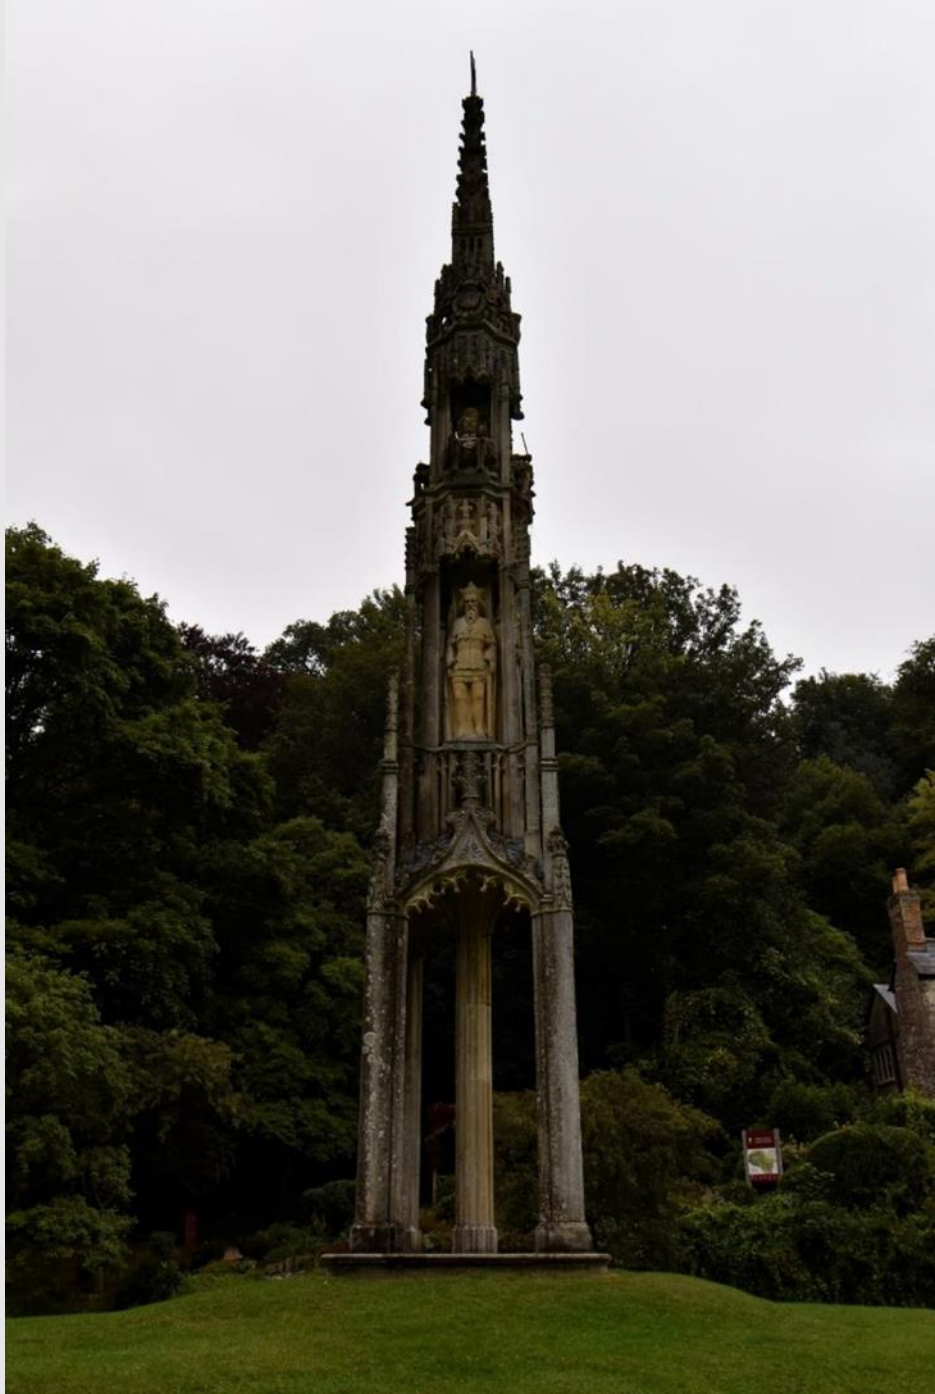
| Photograph ID | 1 |

| Description | 15th-16th century monument which originally stood at the junction of High Street, Broad Street, Wine Street and Corn Street (the four principal thoroughfares) in Bristol. Installed by Henry Hoare in 1764. |

Bristol High Cross is a Scheduled Monument (1005655, Photograph 1) located to the east of the study area, approximately 480m from the Site boundary. This monument originally dates to the 15th-16th century and originally stood at the junction of High Street, Broad Street, Wine Street and Corn Street (the four principal thoroughfares) in Bristol. The cross was removed as an obstruction in 1733 and moved to Bristol Cathedral until it was recovered by Henry Hoare II, the son of Henry Hoare, who had it transported to Stourhead in 1764 (National Trust Collections, Stourhead). The monument is also a Grade I Listed Building (1318471).

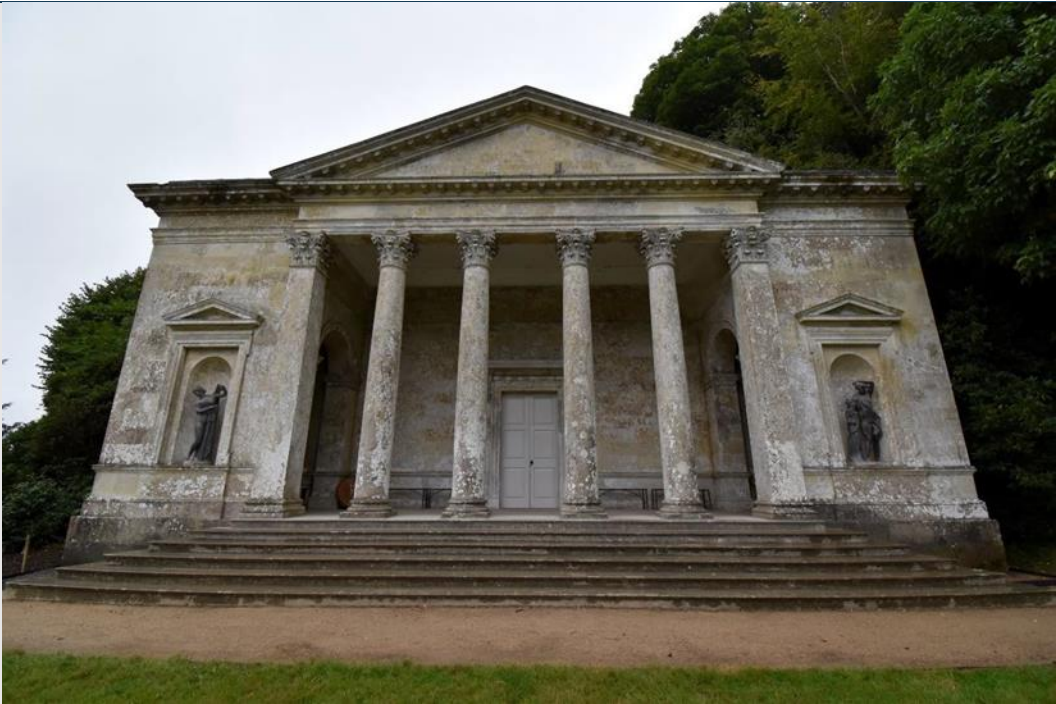
| Photograph ID | 2 |

| Description | Limestone ashlar structure dated to 1753-54. Tetrastyle in antis Corinthian Portico, six step stylobate, with flanking semi-circular niches containing lead statues of Bacchus and Venus. |

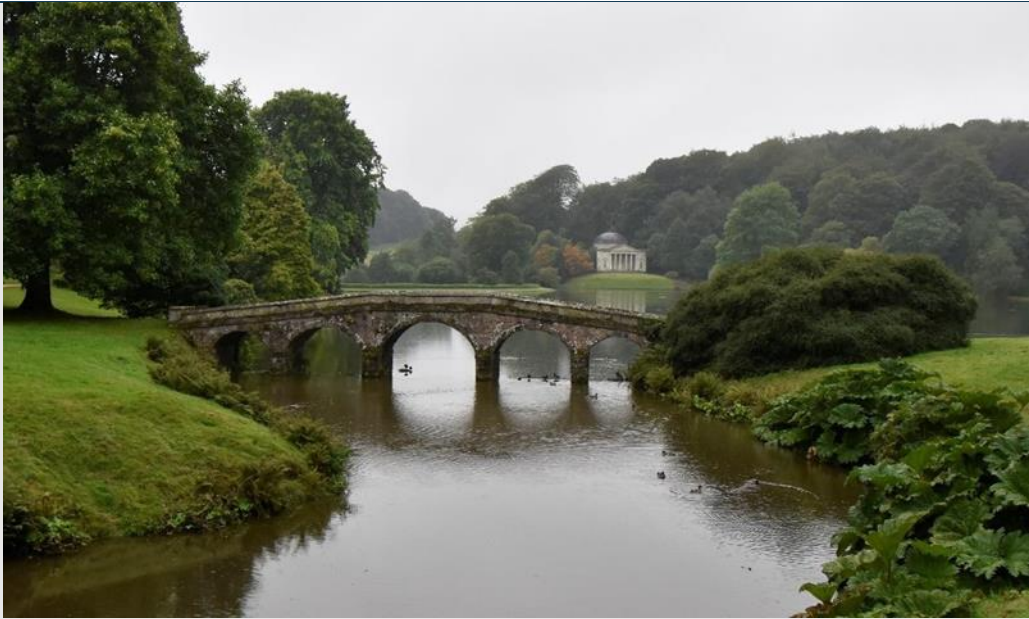
| Photograph ID | 3 |

| Description | Bridge constructed in limestone and carrying a turfed track over the eastern arm of Garden Lake. Built in 1762 following a design from Leoni's The Architecture of Palladio Book III (1721). |

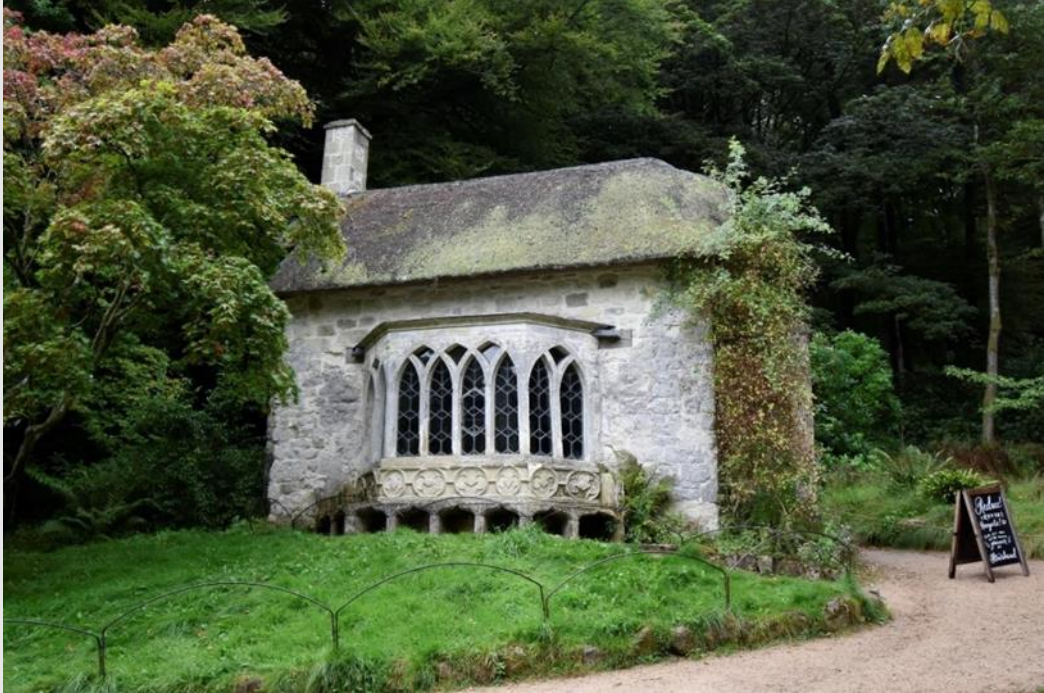
| Photograph ID | 4 |

| Description | Detached cottage and garden feature, thought to date to the mid-18th century with late 18th/early 19th century alterations. Constructed in dressed limestone and rubble stone, with a stone slate roof which has a half-hip to the right and a stone stack to the left. The building is single storey with one window bay on its principal elevation which faces the Garden Lake. It has served as a summer house since at least 1895. |

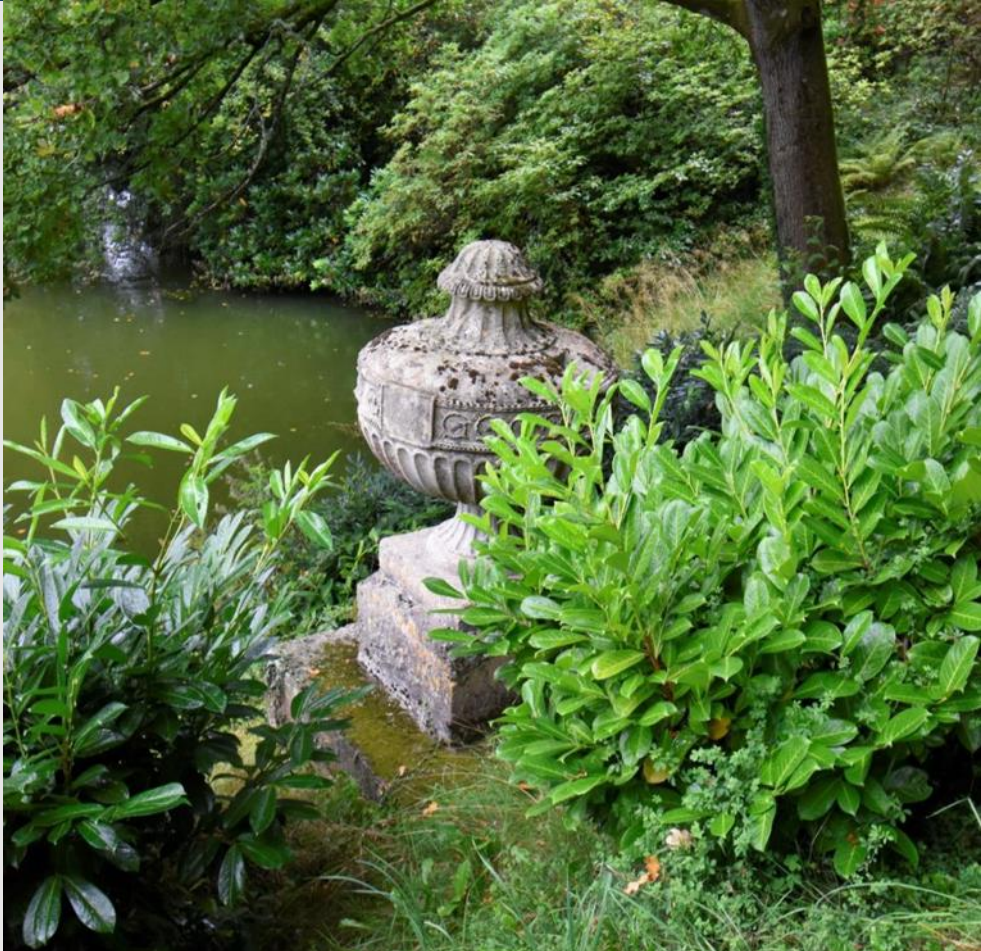
| Description | Probable late 18th century urn placed over a spring head. The urn is wide-bodied with fluting and scrolled frieze, and is built on a limestone square plinth and base. The asset stands on a brick spring head with two arched openings which could not be accessed. |

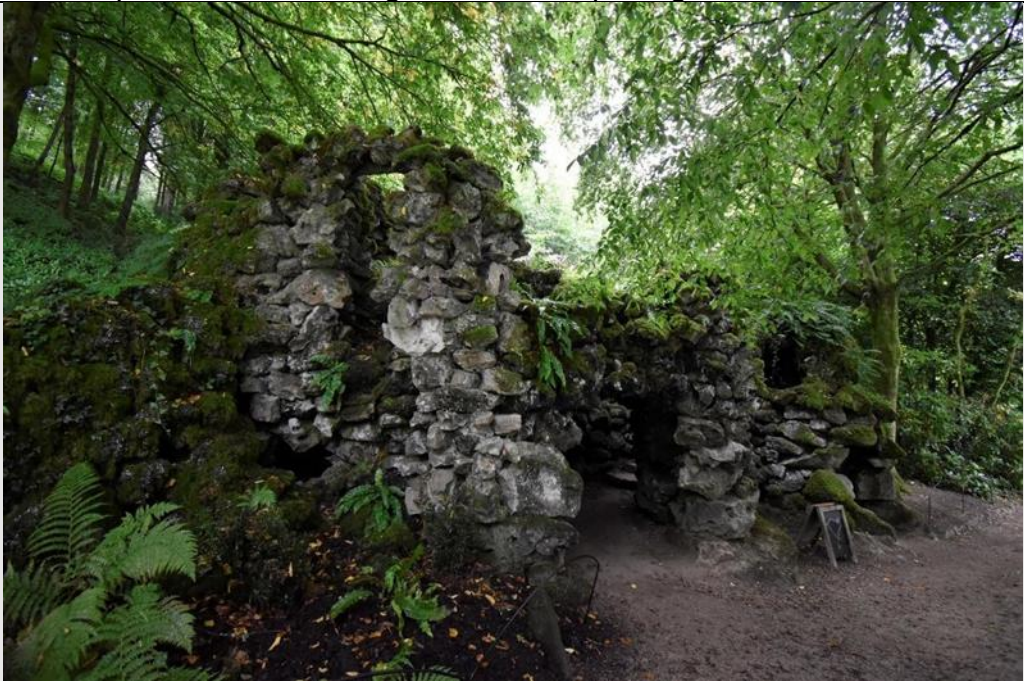
| Description | A rustic bridge carrying a track from the Garden Lake to the Temple of Apollo over the Zeal's Road. The bridge is dated to 1762-65 and is built in rustic limestone with segmental arches, rough niches, and revetment walls. The track over is approached by steps lined with rockwork with several platforms containing niches and openings. |

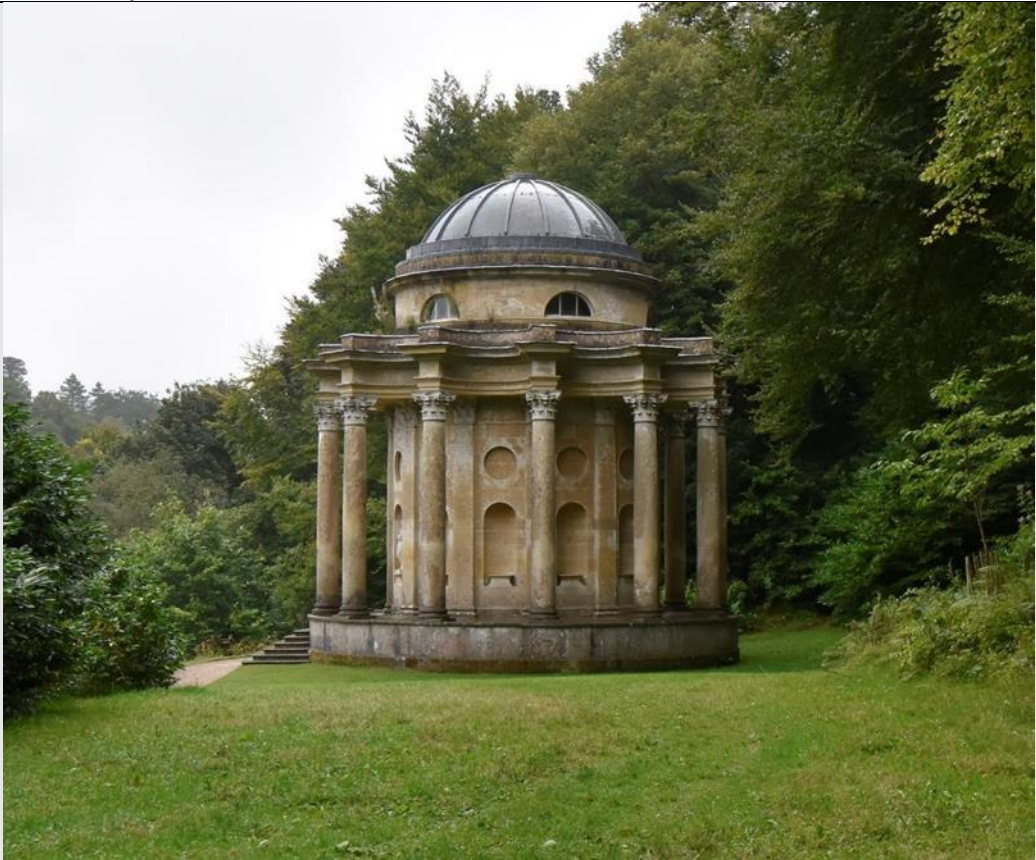
Photograph ID 8

| Description | This temple was built in 1765 following a design from Wood's Ruins of Baalbec (1757). It is constructed in limestone ashlar and is circular in shape, with an eight-stepped plinth on the elevation overlooking the Garden Lake. Twelve Corinthian columns carrying scalloped entablature can be seen around the building, with semi-circular niches and oculi within each bay. The principal elevation contains double doors with six fielded panels, a moulded tympanum with keystones. The northern side of the building houses replica statues dated to 1907-08 within flanking niches. The interior could not be accessed but displays painted brick walls and a small stone fireplace. The interior originally contained a large cast of Apollo, lit from above. |

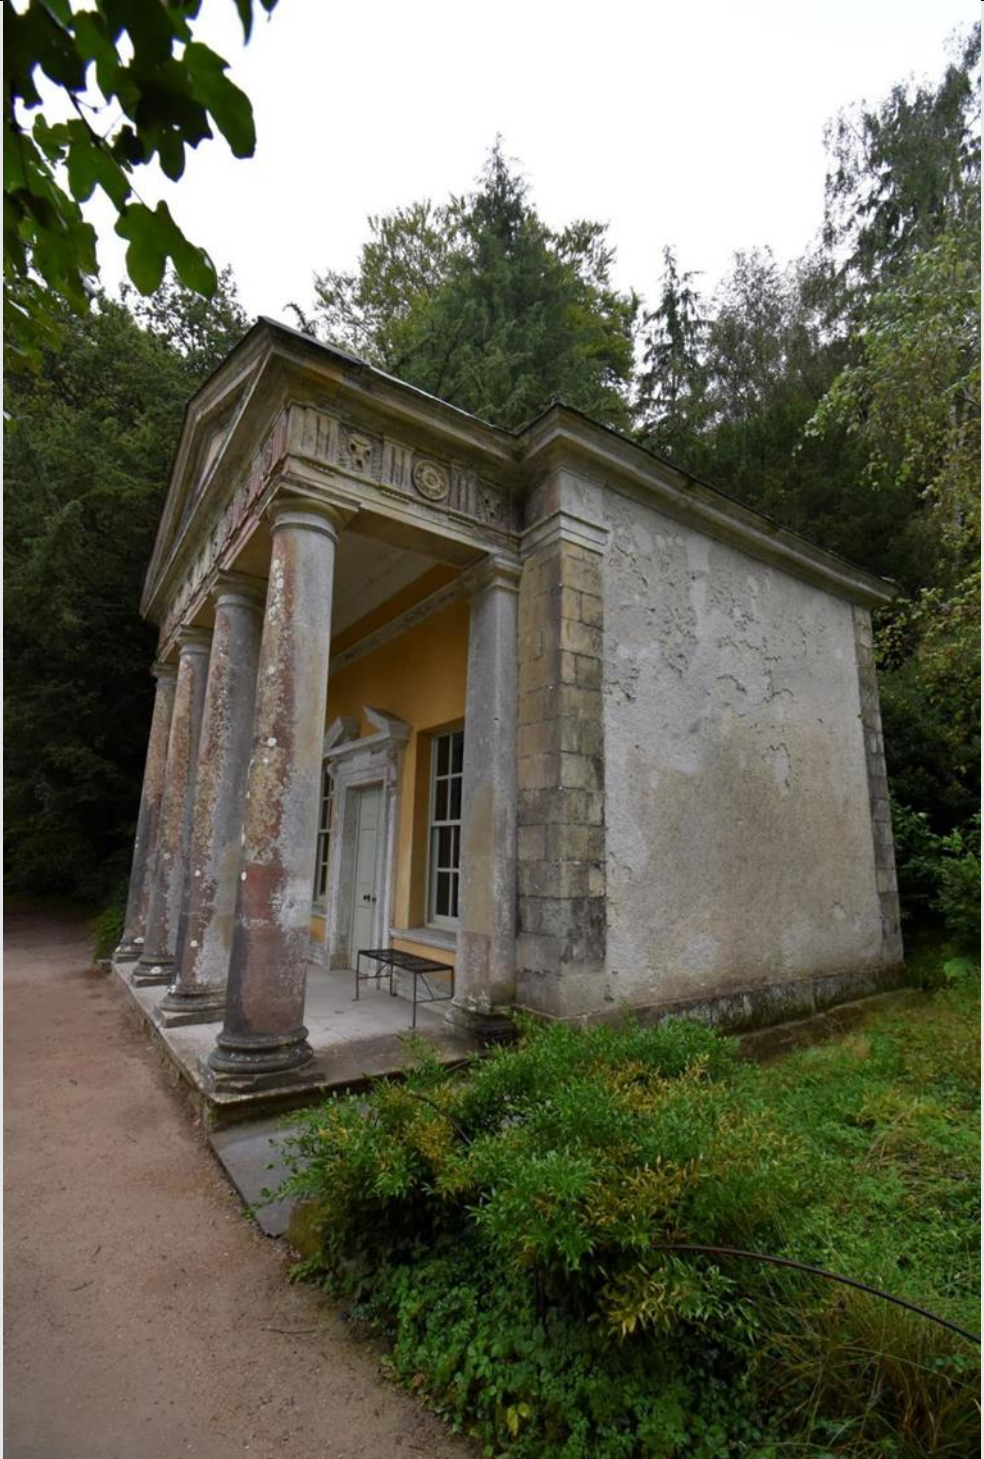
| Photograph ID | 9 |

| Description | This asset dates to 1744-46 and is constructed in limestone ashlar and render with a hipped slate roof. The principal elevation faces the lake and has a tetrastyle Doric portico topped by entablature displaying triglyphs, bucrania and moulded pediment. The side walls comprise plain render with no decoration. The central double doors comprise six panels in a moulded architrave with broken pediment, with a Latin inscription from the Aeneid over the doors and large, 12-pane sashes to either side. |

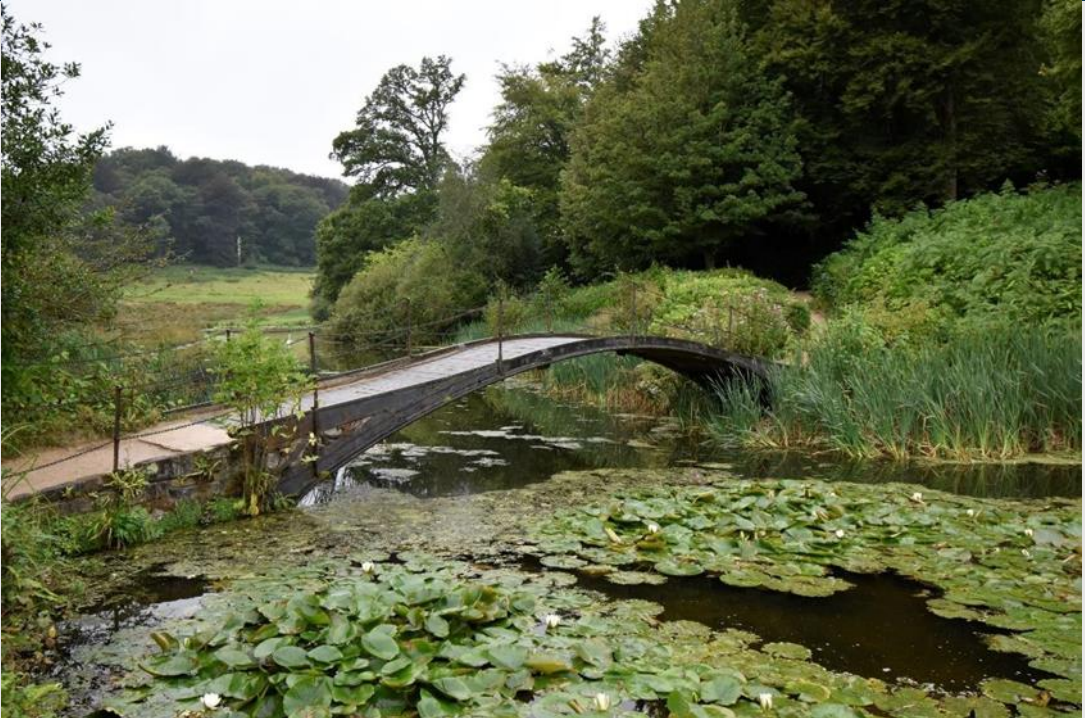
| Photograph ID | 10 |

| Description | This bridge carries the footpath over the western arm of Garden Lake. It was built in 1860, replacing an oak bridge dated to 1840. It consists of a single shallow segmental arch with decorated spandrels, a wooden walkway, and iron stanchions and holding chains. |

The Grade II Listed Iron Bridge (1131103) demonstrates architectural, artistic and historical interest as evidenced by its development in the 19th century by the foundry Maggs & Hindley, owned by early industrialists Daniel Maggs and Edmund Samuel Hindley, and its association with the Hoare family. Its significance is further enhanced by its location within the Grade I Registered Park and Garden of Stourhead, where it is placed to carry the footpath over the western arm of Garden Lake. The Grade II Listed Iron Bridge is considered to be of medium importance.
