# Stourhead MIOS Detailed Design - Garden Lake

## Invasive Non-Native Species Management Plan

Prepared for  
National Trust

Date  
January 2026

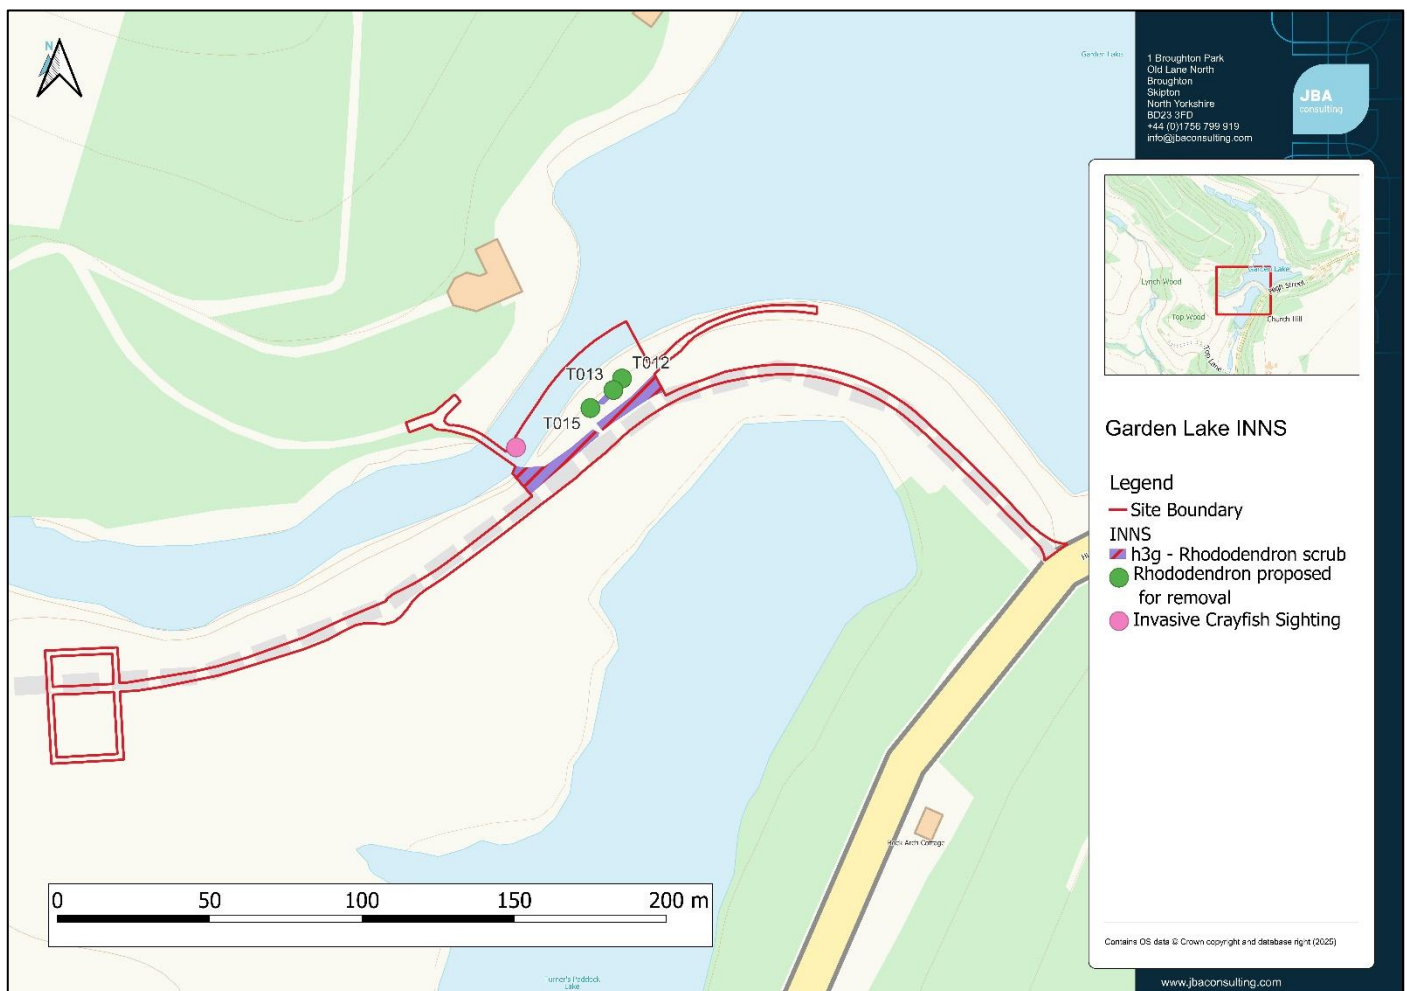
Figure 1-2. Location of INNS on site

Figure 1-2 below shows the location of the INNS recorded on site, including the Rhododendron stands proposed for removal.

A site survey was undertaken on the 19th of August 2025 by ecologist Hannah Webster as part of the Preliminary Ecological Appraisal (JBA Consulting 2025). As part of this survey any INNS observed during the survey were recorded. For stand-forming plant species, the extents of such stands were noted. Rhododendron was recorded within the survey area (as shown in Figure 1-1) and within the wider area. As part of the proposed works, three stands of semi-mature Rhododendron are proposed for removal in order to facilitate the main works.
