HT ECOLOGY

# Bat Survey and Provisional Mitigation Strategy

Pockeridge House and Stables, MOD  
Corsham

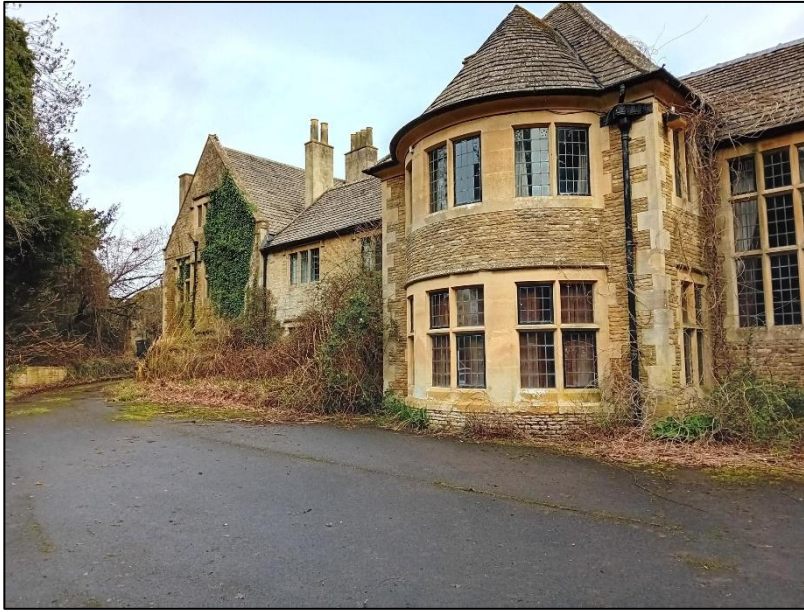
Photograph 1: Western elevation of Building 1 (Pockeridge House)

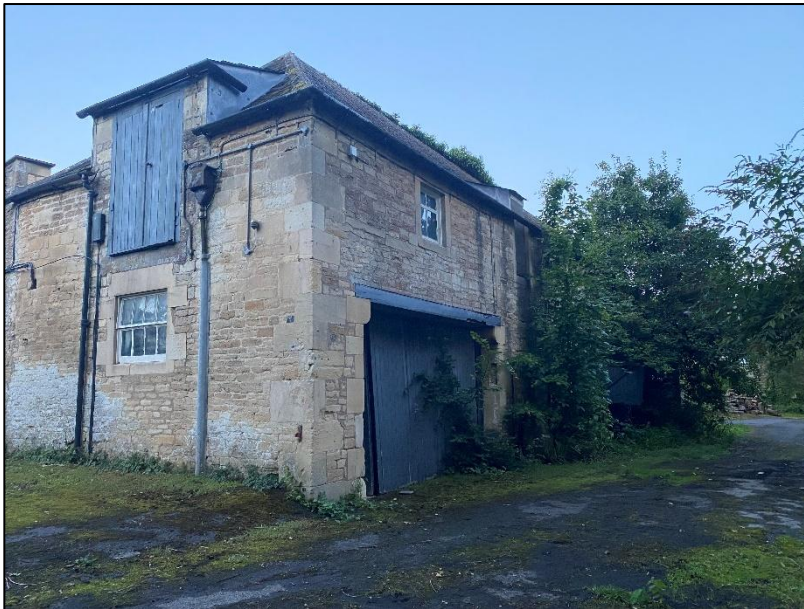
- 2.2.2 These comprised a complex of disused buildings arranged in a linear fashion to the north of Pockeridge House. Building 2 (B2) comprised a two-storey building with a hipped cement tile and slate roof. The ground floor comprised empty, open spaces with flagstone floors and the first floor was open to the rafters with no lining beneath the roof slates/tiles. Access to these buildings was via large wooden doors on the western elevation. Several broken windows were identified on the eastern elevation. A large area of dense bramble scrub was found adjacent the east elevation with buddleia scrub adjacent the western elevation of B2.

Photograph 2: North and western elevations of Building 2

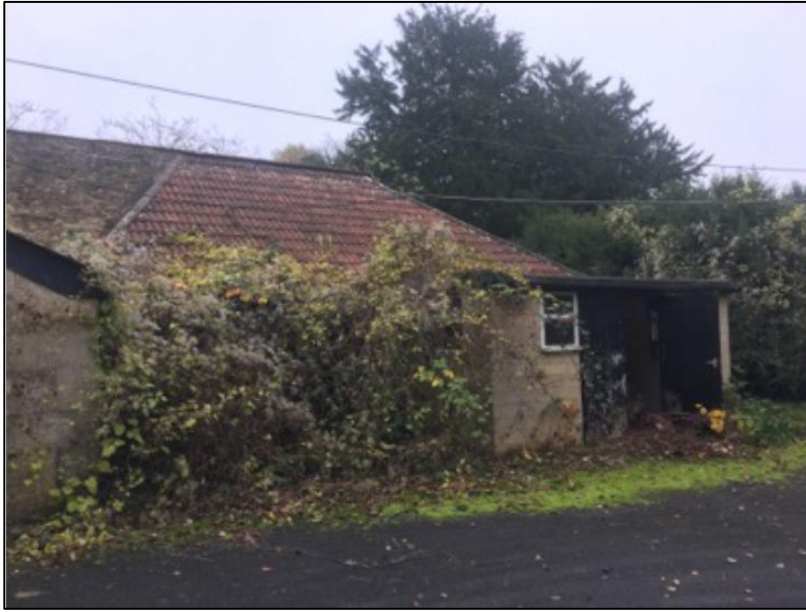
- 2.2.3 Building 3 (B3) included an inaccessible lean-to section adjoined to B2's southern extremity which had a partially open window on the eastern elevation. A small room internally clad with wooden panelling was found at the southern end of the complex. A large amount of dense bramble scrub was recorded on both the east and west elevations of B3.

Photograph 3: Western elevations of Building 3

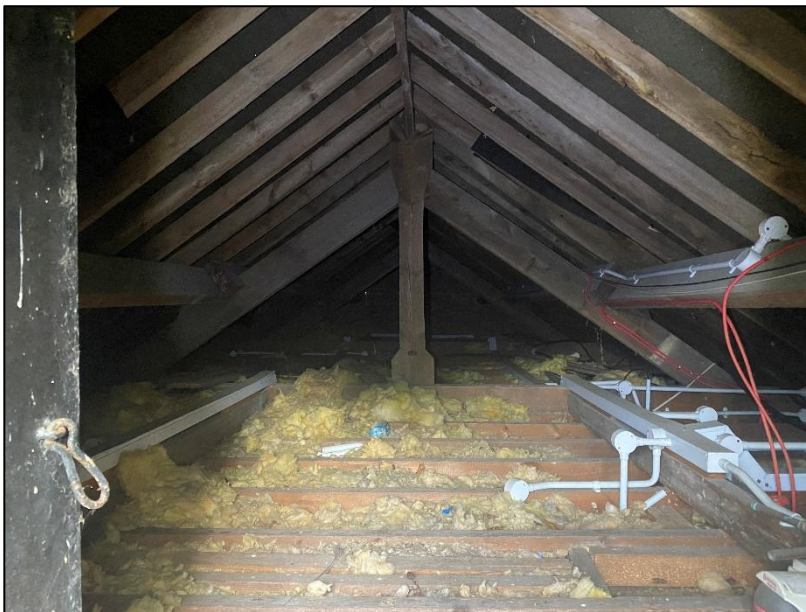
- 2.2.4 B4 comprised a detached, single-storey, stone-built structure with a pitched roof clad in slate tiles adjoined to a large stone wall. Only the loft space was accessible (via a small hay loft door on the northern elevation) which was lined with bitumen underfelt and fibreglass insulation on the floor. It was determined by looking through the windows that B4 was a former office which was divided internally into three rooms.

Photograph 4: Loft space above Building 4

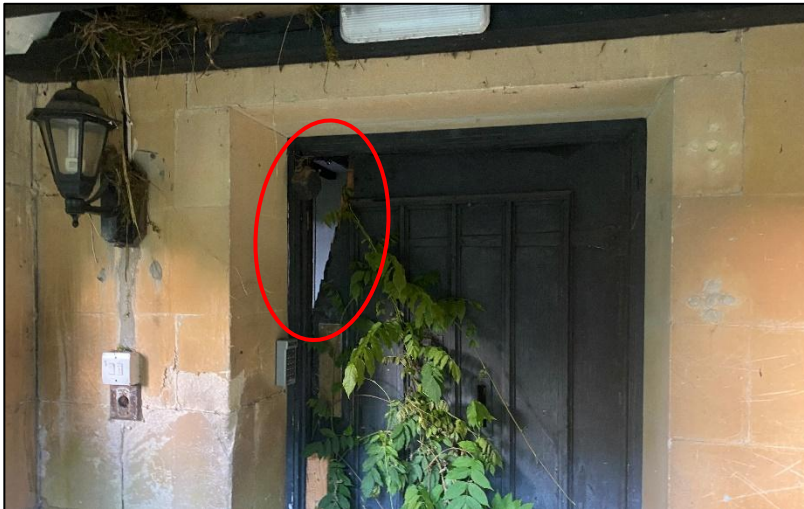
- Gap in the corner of the front door of Building 1;
- Broken windows on the eastern elevation of Building 1;
- Missing/slipped/broken tiles on several elevations of Building 1;
- Broken windows on the eastern elevation of Buildings 2 and 3;
- Open doors on the western elevations of Buildings 2 and 3; and
- Open hay loft door on northern elevation of B4.

Photograph 5: Gap adjacent Front door of Building 1

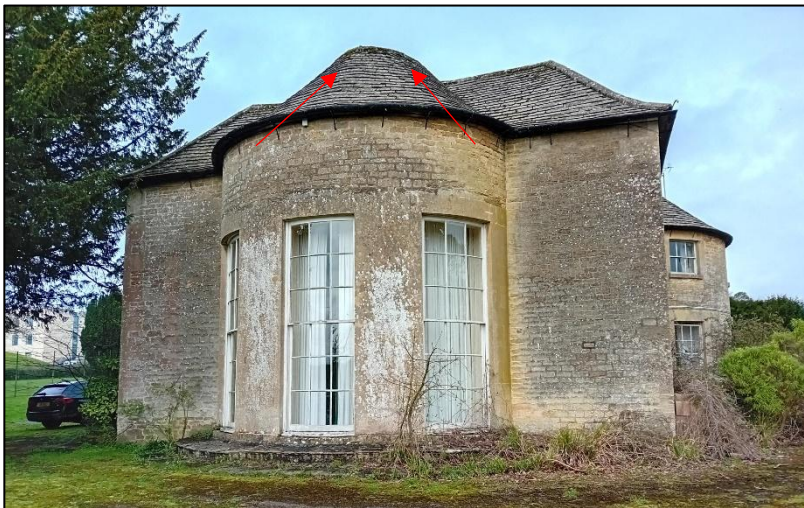
Photograph 6: Gaps under tiles of Building 1

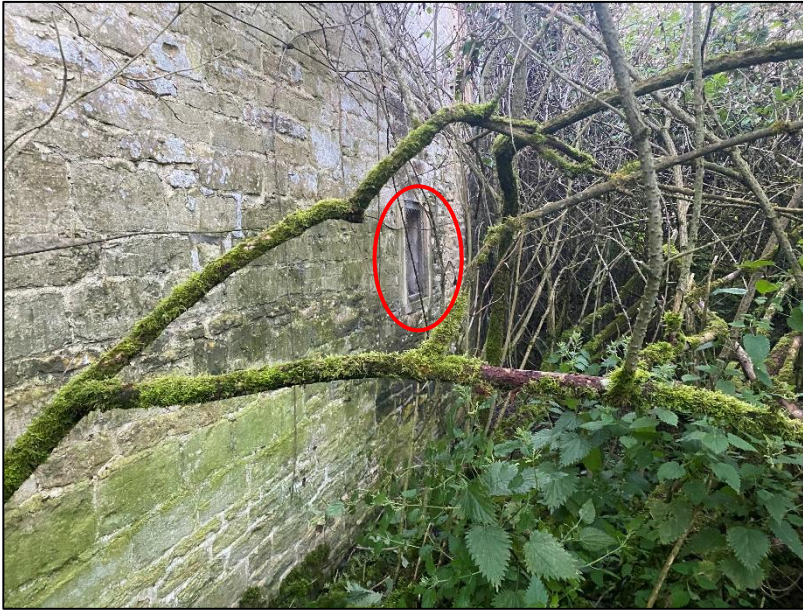
Photograph 7: Broken window on western elevation of Building 3

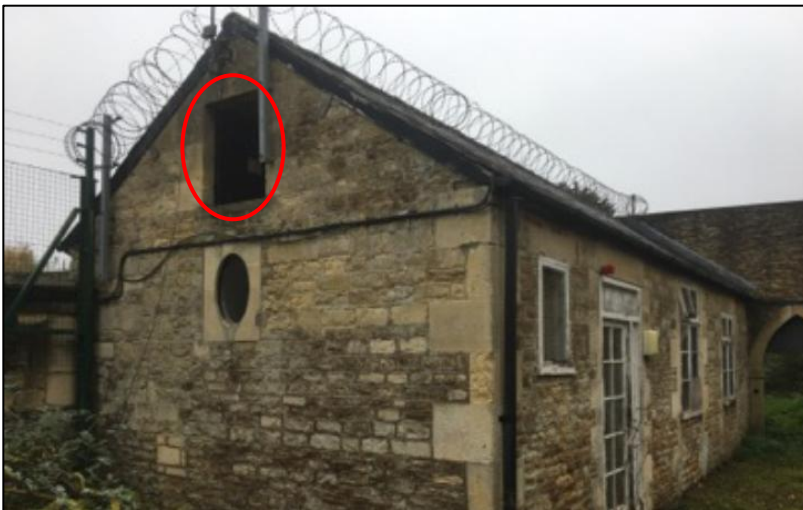
Photograph 8: Open hay loft door on northern elevation of Building 4

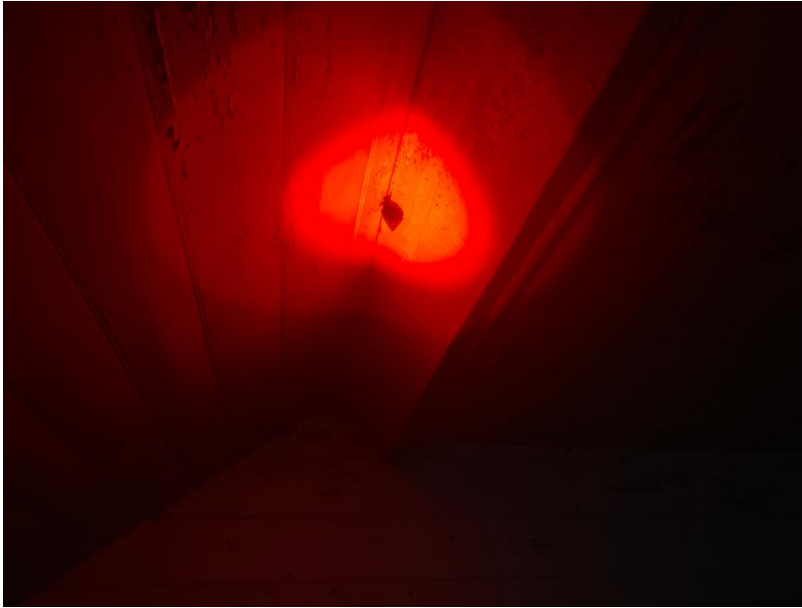
- 2.3.4 Approximately 300 small, mixed age bat droppings (indicative of lesser horseshoe and pipistrelle species) were identified in a loft space in the eastern half of Pockeridge House, 200 of which were aggregated; DNA analysis of a sample of these droppings confirmed they belonged to lesser horseshoe bats (Annexe 5a). This indicates a probable day roost for pipistrelle and lesser horseshoe bats.
- 2.3.5 Inspections of the small room in Building 3 found four lesser horseshoe bats roosting on 20 June with a further individual found on 14 August. Approximately 100 lesser horseshoe bat droppings were also found scattered on the floor (refer to Photo 9 and Annexe 1).

Photograph 9: Lesser horseshoe bat roosting in B3

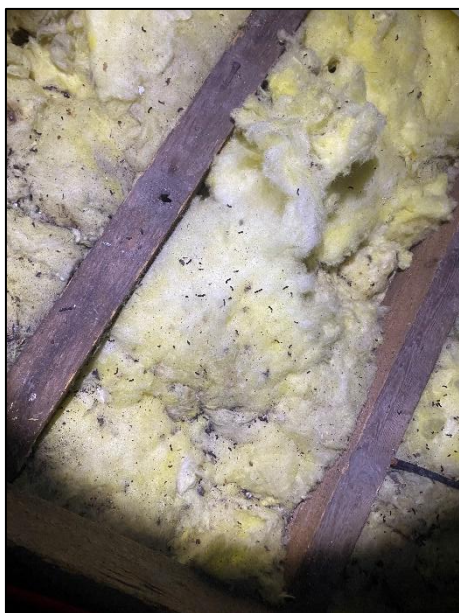
- 2.3.6 Approximately 150 lesser horseshoe bat droppings (confirmed by DNA analysis; refer to Annexe 5) were scattered within the loft space of B4 on 11 July 2023 and 1 July 2024.

Photograph 10: Lesser horseshoe bat droppings found in loft space of B4

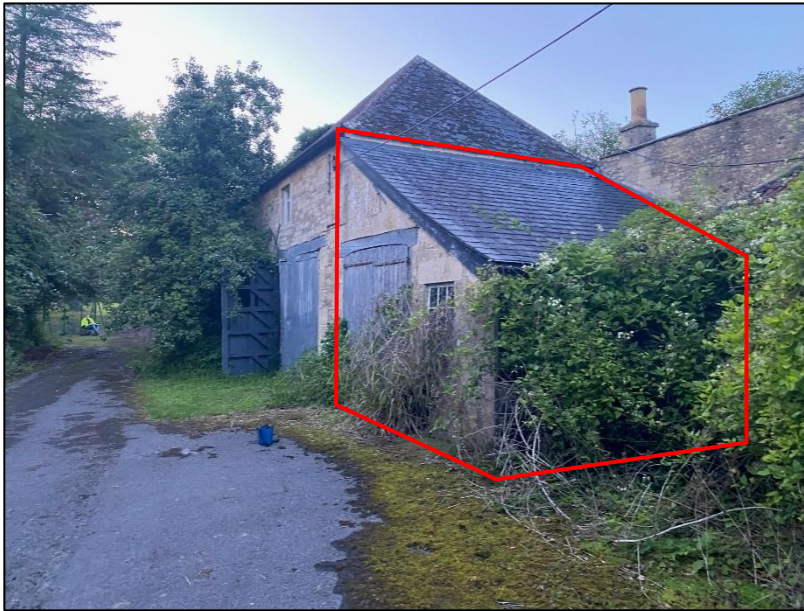
- 2.3.7 At least 14 lesser horseshoe bats were recorded roosting in the lean-to section of Building 3 through a broken window on the eastern elevation on 14 August 2023, 13 lesser horseshoe bats recorded on 1 July 2024 and at least 14 lesser horseshoe bats on 1 July 2025. It was not possible to determine the exact number due to a cluster of individuals furthest away from the open window on each occasion (refer to Photo 11 and 12, and Annexe 1).

Photograph 11: Lean-to on Building 3 containing lesser horseshoe satellite roost

- 3.2.1 The lesser horseshoe bat satellite roost within Buildings 2 and 3 is likely to be linked to the Bradford-on-Avon Bats SAC. Due to the significant value of this roost, it is recommended that Building 3 and part of Building 2 is retained. These buildings could be enhanced for roosting bats to mitigate for the loss of the bat roosts within Pockeridge House and B4.

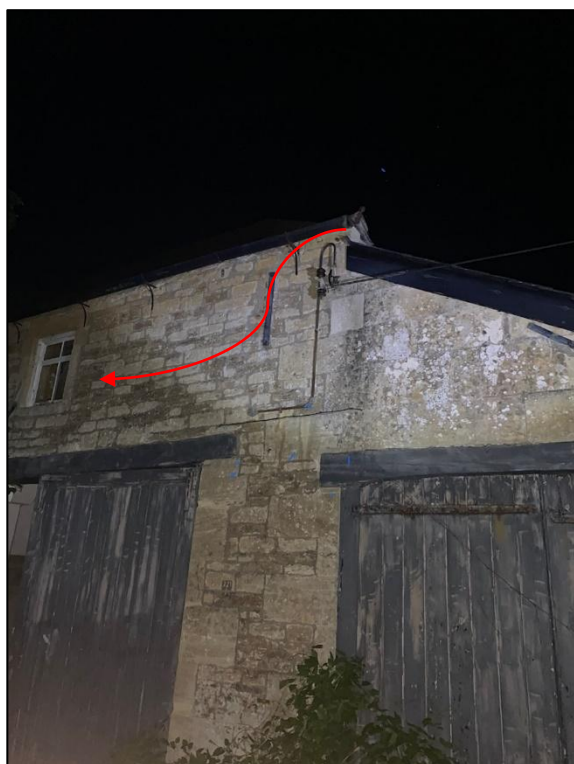
Photograph 13: Emergence point for serotine from Building 3 in August 2023
