St Patrick and St George  
Roman Catholic Church  
AT 0 083  
Tidworth Garrison

# Bat Dusk Emergence Survey

Version 1 dated 8<sup>th</sup> October 2025

2025/5698/A

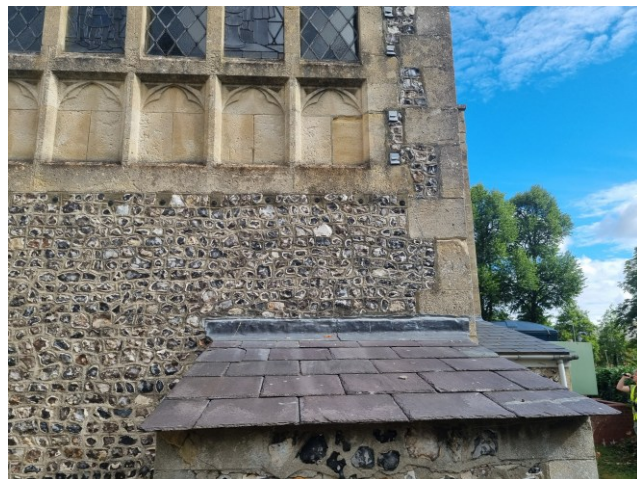
**Photograph 3.** Location of the pump room on the eastern end of the southern elevation of the church

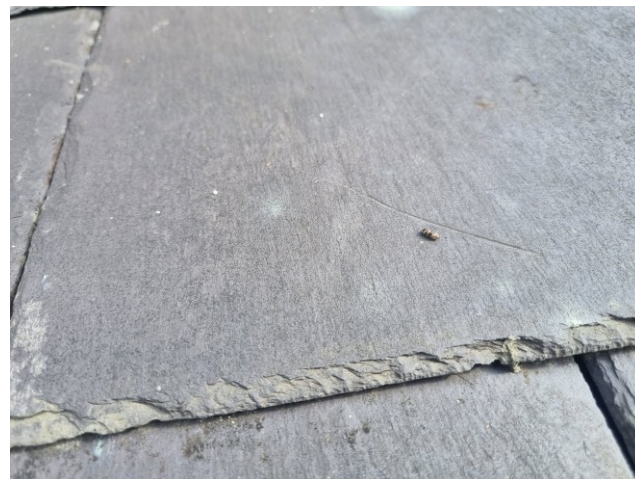
**Photograph 4.** Bat dropping on slate roof (22<sup>nd</sup> July 2025).

3.5.2 The areas above the pump room where scattered bat dropping had been identified was inspected and found to have no lifted or missing tiles and was well sealed all around. There were no opportunities around the stained-glass window, and the stonework on the southern face was in good condition and intact. Away from this area at the top of the east wall of the tower there was a crevice above the rain drainage hopper (photograph 5), which was suitable as a roost feature, but with no evidence of use. The southern elevation of the tower had a pipe coming from the stonework (photograph 6 – upper red circle). It was not possible to see the state of the surrounding stonework, but due to the age of the pipework, it is feasible it has degraded and resulted in a crevice.

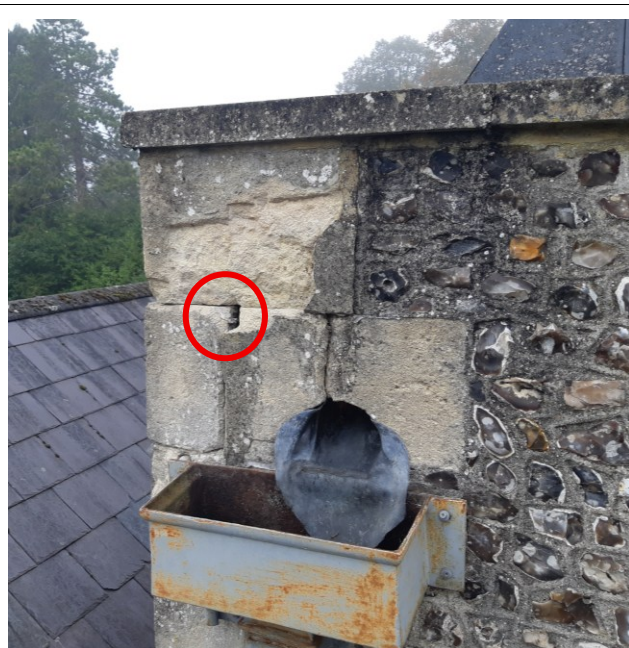
3.5.3 Where the main roof met the southeast corner of the tower a broken slate was identified (photograph 6 – lower red circle), but with no evidence of bat use. Another broken slate was seen on the southern roof (photograph 7), but again with no bat evidence. The eastern most ridge tile of the main roof was slightly raised on both the north and south (photographs 8 and 9), again with no evidence of use by bats.

**Photograph 5.** Crevice above rain drainage hopper on north elevation of the tower.

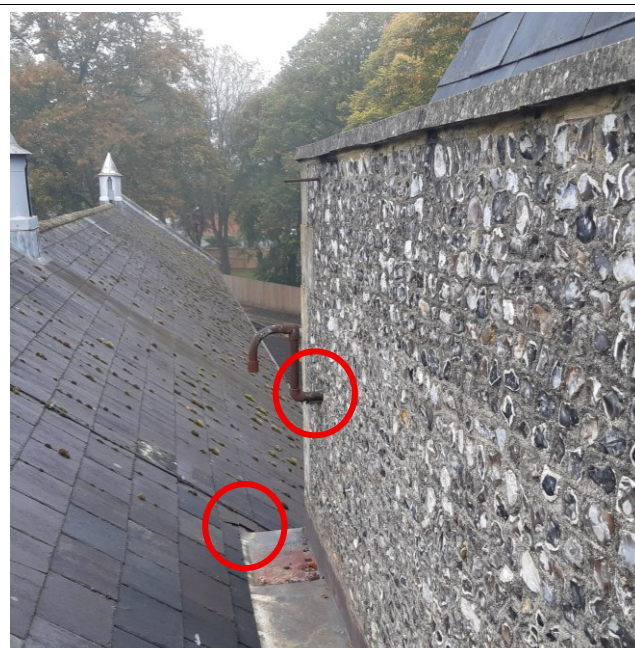
**Photograph 6.** Pipe in south wall of the tower and broken slate at in the main roof at the southwest corner of the tower wall

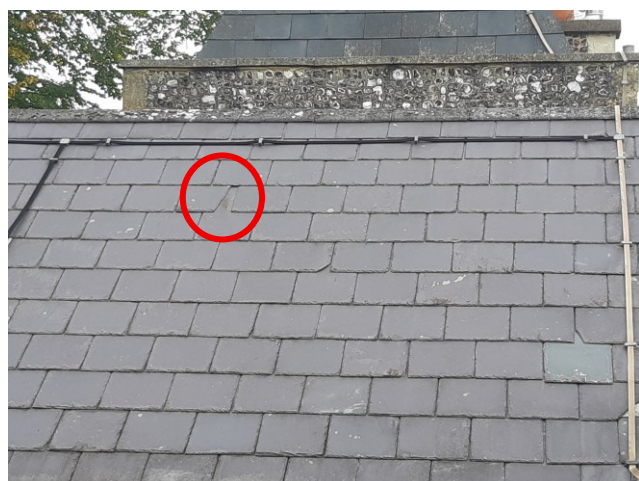
**Photograph 7.** Broken slate on the southern roof.

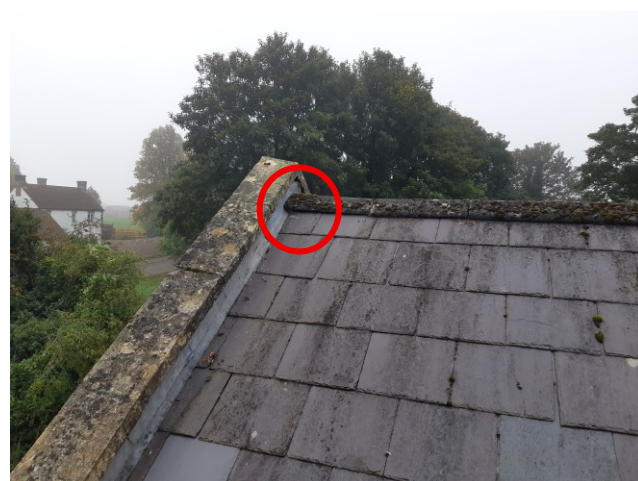
**Photograph 8.** North side of the raised eastern ridge tile on the main roof.

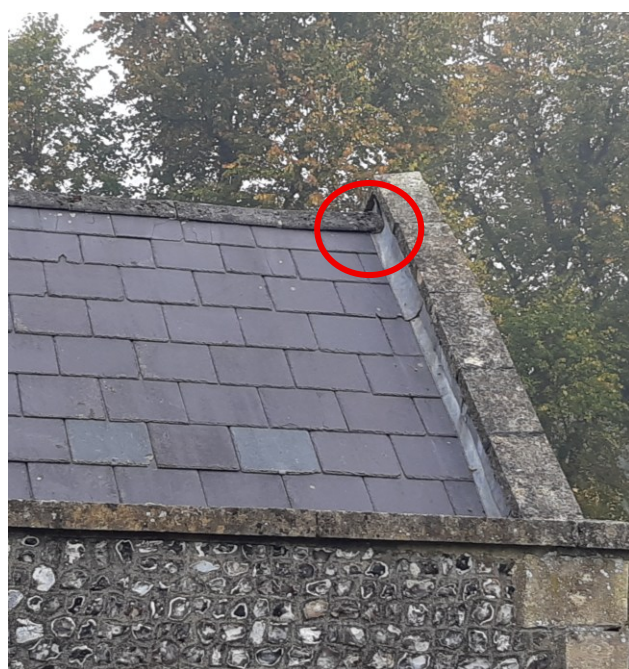
**Photograph 9.** South side of the raised eastern ridge tile on the main roof.

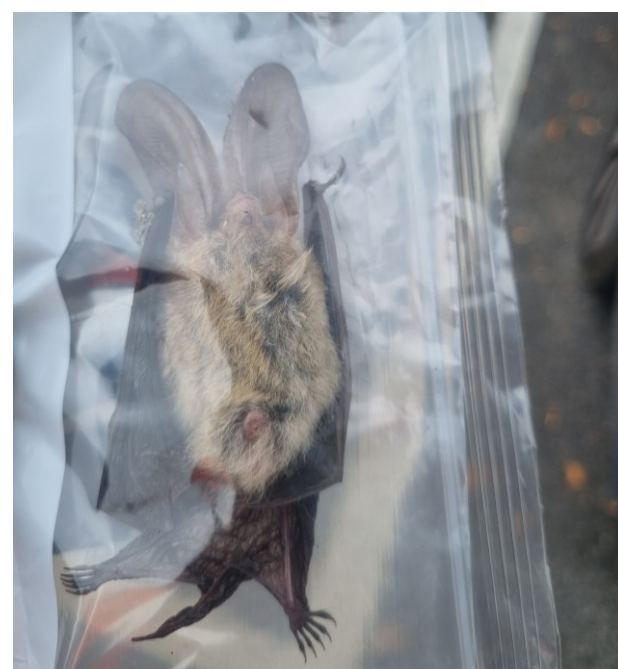
- 3.5.5 While on site a dead brown long eared bat (*Plecotus auritus*) was found on the ground under a mature tree 10 m to the west of the church porch (photograph 10). It did not have any obvious signs of injury, but red blisters were noted on its face. It was still soft and seemed to have died recently. It was handled wearing gloves and bagged to be sent to the Animal and Plant Health Agency (APHA) for passive rabies surveillance testing.

**Photograph 10.** Bagged brown long eared bat found under a tree 10m to the west of the church porch.

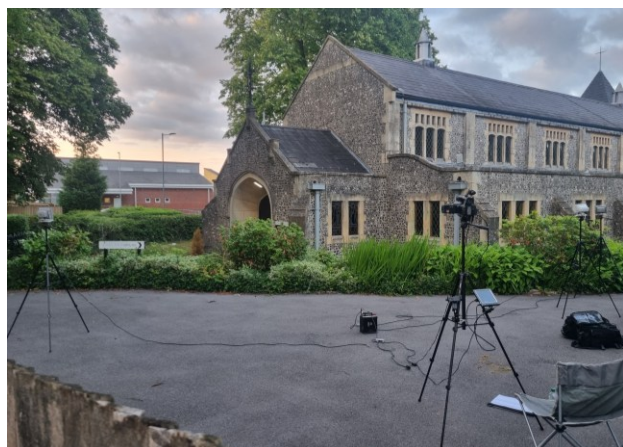
**Photograph 11.** Equipment set up (Surveyor 1), during the first dusk survey on 20th May 2025

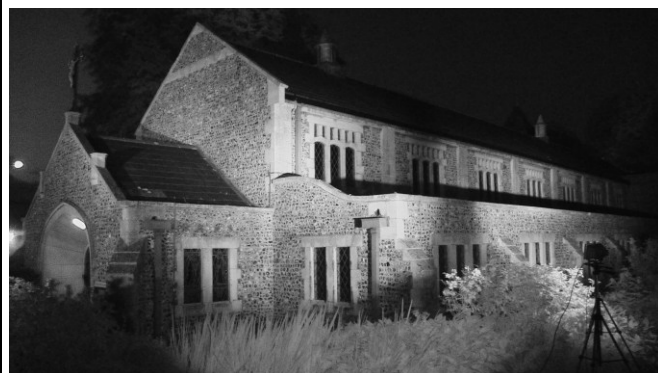
**Photograph 12.** IR image of the south west (Surveyor 1), during the first dusk survey on 20th May 2025

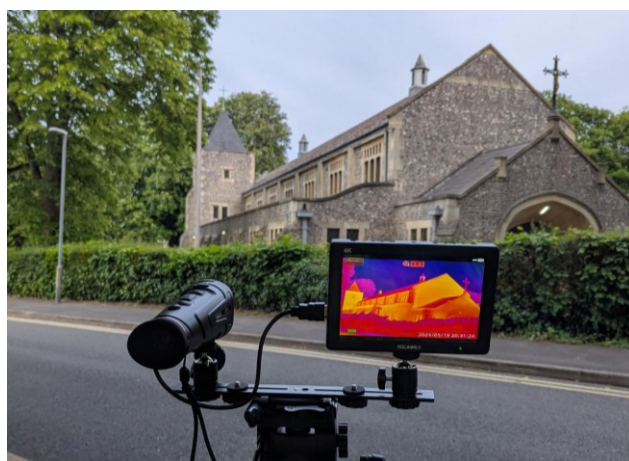
**Photograph 13.** Equipment set up (Surveyor 2), during the first dusk survey on 20th May 2025

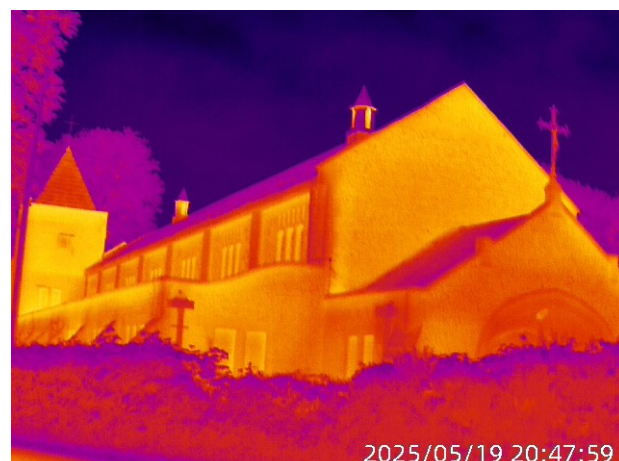
**Photograph 14.** Thermal image of the north western elevation (Surveyor 2), during the first dusk survey on 20th May 2025

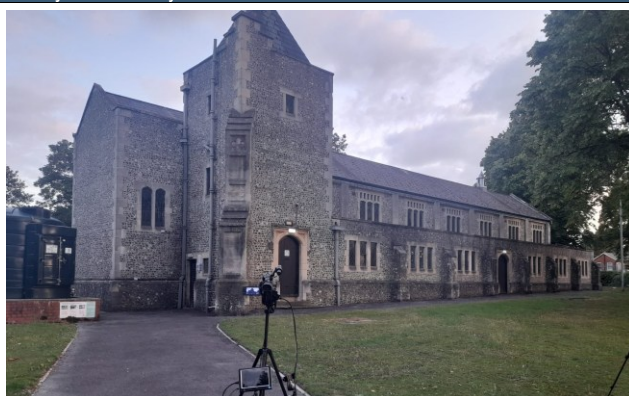
**Photograph 15.** Equipment set up (Surveyor 3), during the second dusk survey on 16th June 2025

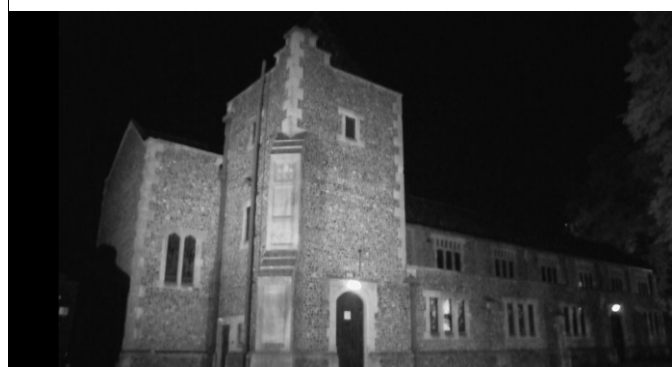
**Photograph 16.** IR still image of north eastern elevation (Surveyor 3), during the second dusk survey on 16th June 2025

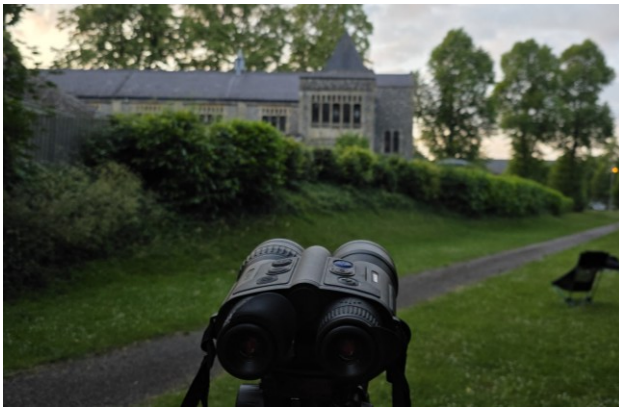
**Photograph 23.** Equipment set up (Surveyor 4), during the third dusk survey on 14<sup>th</sup> July 2025

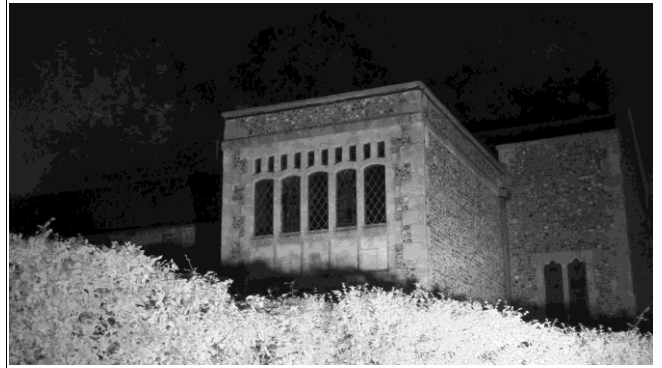
**Photograph 24.** IR still image of the south eastern elevation (Surveyor 4), during the third dusk survey on 14<sup>th</sup> July 2025
