# **PRELIMINARY ROOST APPRAISAL (PRA)**

Hoddinotts House, Hindon Lane, Tisbury, Wilts SP3 6QQ

Prepared on 9th March 2026

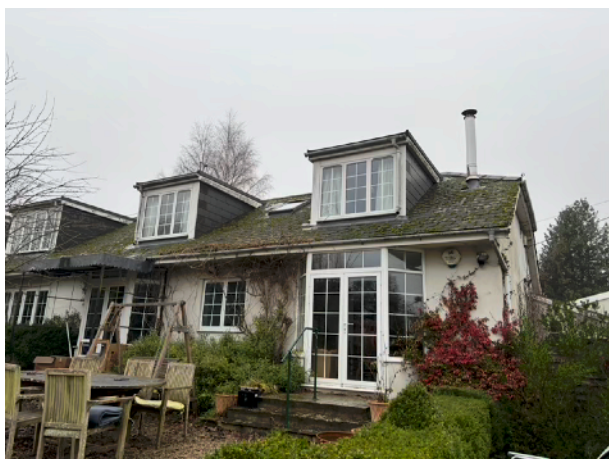
- House – A detached, rendered two-storey house, with a concrete tile roof and four dormer windows on the south-east and north-west elevations, with concrete tiles on the sides of the windows. The doors and windows are uPVC, while the soffits and fascias are wood (Figs. 2 - 5). There is an indoor pool at the south-west end of the house with all uPVC doors and windows (Fig. 5).

Figure 2. Front elevation of property (SE)

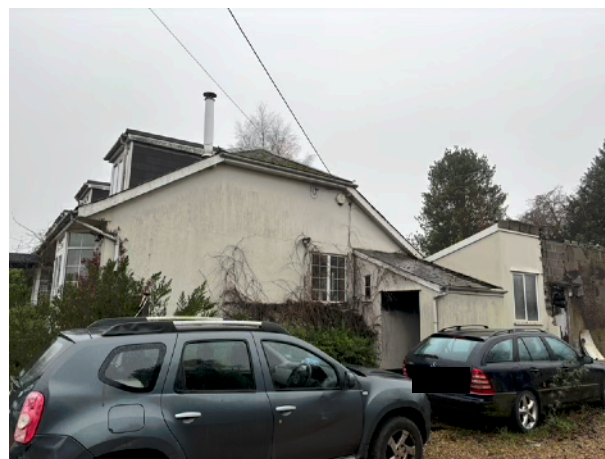
Figure 3. Side elevation (NE)

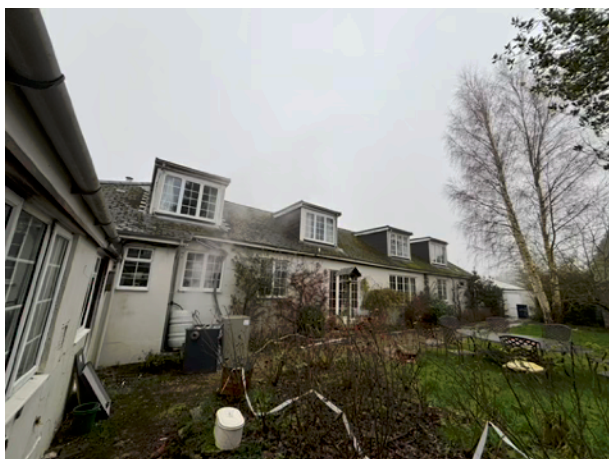
Figure 4. Rear elevation (NW)

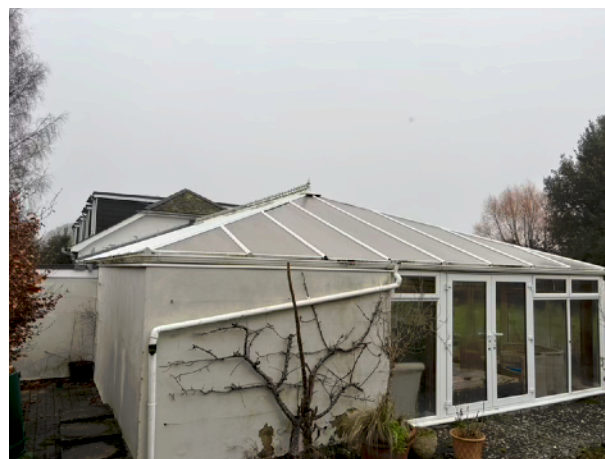
Figure 5. SW elevation & indoor pool

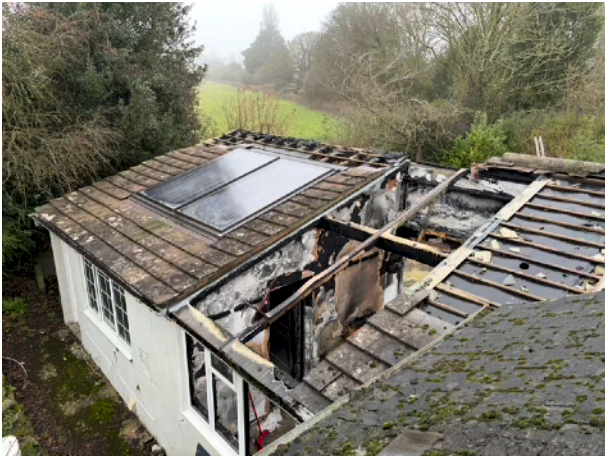
To the north of the house lies a fire-damaged wing (Figs. 6 - 9). A section of the roof remains on the north end (Fig. 6), but most of the roof is missing, along with the doors and windows (Figs. 7 & 8).

There is no loft space. No bats, evidence of bats, potential roost features (PRFs), or feeding remains such as beetle and/or butterfly/moth wings, were observed in this part of the building.

Figure 6. View of fire-damaged wing (SW)

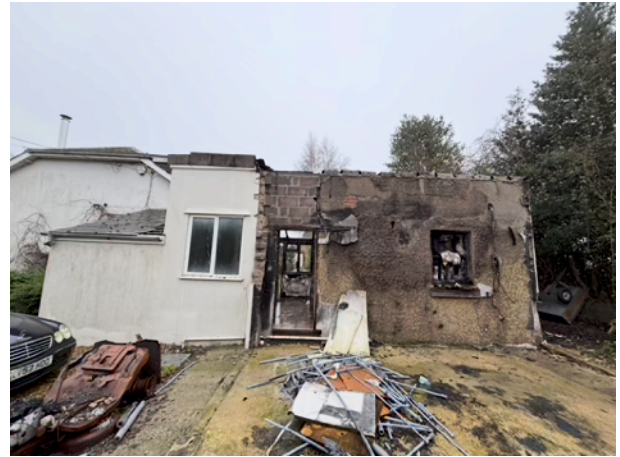
Figure 7. View of fire-damaged wing (NE)

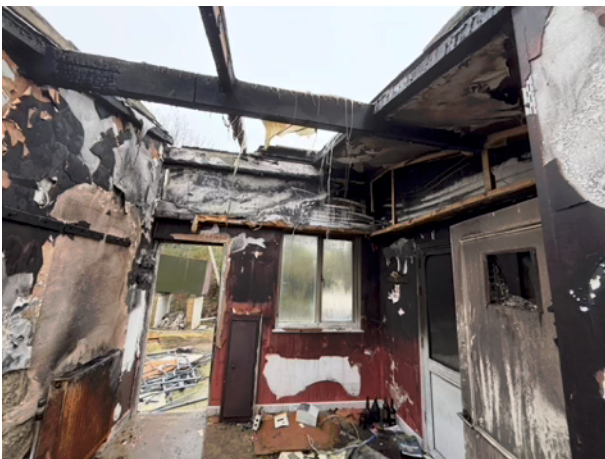
Figure 8. Interior of fire-damaged wing

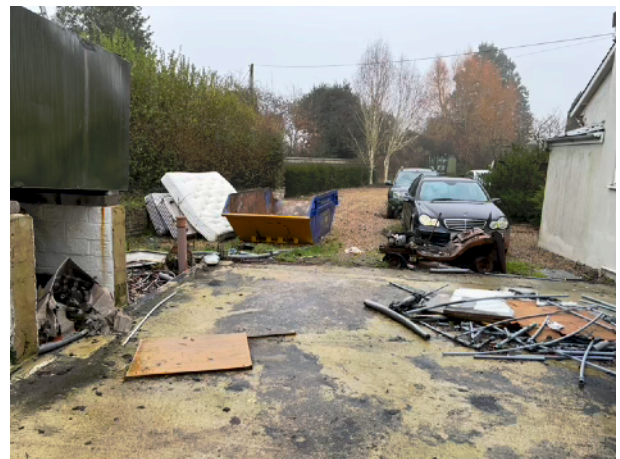
Figure 9. Area outside fire-damaged wing

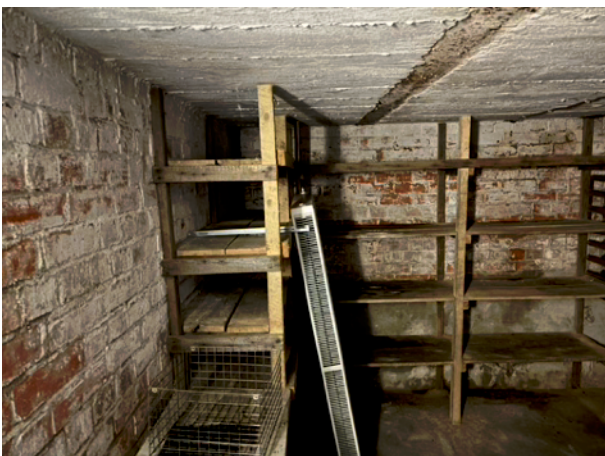
There is also a small brick cellar situated between the house and the fire-damaged wing (Fig. 10). No bats, evidence of bats, potential roost features (PRFs), or feeding remains such as beetle and/or butterfly/moth wings were observed in this part of the building.

Figure 10. Cellar

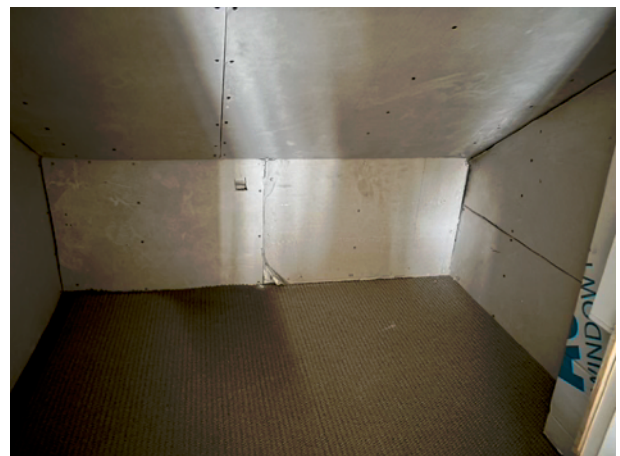
Figure 11. One of eaves spaces in loft

- Loft Space of House – There is no loft space in the house, but there are seven small eaves spaces (Fig. 11). All are boarded out with insulation. No bats, or evidence of bats (i.e. bat droppings, urine stains, or feeding remains, e.g. beetle and/or butterfly/moth wings), were observed in the eaves spaces.
- Roof – The roof tiles, soffits, fascias and lead flashing are all tight, with no gaps. There are no potential bat roost features on the roof.
