## Preliminary Ecological Appraisal and Roost Assessment

Premier Inn, Salisbury North Bishopsdown, Pearce Way, Salisbury, Wiltshire, SP1 3GU

16<sup>th</sup> April 2024

The addition of a 3 storey extension onto the current 3 storey building, serving as a hotel.

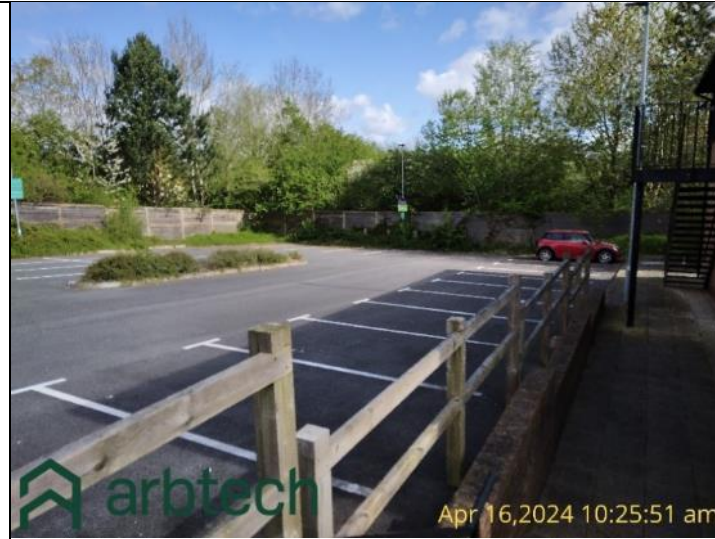
*Figure 2- the area of the car park at the proposed extension.*

| | <p>The majority of the site consists of a tarmac car park and concrete and tiled walkways. The area of proposed extensions on the northern building would be within the existing tarmac car-park areas. (See Fig 2)</p> <p><u>Developed, sealed surface (buildings) [u1b5]</u></p> <p>There are three buildings on the site consisting of 2 hotel buildings and a site pub.</p> <p>B1 and B2 are part of the premier inn hotel accommodation. B3 is a pub south of B2. Further details on the buildings are located within the bat section of this report. Only B1 is subjected to any alterations.</p> <p><u>Other broadleaf woodland [W1g]</u></p> <p>There is a band of woodland around the site's boundary- the majority of this woodland is just off-site. However small sections to the very south and in the northern corners are within the site's boundary. Along the eastern boundary (see Fig 3) the band of trees appears to be newly planted, due to the lack of semi-mature trees and the presence of old tree guards, which they have outgrown.</p> <p>The eastern band of woodland is comprised of young hawthorns-(D), elder (F) field maple (O) hazel (F).</p> <p>There is a lack of established woodland understory flora, with common ivy being present but a lack of abundant flowering species.</p> <p>There is a small wire fence that cuts through within 1m of the woodland boundary, separating the site from the wider woodland landscape beyond.</p> |

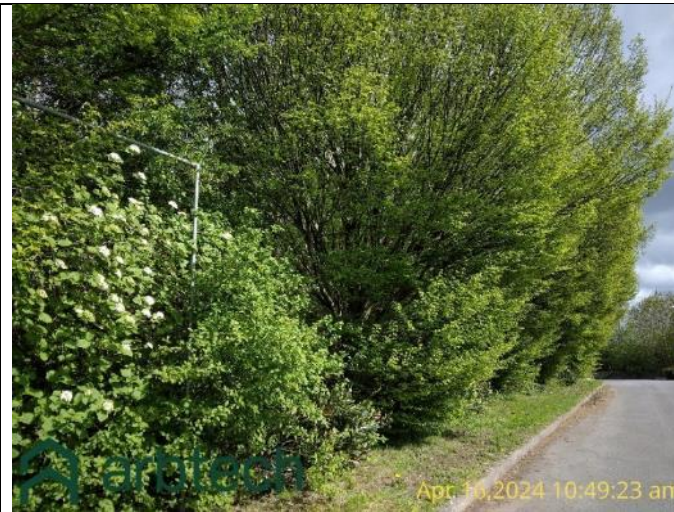
Figure 4- Woodland area in the northwest corner of the site

| | <p>The northwestern corner (see Fig 4) has a larger collection of semi-mature trees which extend in a band north of the boundary 7ft fence- this includes hornbeam (O) field maple (O) poplar (O) honeysuckle box(F), silver birch (F), ash (F), hazel (O), black pine (R) cherry laurel (F) cherry (O) and privet (F).</p> <p>The understory includes a scattering of bramble and young cherry laurel. At the southern edge, several flowering herb species are present, such as herb Robert (A) field speedwell (O) white clover (F), red dead nettle (O), cleavers (O) nettles (F) However, the majority of this consist of bare ground and leaf litter. (See Fig 9)</p> <p><u>G3- Neutral grassland.</u></p> <p>There are patches of grassland around the site- these areas are regularly mown to keep a tidy appearance and in no location was the sward height higher than 10cm. Regular mowing has caused some of the grassland to have bare ground patches and be dominated by pioneering herb species, and springy turf moss, instead of grasses. Grass species within these areas include perennial rye (O) annual meadow grass (F) cocks's foot (D) Yorkshire fog (D) and rough meadow grasses (D).</p> <p>Herb species include- red dead nettle (F), common corn salad (O), fox and cubs (O), dandelion (D), field speedwell (F), common mouse-ear (O), common cranes bill (F), yarrow (O), bulbous buttercup (F), common daisy (D), ribwort plantain (O) and hawkweed (O).</p> <p><u>Flower beds [846]</u></p> <p>There are several flower beds around the car park, (see Fig 8) which contain various non-native evergreen shrubs. Non-native invasive species were identified within these flower beds, such as Spanish bluebells, Virginia creeper and small-leaved cotoneaster.</p> |

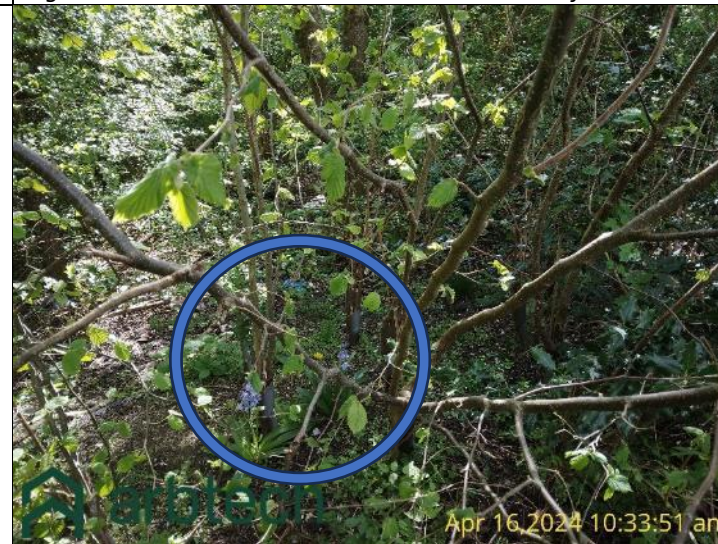
Figure 6- Spanish bluebell on woodland edge (circled)

| <i>Summary of Survey Findings</i> | <p>There were several invasive plant species identified in various locations of the site. This includes Spanish bluebell, cherry laurel, Virginia creeper and small-leaved cotoneaster. All of these species were recorded in low numbers and were not spread across the whole site. The location of which is noted in the map in Appendix 3.</p> <p>The cotoneaster is isolated within flower bed planting with the central car park.</p> <p>The cherry laurel is seen growing along the woodland boundary of the northeast corner, as well as the hedgerow with trees band along the southwest boundary. Although this species is not listed as invasive on Schedule 9 of the Wildlife and Countrywide Act, this non-native species can quickly take over woodland areas and lower the biodiversity of the woodland.</p> <p>Virginia creeper was seen growing on the fence along the north boundary, north of the proposed development area of the site. (see fig 5)</p> <p>Spanish bluebells were in low numbers and included within the northern flower beds as well as the edges of the northern woodland (see Fig 6)</p> |

| <i>Recommendations</i> | <p>All non-native invasive plant species should be removed with best practices from the site. Caution should be taken with species like the cotoneaster on the removal, that berries aren't tracked off the site, which would spread seeds to new locations.</p> <p>This may require follow-up checks by ground maintenance to keep on top of any regrowth of these species in the following years.</p> |

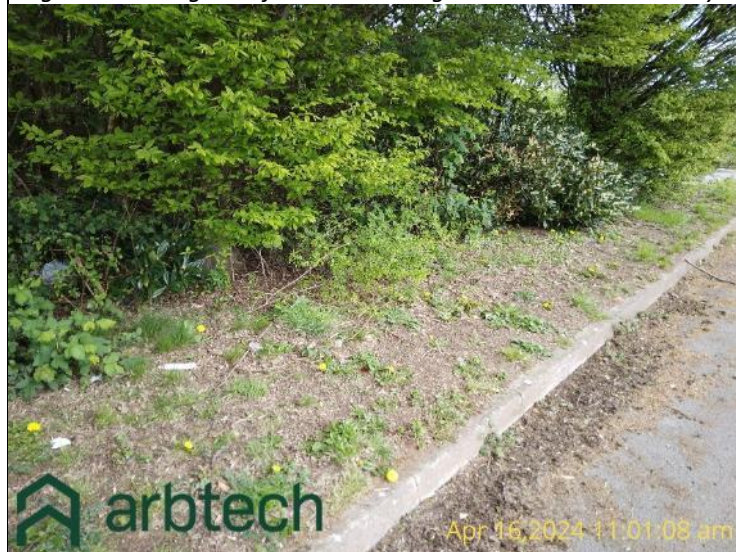
Figure 9- Bare ground areas at northwestern wood, signs of ground-nesting bees

| <i>Recommendations</i> | <p>No further surveys.</p> <p>It's advised the areas identified in use by solitary bees be kept in their current condition to continue to provide patches of bare ground for invertebrates.</p> <p>Allowing areas of longer grass sward height, or wildflower areas will increase shelter and foraging habitat for other species in this taxa.</p> |

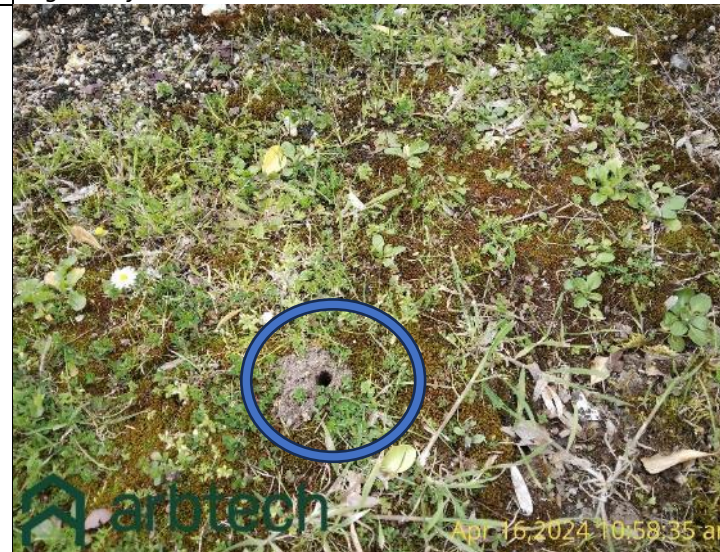
Figure 10- Close-up showing one of the active ground-nesting bee nests

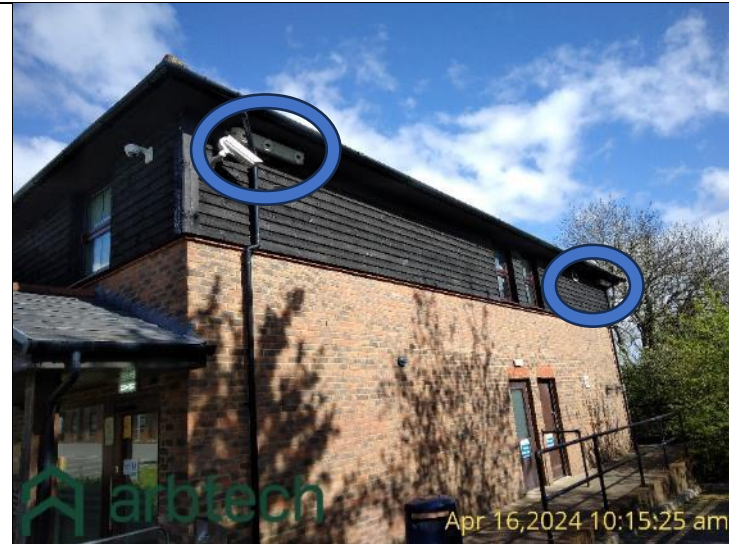
Figure 12- southeast elevation of B1- Swift nest boxes were seen. (circled)

| | <p>There are also two swift bird boxes installed on the east elevation B1, each having 3 chambers. It is too early to observe if these are being used by swifts, but there was no activity from other birds to suggest other species are currently occupying the boxes.</p> <p>The majority of the lifted fascia boards on B1 are too small for nesting birds, but one of two of these spaces is large enough for birds such as wren to nest underneath the board.</p> <p>Nesting collared doves were observed on a security camera on the south-west corner of B2</p> <p>No schedule 1 species was heard during the survey or seen interacting with the site.</p> |

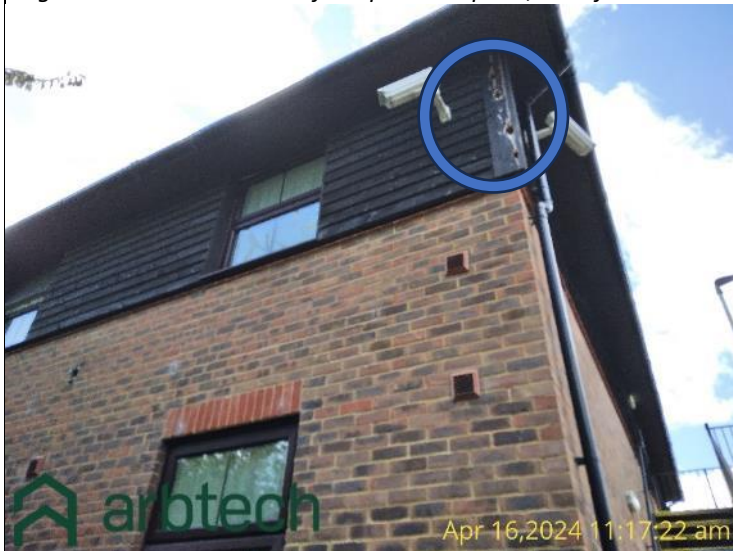
| | <p><b>Feature 2-</b> There are also several locations where woodpeckers have drilled multiple holes in the corner boards (Fig 13 and 18) If not in use by birds, and suitably deep enough, these can be used by roosting bats. These could open up direct access for bats to roost under the fascia boards.</p> <p><b>B1- Interior (Fig 19 and 20)</b></p> <p>The interior loft of B1 was divided into sections creating rooms, with walls and doors separating each section. The central areas are boarded for walking, and the rest with exposed layers of loose wool roll. The lining is a bitumen felt and breathable roof membrane combination in different sections. There are exposed ridges, rafters and truss supports.</p> <p>There are areas where the lining has peeled back around vents which could serve as direct access points.</p> <p>These loft rooms measure- 4m high, 13m long and 10m wide. Internal temperatures at the time of the survey were 13°C and humidity 64%</p> <p>A search was conducted for dropping evidence of bats accessing any of these loft rooms, including underneath top layers of insulation around key features (such as against any gable walls and in darker corners) for any historic evidence. The search also included on top of items within the room, such as fans and water tanks.</p> <ul style="list-style-type: none"> <li>- No bat-dropping evidence was found within any loft room.</li> <li>- No other evidence of bats accessing the internal space was observed, such as grease stain, scratch marks or urine staining on any rafter or ridge line.</li> </ul> <p>This does not rule out the potential of crevice-dwelling bats on external features.</p> |

Figure 13- woodpecker holes on the northern corner of B1

| <i>Foreseen Impacts</i> | <p>The proposals include a two-storey extension to B1 on the northwest elevation. This will destroy bat roost features such as lifted fascia boards as well as features caused by woodpecker holes in these corners.</p> <p>The proposed extension will extend the light range and volume of light spillage of the building towards the northern and northwestern tree lines.</p> |
| <i>Recommendations</i> | <p>B1 is of moderate value for supporting roosting bats. Though there are several features and good habitats nearby. There is not a high volume and quality to these features. Due to the size of gap from the lifted boards, this would be more likely to support smaller crevice-dwelling species, such as pipistrelles.</p> <p>Two bat emergence/re-entry surveys are required on B1 during the active bat season (May – September) to confirm the presence/likely presence of bats roosting in or on the building.</p> <p>These survey visits should be completed during the optimal survey period mid-May to August inclusive. The survey visits should be at least three weeks apart.</p> <p>Sub-optimal: early May and September. Would require greater justification of timing e.g., weather conditions, and known local bat activity.</p> <p>One of the surveys could be a dawn re-entry survey, or all both can be at dusk if supported by night vision aids (NVA).</p> |

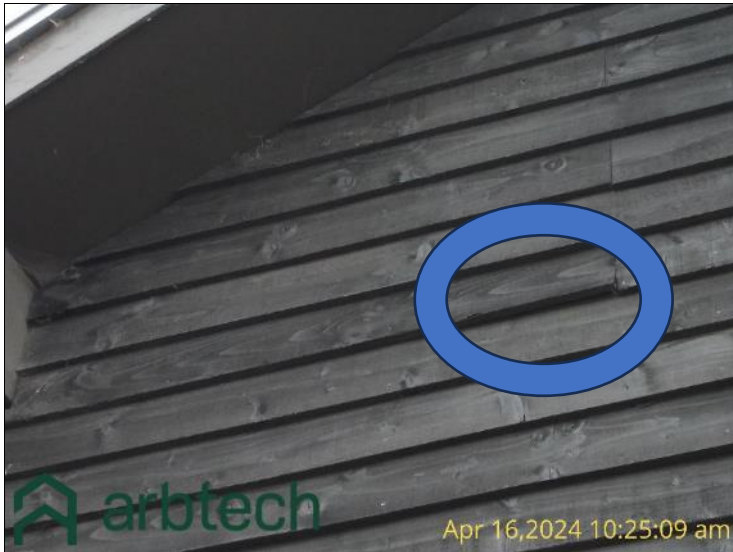
| | <p>The site consists of 3 buildings. Two of these buildings are part of the premier inn hotel and are the accommodation building. The third building is a pub, as part of the same site.</p> <p><b><u>B1</u></b></p> <p>B1 is the building subject for the proposed extension work. This building is a large, detached, two-storey structure against the site's northern boundary. It is a red-brick building, with an upper floor wrapped in timber fascia boards. The roof is a hipped roof, with slate field tiles and red-clay hip and ridge tiles.</p> <p>There were no roosting features identified around the roof tiles of the building.</p> <p>There are two gable walls on the southern elevation.</p> <p><b>Feature 1-</b> There is noted raising of the fascia boards in several locations around B1 (<i>See Fig 14-16</i>) The lifting of these boards is suitable for small crevice dwelling bats, such as pipistrelle to roost under. Spaces under the fascia boards of 2cm are wide enough for pipistrelle bats to access.</p> <p>This has the potential to allow full access for bats around all elevations of the fascia boards and is not limited to the specific locations of where boards were raised.</p> <p>Areas of raised boards are noted on the map in Appendix 1.</p> |

Figure 15- additional lifted boards on B1 southern elevation

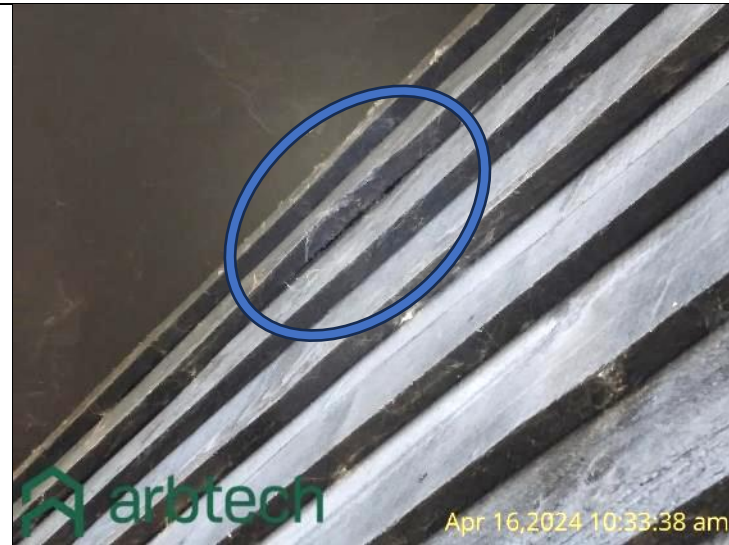
Figure 16- gaps under façade boards on B1 northwest elevation. (circled)

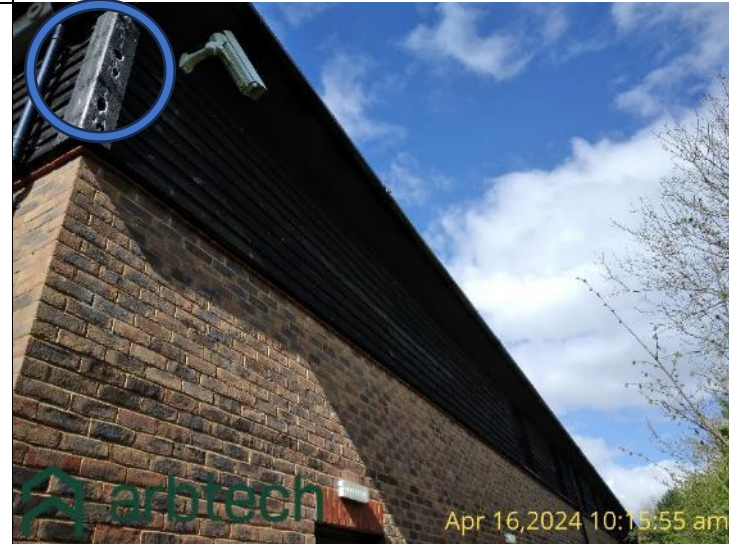
| <i>Summary of Survey Findings</i> | <p>There is evidence of nesting birds around the site, such as within the woodland boundary. There were also indications of nesting birds on several buildings. B1 – which is subject to development- had multiple locations where woodpeckers have been drilling holes within the corners. While great spotted woodpeckers were heard during the survey, no interaction with B1 was observed. However, the excavated holes could be used by other bird species if the holes are suitably deep enough.</p> |

Figure 18- Overall northern view of B1- woodpecker holes in the corner (circled)

| <i>Foreseen Impacts</i> | <p>The proposed development could result in the destruction or the disturbance and subsequent abandonment of active bird nests. In particular, if the woodpecker holes on the western elevation of B1 are occupied.</p> |
| <i>Recommendations</i> | <p>Any building or vegetation removal should be undertaken outside the period from 1st March to 31st August. If this timeframe cannot be avoided, a close inspection of the vegetation should be undertaken immediately, by a qualified ecologist, before the commencement of work. All active nests will need to be retained until the young have fledged.</p> <p>Precautions should be taken with machinery and noise levels when working close to any retained nests so as not to disturb any nearby nesting birds during construction works. At least a 3-5m buffer should be created between any machinery and active nests until the young have fledged.</p> <p>Retain the swift nesting boxes already on B1 and include the addition of other boxes, including a mix of boxes for swift and swallow. This should be installed under the eaves of B1 or B2 and should avoid facing the south elevation.</p> |

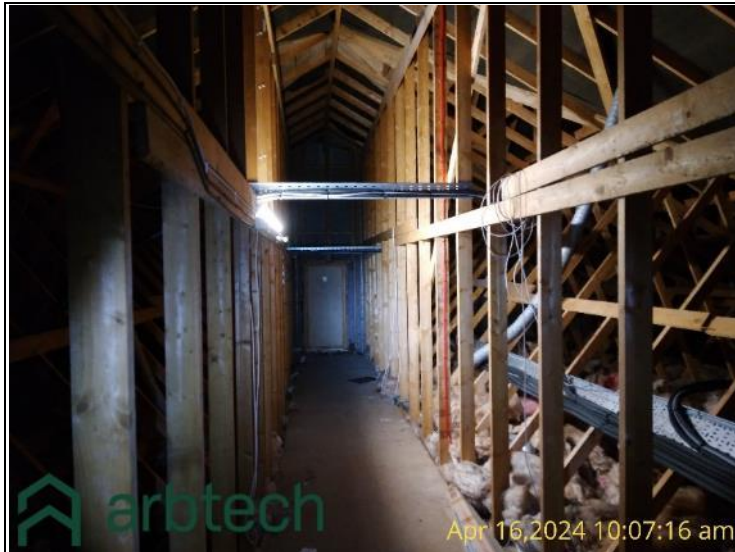
Figure 19- Northern loft space of B1

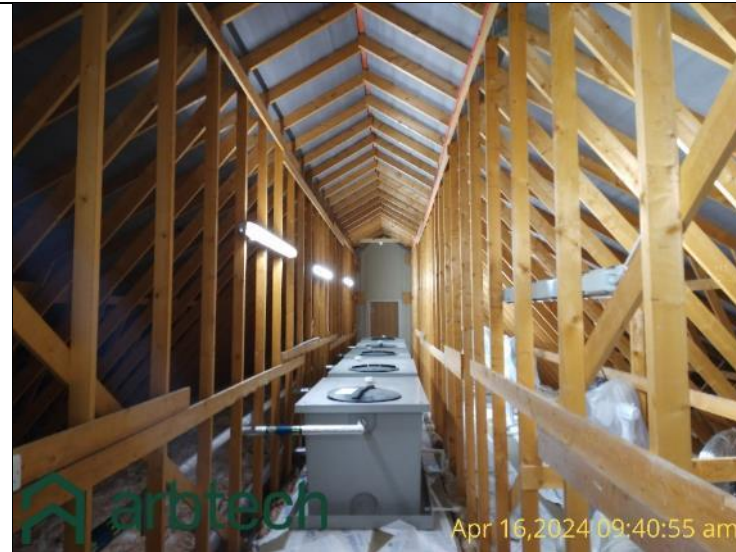
Figure 20 – Southern loft space of B1.
