## Bat Emergence and Re-Entry Surveys (BERS)

Premier Inn, Salisbury North Bishopsdown, Pearce Way, Salisbury, Wiltshire, SP1 3GU

This report is prepared to inform a planning application for the proposal described as:  
The addition of a 3 storey extension onto the current 3 storey building, serving as a hotel.

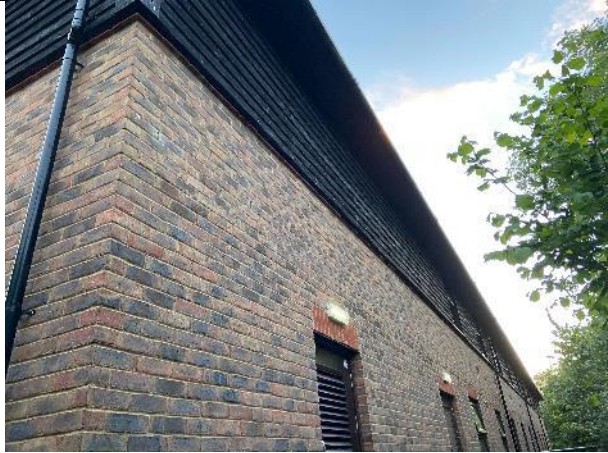
| Surveyor 1 | <p>The first bat recorded at 21:32, a Myotis spp. heard not seen.</p> <p>Following this, regular commuting activity along the northern hedge/tree line was recorded mostly comprising Myotis spp. however a few Daubenton's were recorded.</p> <p>The Last bat recorded at 22:22, a soprano pipistrelle seen foraging along the north elevation constantly until the end of the survey.</p> <p><b><u>No roosting activity recorded</u></b></p> | |

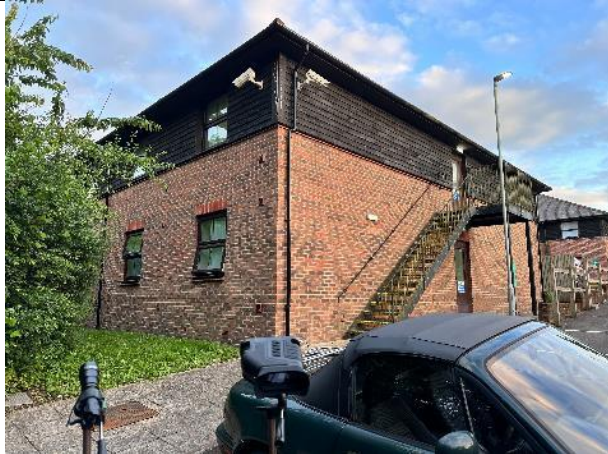
| Surveyor 2 | <p>First bat was a Common pipistrelle at 21:30, heading north, passing over southern corner.</p> <p>21:39 &amp; 21:41 CP Feeding around trees, then passed, N&gt;S</p> <p>After, from 21:43-22:23 general Common pipistrelle passes, many heard but not seen, with constant feeding activity for 7 mins from 22:15.</p> <p>22:27-22:43 Constant activity of common pipistrelle continuing past end of the survey.</p> <p><b><u>No roosting activity recorded</u></b></p> | |

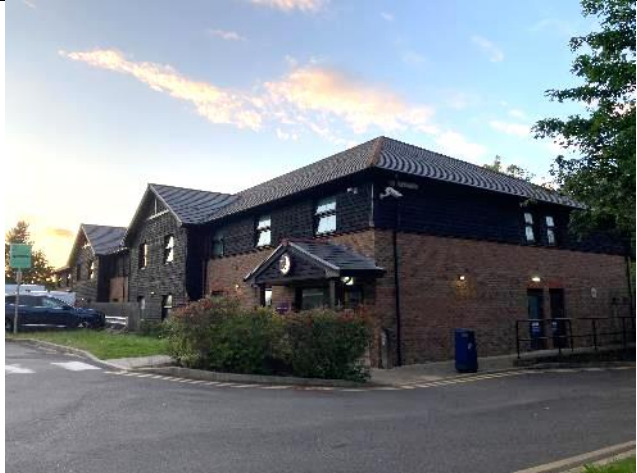
| Surveyor 3 | <p>The first bat common pipistrelle at 21:17, faint heard not seen. Occasional single common pipistrelle passes at 21:38 and 22:19 were heard not seen. Continuous common pipistrelle feeding 22:26 to end of the survey at 22:40, heard not seen but determined to be foraging along the tree line on the eastern site boundary.</p> <p><b><u>No roosting activity recorded</u></b></p> | |

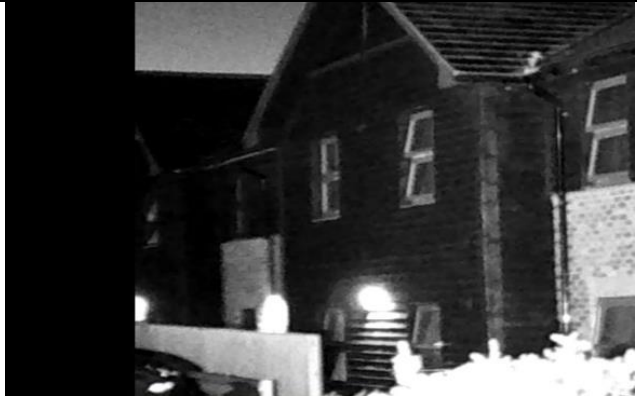
| IR position | <p><b><u>No roosting activity recorded</u></b></p> | |

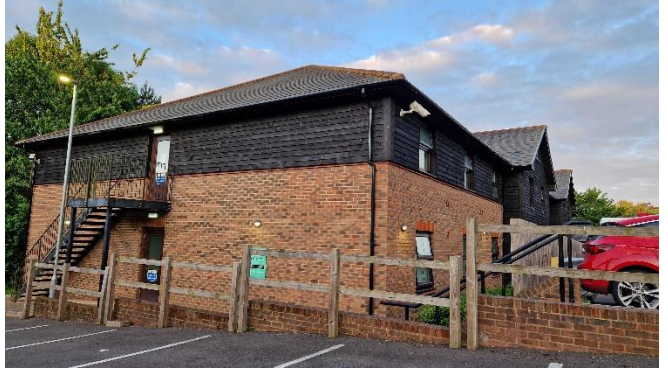
| <i>Surveyor 4</i> | <p>The first bat was a Common Pipistrelle pass heard not seen (HNS) at 21:30. Between 2215 and the end of the survey there was intermittent distant Common Pipistrelle activity, HNS, including social calling. The last bat was a distant Common Pipistrelle, HNS, at 22:40.</p> <p><b><u>No roosting activity recorded</u></b></p> | |

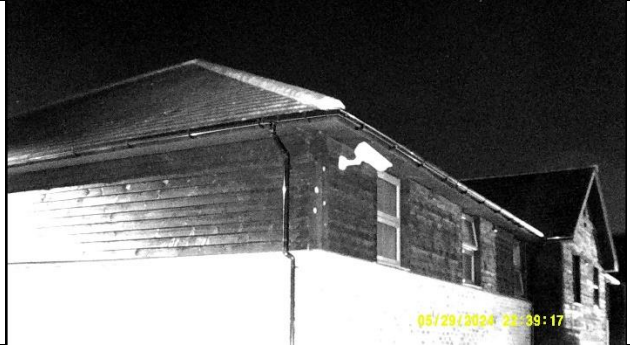
| <i>IR position</i> | <p><b><u>No roosting activity recorded</u></b></p> | |

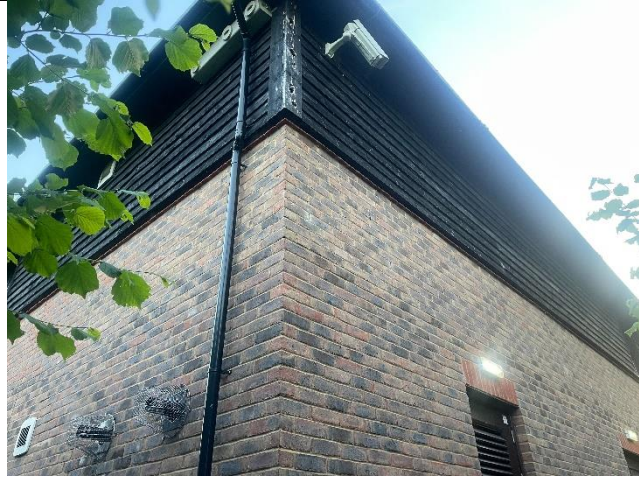
| <i>Surveyor 1</i> | <p>The first bat heard was a common pipistrelle at 21:54 determined to be foraging in the vegetation to the east.</p> <p>Noctules were heard passing over the site at 21:57, 22:09, 22:11, 22:20 and 22:28. Two common pipistrelles were seen foraging in the vegetation at 22:00 and 22:25.</p> <p>The final bat of the survey was a noctule at 22:37 which was heard but not seen.</p> <p><b><u>No roosting activity was observed.</u></b></p> | |

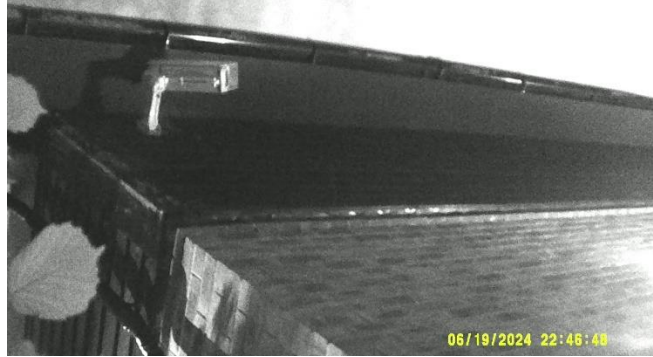
| <i>IR position</i> | <p><b><u>No roosting activity was observed.</u></b></p> | |

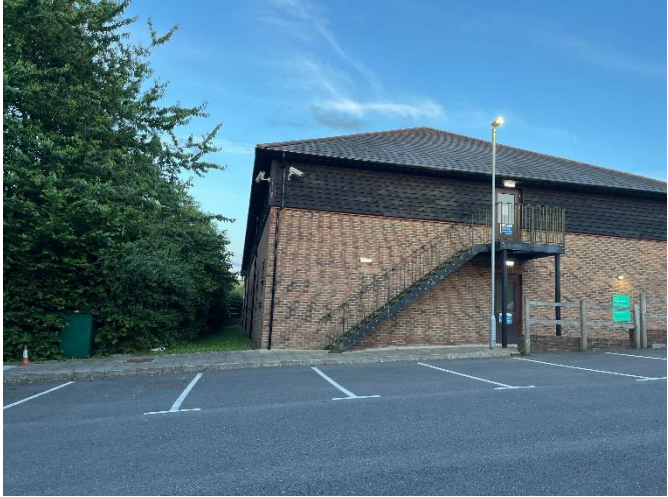
| <i>Surveyor 2</i> | <p>The first bat 21.40 was a common pipistrelle, heard but not seen. 21.48 Noctule commuting east to south. 21.49 common pipistrelle was seen flying by over the building east to south. Common pipistrelles were heard but not seen throughout the survey until 22.29.</p> <p>Noctules bats were heard but not seen at- 21.55, 22.09, 22.11, 22.20.</p> <p>At 21.54 a soprano pipistrelle was heard and not seen and again at 22.29.</p> <p><b><u>No roosting activity was observed.</u></b></p> | |

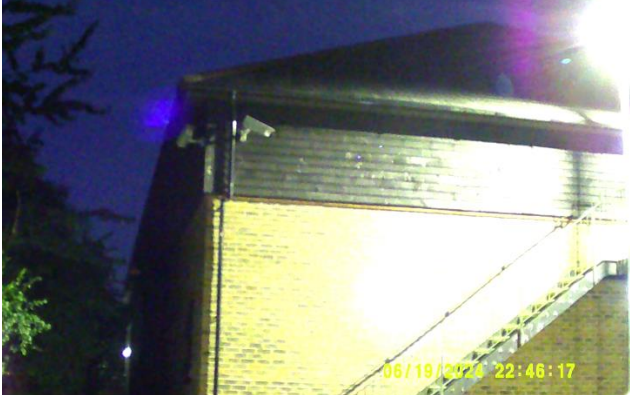
| <i>IR position</i> | <p><b><u>No roosting activity was observed.</u></b></p> | |

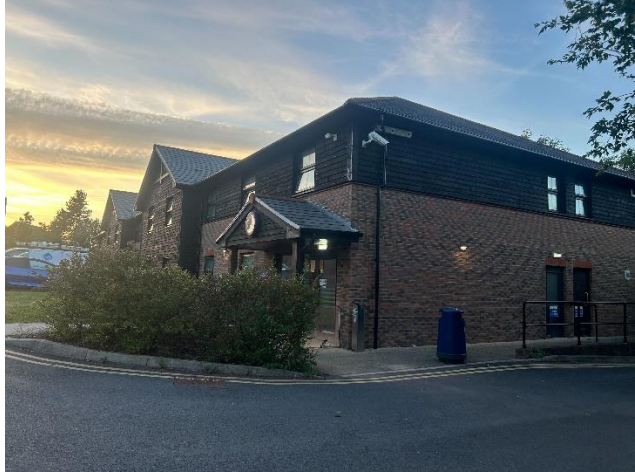
| <i>Surveyor 3</i> | <p>First bat recorded was a noctule at 21:57 commuting south over the tree line southeast of the building.</p> <p>Four more noctule passes were recorded, all heard not seen. The last noctule recorded was at 22:20.</p> <p><b><u>No roosting activity was observed.</u></b></p> | A color photograph of the Premier Inn building at dusk. The building is a two-story structure with a dark roof and brick walls. The sky is a mix of blue and orange from the setting sun. There are some bushes in the foreground and a blue bin near the entrance. |

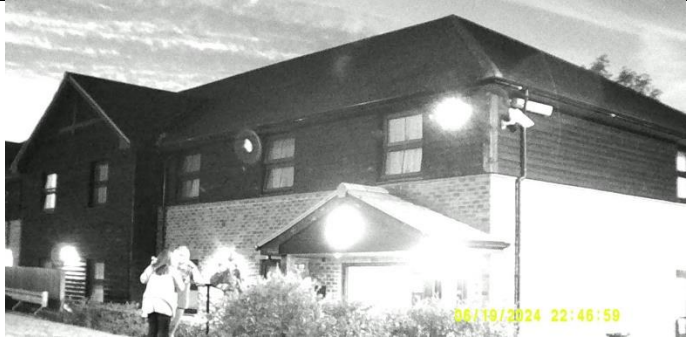
| <i>IR position</i> | <p><b><u>No roosting activity was observed.</u></b></p> | A black and white infrared photograph of the same Premier Inn building at night. The building is illuminated by artificial lights, making it stand out against the dark background. A person is visible in the foreground near the entrance. A timestamp in the bottom right corner reads "06/19/2024 22:46:59". |

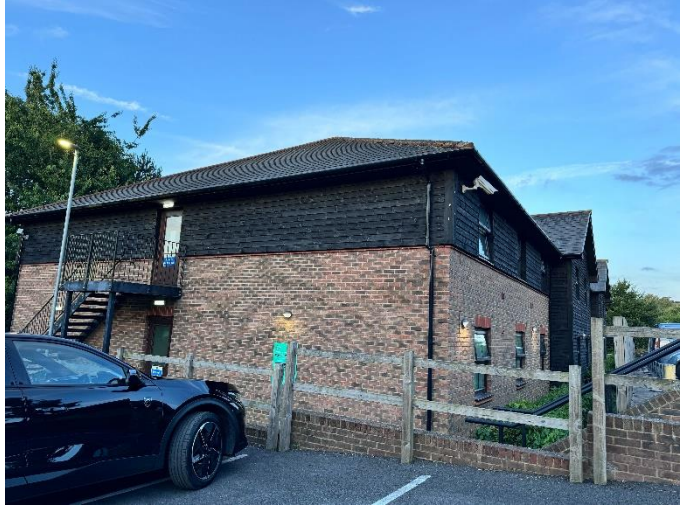
| <i>Surveyor 4</i> | <p>The first bat recorded was Noctule at 21:48 but not seen.<br/>At 21:52 a common pipistrelle was heard and not seen.</p> <p>There were intermittent noctules heard between 21:55 and 22:23</p> <p><b><u>No roosting activity was observed.</u></b></p> | |

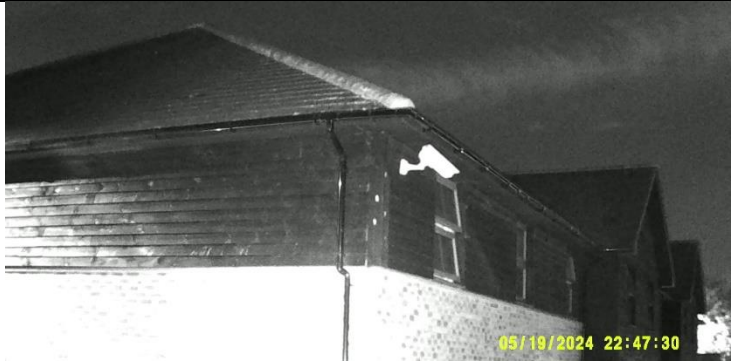
| <i>IR position</i> | <p><b><u>No roosting activity was observed.</u></b></p> | |
