## Off Mains Survey Report Prepared For:

The White House, Manningford Bruce, Pewsey, SN9 6JW.

## General Pre-Purchase Survey Report:

**What type of survey are we attending?** Off mains drainage survey.

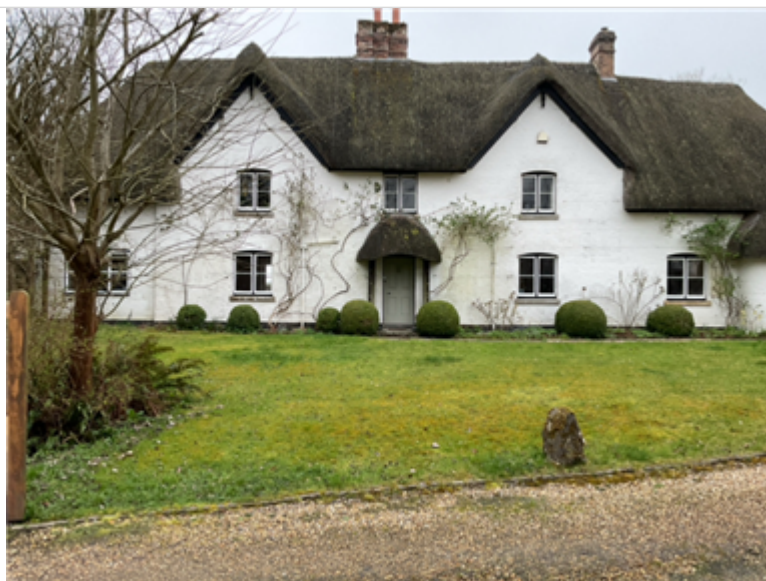
**View of the front of the property:**

**Type of property surveyed:** Detached house.

**Property construction type:** Brick built with thatched roof.

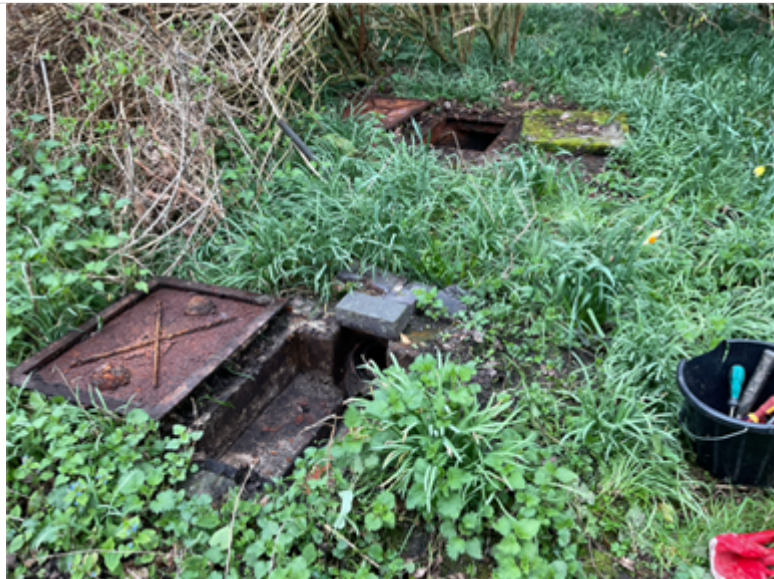
Photograph of the general area of the tank:

**Type of drainage tank at the property:** Septic tank with clinker bed.

**Construction / design of the tank at the property:** Concrete ring septic tank with brick built clinker bed.

**Location of tank:** The tank is located to the right side of the rear garden, close to a watercourse.

**Dimensions of the tank:** Depth: 1.8m  
Diameter: 1200mm

| <b>Overall condition of the tank:</b> | Satisfactory |
| <b>Was there any damage observed to the tank during the inspection?</b> | No |
| <b>Was the outlet pipework accessible from the tank in order to conduct a CCTV survey?</b> | No, the outfall was via a clinker bed chamber with no access to the outfall pipe in the base. |

Septic tank with clinker bed discharging into a watercourse.

Recommend diverting the system to a complaint in boundary solution, new STP discharging to a new drainage field in the rear garden.

Empty, backfill and decommission the existing septic tank and clinker bed, plus MH6.

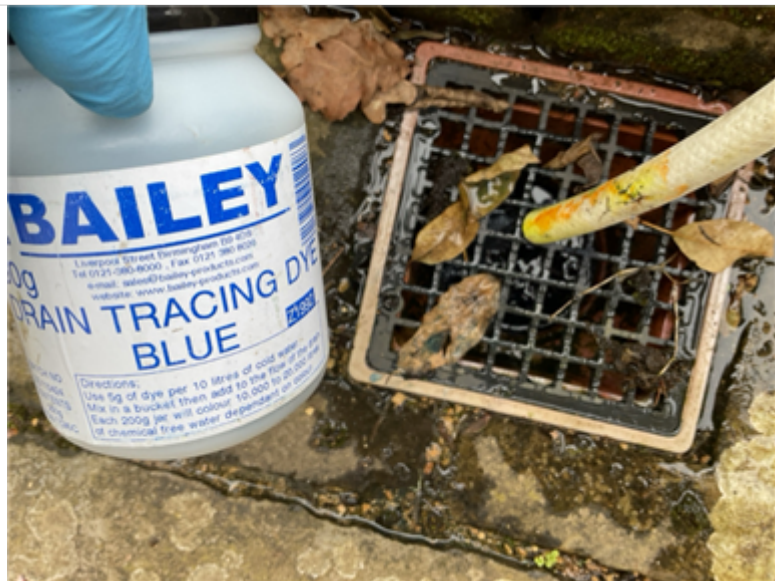
Photograph of dye test undertaken

Was a dye test carried out to the accessible upstream rainwater pipes? Yes

Were there any cross connections found between the rainwater system and the foul system? No

The existing septic tank and clinker bed were dye tested and confirmed to discharge inlet the watercourse.
