Title : **17 Cathedral Close Salisbury SP1 2EB**

Drawing : **Detail Specifications for repair works to:**

**Hearth and Mantle - F03**

**1306.D.17**

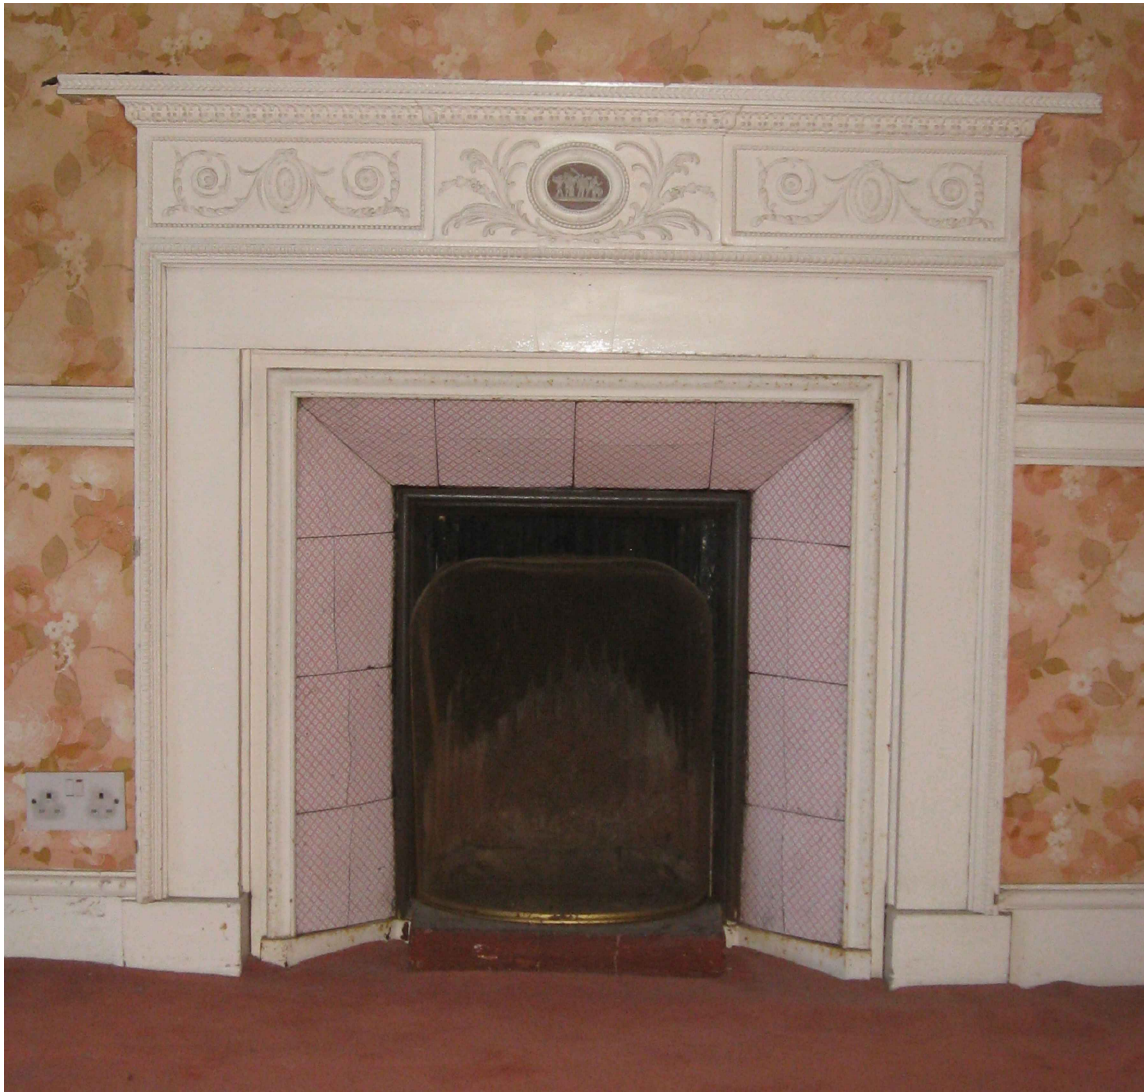
F03 Fireplace

Late C18 carved, moulded and painted mantle surround with modern ceramic tile battered slips, much cracked.

Cast iron, fluted and part rusted frame with fire brick linings.

There is a raised plain brick plinth.

There is evidence of a former, plain bolection moulded surround that partly exists behind but now over-built. It would match that in F.02.

Remove the ceramic tile slips.

Ensure the flue is cleaned and not blocked.

Make good any loose brickwork.

Install new ceramic tile slips to the the choice of the Cathedral Close surveyor.

Cast iron components to be cleaned, sanded and given 2 coats of heat-proof black paint.
