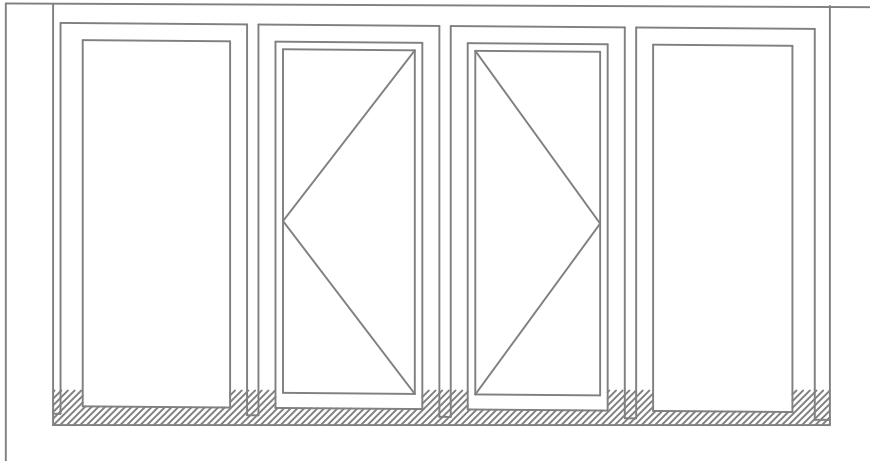
Drawing from exterior

Chilmark stone mullioned window with matching, moulded transom.

Mouldings are ovolo with fillets. The sills and transome have weathered resulting in a loss of profiles.

Glazing is hand-blown cylinder glass. Glass quarries are fixed using a mixture of linseed oil putty and/or a soft lime mortar.

There are 2 metal, side-hung casements with wrought iron, spring casement stays.

Remove the casements, sprung stays and frames. Replace missing catches and stays, to match existing.

De-rust the metal components. Paint with an epoxy-based primer and give 2 coats of Zinser oil-based paint in off-white. Replace the casements in a soft lime mortar.

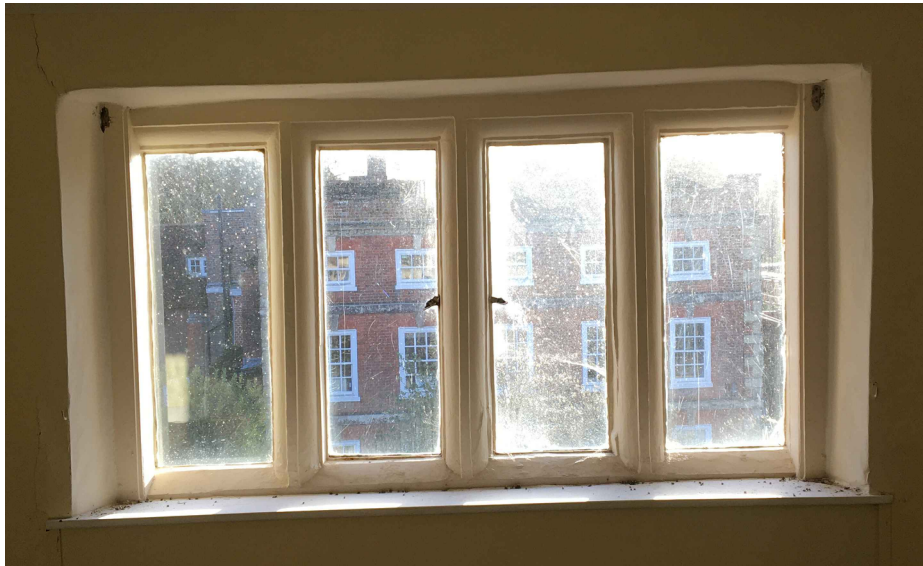
Photo from interior

There is a panelled shutter below the sill, hidden in the panelling, which could be drawn up to cover the inside of the window.
