**Middlecroft Farm, Shrewton  
Preliminary Roost Assessment  
March 2026**

**Report Title:** Middlecroft Farm, Shrewton: Preliminary Roost Assessment

**Report reference:** MFS26.02

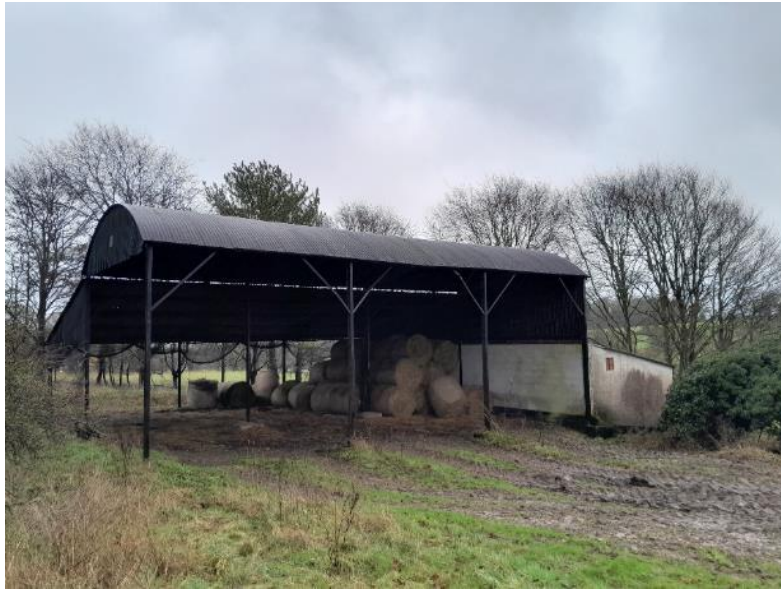
The largest building on the site is a Dutch barn (B1), it has a metal frame and corrugated metal roof. Three sides are open with the fourth side being enclosed by the adjoining building. There is an owl box within the barn, the box wasn't inspected but there were no signs of owls from ground level and evidence of material found under the box suggests the box is/was used by pigeons or stock doves.

Photo 1. Northern and western elevation of the barn (B1)

No evidence of bats was found in the buildings and it is considered unlikely they would be used as bat roosts due to the materials they are constructed from and the light and draft levels inside, therefore the buildings are considered to have negligible bat roost potential.

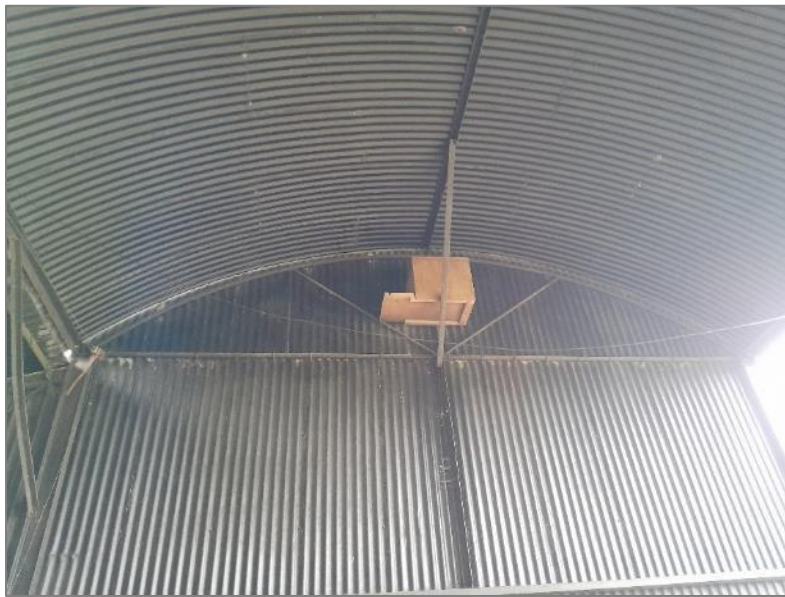
Photo 2. Roof structure of the barn (B1) with owl box

The three buildings are all considered to have **high** suitability for nesting birds. The owl box should be checked prior to work commencing and closed if there is no occupancy and relocated elsewhere in the landownership. If the box is occupied then it will need to be left in situ and undisturbed until after nesting has finished and relocated once vacated. Work on the buildings should take place outside of the bird nesting season (March – August inclusive) to avoid potential disturbance. If this is not possible then a nesting bird check should be completed by an ecologist before work begins.

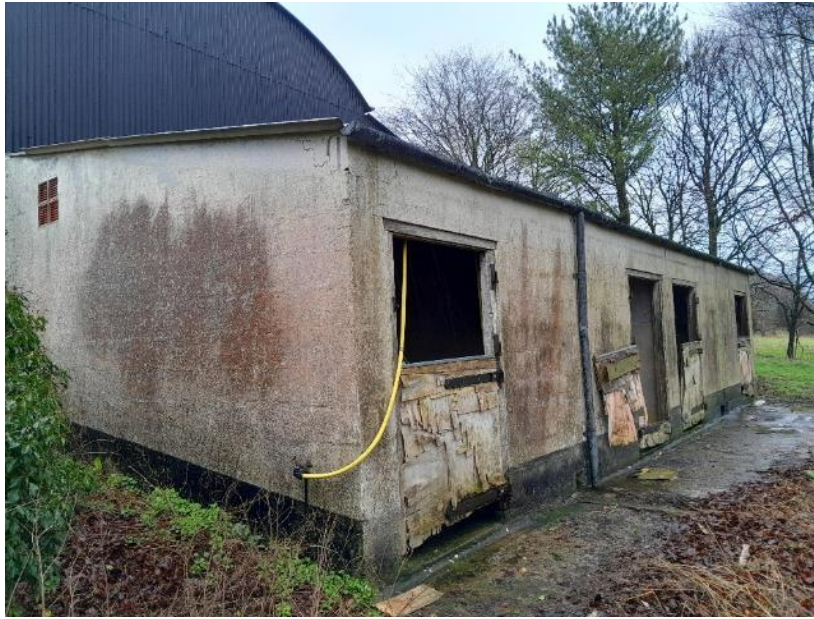
Immediately south of the Dutch barn (B1) is a block built agricultural building (B2) with four internal compartments. Each compartment is rendered on the lower walls. The roof is covered with fibrous cement sheets, supported by metal beams. The doors to each compartment are all half stable doors, made from plywood.

Photo 3. Southern and western elevations of the building (B2)

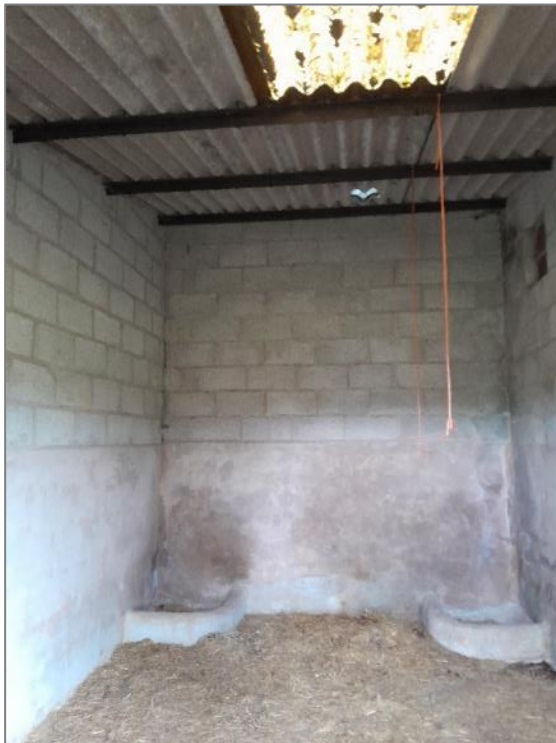
Photo 4. Internal compartment of building (B2)

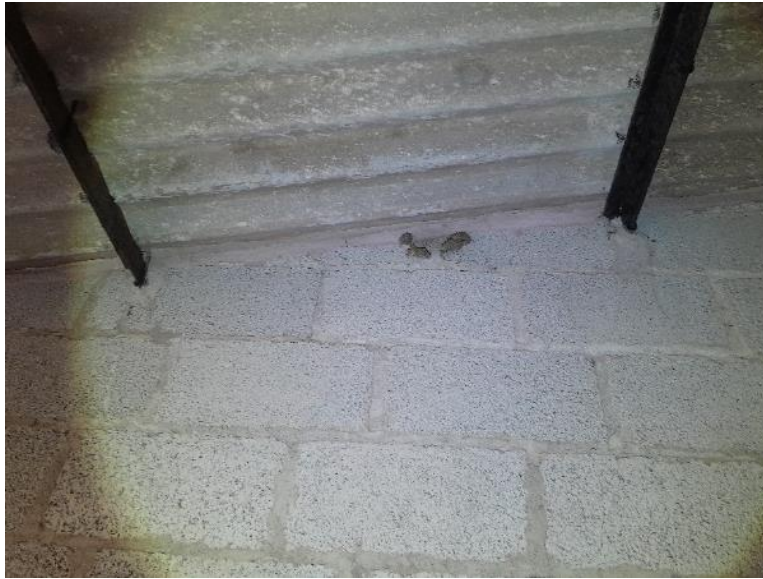
Photo 5. Remanence of historic swallow nest within building (B2)

The nest box found in the barn (B1) provides nesting potential, with evidence of historic use and there is evidence of historic nesting in the agricultural building (B2). Therefore, B1 & B2 confirmed bird nesting potential. The storage shed (B3) had no evidence of nesting but has high potential to act as a nesting site.

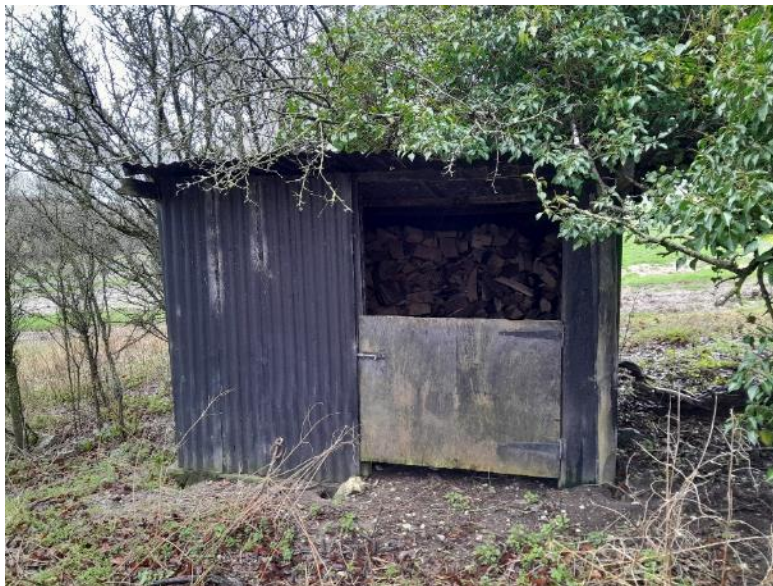
A small storage shed (B3) is to the southeast of the barn and building and is made from corrugated metal sheet with a half wooden door. This building is currently being used as a log store.

Photo 6. Metal storage shed (B3)
