# Road Safety Audit Report

**Incorporating**  
**Stage 2 Completion of Detailed Design;**  
Design Organisation Response to items raised.

## **Proposed A350 Yarnbrook Road and West Ashton Relief Road, Trowbridge**

| Report Title: | Stage 2 Road Safety Audit |

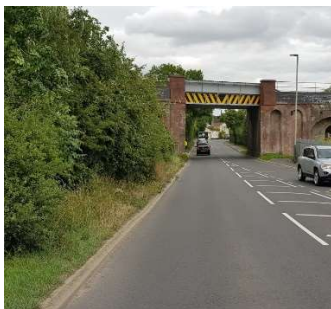
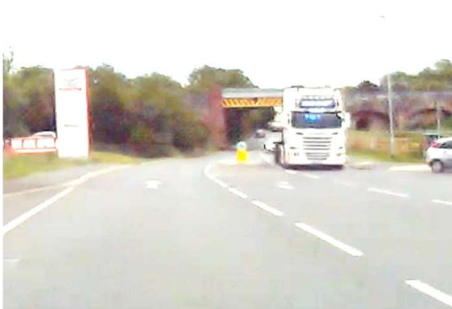
| <b>Location:</b> | Roundabout 1 |
| <b>Summary:</b> | Drivers approaching the roundabout may not become aware of the junction at a safe distance |
| <b>Acc Type:</b> | Vehicle loss of control |
| <p>The A363, Westbury Road is subject to a 40mph, and passes under a rail bridge. The scheme subject to this Stage 2 Road Safety Audit, includes the provision of the Yarnbrook and West Ashton Relief Road which commences from the west at a 3-arm roundabout just to the east of the rail bridge. A road safety concern raised within the previous Stage 1 Road Safety Audit (item 2.1) undertaken by others, identified a concern regarding the restricted level of forward visibility to the roundabout for eastbound drivers due to the bridge abutments and recommended the appropriate stopping sight distance and suitable advance warning signage is provided. The scheme drawings provided with the Audit Brief, illustrate that Advanced Directional Signage (ADS-1), as well as, an advanced 'SLOW' carriageway marking are to be provided to highlight the presence of the feature to encourage reduced speeds. However, insufficient forward visibility to the give-way line of the entry to the roundabout, could give rise to heavy braking, loss of control type incidents and junction overshoots.</p> | |

| <b>RECOMMENDATION:</b> | |
| It is recommended that an illuminated give-way road sign is provided either side of the southbound entry to enhance the conspicuity of the give-way | |
| Agreed. Give Way signs to be used. Proposed raised Keep Left sign on splitter island to be removed to avoid excess signage. | |

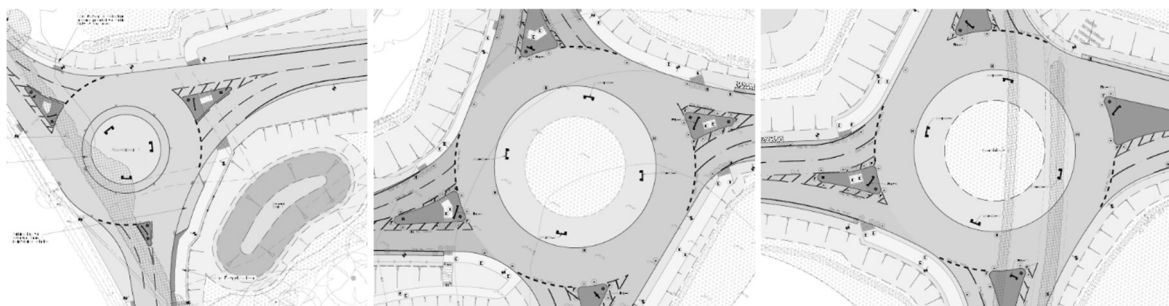
#### Location Plan:

| <b>Location:</b> | Scheme |
| <b>Summary:</b> | Insufficient space may be available for the expected vehicles |
| <b>Acc Type:</b> | Sideswipe type collisions |

The scheme associated with this Stage 2 Road Safety Audit includes the provision of a relief road that incorporates 3 roundabouts that are subject to a speed limit above 40mph and each entry accommodates two lanes. Roundabout 1 provides access to the relief road from the west, via the A363 and is formed with a 34.6 metre ICD with a 12.8 metre circulatory carriageway to include 3.65 metre overrun area, Roundabout 2 and 3 are formed with a 55 metres ICD. Whilst, the proposed roundabouts should be sufficient to accommodate the majority of vehicles with departures based on swept paths according as stated within the documents provided, the Audit Team observed a significant proportion of heavy goods vehicles and no proof was provided to the Audit Team to identify that the vehicles can travel side by side. Insufficient space for the expected vehicles to manoeuvre, could give rise to sideswipe type collisions.

It is recommended that the proposed roundabouts are adequate for the expected vehicles

Agreed. Refer to swept path plans

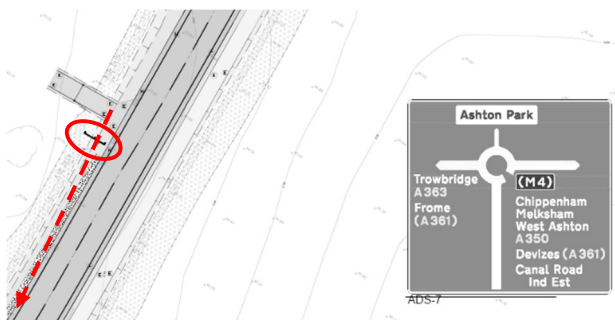
**Location Plan:**

**Location:** Proposed A350 / Southern arm of Roundabout 2

**Summary:** Proposed sign within the verge restricts visibility

**Acc Type:** Side impact and rear end collision

The proposals associated with this Road Safety Audit realign the A350 to the east of Yarnbrook to meet the Yarnbrook West Ashton Relief Road at Roundabout 2. The realigned A350 accommodates a field access off the western side of the carriageway. No road safety concerns regarding the field access are raised at this stage, however, an Advanced Directional Signage (ADS-7) situated in the verge to the south of the access and mounted at 1500mm above the surrounding ground level, will restrict visibility to and from the field access. Restricted visibility to and from an access, could result in a vehicle attempting to exit when it is not safe to do so and increase the likelihood of a side or rear impact collision.

It is recommended that the appropriate visibility splays are maintained clear and free of obstructions.

Agreed. Sign either to be raised to 2.0m clearance and or repositioned on north side of junction.

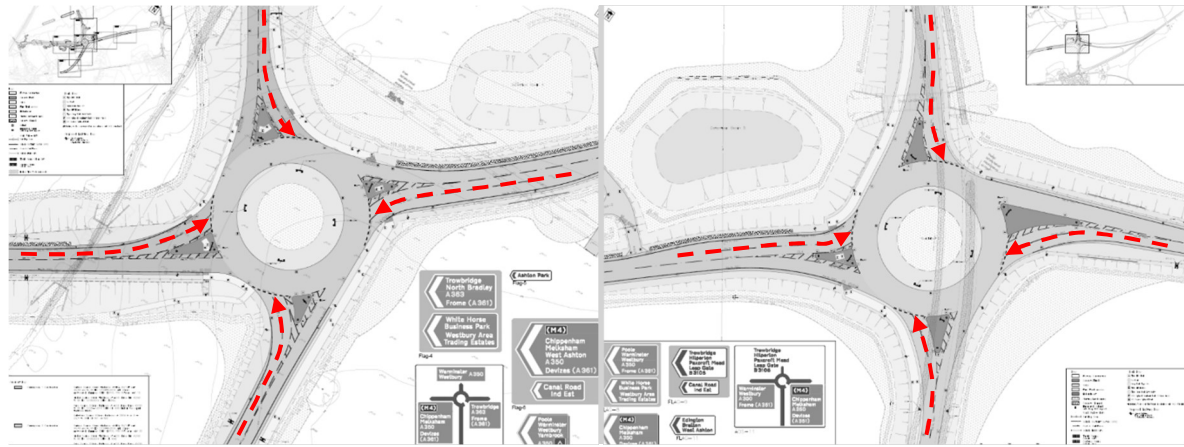
**Location Plan:**

**Location:** Roundabout 2 and Roundabout 3

**Summary:** Frictional properties on approach to the roundabout may be insufficient

**Acc Type:** Loss of control and junction overshoots

The proposals subject to this Stage 2 Road Safety Audit include the provision of the Yarnbrook and West Ashton Relief Road that includes a total of three roundabouts of which two accommodate 40mph/50mph approaches and the other 50mph/60mph approaches; two are on a steep down gradients, albeit at 1 in 40 on immediate approach. The scheme drawings identify that the proposed highway is to be surfaced with hot rolled asphalt (HRA) that benefits from a polished stone value (PSV) of 65. The information provided within the Audit Brief, identifies that the Relief Road is likely to observe a traffic flow in excess of 3000 vehicles during the peak hours which can be assumed to equate to a daily traffic flow of approximately 25,000. No details have been provided to identify the expected number of commercial vehicles, however, the more commercial vehicles that are observed, the more the surface deteriorates and experiences polishing, reducing the frictional properties. As such, a PSV of 65 on each approach to the proposed roundabouts may not be sufficient to assist heavy braking during the whole lifecycle of the surface, which could give rise to skidding and loss of control type incidents as well as overshoot type collisions.

It is recommended that the frictional properties of each approach are adequate and accord with Table 3.3 of CD236.

Agreed. The use of PSV 68+ is referenced in the pavement report. Therefore, note to be added to the drawings and Specification.

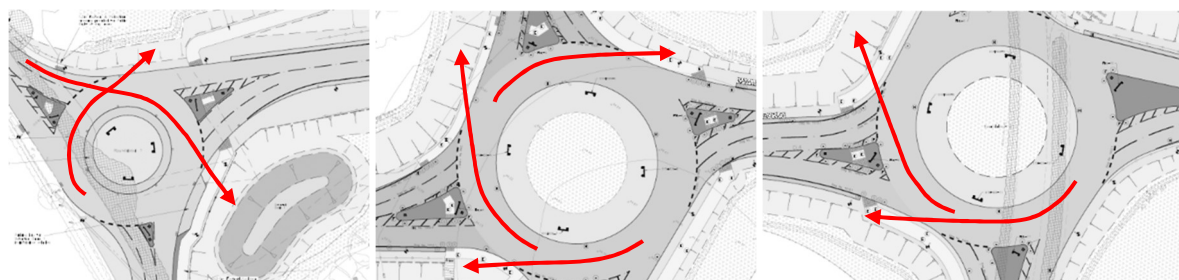
**Location Plan:**

**Location:** Scheme

**Summary:** Errant vehicles could leave the carriageway down the adjacent embankments

**Acc Type:** Vehicle loss of control

The scheme associated with this Stage 2 Road Safety Audit includes the provision of a relief road that incorporates 3 roundabouts that lie at a level above the surrounding land and are subject to a speed limit above 40mph, as well as a number of detention basins for the sustainable drainage system. A post and rail fence is to be provided along the edge of the proposed verges and a vehicle restraint system is provided at certain locations, however, errant vehicles may be observed in proximity of the proposed roundabouts junctions where a VRS is not provided. The severity of an incident involving an errant vehicle leaving the carriageway is likely to be exacerbated by the presence of an embankment or detention basin, particularly following heavy rainfall.

It is recommended that a vehicle restraint system is provided in proximity to where errant vehicles could be observed

Agreed, subject to assessment including impact on other modes.

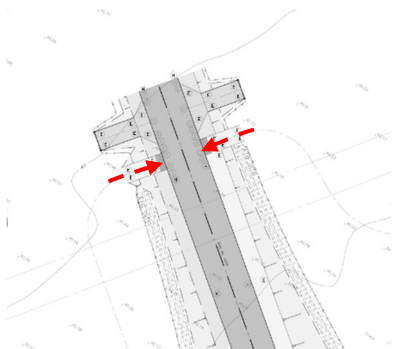
**Location Plan:**

**Location:** Development access off Roundabout 2

**Summary:** Users of wheeled devices could continue onto the carriageway suddenly

**Acc Type:** Vehicle-non-motorised user and rear end collisions

The scheme subject to this Stage 2 Road Safety Audit includes a development access road off the northern side of Roundabout 2 that is to be subject to a 30mph speed limit, as well as a network of pedestrian and cycle routes to include a 3 metre shared facility to the east of the development access. The shared facility terminates at a crossing facility that benefits from dropped kerbs and tactile paving where a link is provided into the land either side. The scheme drawings provided with the Audit Brief include a centreline identifying that the proposed links are to bend by 90° which would force users to slow, however, this is not confirmed. A user of a wheeled device such as a child on a scooter or cyclist approaching the crossing point may continue across the carriageway without slowing for approaching traffic raising the risk of vehicle user collisions or rear end impact collisions where an approaching driver brakes suddenly.

It is recommended that staggered barriers are provided to ensure users slow.

Agreed.

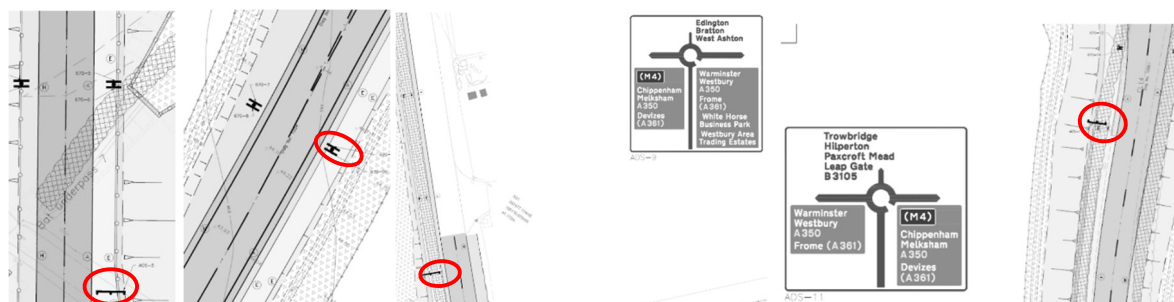
#### Location Plan:

**Location:** Scheme

**Summary:** Signposts located within a footway cycleway will be an obstruction

**Acc Type:** Pedestrian / cyclist collision with post

The drawings provided with the Audit Brief, identify the location / design of signs and illustrates that the posts associated with a number of roundabout direction sign as well as back to back

speed limit signs that are to be situated within the centre of a proposed 3.0 metre shared footway / cycleway, albeit mounted at a height of 2.4-metres. A post within a footway / cycleway will be an obstruction particularly for the visually impaired and could result in a pedestrian or cyclist striking the item of street furniture.

It is recommended that signposts are located outside of non-motorised user facilities if possible or sufficient width is available between signposts and that measures are provided to highlight their presence.

Agreed. The aim will be to reduce number of posts in any footway to one which will have the additional of a white triangle on the ground each side of post.

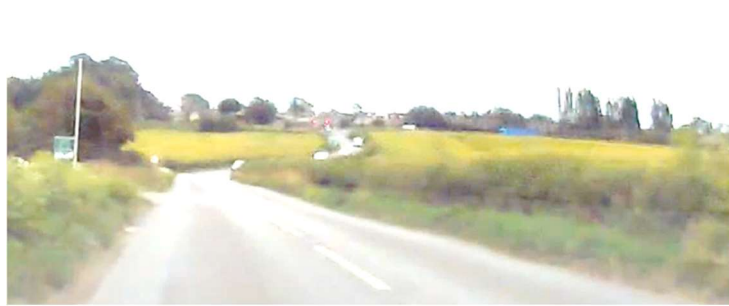
**Location Plan:**

**Location:** West Ashton Road

**Summary:** Signposts located within a footway could become an obstruction / Post associated with a proposed sign is located within the footway / cycleway

**Acc Type:** Pedestrian / cyclist collision with post

It is recommended that the roundabout direction sign is relocated to the eastern verge, south of the access to Farm 5.

Agree, but the land control does not permit the sign and its visibility splay being on the nearside. Proposed position of this sign on the offside has been discussed and agreed with WC.

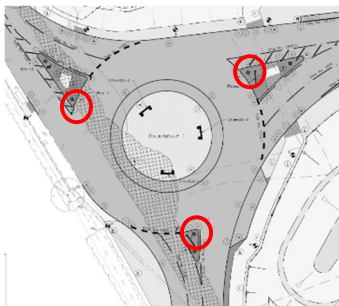
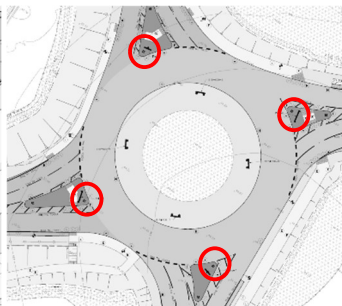
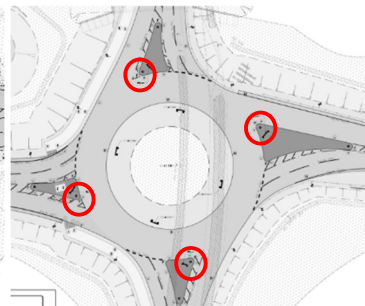
**Location Plan:**

**Location:** Scheme

It is recommended that plain faced bollards are provided where applicable.

Agreed. Design to be amended.
