# Stage 2 Road Safety Audit Report

**West Ashton Roundabout,  
Trowbridge  
Proposed Spine Road S278 Highway  
works.**

**Project Name:** West Ashton Roundabout, Trowbridge S278 Highway Works

**Report Title:** Stage 2 Road Safety Audit

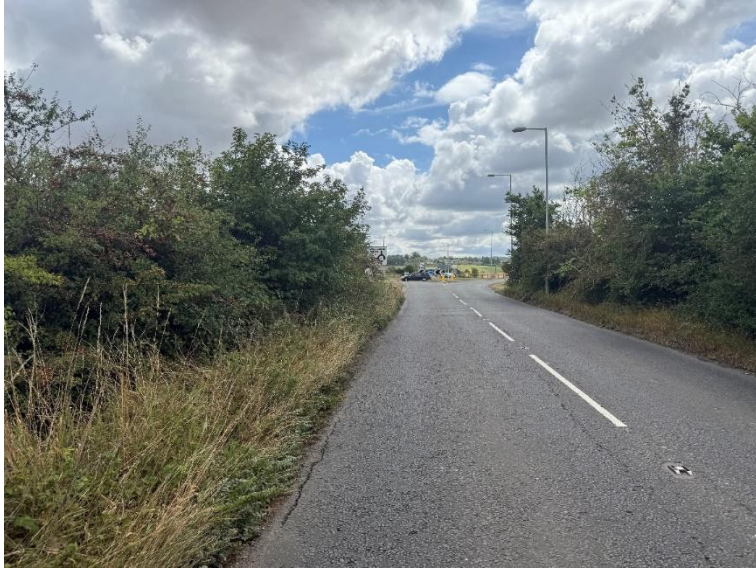
| 8.6 *Problem* (Item B5.1) | |
|---|---|
| <b>Location:</b> | West Ashton Gate, northern arm of roundabout. |
| <b>Summary:</b> | Existing / proposed roundabout map sign is obstructed by vegetation |
| <p>The map type signs on approach to the roundabout are to be replaced with new signs in the same location to include the fourth arm. Visibility to the existing sign on the northern arm is obstructed by adjacent vegetation. This lack of appropriate visibility on approach to the roundabout may result in sudden braking by drivers unfamiliar with the area wishing to read the sign. Sudden braking may result in rear shunt accidents. Trim back or remove the vegetation such that suitable forward visibility to the proposed map sign is available to approaching drivers.</p> | |
| Risk of rear shunt type accidents. | |

| 8.6 *Problem* (Item B5.1) | |
|---|---|
| Trim back or remove the vegetation such that suitable forward visibility to the proposed map sign is available to approaching drivers. | |

| <p>Stage 2 (Road Safety Audit)</p> <p>DESIGNER'S ROAD SAFETY AUDIT RESPONSE</p> <p><b>Scheme Name:</b> VP RMIB Phase 1 Spine Road 2 S38 highway works</p> | | | |
|---|---|---|---|
| 8.6 | Sign obstructed by vegetation | Agreed. Notes added to drawing P881/04 Rev S, identify that vegetation is to be cut back to achieve sufficient visibility. | |

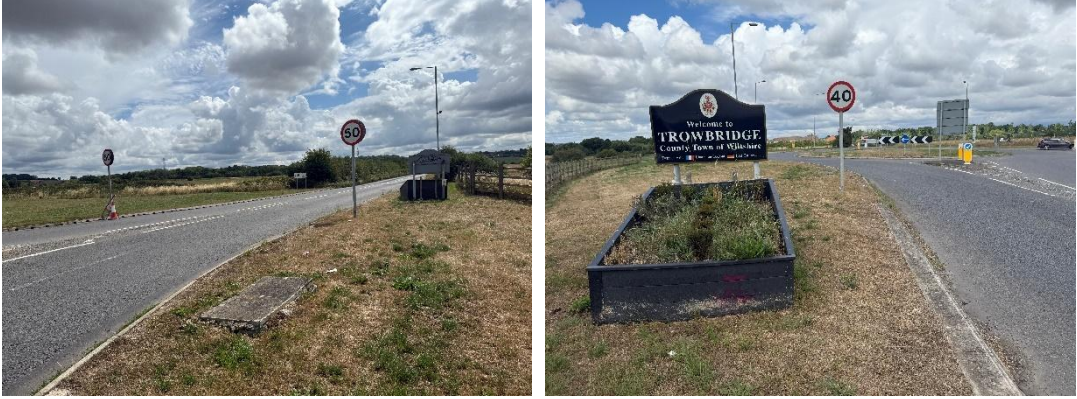
| 8.7 *Problem* (Item B5.1) | |
|---|---|
| <b>Location:</b> | West Ashton Gate, southern arm of roundabout. |
| <b>Summary:</b> | Existing speed limit change within proposed pedestrian crossing point |
| <p>A toucan crossing is proposed across the southern arm of the roundabout junction, on West Ashton Gate. The location detailed on the drawings provided is currently where the speed limit changes from 40mph to 50mph. It does not appear that this speed limit change signage has been shown on the topographical survey, nor has relocation of the speed limit change has not been detailed on the drawings provided to the Audit Team. The audit brief does not mention a 50mph speed limit within the scheme. Drivers approaching from the south may approach the crossing / roundabout at an inappropriate speed, resulting in skidding / loss of control issues. Ensure the speed limit signage is relocated to a suitable location, with adequate visibility to the signage. Amendments to the speed limit TRO will be required.</p> | |
| Risk of skidding / loss of control accidents. | |

| 8.7 *Problem* (Item B5.1) | |
|---|---|
| Ensure the speed limit signage is relocated to a suitable location, with adequate visibility to the signage. Amendments to the speed limit TRO will be required. | |

| 8.7 | Existing speed limit change within proposed pedestrian crossing point | Agreed. Both signs to be relocated outside of pedestrian visibility splays and unobstructed by vegetation, as shown on P881/04 Rev S | |
