# Road Safety Audit Report

**Incorporating**  
**Stage 2 Completion of Detailed Design;**  
Design Organisation Response to items raised.

## **Proposed downgrade of A350 West Ashton Road and A350 Yarnbrook Road, Trowbridge**

| <b>Job no</b> | RSA-20-044 | <b>Issue no</b> | 3 | <b>Date</b> | August 2020 |

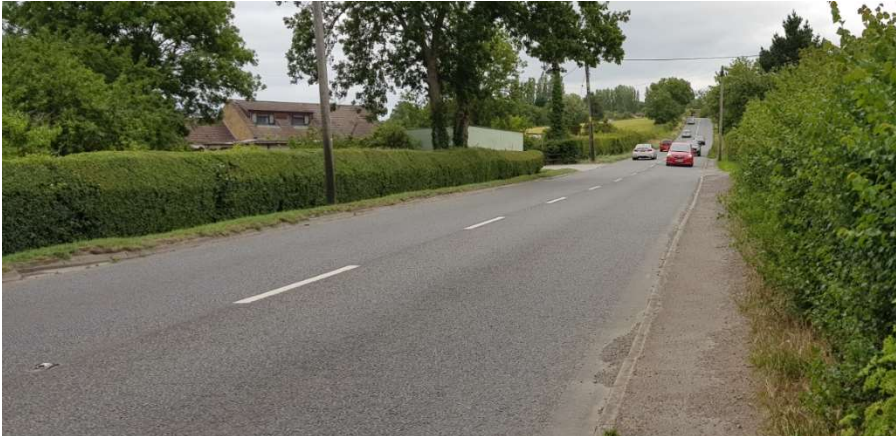
| <b>Location:</b> | Old A350 west of West Ashton |
| <b>Summary:</b> | The long straight wide carriageway encourages high vehicular speeds |
| <b>Acc Type:</b> | Loss of control |
| <p>The existing A350 that is subject to this Stage 2 Road Safety Audit, is straight in alignment and climbs up to Bratton Road either side of the existing signalised junction. Whilst the existing signalised junction of the A350 and Bratton Road is subject to a 40mph speed limit, the carriageway to the east is derestricted and west is subject to a 50mph speed limit. The proposals realign the A350 just to the east of Yarnbrook but retain the existing carriageway to allow access to an existing farm and a number of dwellings via Bratton Road. The Audit Team are not aware that of any proposals to amend the existing speed limits and as such, can only assume that they will remain unchanged. A long straight cul-de-sac that is 7.3 metres wide and lightly trafficked, will encourage high vehicular speeds and could be utilised for racing, raising the risk of loss of control type incidents.</p> | |

| It is recommended that measures are introduced to prevent high speeds along the cul-de-sac. | |

This matter has been discussed in detail with Wiltshire Council (WC), including possible traffic calming schemes, but based on WC's experiences elsewhere, it is their preference that the road does not require the introduction of physical speed control measures, as through the removal of the road markings and cats eyes as proposed it will overtime achieve a more rural aspect. This preference is recorded in the design meeting notes with WC.

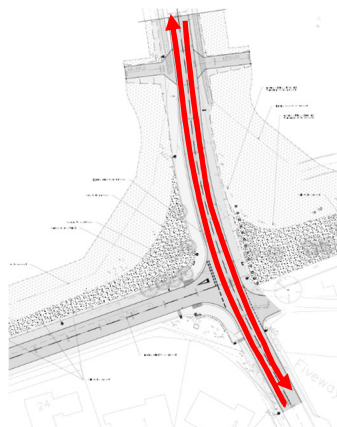
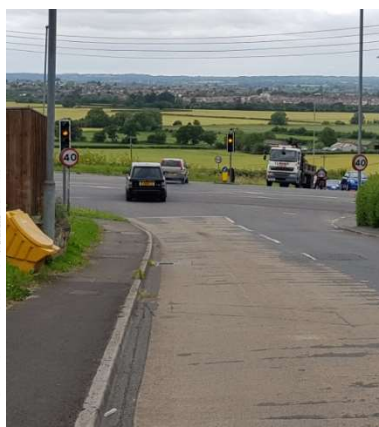
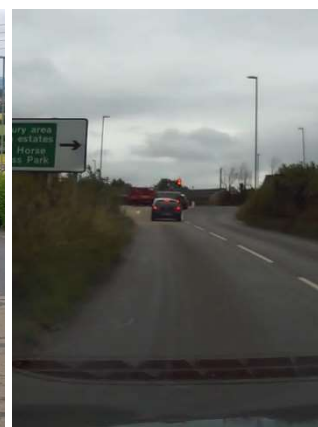
#### B.2.2 PROBLEM

**Location:** Bratton Road

**Summary:** Increased vehicular speeds are likely to be observed on approach to West Ashton

**Acc Type:** Side impact collisions and loss of control type incidents

Bratton Road is mostly rural in nature but passes through a number of small villages providing a link between the A350 and B3098 which connects with the A360 and A303 to the southeast. It is likely that the road is utilised by some as a cut through. At present, southbound vehicles travelling along Bratton Road on approach to West Ashton, are subject to a 50mph speed limit which reduces to 40mph in proximity to the existing signalised junction with the A350 which acts as a traffic calming feature slowing traffic on approach the village where the speed limit reduces to 30mph. The proposals remove the existing signalised junction and replace it with a simple priority junction with Bratton Road as the major road. As such, following implementation of the proposals, no measures will be present that force vehicles to slow on approach to or exiting the village and as such, the proposals could give rise to incidents resulting from inappropriate speeds to include side impact collisions when a vehicle attempts to manoeuvre out of the old A350 priority junction when it is not safe to do so or loss of control type incidents due to heavy braking and the existing vertical alignment of the Bratton Road.

It is recommended that a 30mph speed limit gateway is introduced just north of the proposed simple priority junction and that street lighting is extended to an appropriate location.

Agreed subject to TRO. The possibility of extending the 30mph and forming a 'gateway' has been agreed with WC. The 30mph 'gateway' will be where the existing 40mph starts on the north side of the junction. TRO Schedule to be revised.

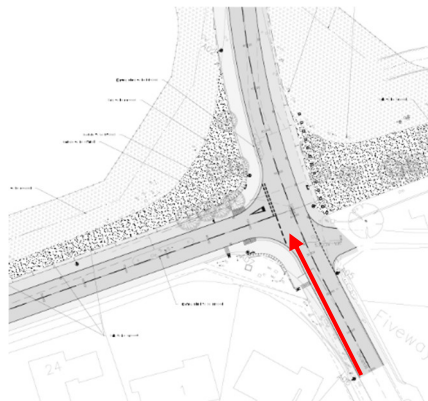
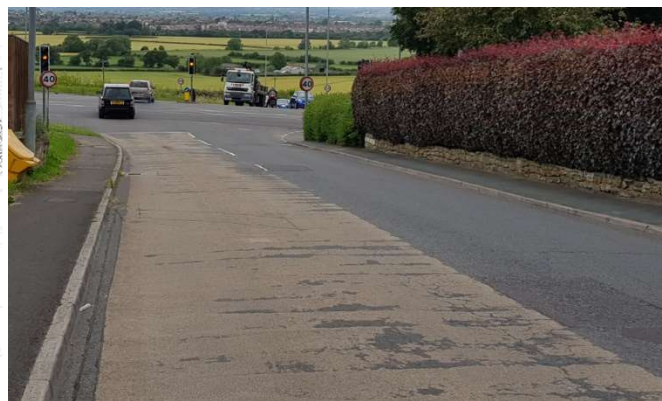
**B.3.1 PROBLEM**

**Location:** Bratton Road

**Summary:** Proposed priority is likely to increase speeds on approach to the junction

**Acc Type:** Heavy braking and loss of control

Bratton road is set at a down gradient from south to north on approach to and through the signalised junction with the old A350. The existing northbound approach to the signalised junction benefits from high friction surfacing that appears to be in poor condition. It is proposed to downgrade the existing A350 carriageway to the west of the Bratton Road, stop up the A350 to the east of Bratton Road and provide a simple priority junction in place of the existing signalised junction. Visibility to and from the proposed simple priority junction is of a good level, however due to the down gradient, heavy braking could give rise to skidding and loss of control type incidents.

It is recommended that the northbound Bratton Road approach to the junction benefits from high frictional properties to aid braking.

Agreed. HFS to be extended across width of junction or resurface with PSV68+. Resurfacing of existing HFS is a maintenance issue for WC, but will be discussed accordingly.

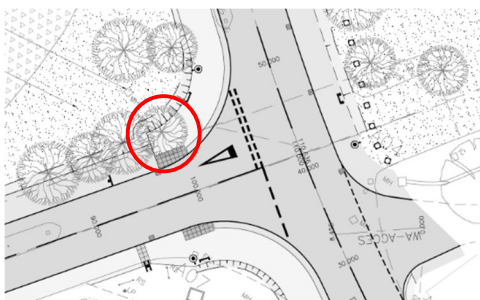
| <b>Location:</b> | Proposed West Ashton Junction |
| <b>Summary:</b> | Proposed tree located within a footway will be an obstruction |
| <b>Acc Type:</b> | Pedestrian trips / falls and cyclist loss of control |
| <p>The existing A350, Yarnbrook Road carriageway accommodates a verge along the northern side with trees and other vegetation, providing a footway along to the southern side. The drawings provided with the Audit Brief, illustrate the location and details of street furniture, as well as, trees and vegetation within the proposed verges and identify that a tree is to be provided within the proposed shared footway / cycleway to the northwest of the proposed simple priority junction. A tree within a footway / cycleway is likely to cause ground heave, forming an uneven surface and increasing the likelihood of loss of control type incidents.</p> | |

| It is recommended that the proposed tree is relocated away from the footway. | |
| Agreed. Drawing to be corrected. | |

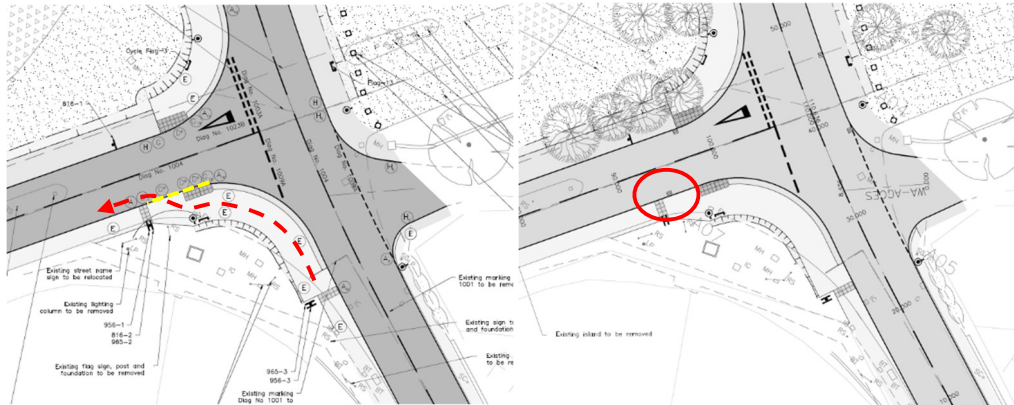
| <b>Location:</b> | Proposed West Ashton Junction |
| <b>Summary:</b> | Proposed road gully will become an obstruction to cyclists |
| <b>Acc Type:</b> | Loss of control |
| <p>The existing West Ashton signalised junction accommodates a network of gullies that are situated along the channel lines. It is proposed to downgrade the old A350 West Ashton Road to form a long cul-de-sac and amend the existing signalised junction with Bratton Road, to a simple priority junction that benefits from a shared footway cycleway along the western side. The scheme drawings provided with the Audit Brief detail that the gullies within proximity of the junction are to be relocated, however, one gully is proposed to be located adjacent to the elongated dropped kerb to the southwest of the junction which allows cyclists level access between the footway cycleway and carriageway. Gullies within the path of a pedestrian or cyclist will become an obstruction and could give rise to loss of control type incidents resulting in a fall.</p> | |

It is recommended that the gully is relocated or a cyclist friendly grate is provided on all gullies within a cyclist or pedestrian desire line.

Agreed. Design to be amended.

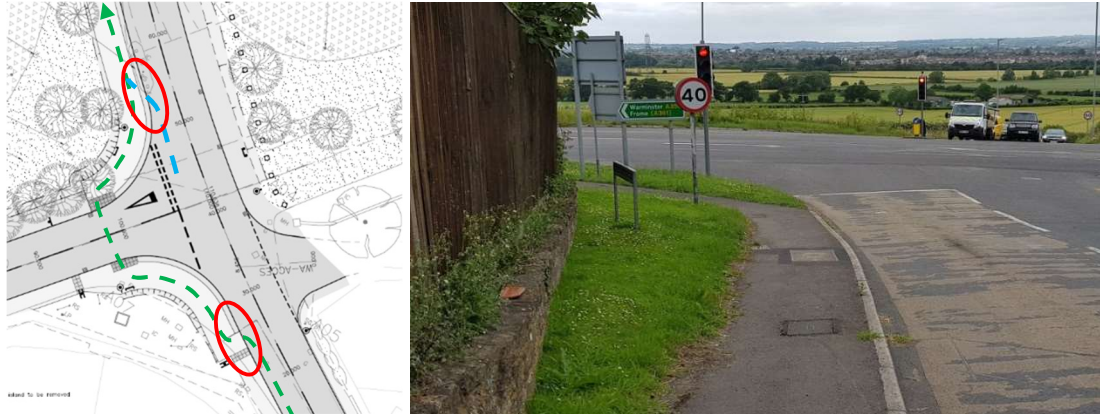
**B.4.3 PROBLEM**

**Location:** Bratton Road, Proposed West Ashton Junction

**Summary:** Full height kerbs will be an obstruction to cyclists

**Acc Type:** Loss of control

The existing West Ashton signalised junction accommodates a footway to the southwest which wraps around the junction linking to the footway to the south and west providing pedestrian access between Yarnbrook and West Ashton. The proposals downgrade the A350 West Ashton Road and convert the existing signalised junction to a simple priority junction and accommodates an uncontrolled crossing point across the old A350 West Ashton Road linking a proposed shared footway cycleway to the north with a section of footway cycleway to the south whilst maintaining the pedestrian footway links to West Ashton and to Yarnbrook. A dropped kerb is provided where the proposed shared facility terminates and footway commences along the old A350 which allows cyclists level access to / from the carriageway, however, a cyclist is unable to access the shared surface facility from the Bratton Road carriageway without having to negotiate full height kerbs. It is likely that a northbound cyclist will bypass the shared surface facility to the southwest of the junction and attempt to gain access just north of the priority junction where full height kerbs are present which will be an obstruction, however, a northbound cyclist intending to utilise the shared facility will be required to mount full height kerbs increasing the likelihood of a loss of control type incident and fall.

It is recommended that dropped kerbs are provided where appropriate, to allow cyclists level

access between a carriageway and shared facility.

Agreed. Design to be amended.

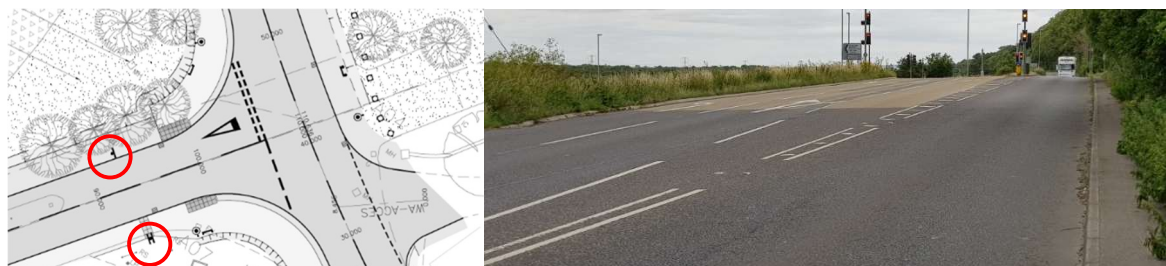
#### **B.5.1 PROBLEM**

**Location:** Old A350 West Ashton Road

**Summary:** No through road signs could become an obstruction for pedestrians and vehicles

**Acc Type:** Vehicle collision with street furniture

It is proposed to provide a number of warning, informative and directional road signs within the verge and footway of the old A350 West Ashton Road that is to be downgraded. The scheme drawings provided with the Audit Brief, illustrates a “No through Road” either side of the road in close to the junction with Bratton Road which are both to be mounted at a height of 1.5 metres. The sign to the north of the carriageway appears to be abutting the edge of carriageway and the sign to the south of the carriageway is situated within the footway. A road sign situated in close proximity to the path of a vehicle could give rise to vehicle collisions with the sign face and a sign face mounted at 1.5 metres along a footway would be an obstruction to pedestrians resulting in a personal injury.

It is recommended that all sign faces and street furniture is at least 450mm from the channel line and at an appropriate height.

Agreed. Design to be amended.

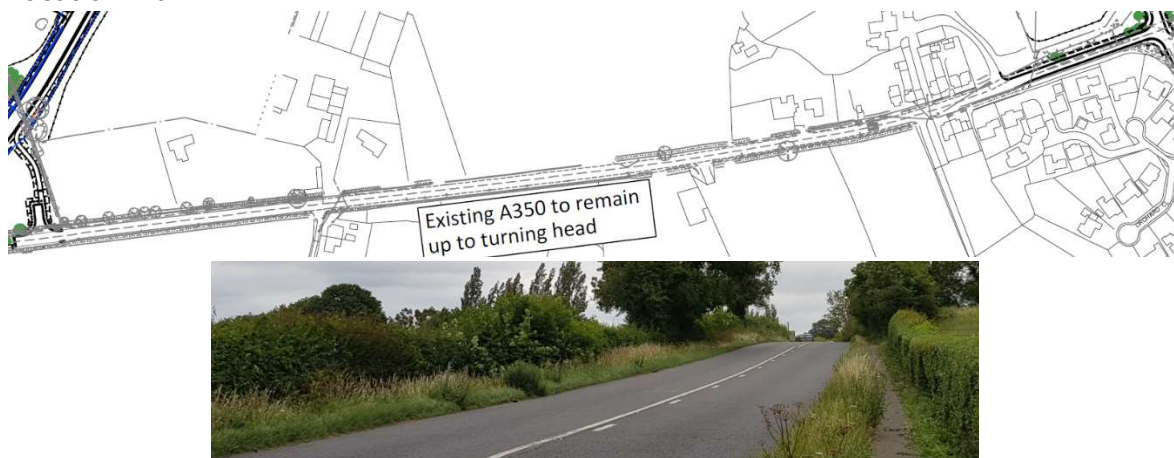
**B.5.2 PROBLEM**

**Location:** Old A350 West Ashton Road

**Summary:** No guidance is provided to identify the two-way nature of the cul-de-sac

**Acc Type:** Sideswipe and head-on collisions

The existing A350 that is subject to this Stage 2 Road Safety Audit, is straight and climbs up to Bratton Road either side of the existing signalised junction. The carriageway is subject to various speed limits; 40mph in proximity to the signalised junction, 50mph to the west and derestricted to the east. A road centreline is present along the carriageway which becomes solid at various locations due to the vertical alignment of the road and limited forward visibility. The proposals downgrade the existing A350 between Yarnbrook and West Ashton and stop up the section between West Ashton and the Jubilee Wood Scout Campsite to the east. The existing carriageway that is to be downgraded therefore, forms a cul-de-sac and allows access to an existing farm as well as a number of dwellings. The scheme drawings provided with the Audit Brief, identify that the road centre line and associated bifurcation arrows are to be removed. As such, no guidance will be present to ensure that vehicles travelling along the existing carriageway, will do so appropriately and may attempt to overtake where the existing vertical alignment restricts forward visibility which could give rise to head-on collisions.

It is recommended that a road centre line is provided and restrictions on crossing into the opposing lane of traffic unless certain conditions are met, are retained.

Refer to response to Problem B2.1
