# Road Safety Audit Report

**Incorporating**  
**Stage 2 Completion of Detailed Design;**  
Design Organisation Response to items raised.

## **Proposed Development Spine Road off the Leap Gate Roundabout, Trowbridge**

| <b>Job no</b> | RSA-20-045 | <b>Issue no</b> | 3 | <b>Date</b> | August 2020 |

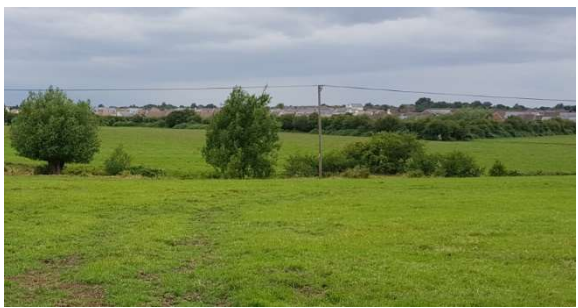
| <b>Location:</b> | North of the western section of Development Spine Road |
| <b>Summary:</b> | Errant northbound vehicles could leave the public highway down the adjacent embankment |
| <p>The proposed Development Spine Road passes over the River Biss and through an area of open space and is set above the surrounding lane with embankments bound either side of the carriageway. The scheme drawings identify that a Vehicle Restraint System (VRD) is to be provided in close proximity of the proposed bridge structure, however, no VRS is present on the outside of a bend that consists of a 180 metre centreline radius without any super elevation. A northbound vehicle travelling around the bend in the road on approach to the bridge crossing of the River Biss to head in an eastbound direction, may loss control and leave the carriageway falling down the proposed embankment to the 2.85 metre embankment exacerbating the severity of an incident.</p> | |

| It is recommended that a Vehicle Restraint System is extended, if appropriate | |
| <p>Disagree. A Road User Risk Assessment (reference P881-FN01) has been undertaken in accordance with guidance published by the UK Roads Liaison Group and Department for Transport, which confirms that the vehicle restraint system currently proposed does not need to be extended.</p> | |

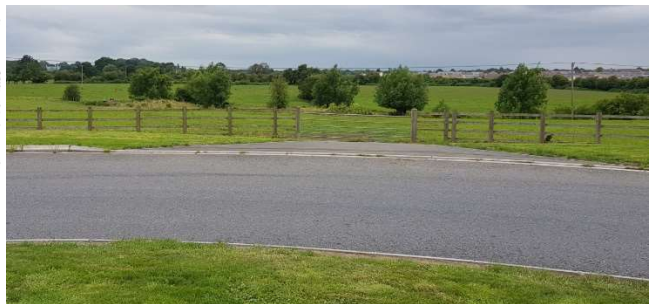
| <b>Location:</b> | Proposed minor road off north side of Development Spine Road |
| <b>Summary:</b> | HGV's may not be able to access the parcel of residential development safely |
| <p>The proposals include the provision of a right turn lane to a side road off the northern side of the proposed Development Spine Road, that accommodates a splitter island to deter the right turn out manoeuvre. The swept path analysis provided with the Audit Brief includes an illustration of a large Refuse / Recycling Collection Vehicle (RCV) turning right into the site road which is tight but proves that the manoeuvre can be undertaken, however, the scheme drawing does not illustrate the left turn in. Should a RCV or similar size removals HGV, attempt to access the parcel of development and the manoeuvre not be possible, the vehicle could stop abruptly which could give rise to rear end collisions or loss of control as a result of encroaching the kerbing.</p> | |

| It is recommended that the junction is sufficient to allow for the expected manoeuvres | |
| Agreed. Addition swept path shown on drawing P881/14 demonstrating a refuse vehicle can centre the side road from an eastbound direction along the spine road. | |

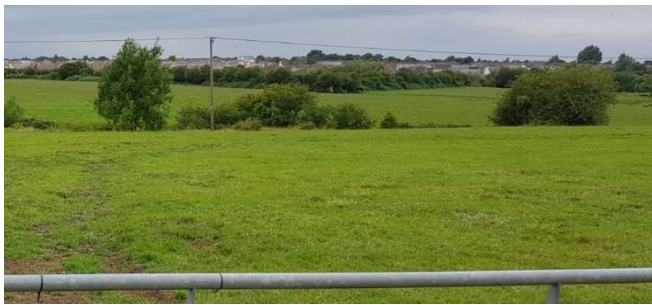
| <p><b>Location Plan:</b></p> | |

| <b>Location:</b> | Development Spine Road |
| <b>Summary:</b> | Pedestrians may not become aware of cyclists |
| <p>The scheme drawings provided with the Audit Brief, detail that a 3 metre footway cycleway is to be provided along the southern side of the Development Spine Road and that a 2 metre footway is to be provided along the northern side. The proposed footway terminates at a Toucan crossing just to the east of the proposed bridge crossing where cyclists cross the proposed Development Spine Road in order to travel between the proposed parcel of residential development just to the north as well as the proposed South Trowbridge Business Park that is accessible via the development and a Toucan crossing over West Ashton Road. Eastbound pedestrians travelling</p> | |

| <p>along the northern footway, may not become aware of the potential presence of cyclists at or to the east of the Toucan crossing which could give rise to cyclist pedestrian collisions.</p> | |

| <p>It is recommended that measures are provided to ensure pedestrians become aware of the potential for cyclists to be present and cyclists dismount accordingly.</p> | |
| <p>Agreed. Corduroy paving and bollard with appropriate signage now shown on drawing P881/04 Revision D to make pedestrians aware of the potential of cyclists, and for cyclists to dismount accordingly.</p> | |
