# Ecology Report inc. Biodiversity Net Gain Assessment

**DS Smith, Devizes**

| Document No.: | NPA 30243 0400 |

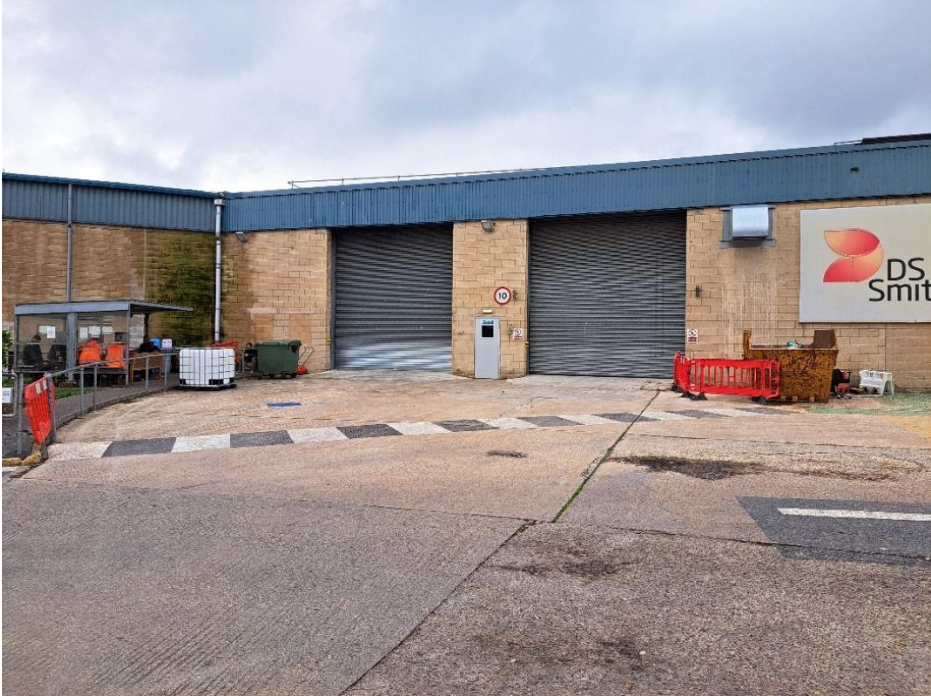
| Photo No. | |
|---|---|
| 1. | <div></div> <p>Area of hard standing / forecourt comprising majority of Site.</p> |

- 4.3 The majority of the Site comprised an area of hard standing forming the existing forecourt and footpaths, and part of the Site extends into the warehouse (Appendix 1; Photo 1). Two structures; a smoking shelter and a bike shelter (Appendix 1; Photo 2) were also present.

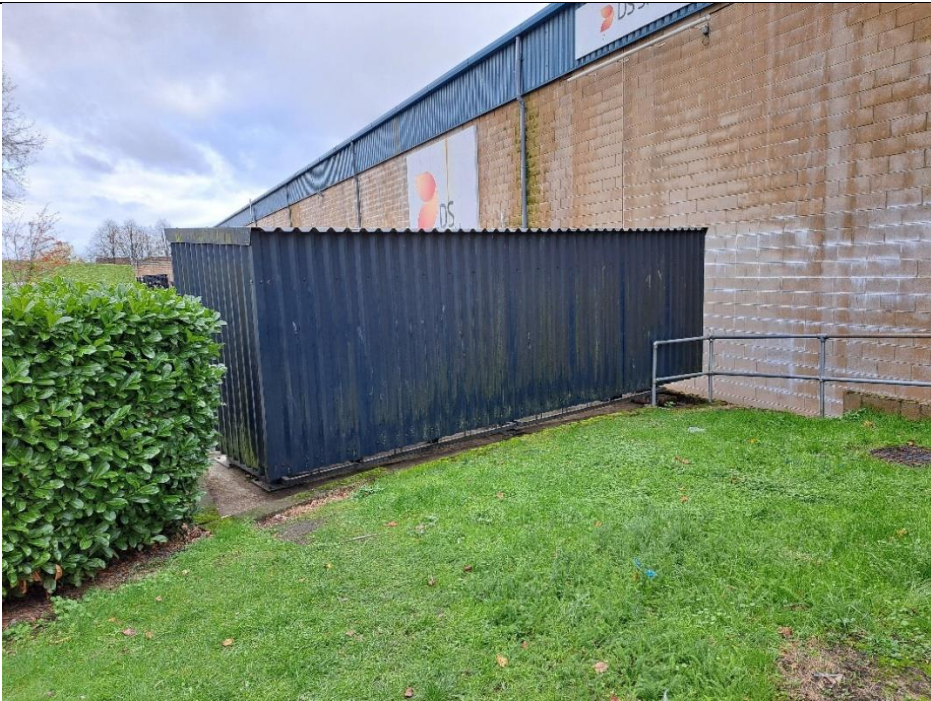
| Photo No. | |
|---|---|
| 2. | <div></div> <p>Metal constructed bike shelter.</p> |

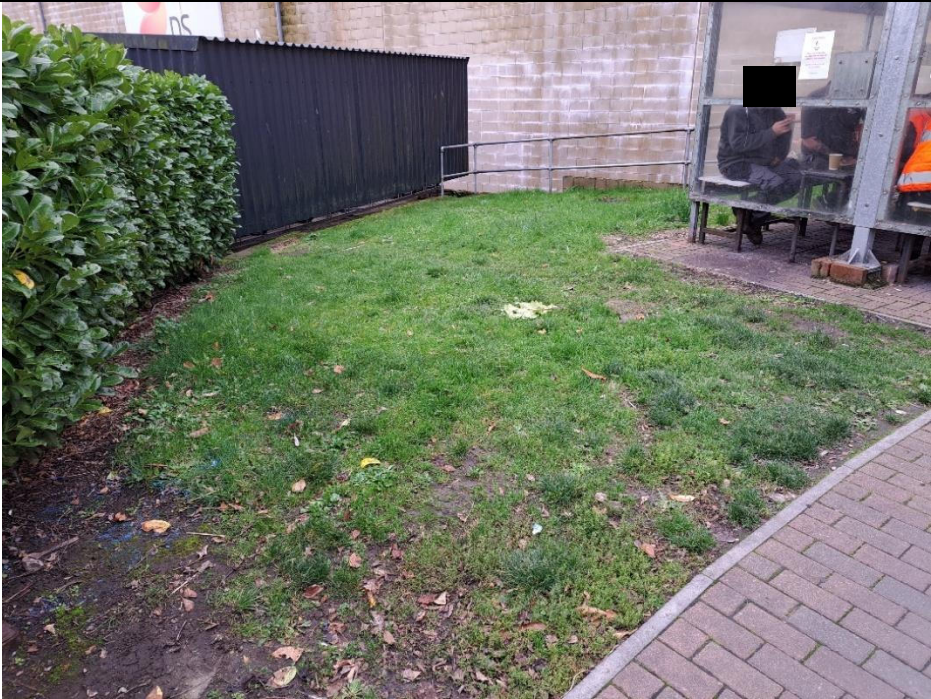
| 3. | <p>Area of species-poor grassland habitat.</p> |

- 4.4 A small (c. 74m<sup>2</sup>) area of species-poor grassland habitat with 7 – 9 species per m<sup>2</sup> was present to the north-west of the Site (Appendix 1; Photos 3 – 5). Perennial Ryegrass *Lolium perenne*, Creeping Bent *Agrostis stolonifera*, and Red Fescue *Festuca rubra* were Frequent within the sward, with Meadow-grass *Poa sp.* and Cock's-foot *Dactylis glomerata* Occasional. White Clover *Trifolium repens* and Creeping Buttercup *Ranunculus repens* were Abundant within the sward and accounted for up to 40% cover of forbs in some localised areas. Other forb species comprised Dove's-foot Crane's-bill *Geranium molle*, Daisy *Bellis perennis*, Self-heal *Prunella vulgaris*, Yarrow *Achillea millefolium*, Common Dandelion *Taraxacum officinale agg.*, Common Ragwort *Jacobaea vulgaris*, Germander Speedwell *Veronica chamaedrys*, Knot Grass *Polygonum aviculare*, and Greater Plantain *Plantago major*. Cover of bare ground was up to 15%, which appeared to be the result of footfall.

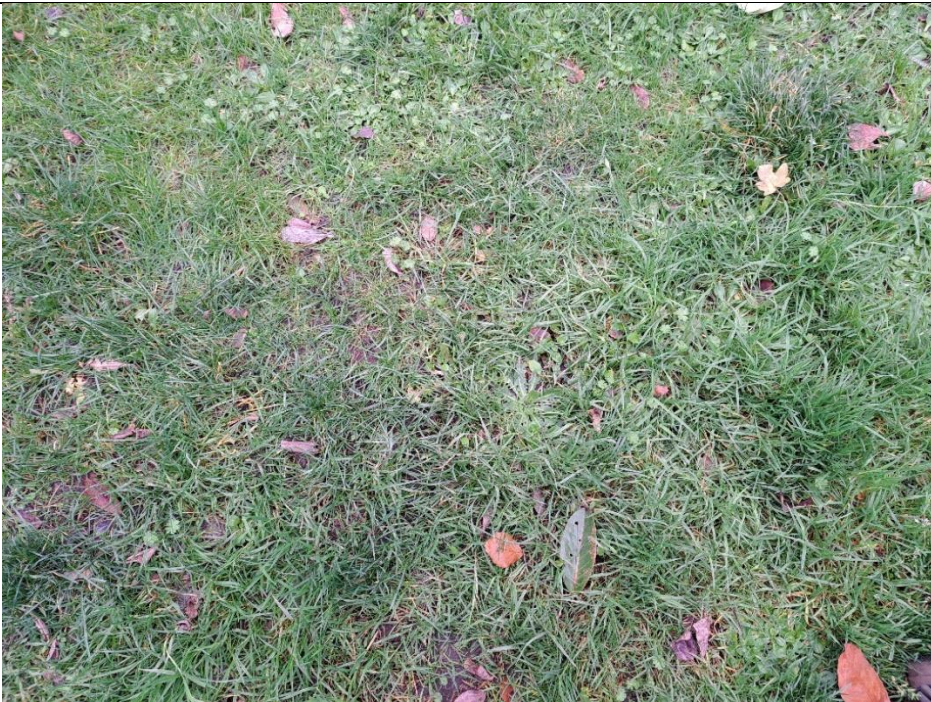
| 4. | <p>View looking down at sward of grassland habitat.</p> |

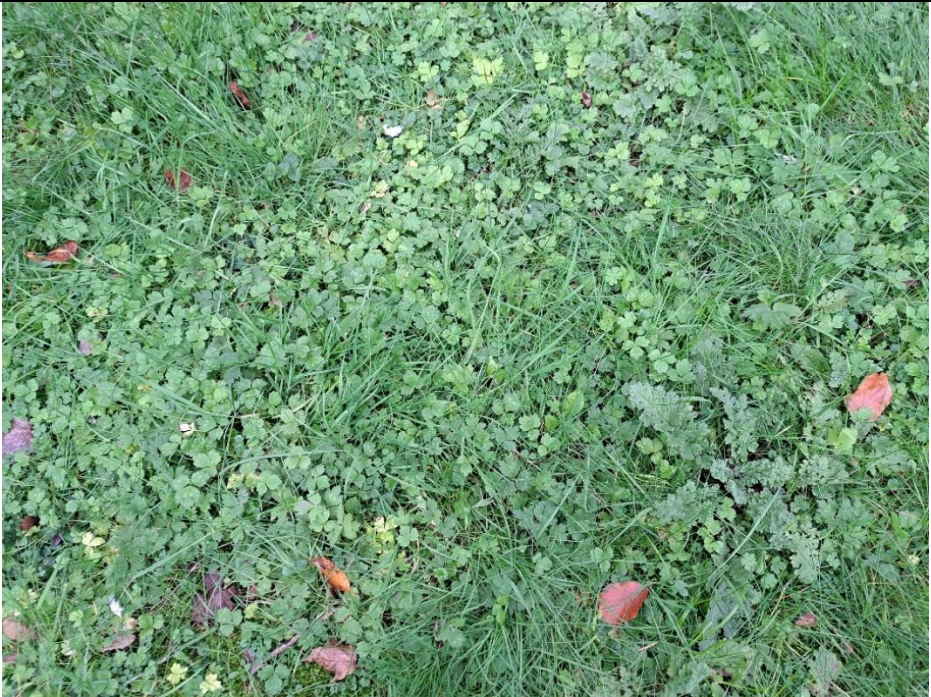
| 5. | | |

View looking down at sward of grassland habitat showing high cover of Creeping Buttercup / White Clover

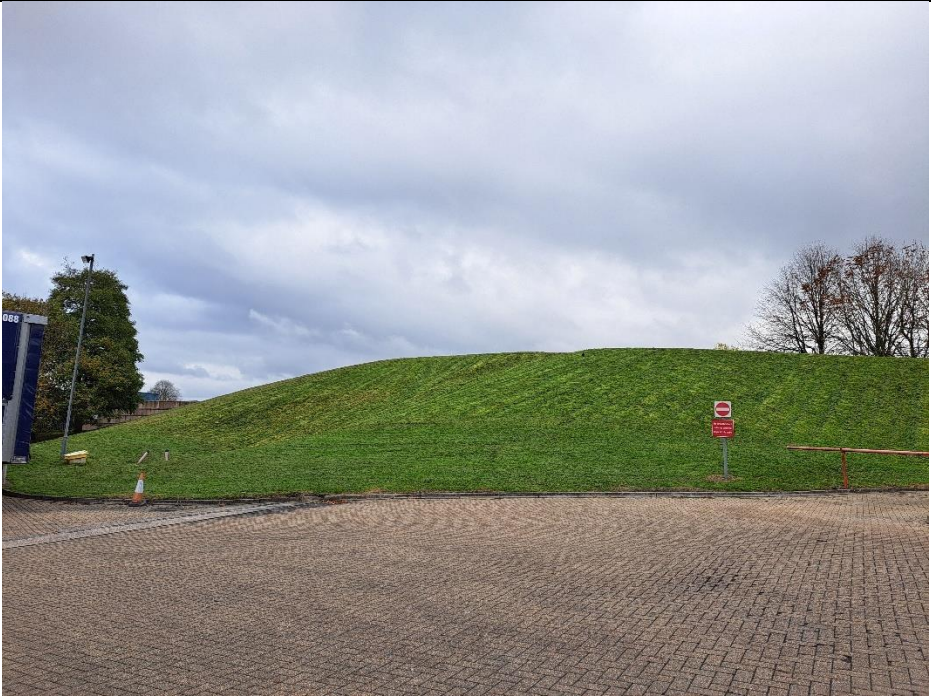
| 6. | | |

View looking south-east at area of modified grassland on sound bank to south-east of Site.

- 4.5 An area of modified grassland habitat with 6 – 8 species per m<sup>2</sup> was present on a sound bank to the south-east of the Site (Appendix 1; Photo 6 and 7). The majority of this habitat was recently mown at the time of survey, except for the south-facing slope, which was left uncut. Yorkshire Fog *Holcus lanatus* was Abundant within the sward, with Cock's-foot Grass and False Oat-grass *Arrhenatherum elatius* Frequent, and Red Fescue Occasional. Forb cover ranged from 4 – 15% per m<sup>2</sup> and included Yarrow, Dove's-foot Crane's-bill, Ribwort Plantain *Plantago lanceolata*, Cat's-ear *Hypochaeris radicata*, Spotted Medick *Medicago arabica*, Red Clover *Trifolium pratense*, Creeping Buttercup *Ranunculus repens*, Common Sorrel *Rumex acetosa*, and Meadow Buttercup *Ranunculus acris*.

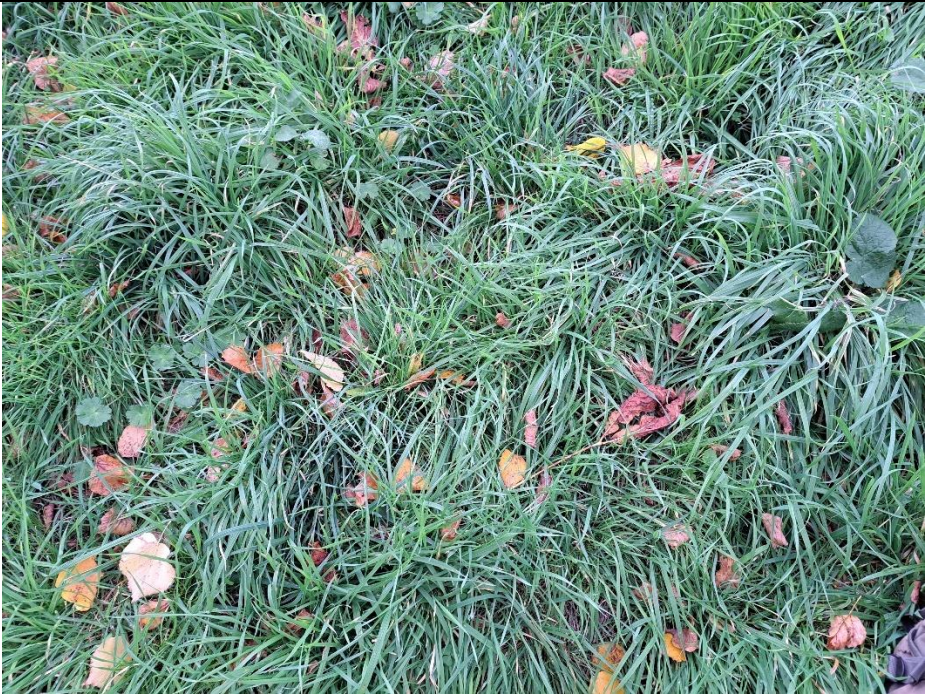
| 7. | <p data-bbox="354 974 1165 1001">View looking down at sward of modified grassland (uncut areas) to south-east of Site.</p> |

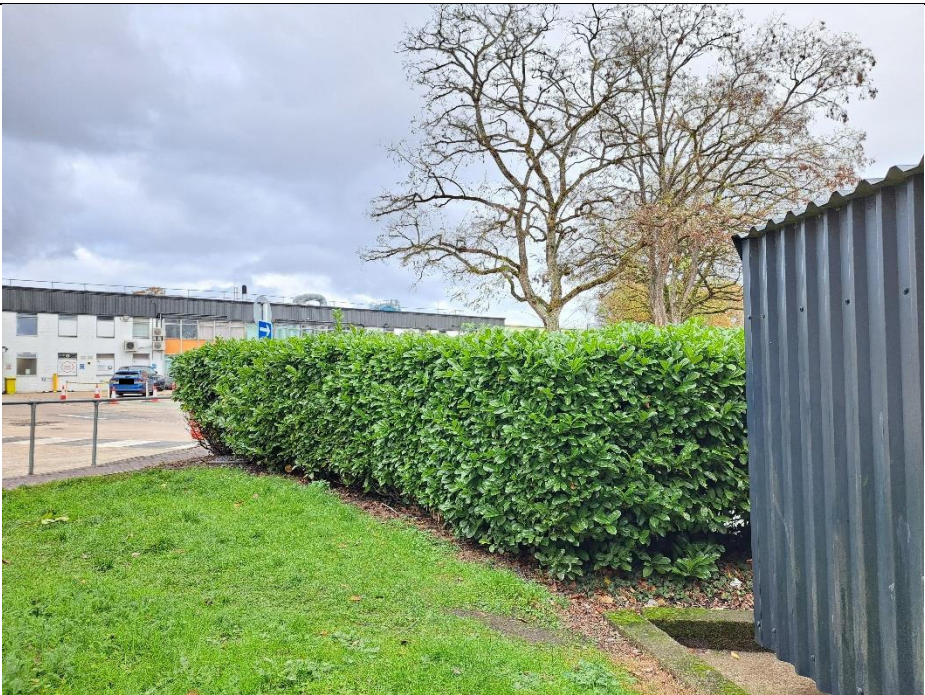
| 8. | <p data-bbox="354 1724 1114 1751">Short Cherry Laurel hedge along edge of grassland habitat to north-west of Site.</p> |

- 4.6 A short length (~11.5m) of Cherry Laurel *Prunus laurocerasus* was present along the eastern edge of the grassland habitat to the north-west of the Site (Appendix 1; Photo 8). Please note as it is below 20m it is not classed a hedge in ecology/BNG terms.

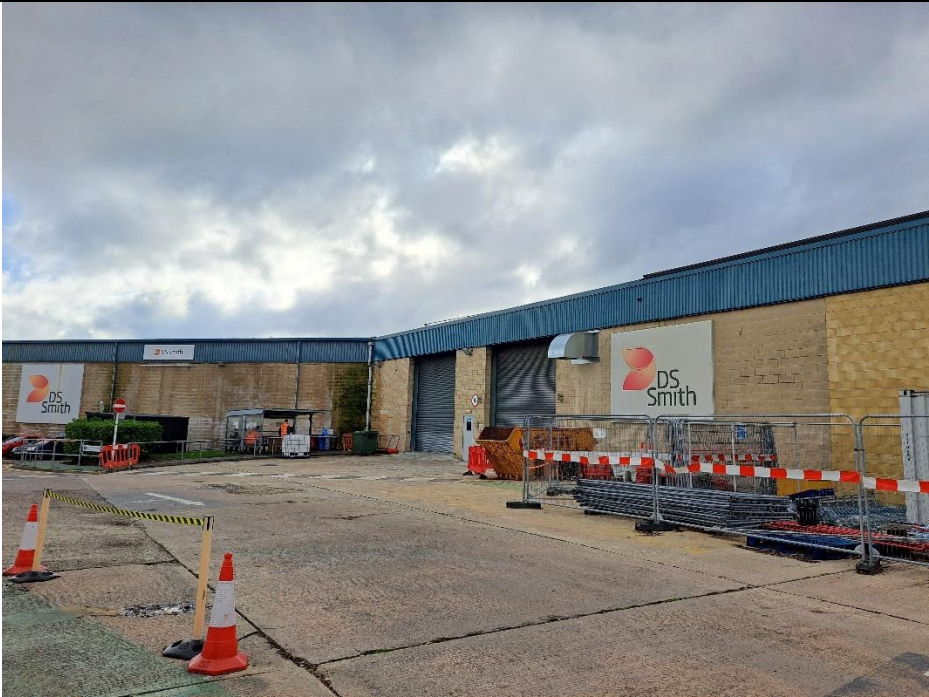
| 9. | <p>A photograph showing the exterior of a large industrial building with a blue corrugated metal roof and light-colored brick walls. The building features several large roller doors, some of which are closed. In the foreground, there is a paved area with orange and white traffic cones and a yellow and black striped barrier. To the right, there are stacks of materials and a red and white striped barrier. The sky is overcast with grey clouds.</p> |

| Overview | |
|---|---|
| <p><b>Industrial Warehouse</b></p> <p>See Appendix 1: Photo 9 for external elevation and Appendix 1; Photo 10 for internal elevation.</p> <p><u>Walls</u> – Constructed from a mix of concrete and breeze block. Blockwork extends the full height of the building and there is a cavity wall present between the breeze and concrete blockwork. 2 No. metal bay door and a single pedestrian door is present along the elevation. Steel pillars/beams are spaced at intervals along the elevation (visible internally). On the external wall, there is a thin (~1m) band of metal corrugated cladding present at the top of the elevation, which appears to be attached to a timber batten running horizontally. This batten appears to be attached to a metal frame. 2 No. flood lights are present along the elevation.</p> <p><u>Roof</u> – Flat roof constructed from metal roofing sheets. No roof voids present.</p> <p><u>Internal</u> – Well-lit and subject to high-levels of human activity and noise from conveyors/machinery.</p> | |

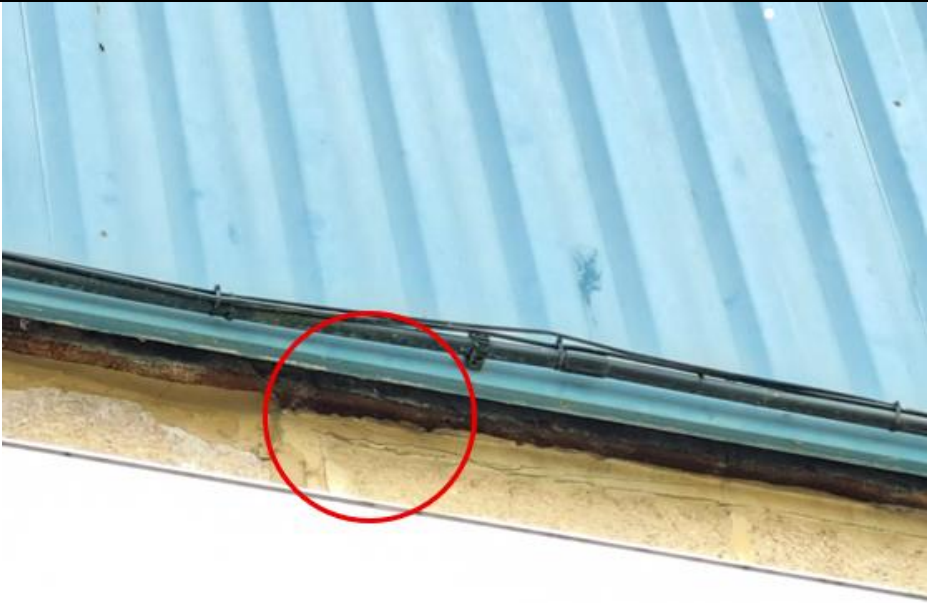
| 11. | <p>Linear gap present where mortar is missing at the join between the metal frame and external blockwork.</p> |

| Overview | |
|---|---|
| External | Gaps behind metal cladding / within overhang of metal frame. There are two of these, both located to the right of a large metal sign on the east-facing elevation. Linear gaps were also present where mortar is missing at the join between the metal frame and external blockwork (Appendix 1; Photo 11). Gap where mortar is missing at side of blockwork below cladding (Appendix 1; Photo 12). Gaps above the bay doors which lead into the interior of the warehouse. Gaps where mortar is missing between the external blockwork and steel pillar at side of bay doors, however, the aerial inspection confirmed that these lead directly into the interior of the warehouse. All of the features above were endoscoped by a licenced bat worker and considered 'negligible' for roosting bats ( <i>i.e.</i> due to their limited size) and none of the features endoscoped lead into a cavity behind the blockwork. |

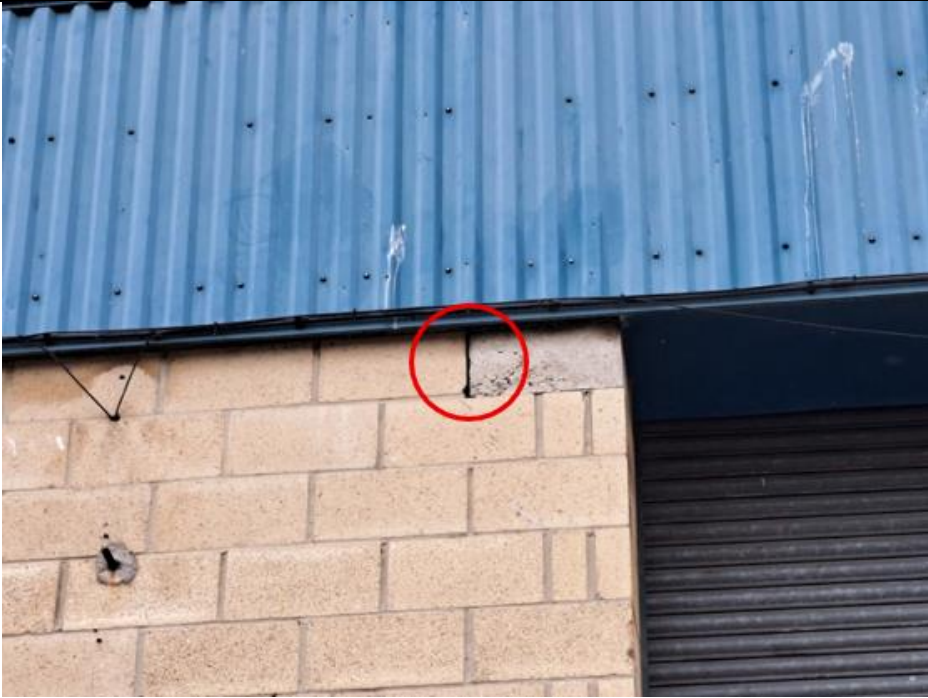
| 12. | <p>Gap where mortar is missing at side of blockwork below cladding.</p> |

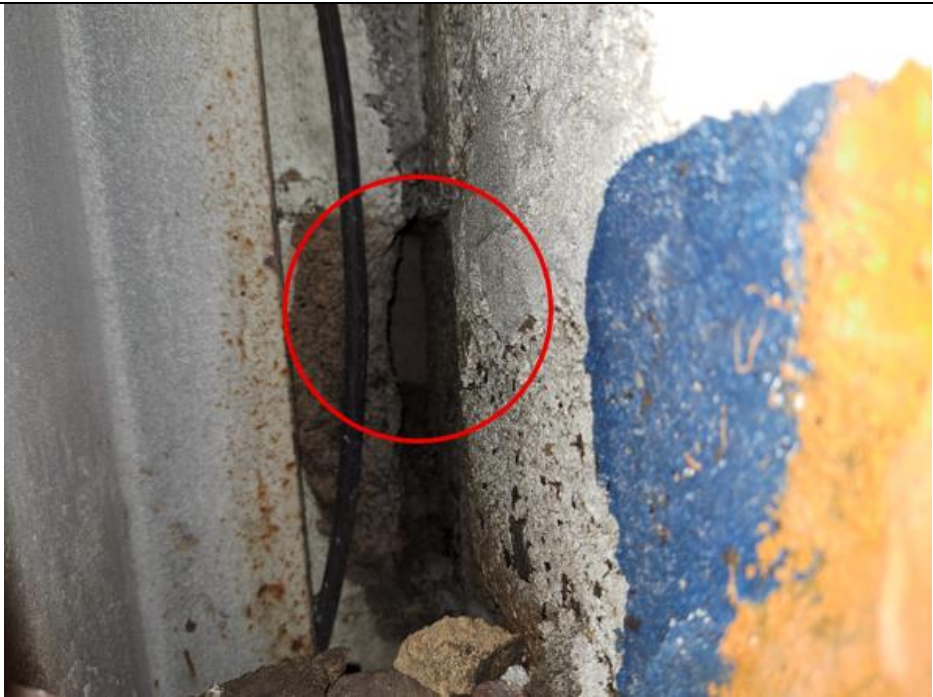
13.

Holes in internal blockwork which appear to lead to a cavity behind the internal and external wall.

| Overview | |
|---|---|
| Internal | Gaps behind the steel pillars and behind pipework. Holes in internal blockwork which appear to lead to a cavity behind the internal and external wall (Appendix 1; Photo 13). 2 No. holes in mortar where a fire alarm has been installed. Given the high levels of disturbance associated with the interior, the gaps ( <i>i.e.</i> gaps leading to cavity) along the internal wall are unlikely to be used as access features for bats. |
