## Technical Note

| <b>Project:</b> | Land at Blackmore Farm – Phase 1 |
| <b>Title:</b> | Ecological Compliance Statement |

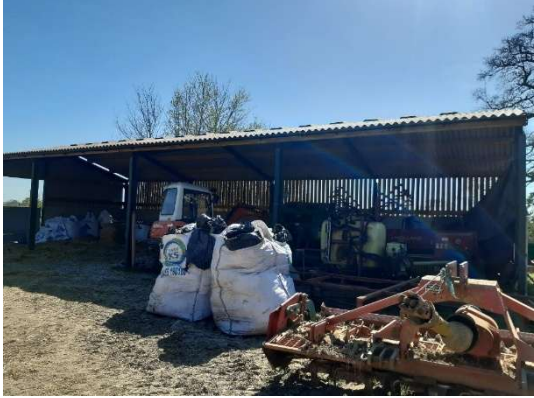
| Building ref | Structure Description | Photo | Bat Potential & Evidence | Roost suitability |
|---|---|---|---|---|
| 7 | Open-fronted barn. Constructed from a steel girder framework with blockwork and timber slats on west elevation, half height metal doors on the north and south elevations and open to the east. Gabled roof covered with corrugated fibre cement. | | No evidence of bats. Potential bat access through gap under timber fascia on east elevation, however very limited in extent. | Negligible |

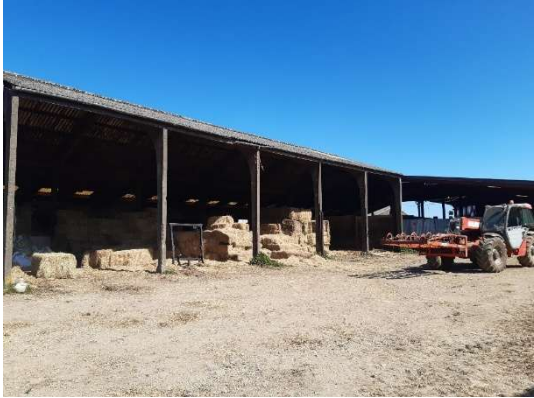
| Building ref | Structure Description | Photo | Bat Potential & Evidence | Roost suitability |
|---|---|---|---|---|
| 8 | Hay barn and cattle shed. Building constructed from blockwork and corrugated tin with internal walls created from wooden sleepers. Gabled roof covered with corrugated asbestos that has been extended to the south. Open structure. | | No evidence of bats. Potential roosting feature in small crevice under asbestos gable trim on southern elevation but very limited. | Negligible |

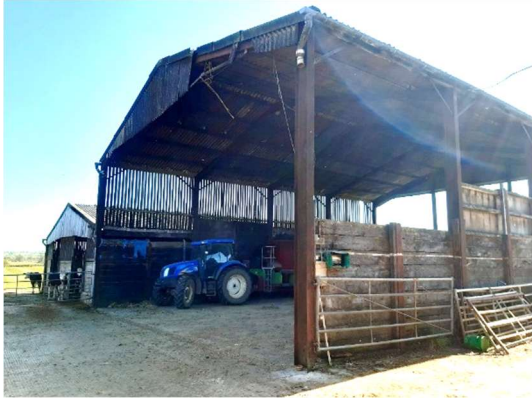
| Building ref | Structure Description | Photo | Bat Potential & Evidence | Roost suitability |
|---|---|---|---|---|
| 9 | <p>Barn and cattle shed (open barn for storage to the north and cattle shed to the south). Open-sided barn constructed from wooden sleepers, breezeblock and timber slats on southern upper half of the wall. Cattle shed constructed from corrugated tin and breezeblocks on west elevation, wooden sleepers on north elevation, timber slates and breezeblocks on east and south elevations. Double gable roof covered with corrugated asbestos.</p> | | <p>No evidence of bats. Potential bat access through lifted gable trim on east elevation of cattle shed and on west elevation of open-sided barn.</p> | <p>Low</p> |

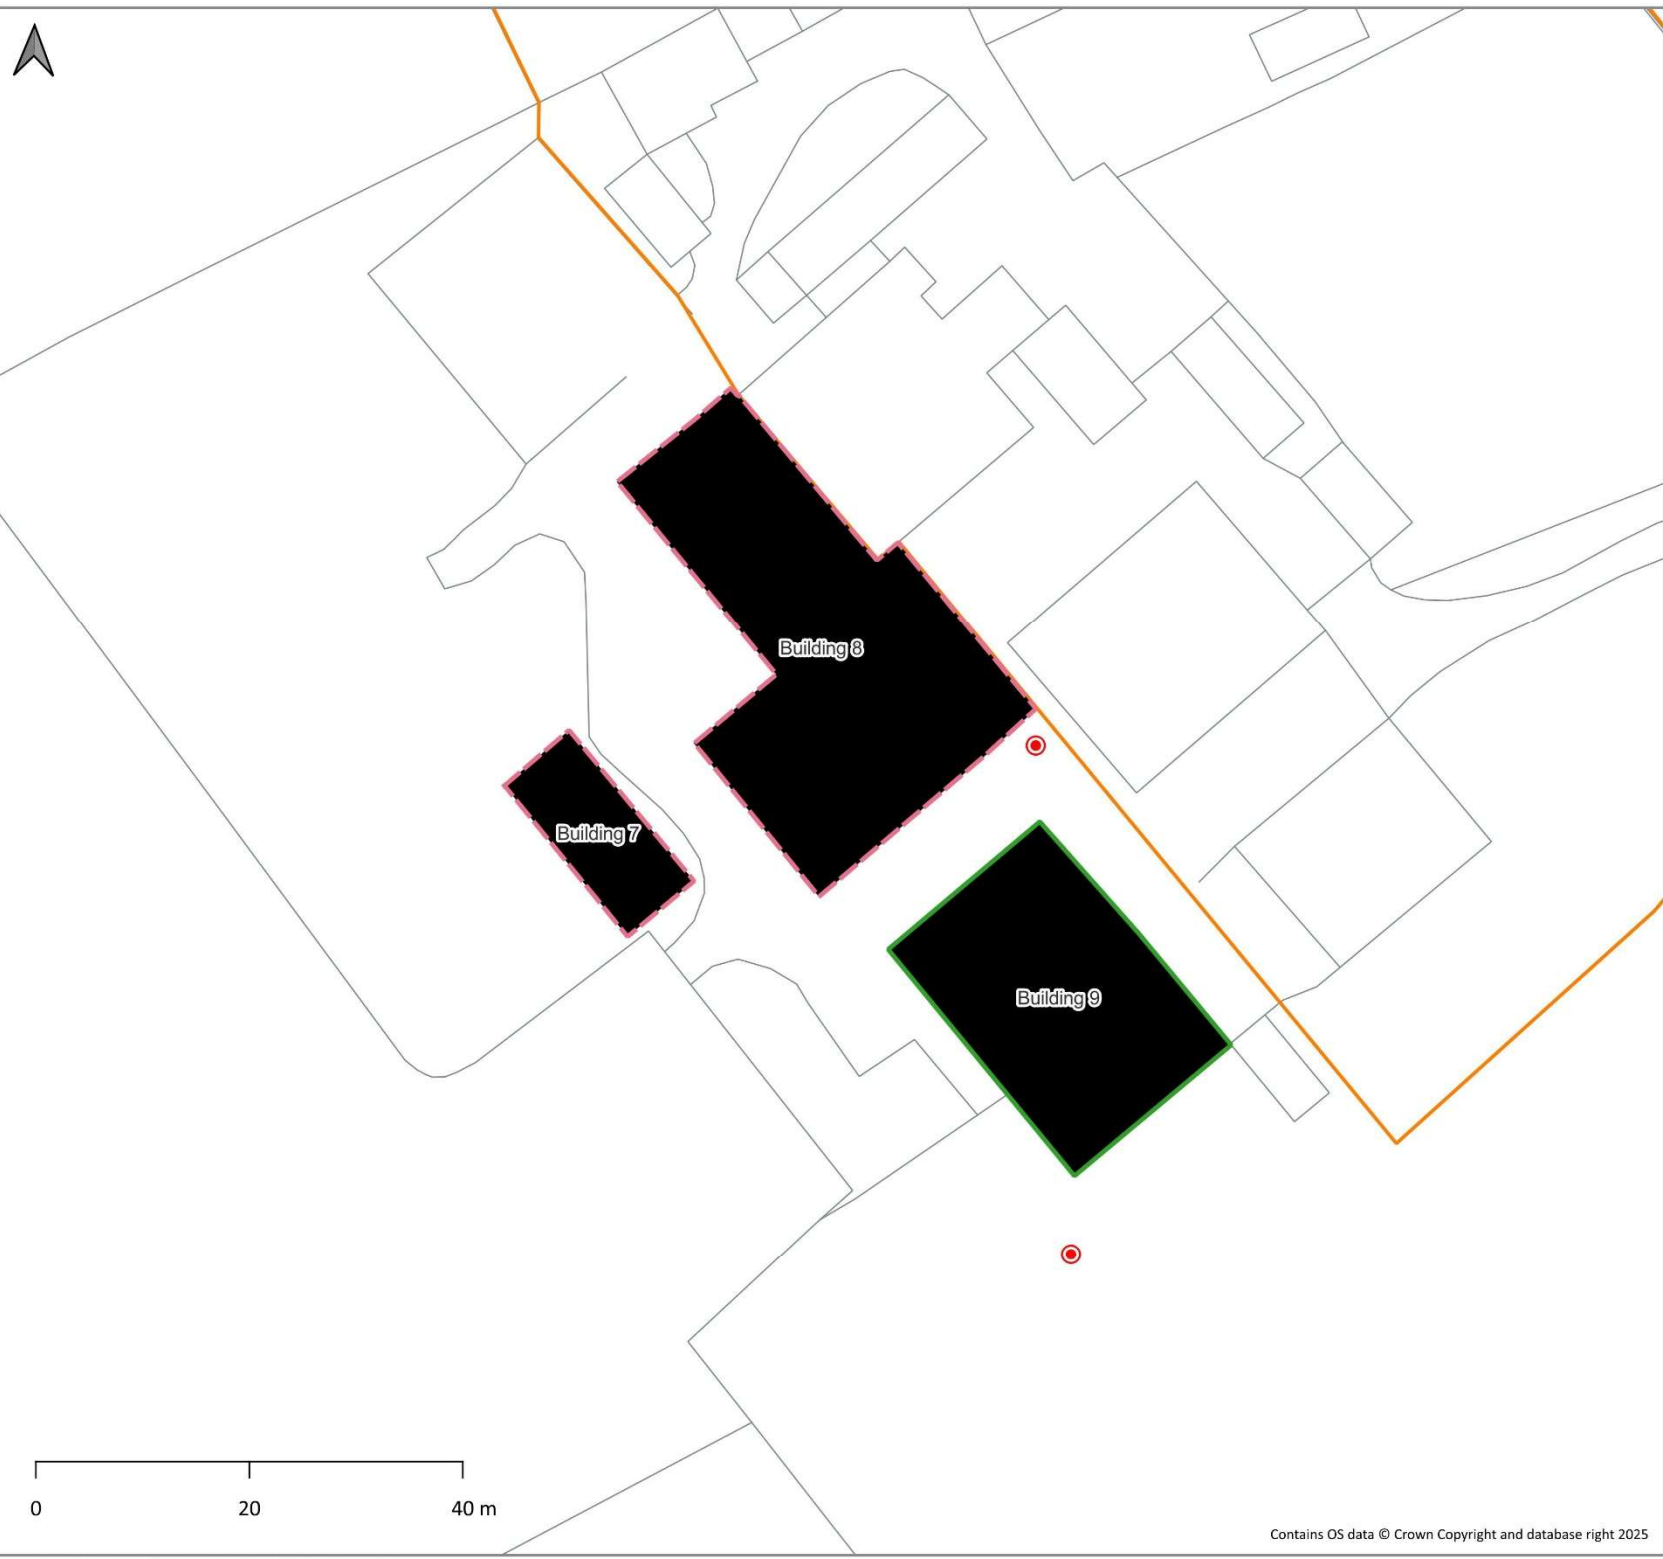
## **Figure A3.4: Bat Roost Suitability Plan (Buildings)**

- Phase 1 survey boundary
- Building - negligible bat roost suitability
- Building - low bat roost suitability
- Surveyor Position

All buildings located within or adjacent to the site were assessed on 14 May 2024 for their suitability to support roosting bats in accordance with the Bat Conservation Trust (BCT) guidelines (Collins [ed.] 2023); refer to Table A3.3. Buildings were subject to detailed internal and external inspections by licenced bat ecologists for evidence of bats, such as droppings, staining and feeding remains, using a high-powered torch and endoscope. Following the initial inspection, any buildings with suitability for roosting bats were subject to emergence surveys to establish and characterise any roosts present.
