# BRIDGEWALK HOUSE, BRIXTON DEVERILL, WILTSHIRE

Results of an archaeological trial trench evaluation

Wiltshire Council planning reference PL/2022/05624

Report No: ACW1518/2/1

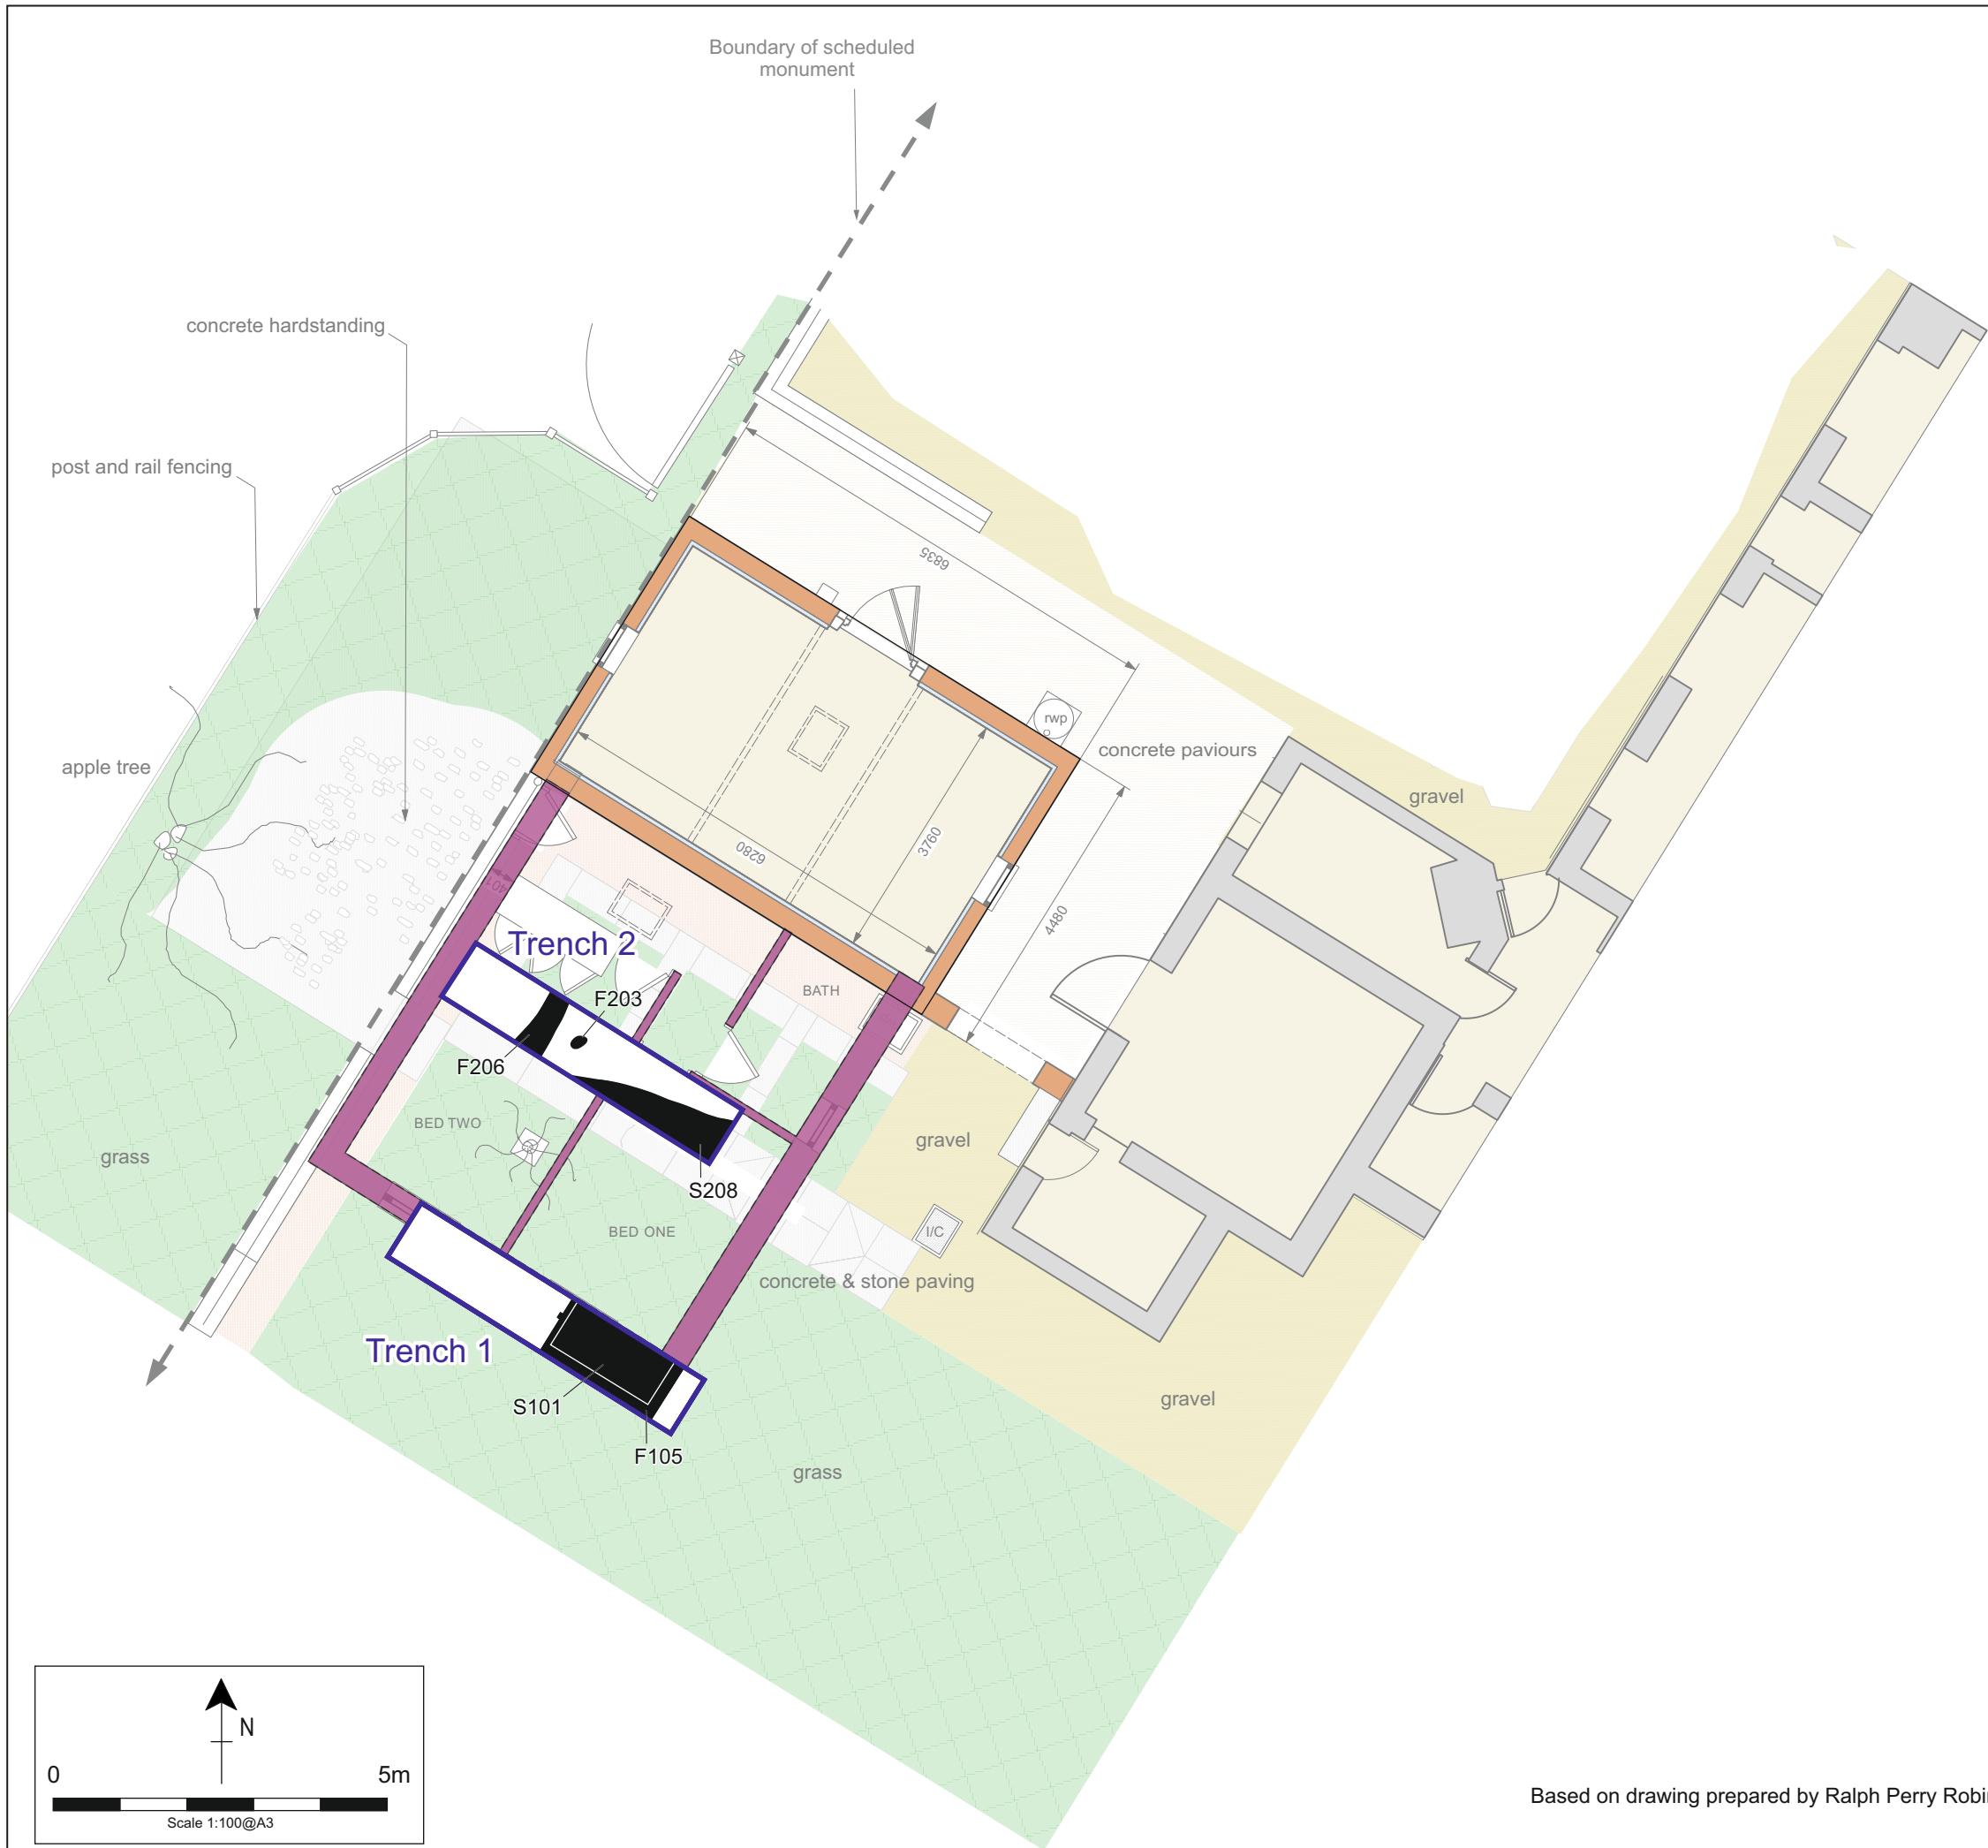
TITLE  
Fig. 1: Location of site and  
excavated trial trenches and  
proposed development plan  
with archaeological features  
shown

Archaeological features and deposits were exposed in both trenches and were present from beneath an approximately 0.1m to 0.3m thick garden topsoil. The results from the trenches are described in detail below

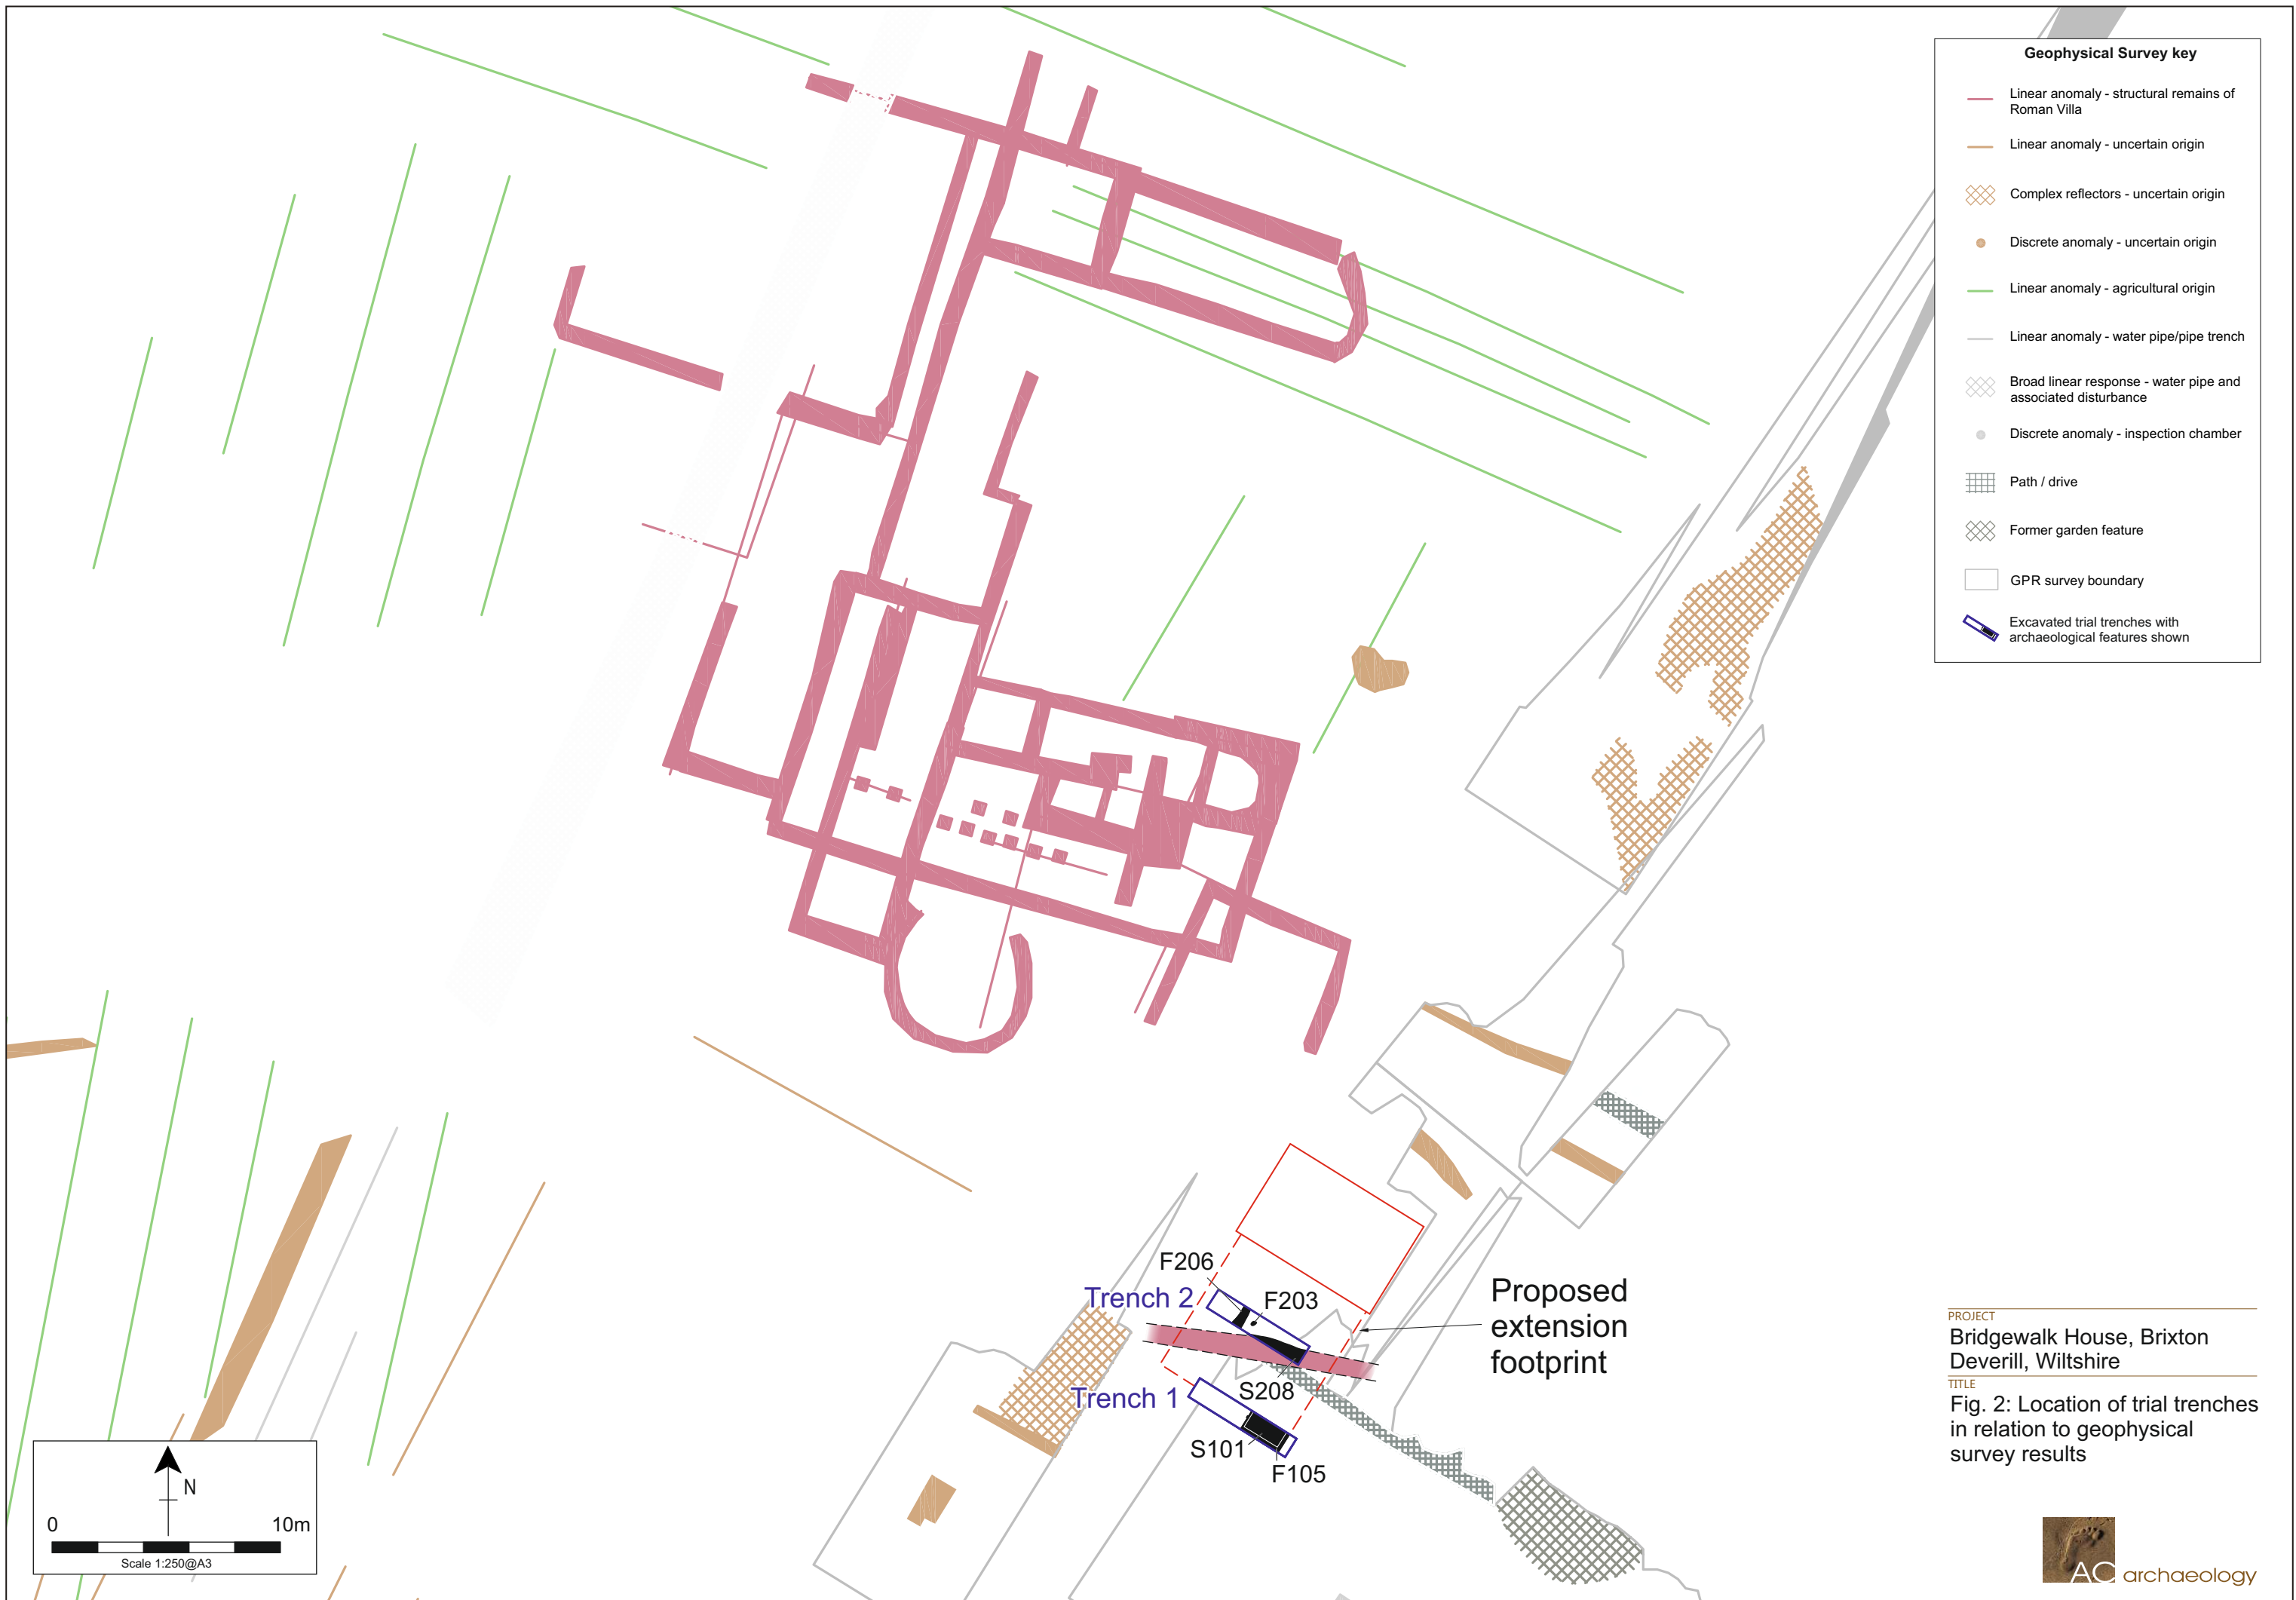
a) Plan of Trench 1

Trench 1 was aligned northwest to southeast and was positioned over the southwest extent of the footprint of the proposed new extension. It was excavated onto natural subsoil (context 105), which comprised a mixed brown clay with flints and creamy white marly chalk that was present from a depth of approximately 0.6m below existing levels. The natural subsoil was overlain by a 0.45m thick mid grey clay loam with sandstone roof tiles fragments, crushed wall plaster, and frequent flint and stone inclusions (107). Finds recovered from this layer consisted of Roman pottery sherds, an iron nail, ceramic tile fragments, animal bone and oyster shell. Layer 107 was sealed by a mid to light grey silty loam subsoil (106), which was cut by the construction cut (F104) for a brick structure (S101).

Structure S101 was partially exposed and measured 1.9m across and 0.5m deep. It was comprised of lime mortar bonded brick walls and un mortared brick base. The structure was set within a construction cut (F104) that had been backfilled with a mid-grey silty clay with abundant lime mortar fragment inclusions. The structure contained a light grey silty loam fill (102) that had frequent stone and brick fragment inclusions and from which 19th century pottery was recovered.

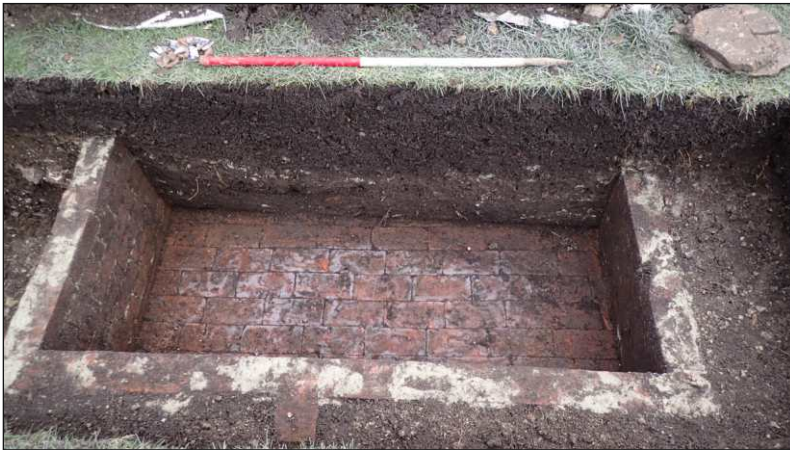
Plate 3: Trench 1, brick structure S101. View to northeast (scale 1m)

**7.4** Post-medieval activity was shown to also be present within the footprint of the proposed new extension. This comprised the small pit containing the remains of a probable fowl (F203), a small ditch (F206) and a brick structure (S101), which based on the depiction of a glasshouse shown in this location on the 1887 First-Edition 25-inch Ordnance Survey map is perhaps likely to represent an associated structural element.

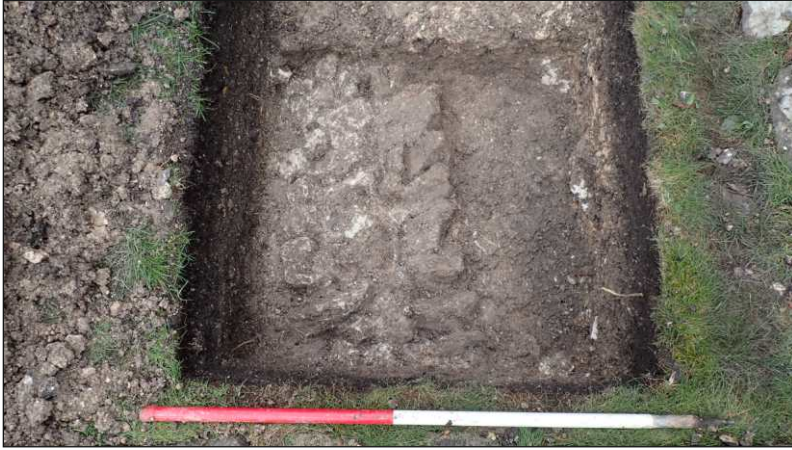
Plate 5: Trench 2, wall S208, view to northeast (scale 1m)

Partially exposed wall S208 was approximately east to west aligned and at least 0.65m wide. It was exposed from a depth of around 0.45m below existing levels and was sealed by demolition deposit sequence comprised of layers 210 and 209. The wall was comprised of light yellowish grey lime mortar bonded flint nodule facing and a rubble core.

**7.1** The results from the trial trench evaluation have recorded evidence for Roman activity within the footprint of the proposed new extension. This comprised the exposure within Trench 2 of an east to west aligned stone-built wall at a depth of 0.45m below existing levels. The results also demonstrated that the wall was sealed by demolition deposits (209 and 210) that included fragments of Roman painted wall plaster. A likely equivalent deposit containing structural demolition material and Roman finds was also exposed in Trench 1 (107). These demolition deposits were present from a depth of 0.2m to 0.3m below existing levels, and for Trench 2, extended to a depth of 0.6m where the natural subsoil was encountered.

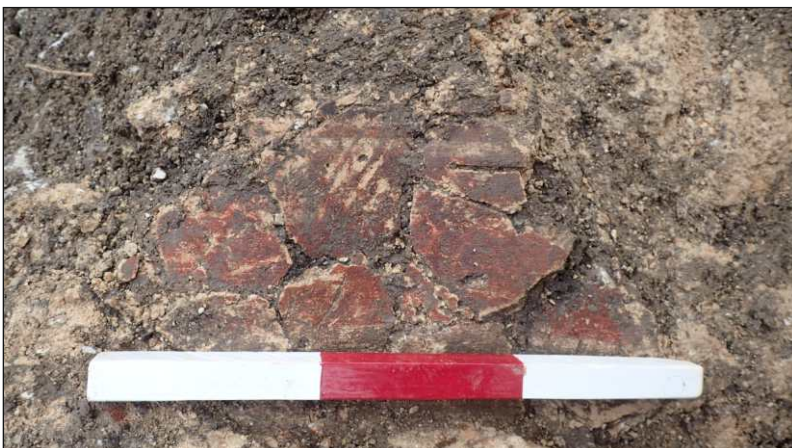
Plate 8: Trench 2, showing painted wall plaster fragments in demolition layer 209 (scale 0.3m)

Twenty-four fragments (1520g) of wall plaster were recovered from demolition deposit 209. The fabric of this assemblage is consistent and have an abraded, painted surface

of a predominately reddish/brown colour, with some pieces also having additional pink, grey, white and blue/green colours.

**7.3** Given the limited exposure of the structural remains, a function of the building is difficult to ascertain, although the presence of a moderate quantity of painted wall plaster would suggest that an elevated status continued into this part of the site.
