# **Prospect House, Shaftesbury Road, East Knoyle, Wiltshire, SP3 6AR**

## **Preliminary Roost Appraisal**

Final Report

24 February 2026

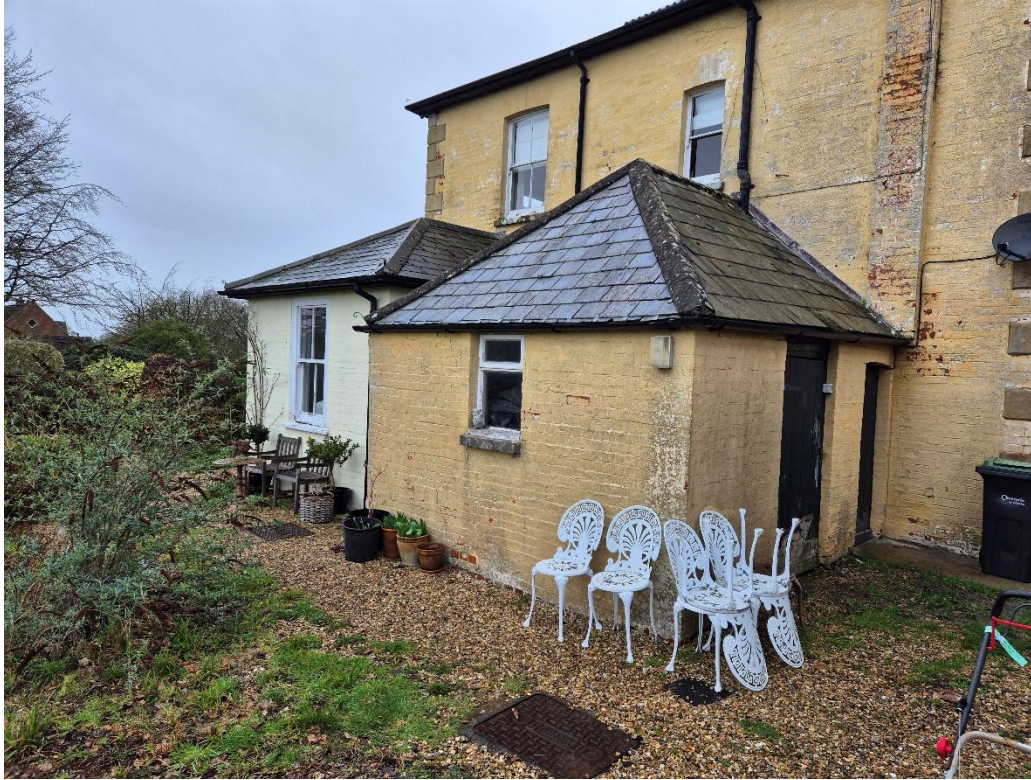
*Photograph 1: Two rear single storey extensions proposed for works (outbuilding on right of photo)*

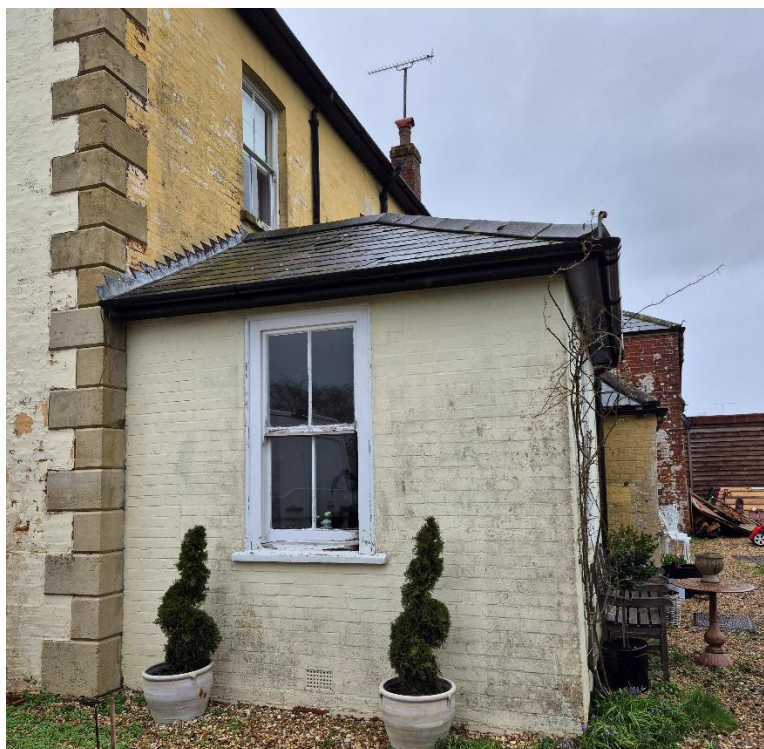
- The single storey extension has brick elevations with hipped slate covered roof, concrete bonnets.
- There was one slightly raised slate on the side and one slipped slate with a slight gap.
- The flashing where it meets the main house was noted flush and tight.
- It has wood windows (one in moderate condition) and wooden soffits in good condition with no gaps.

*Photograph 2: Side elevation of Lounge extension*

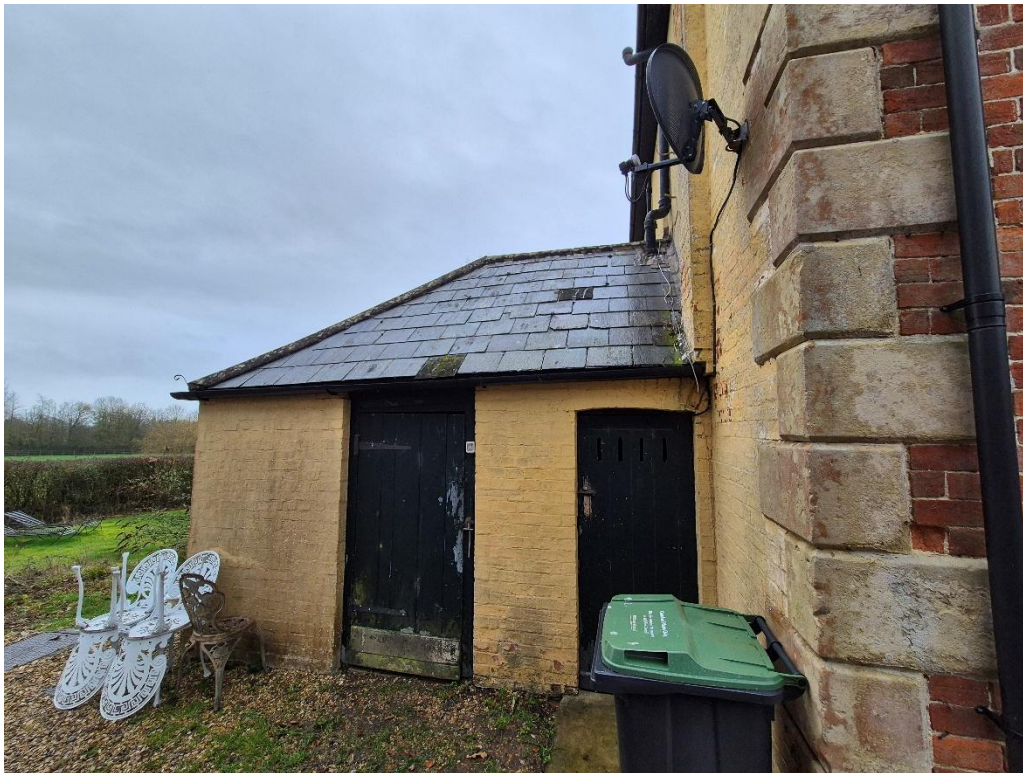
- 3.5 The following was noted:
- The single storey extension has brick elevations with hipped slate covered roof, with concrete bonnets. There was one raised slate was noted (there is no liner internally and no cavity formed).
  - The flashing where it meets the main house was noted flush and tight.
  - It has wood windows and doors, and closed wooden eaves. The slates at gutter level were damaged in a couple of places, however there was no wall top cavity formed.

*Photograph 3: Side elevation of outbuilding extension*

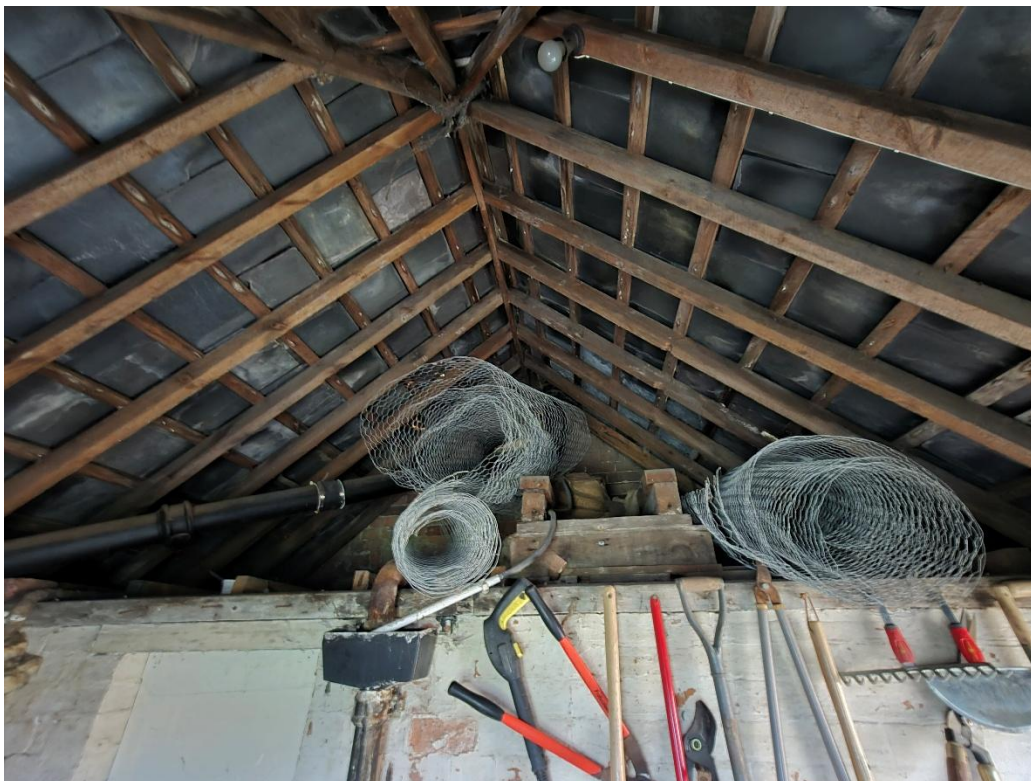
- 3.6 The following was noted inside the extensions:
- The roof is unlined with slates visible from the inside. There were broken slates under the hip rafter noted, however externally these bonnet tiles were well sealed.
  - There is a front room (eastern side) which is open to the ridge with no void, this connects to a void above the rear rooms (adjacent to the house). There is an internal brick dividing wall.
  - There is a wooden ridge.
  - The space measure 3.8m long, 3.3m wide and 3.8m high from the floor level (with a smaller open void above the rear rooms).
  - No bat droppings or other evidence of bats was observed.

*Photograph 4: Inside of roof, outbuilding extension*
